Liberty Bridge Incident

QAW February 2018
Tom Macioce, P.E.
Chief Bridge Engineer
PennDOT

Liberty Bridge Fire – 9-2-2016

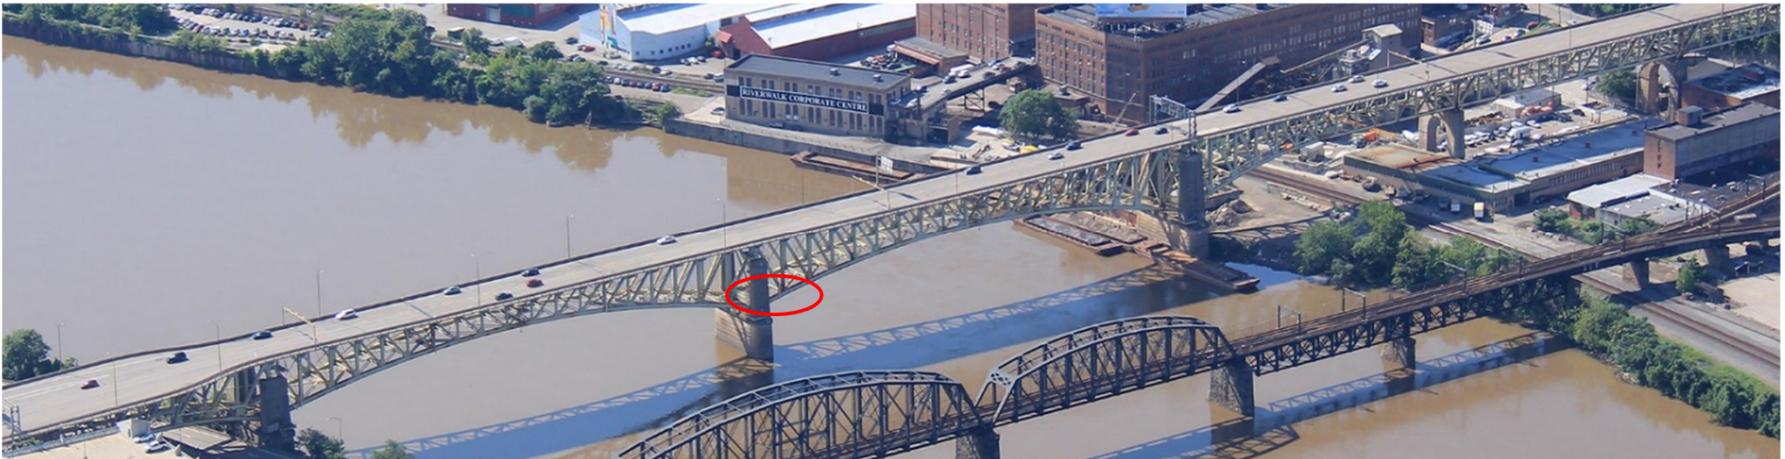
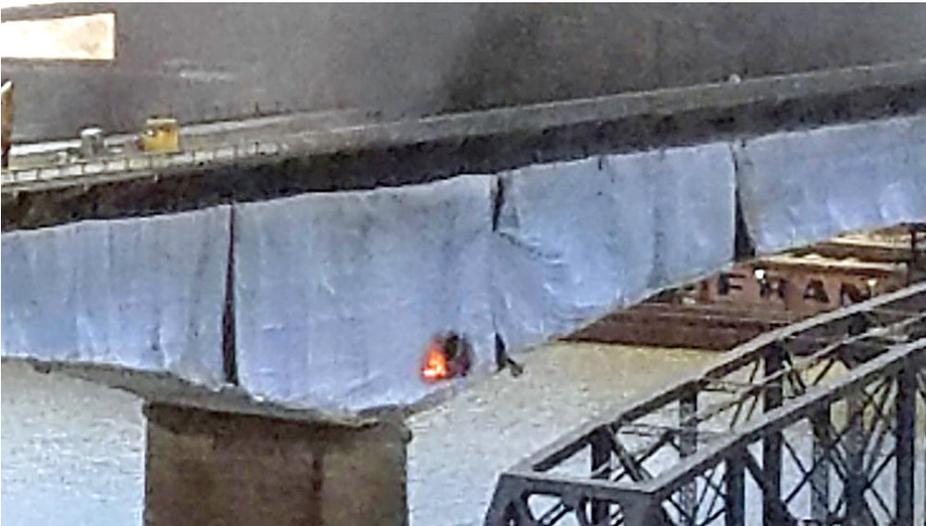
A fire ignited on the lower safe span platform causing damage to the bottom chord of west truss (downstream side) behind pier 7.

Fire started at
approximately 1:00pm,
September 2nd

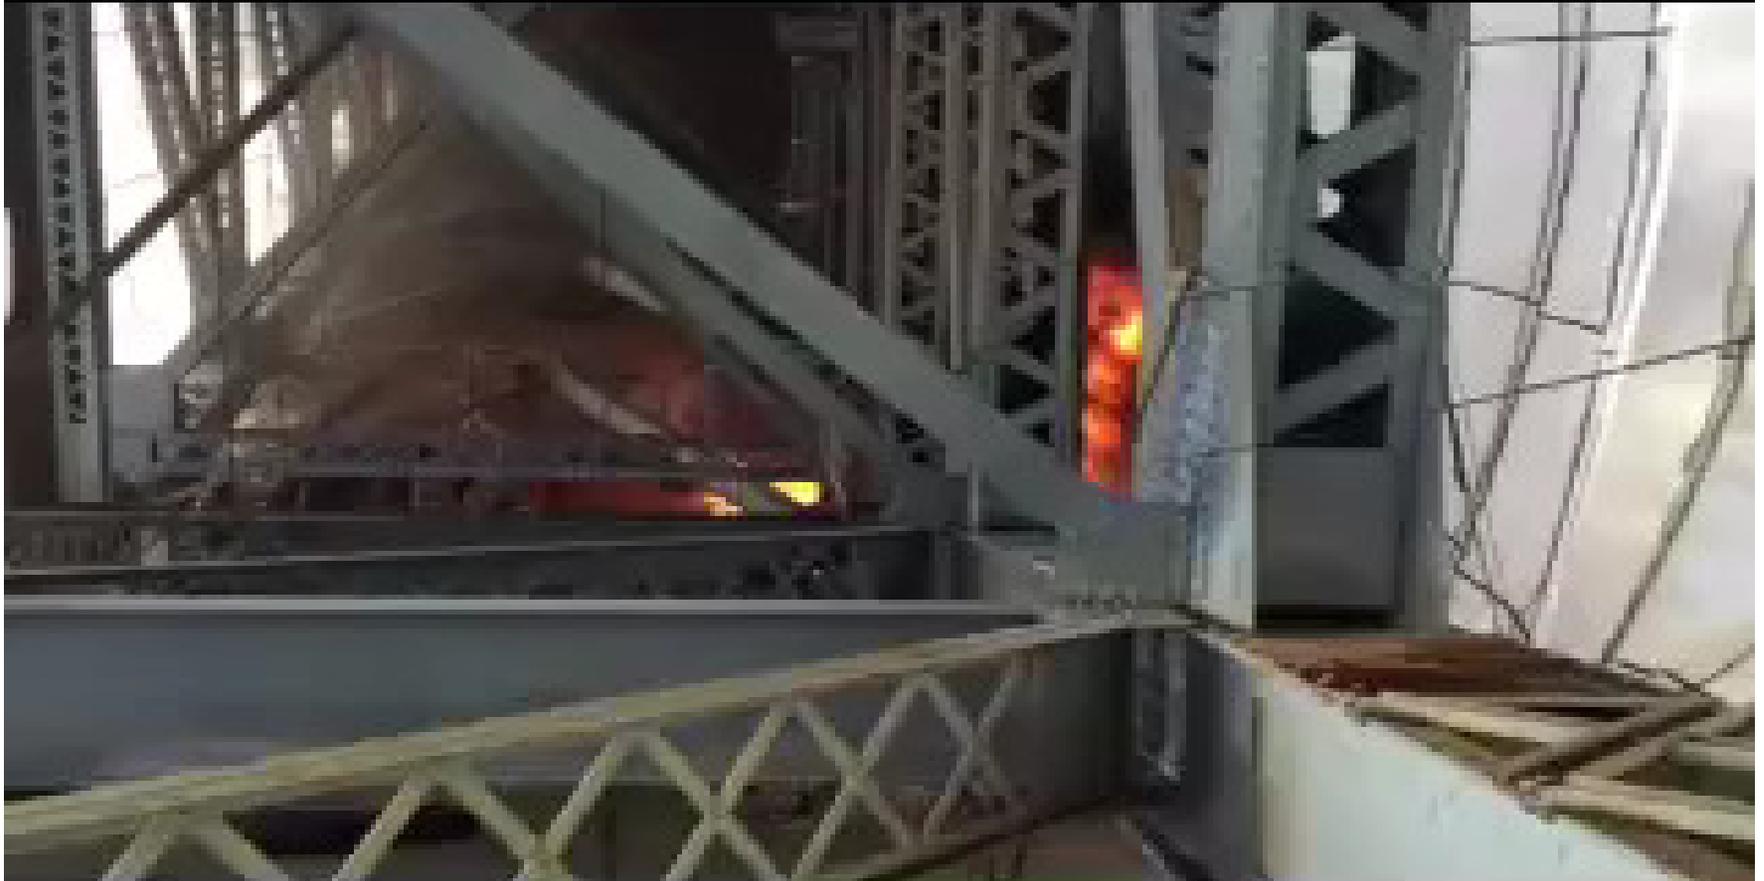
The fire was ignited by errant sparks from a welder's torch from above deck remove operations (last phase of existing deck removal). These sparks ignited plastic piping, which then lit a containment tarp draping the bridge.

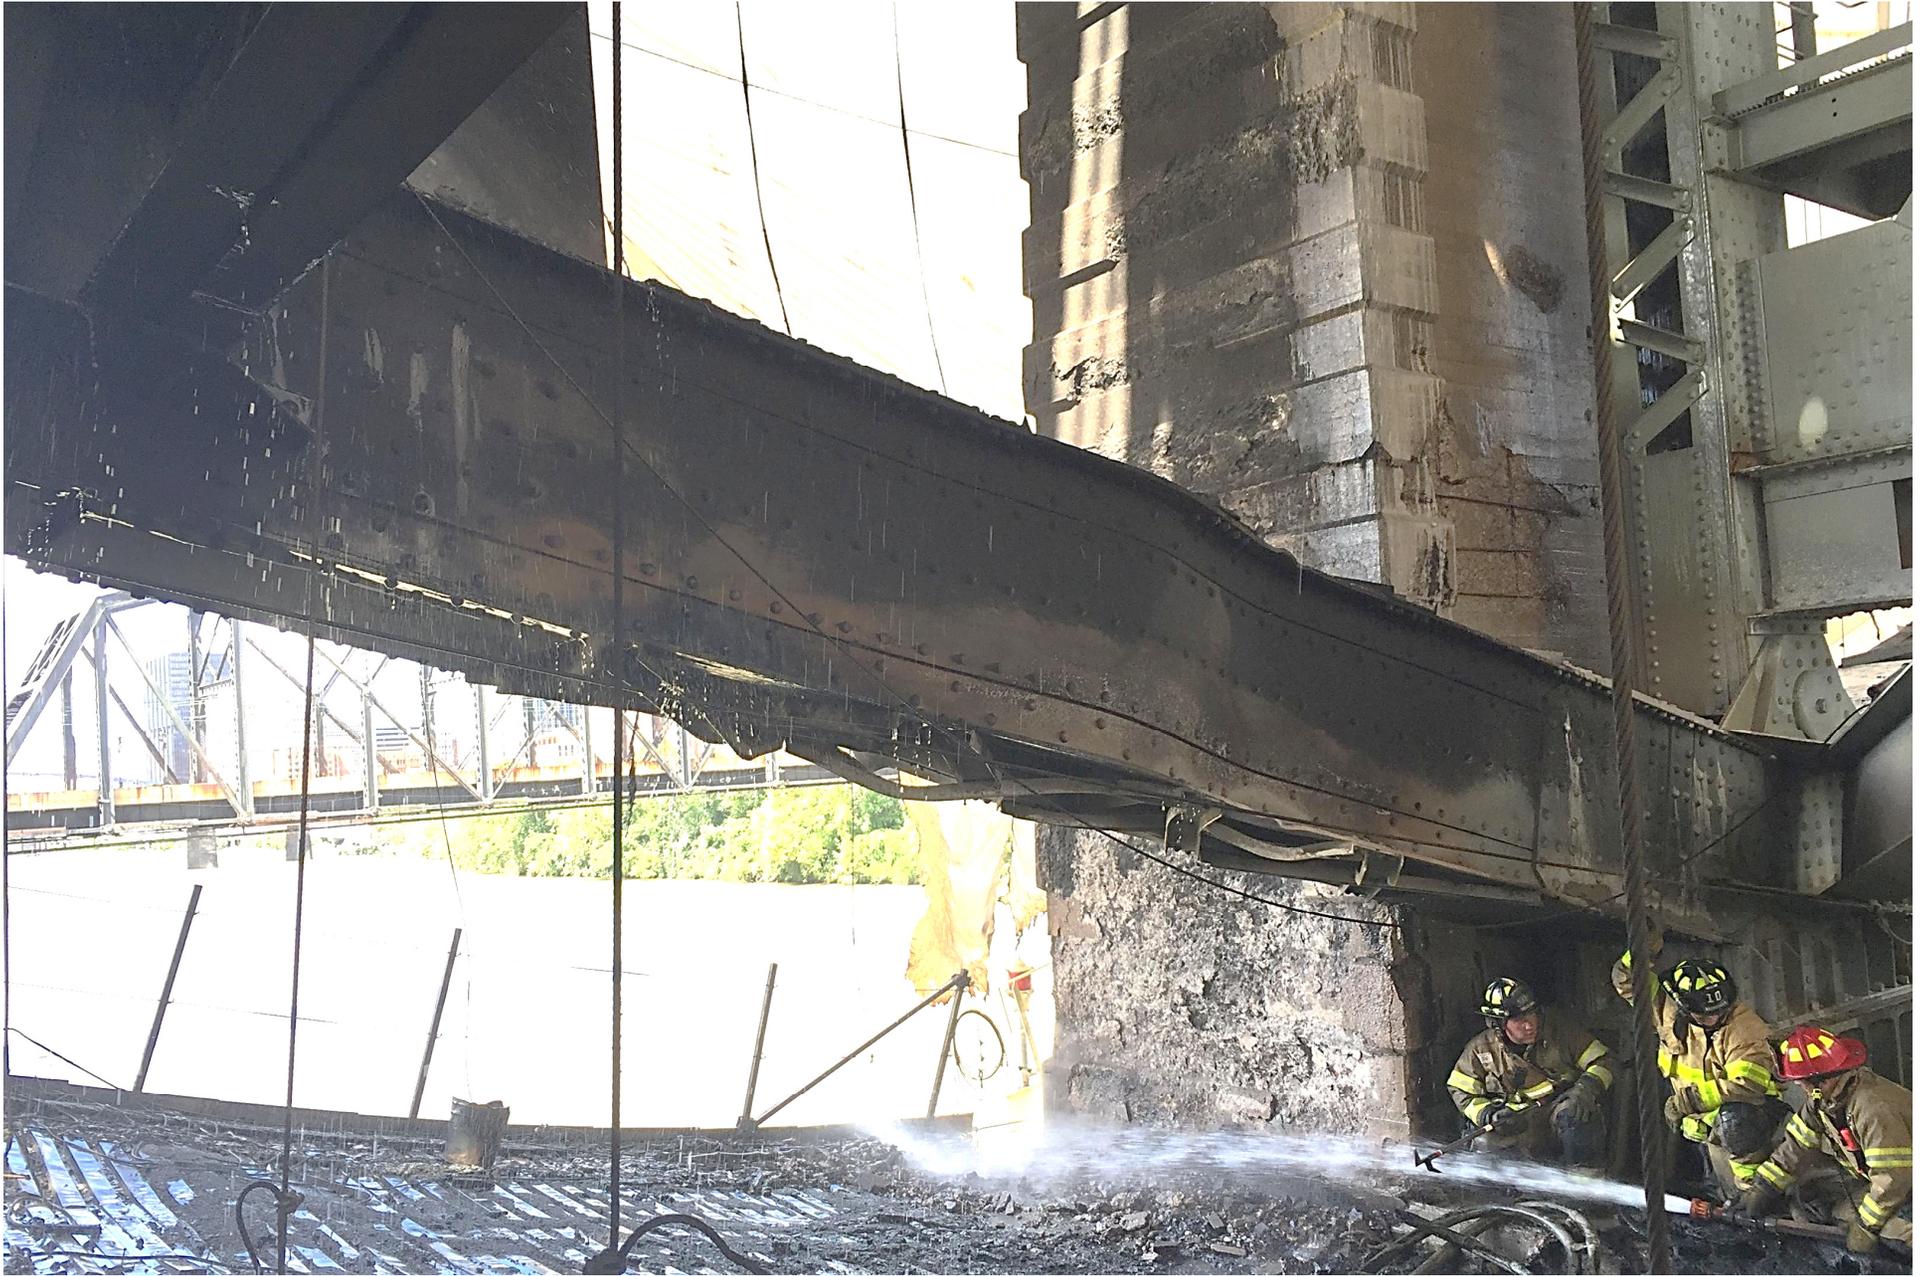
The fire was extinguished by the City of Pittsburgh Fire Department within a half hour of their arrival. There were no injuries reported.

The City of Pittsburgh Firefighters did a great job of getting the fire out in 30 minutes.

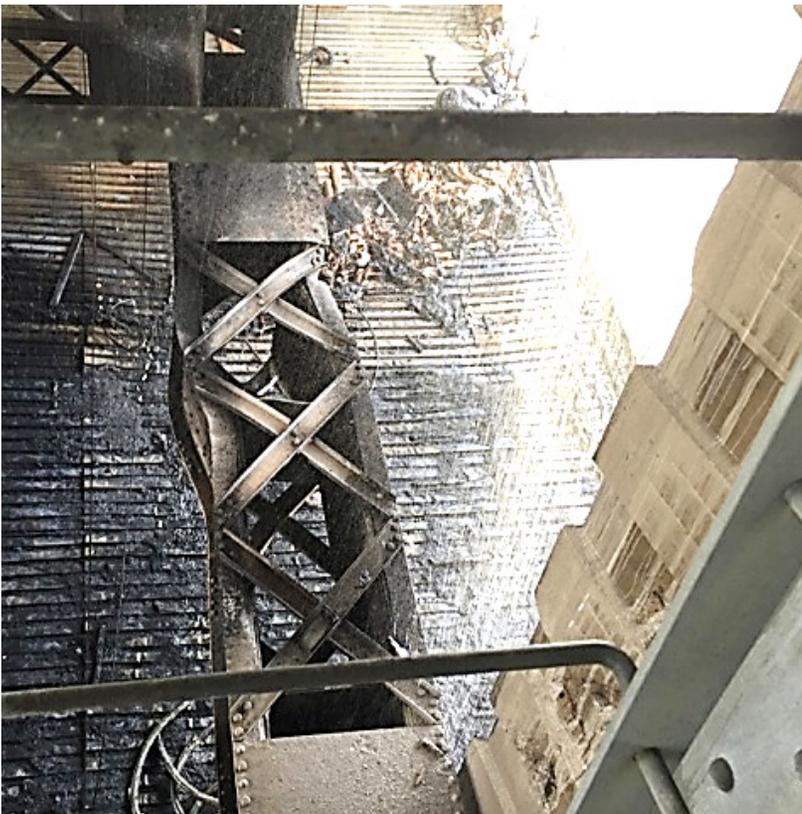
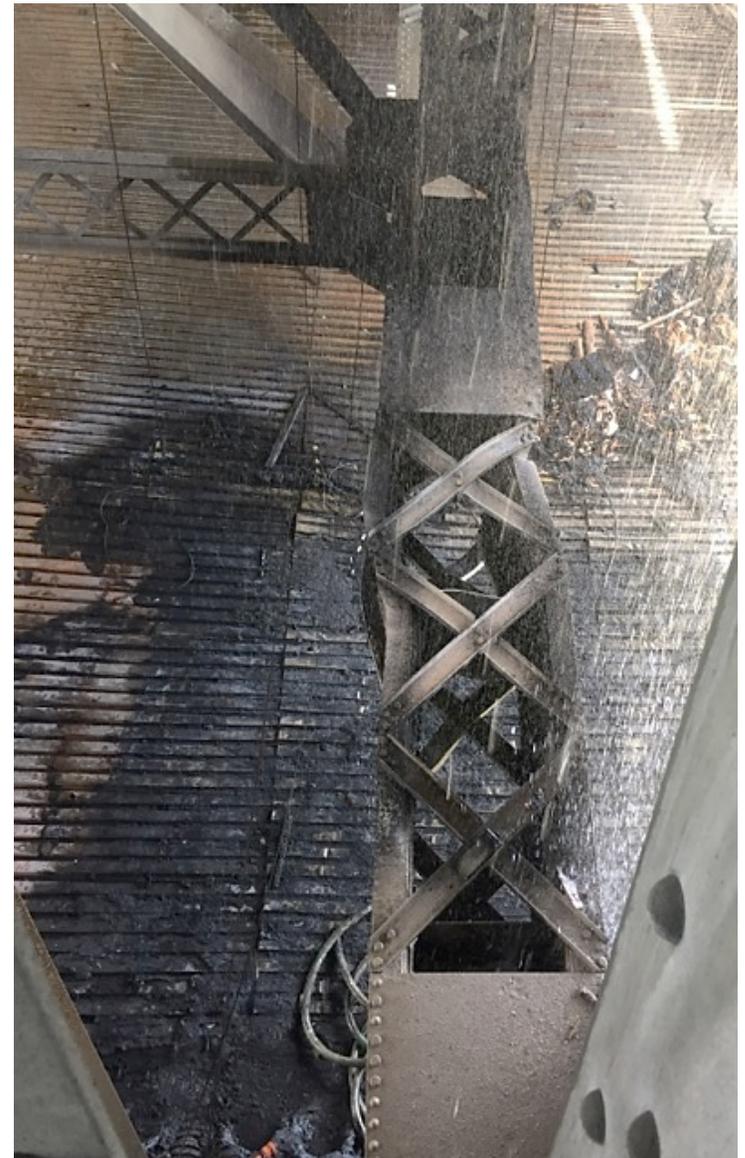
- 30' primary member compression chord L31L32 severally damaged.
- Local lateral buckling shortened the beam (by ~2" and bent in the lateral direction by 6 ¾"), load shedding to other members of the bridge.

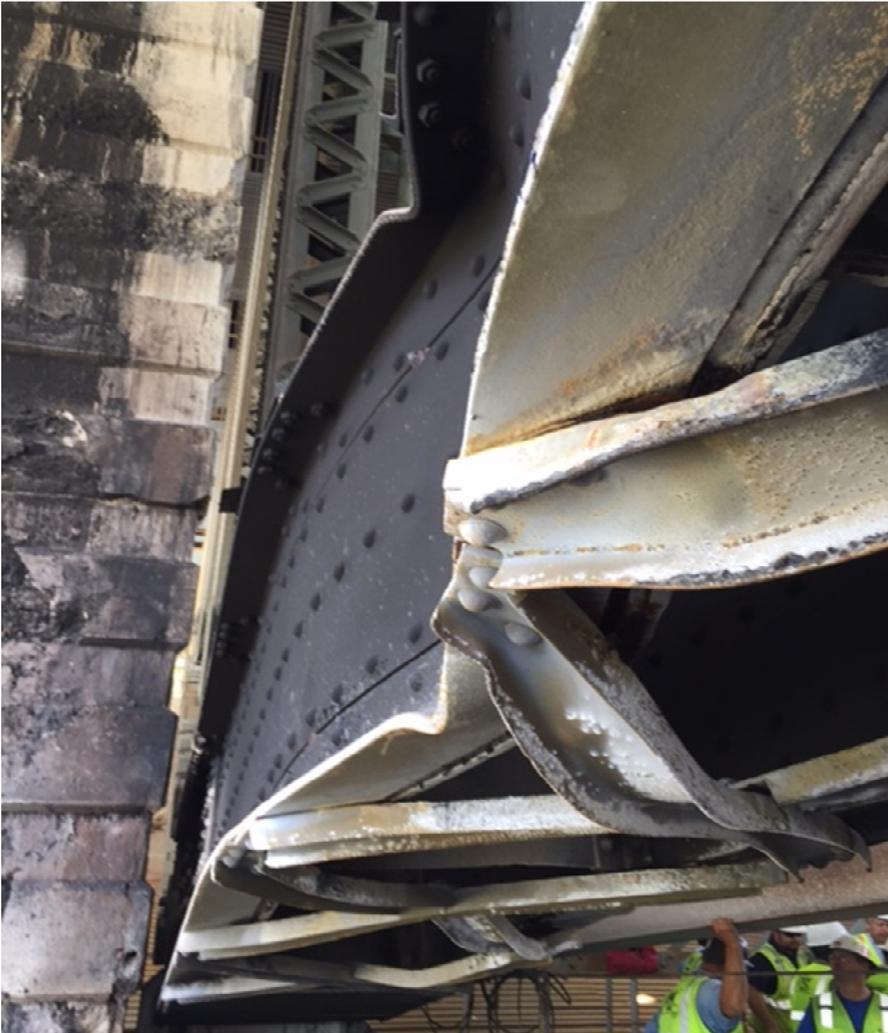
▶ Fire Damage to L31L32 West Truss

- Note:
 - Sagging of lacing channels
 - Crippled flanges

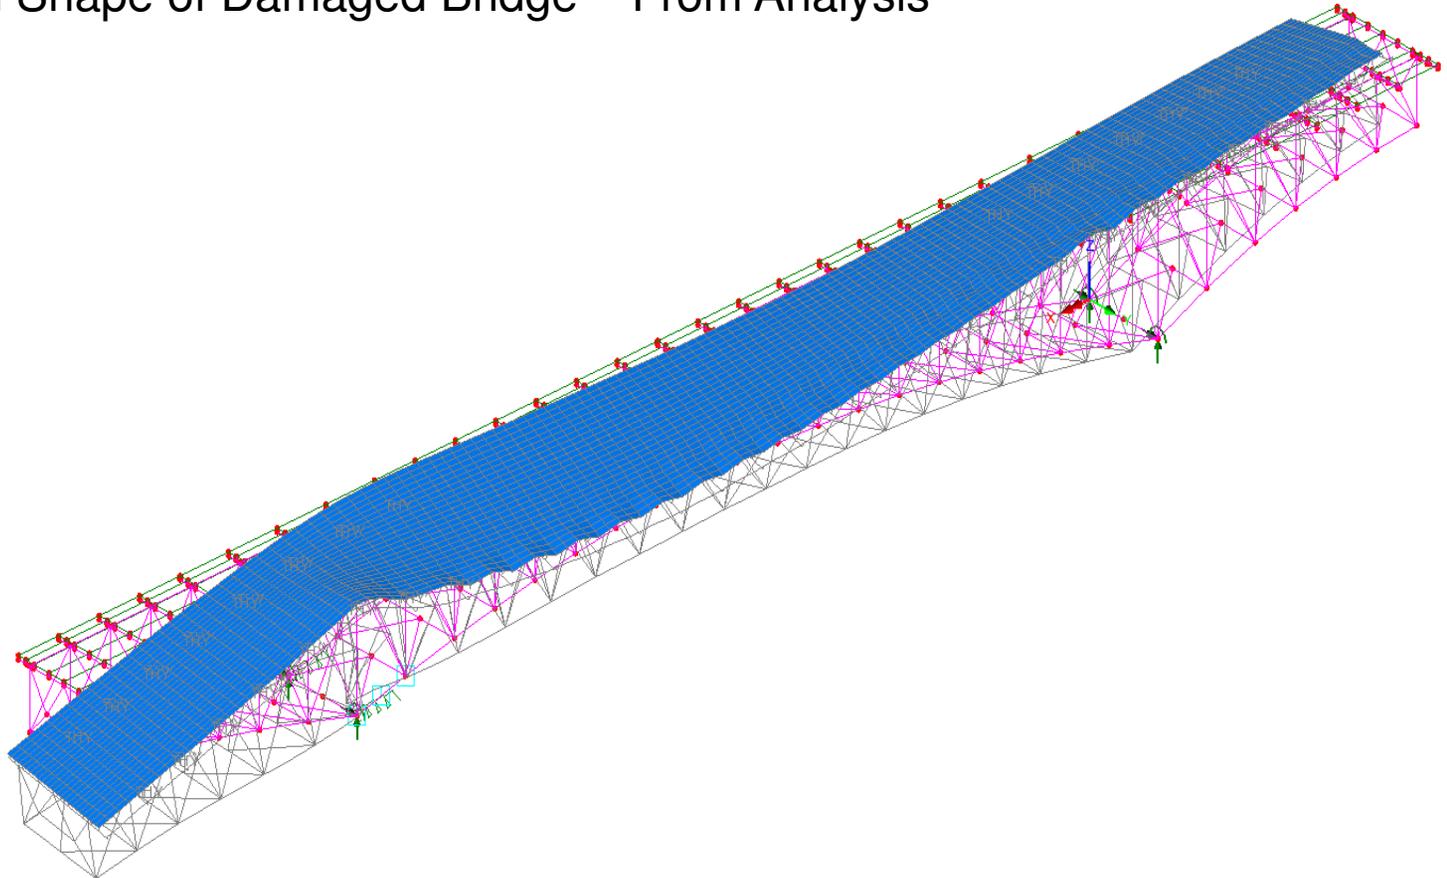
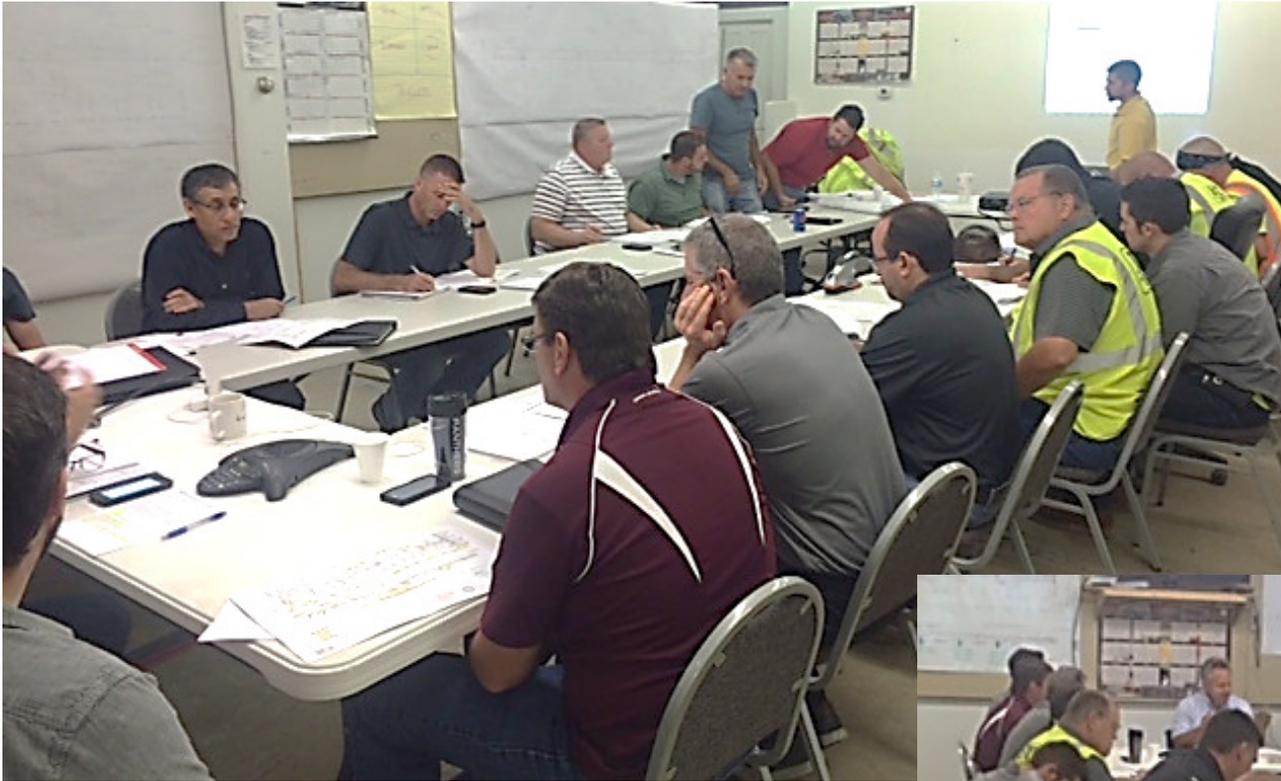
Deformed Shape of Damaged Bridge – From Analysis

- Deformed shape of bottom chords and lower lateral system due to shortening of L31L32W
 - Blue – compression added
 - Red – Tension added

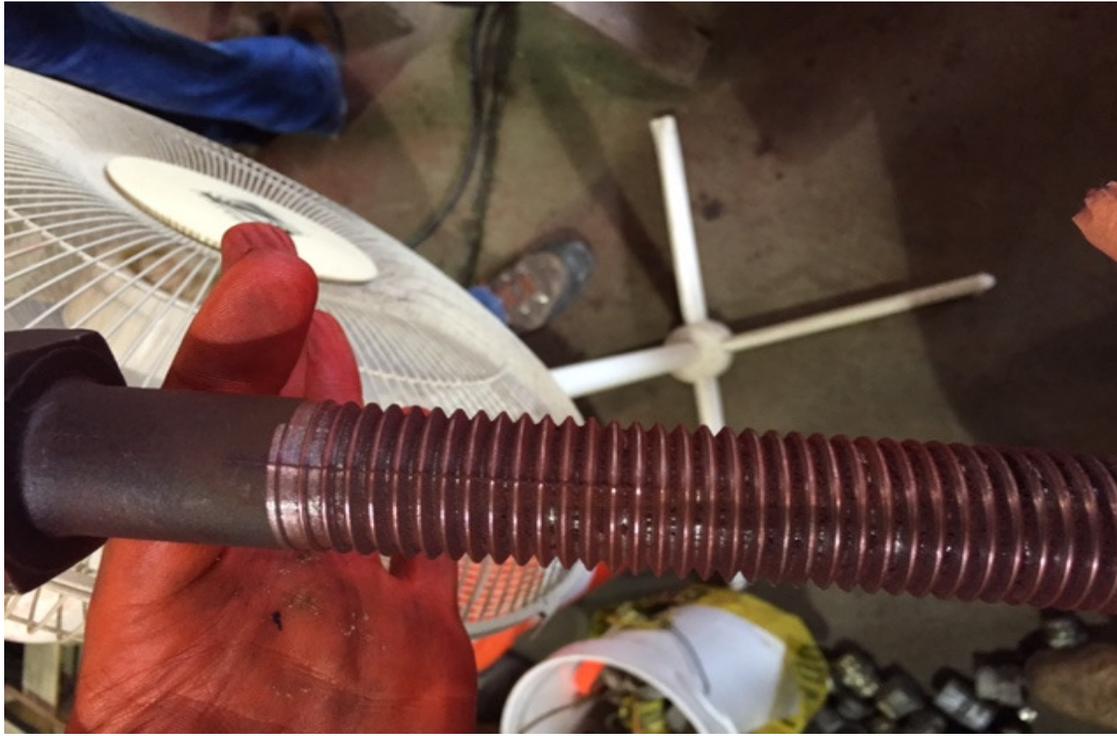
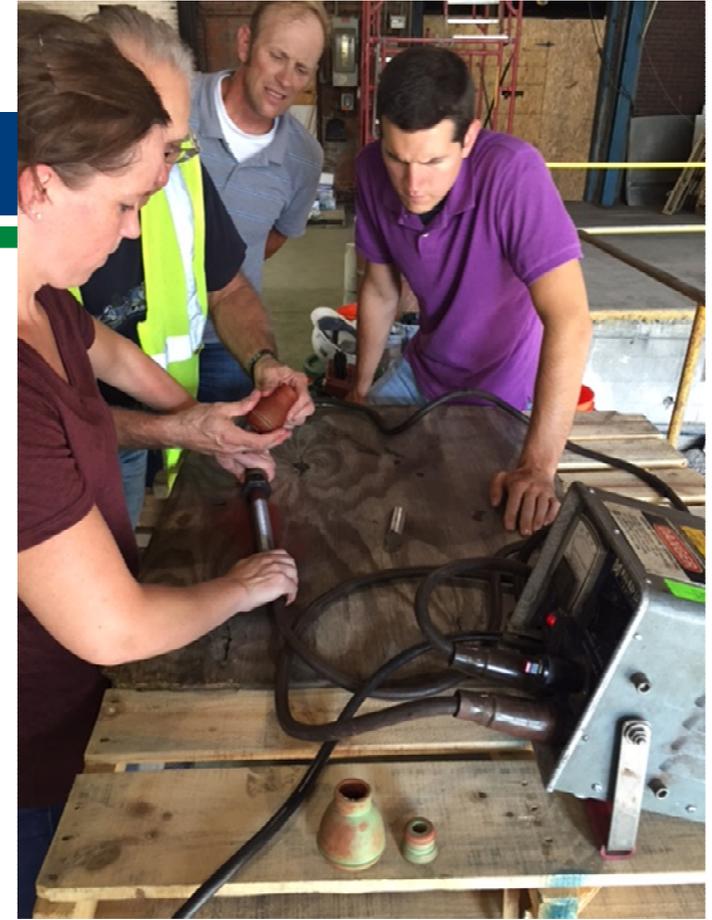
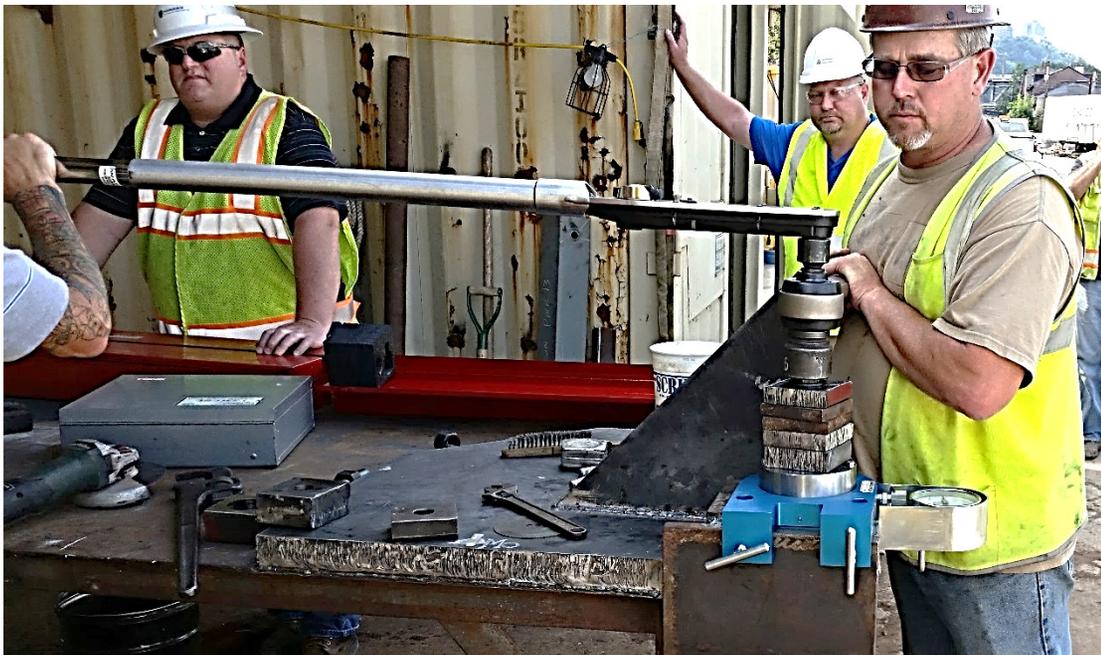
A490s Bolt ROCAP Testing
Bolt issues – procurement,
cracks, testing

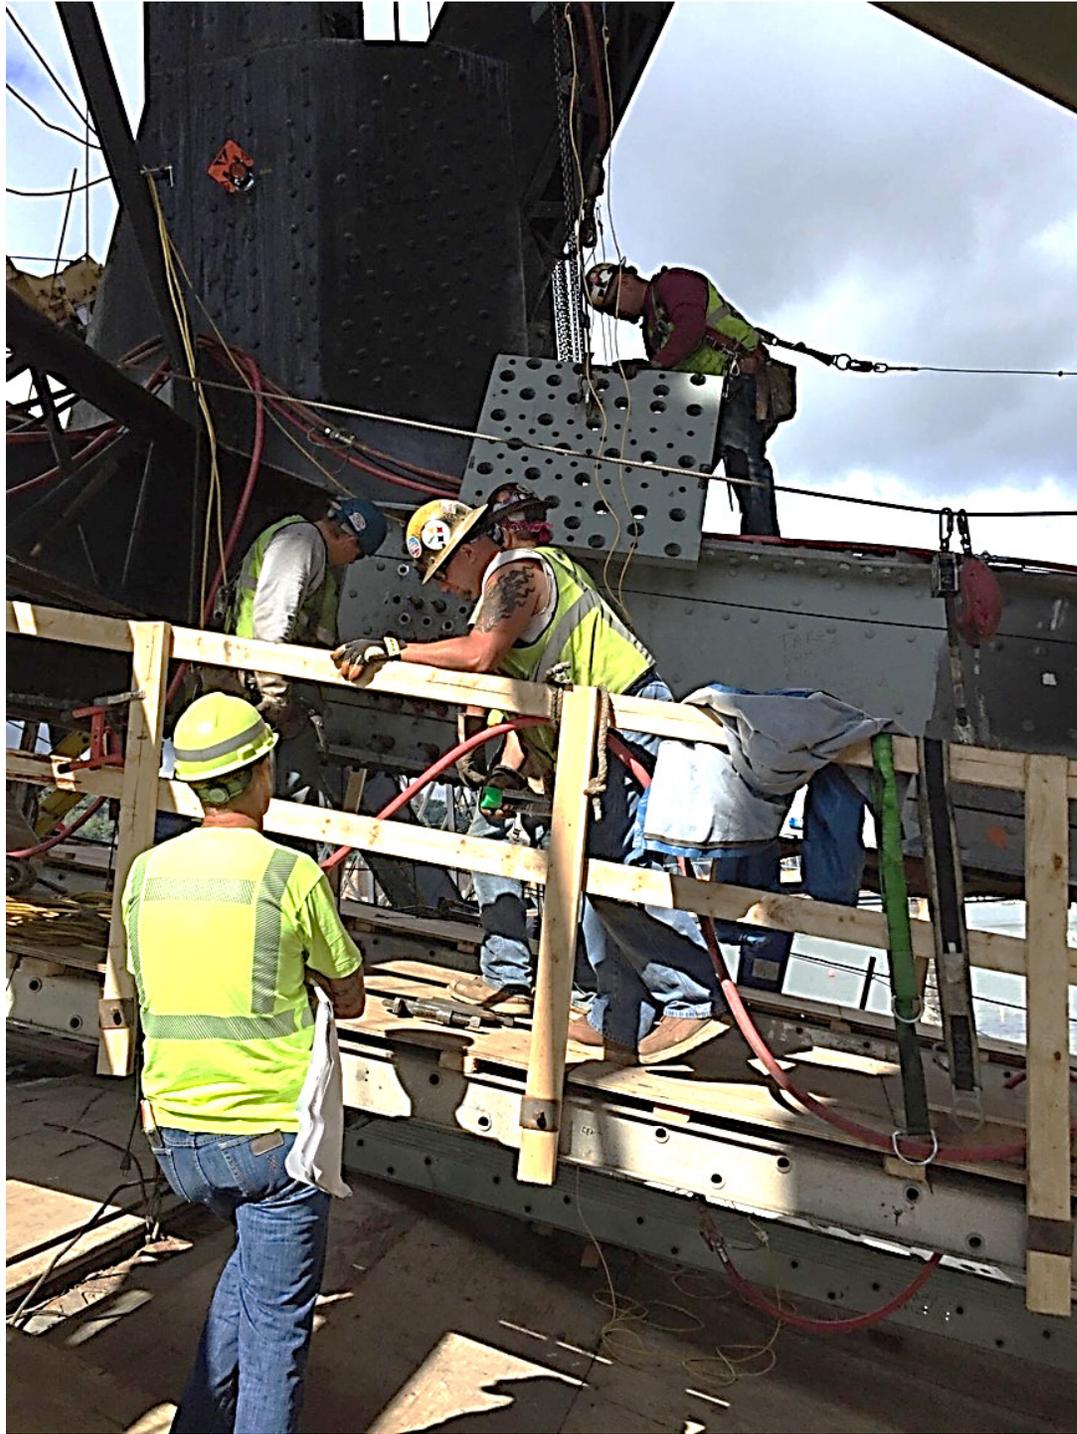
Jacking Brackets from
fab. Shop w/ only $\frac{1}{4}$
stiffeners, permitted
bolt tensioning.
