2020 MID-ATLANTIC QUALITY ASSURANCE WORKSHOP – WILLIAMSBURG, VIRGINIA

Micropile Supported Slab for Sinkhole Mitigation on S.R. 422

Frank P. Namatka, P.E.
Chief Geotechnical Engineer

February 12, 2020

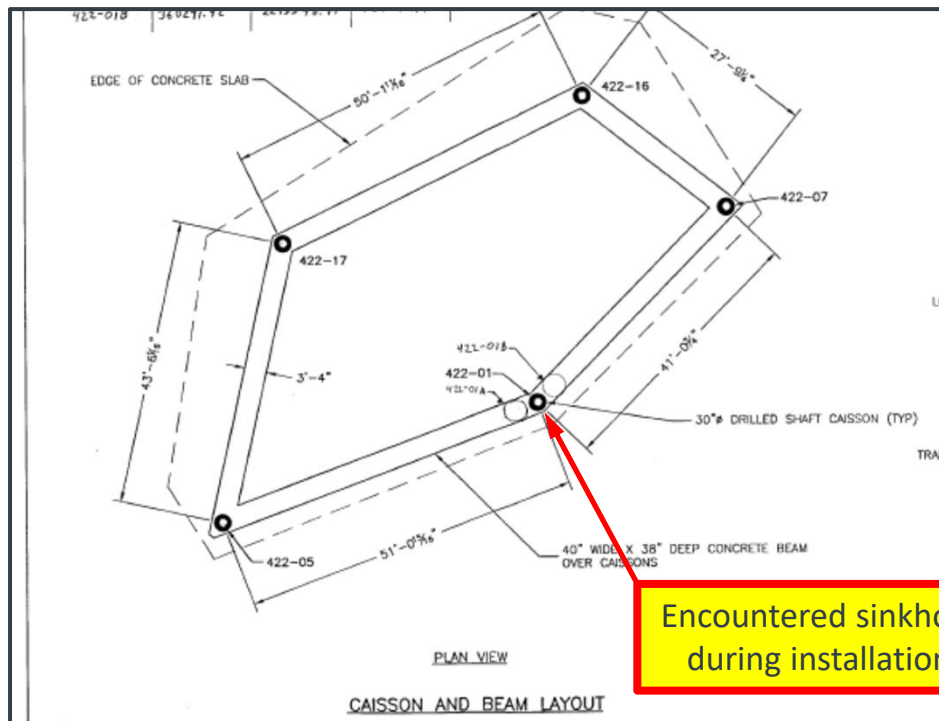
2014 Sinkhole Repair – Land Bridge

- Concrete Slab with Edge Beams

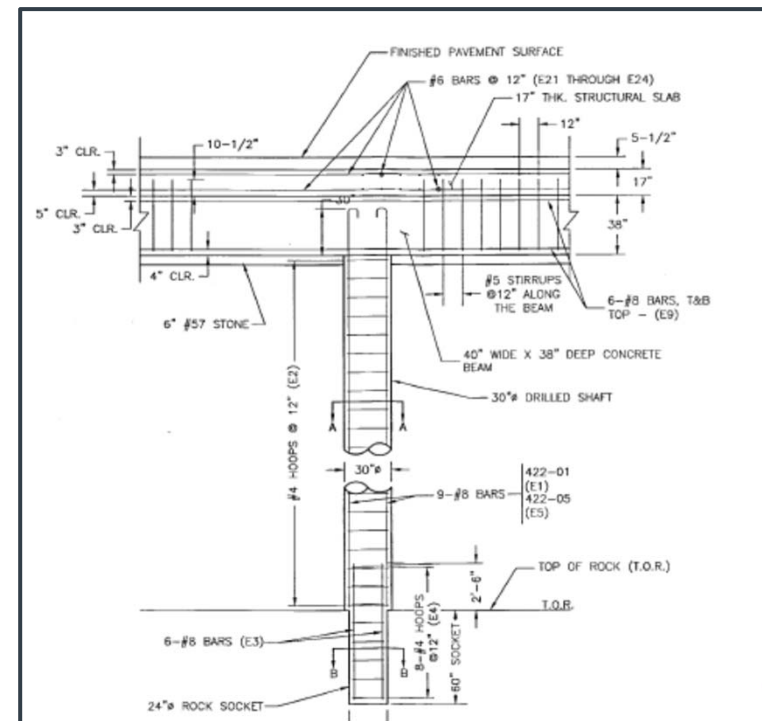
- Drilled Shaft Supports

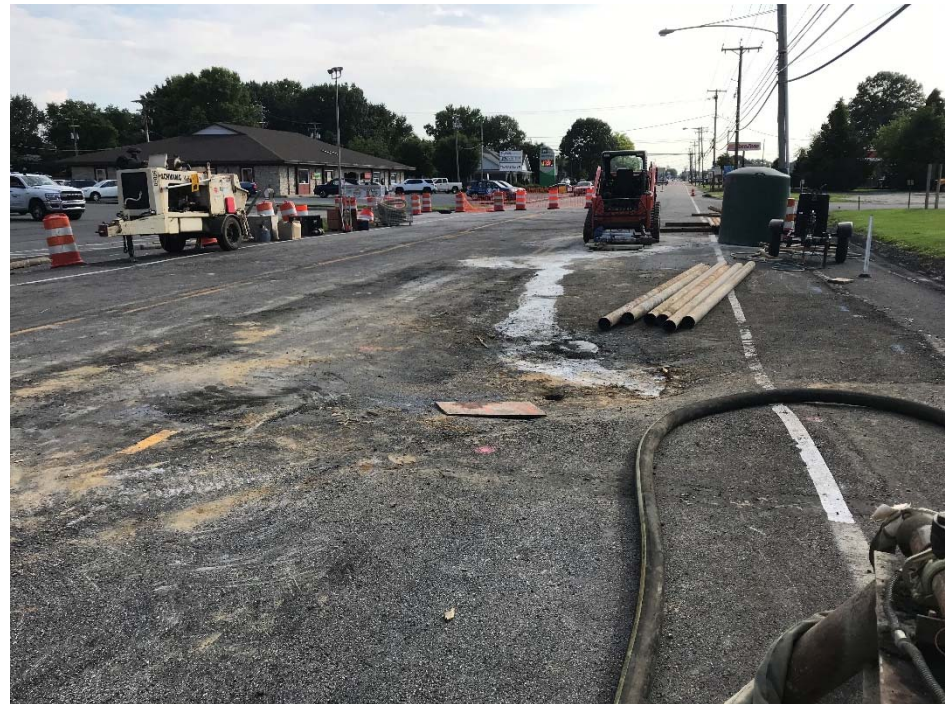
2019 Sinkhole Repair

- Depression in westbound lane of S.R. 422
- Steadily increased in depth
- PennDOT forced to close the roadway in June 2019
- Gannett Fleming, Inc. contacted by PennDOT to assist in a “long-term” repair solution
- “Safety Net” was good, but required immediate maintenance when depressions formed
