Research Project # 2001-060
Evaluation of Concrete Pavement Cracking Rehabilitation

Final Report
August 2009

Prepared By:
Dave Serra and J. Alberto Medina

Evaluations and Research Section
Engineering Technology and Information Division
Bureau of Construction and Materials

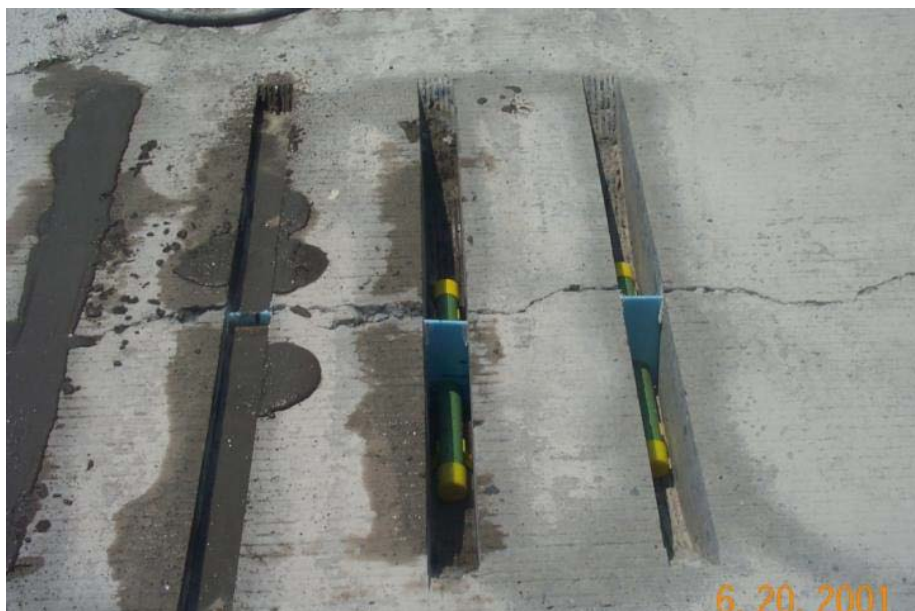
Figure 2: DBR Installation

The reinforced (WWF and rebar) patches show no signs of major distress, however, since last year's survey, several of the patches have begun to spall along the seal. The slabs that had preemptive sawcuts at the mid-slabs and DBR's installed do not show signs of distress. A majority of the mid-slab cracks that were repaired with DBR's show signs of distress in the form of cracking; spalling and popouts (Refer to the attached photos). The majority of these are in the travel lane which is to be expected due to higher loadings. The DBR repairs appear to be a better repair strategy for the passing lane where most of the low severity cracks are present and have no movement. High severity cracks like the one shown in Figure 2 seem to be a better candidate for full depth patch.

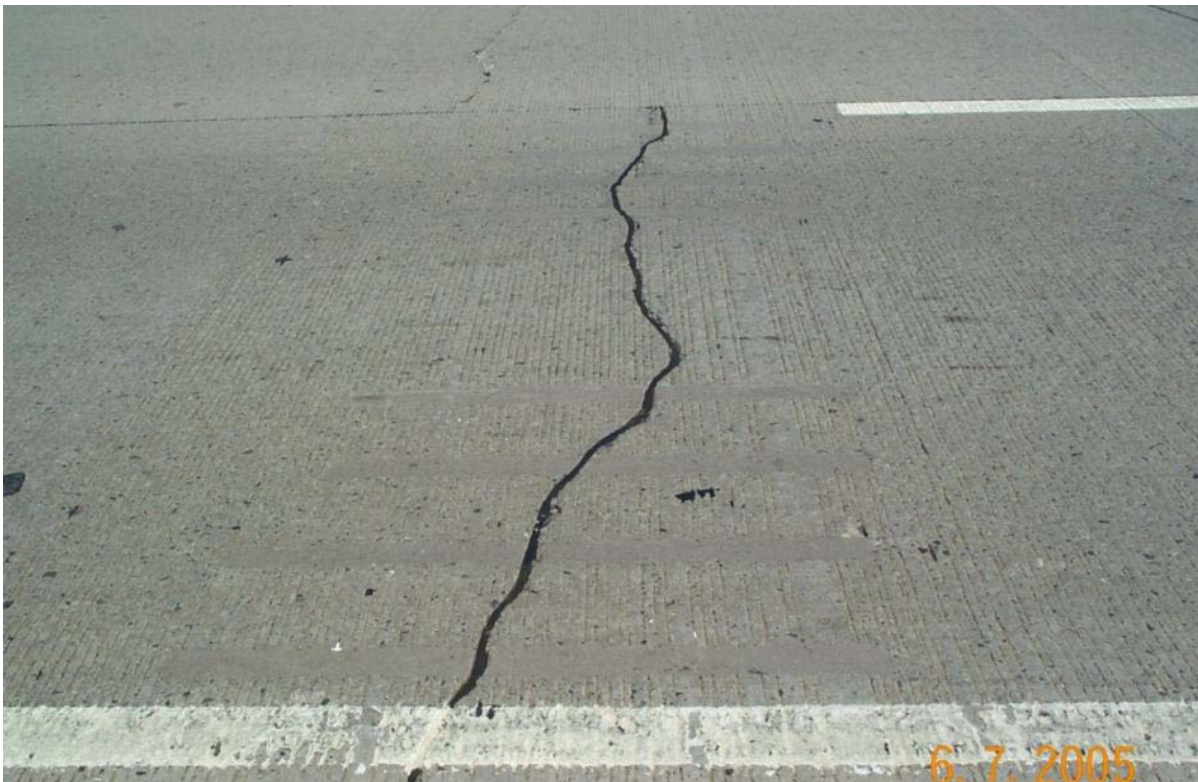
Figure 1.0 Typical DBR Condition

A condition survey conducted on June 7th, 2005 revealed no signs of degradation on exposed DBR's throughout Zone 1 due to traffic or further slab movement (See figure 1.0).

Figure 1.0 shows a DBR location in the eastbound driving lane. Note that the passing lane now has cracked near the middle of the slab (top of photo). This condition did not exist during the time of original DBR construction.

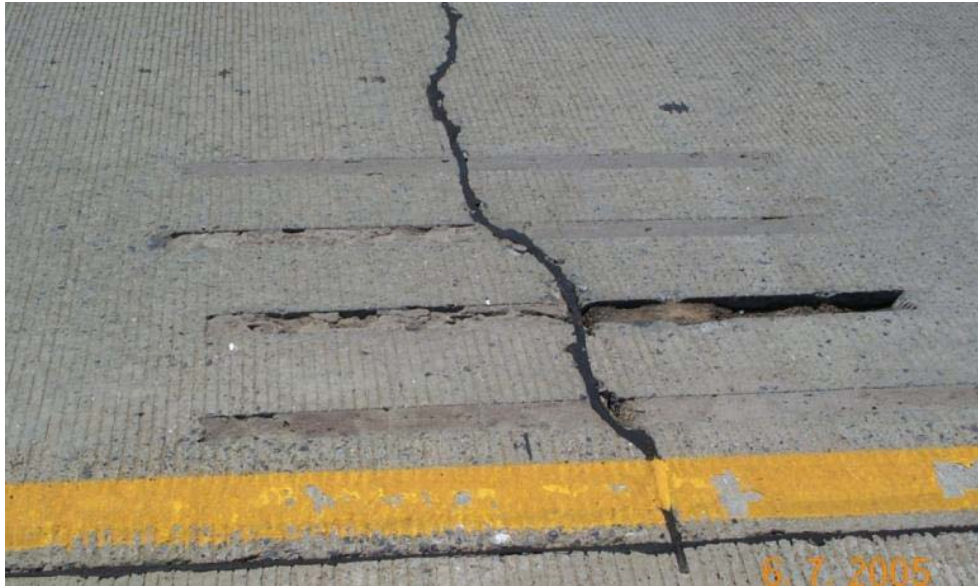
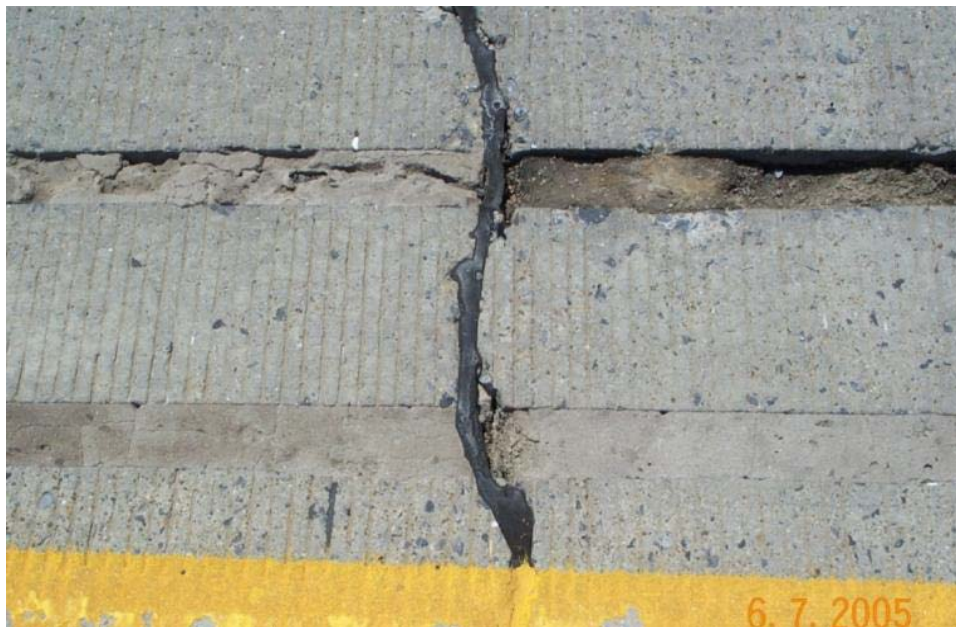
Figure 2.0 Compromised DBR at 2240/0438

There was one DBR location in the passing lane at 2240/0438 where the grout material placed in the DBR slots was scaling and spalling. This could be due to construction-related factors such as poor field curing, grout beginning to set-up during placement, etc. Otherwise, the DBR at this location seems to be stable and performing as designed. (See figures 2.0 and 2.1)

Figure 2.0 shows scaling and spalling of grout in DBR slots. No evidence of slab movement exists.

Figure 2.1 Close-up View of Figure 2.0

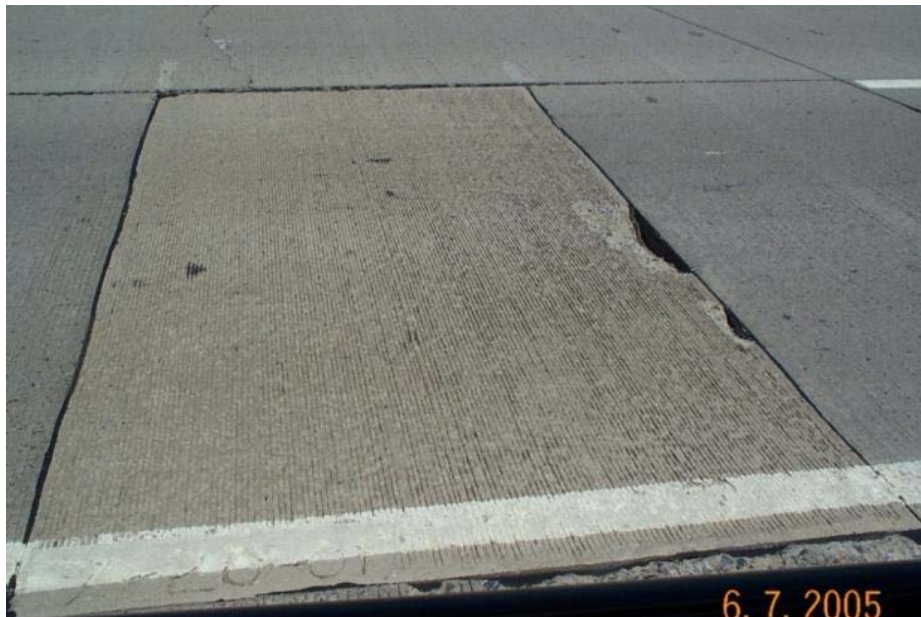
Figure 3.0 Type A Concrete Patch at 2240/0302

Type A patching in Zone 1 is showing some settlement and movement-related problems as evidenced by spalling along the transverse joints a contributing factor to this may be an inadequate seal at the joint. (See figures 3.0 and 4.0)

Figure 3.0 shows a Type A patch placed in the traveling lane. Note the spalling of the Type A patch along the leave side of the transverse joint.

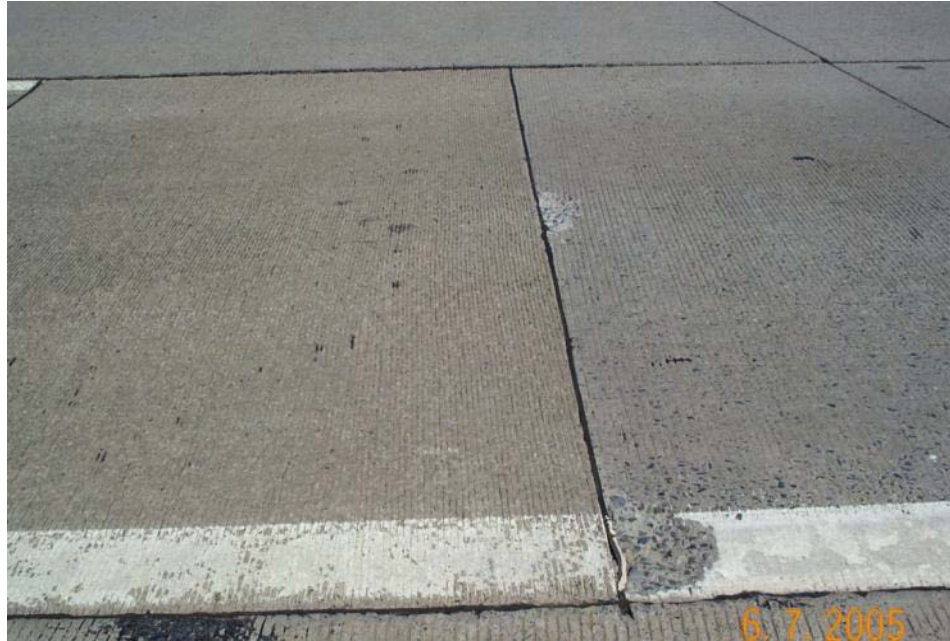
Figure 4.0 Type A Concrete Patch at 2240/0384

Figure 4.0 shows a Type A patch placed in driving lane with spalling in original concrete roadway.

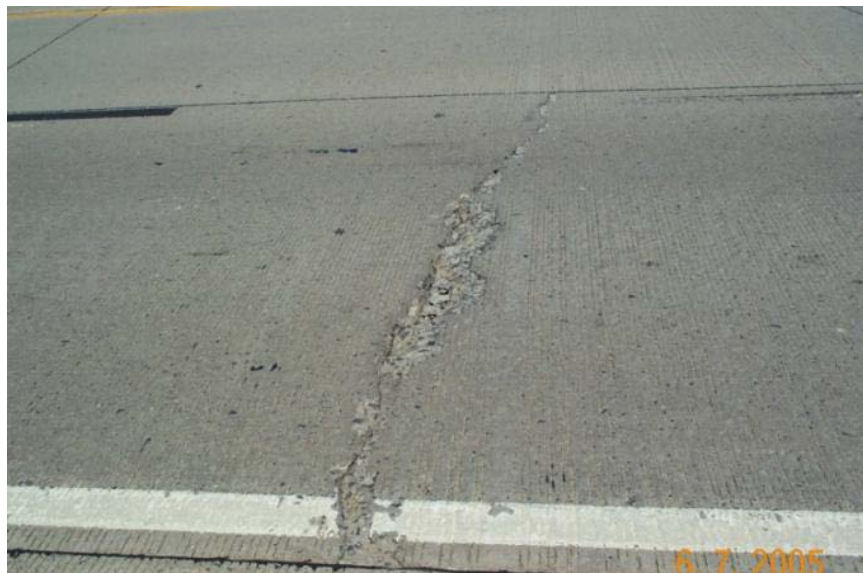
Figure 5.0 Mid-slab Crack at 2240/0070

Figures 5.0, 5.1, and 5.2 show mid-slab cracking in the driving lane which has occurred since construction:

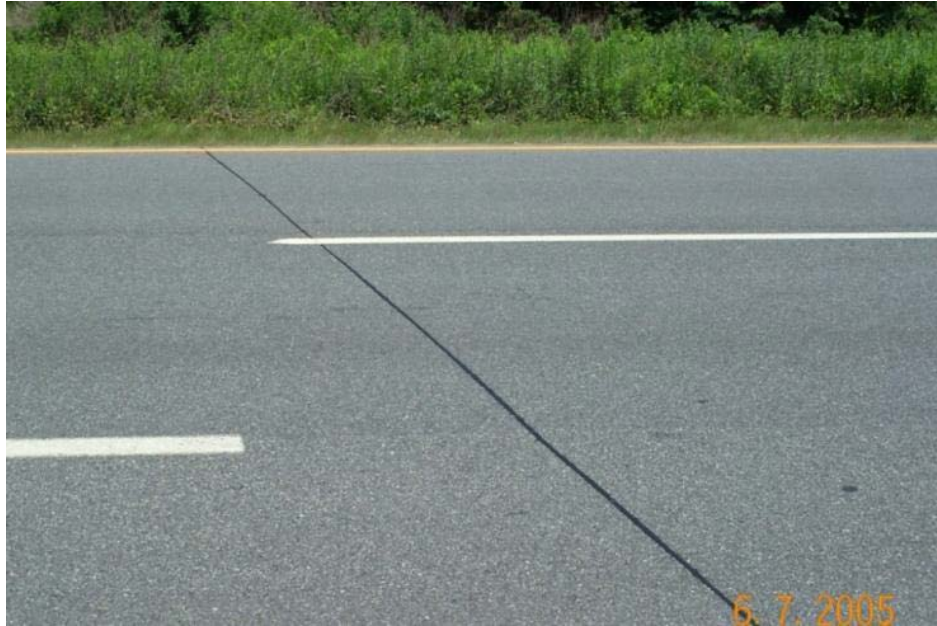
Figure 6.0 Typical Condition of Zone 2

Figure 6.0 shows the condition of surface at 2244/1127 over an existing concrete pavement joint. This location was typical of conditions throughout the Zone. The 2005 condition survey revealed absolutely no visible signs of deterioration. Most importantly, no reflective type cracking was noted at mid-slab locations where pre-emptive sawing was not performed.

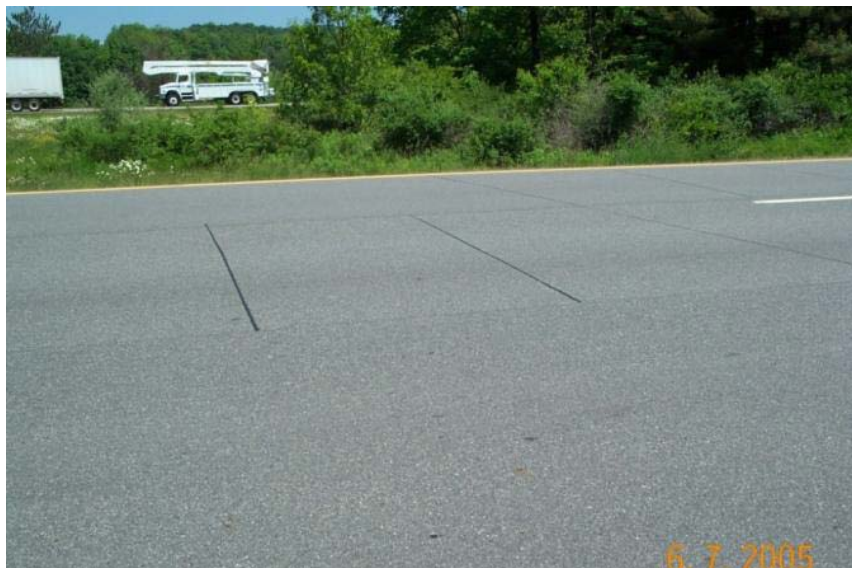
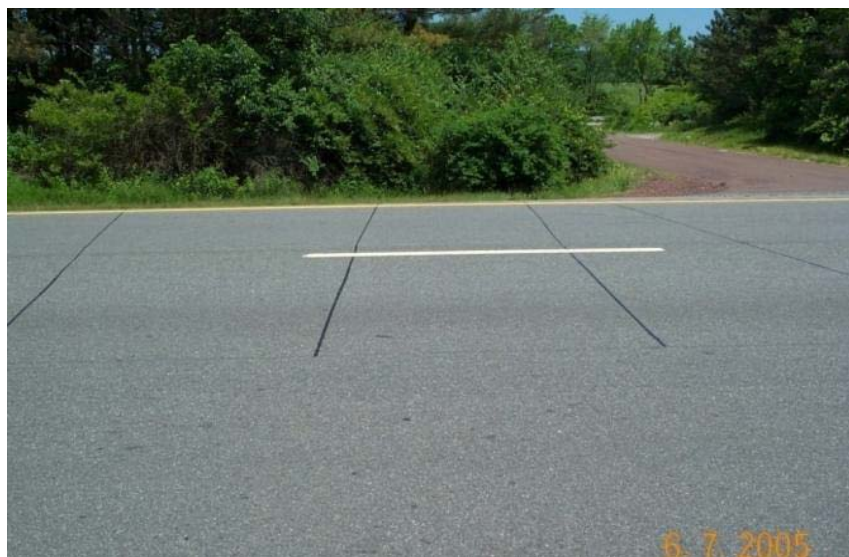
Figures 7.0 and 7.1 show sawed joints over new Type A patches. The “sawed and sealed” joints over existing and pre-emptive pavement joints were in good condition, with no visible evidence of distress.

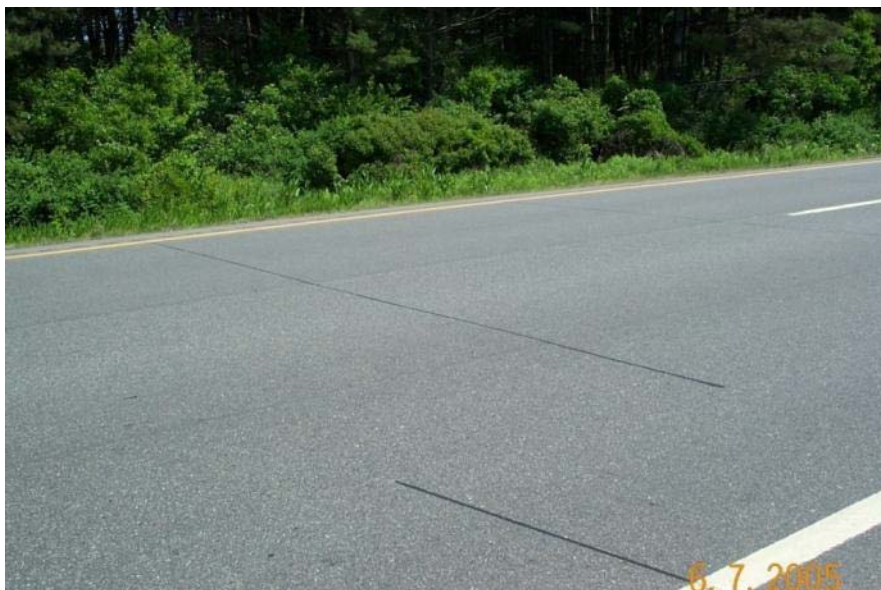
Figure 8.0 Zone 4 at 2240/1815

Figure 8.0 shows the typical condition of Zone 4 which received total reconstruction. No deterioration was noted in the field during the 2005 condition survey.

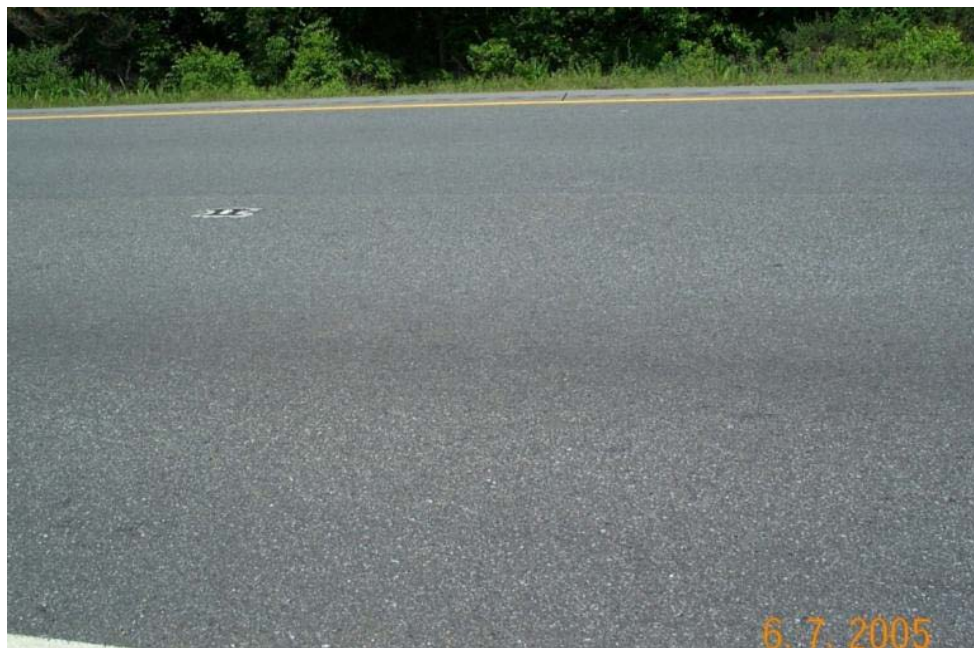
Figure 9.0 Zone 5 at 2244/0698

Figure 9.0 shows typical condition of Zone 5. This Zone received the steel paving mesh with a slurry seal prior to placement of the bituminous overlay. No evidence of cracking exists anywhere.

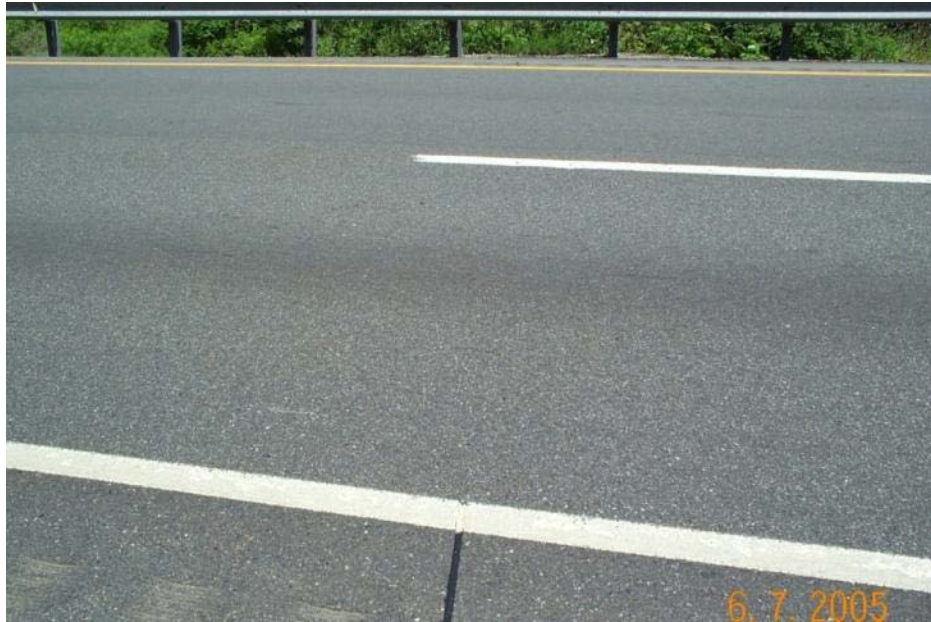
Figure 10.0 Zone 6 at 2244/1310

Figure 10.0 shows condition of the overlay above an existing pavement joint. This zone received the steel paving mesh typical to Zone 5 and no cracking was found. Zone 6 also did not receive DBR's at pre-existing low-severity crack locations. The mesh appears to be performing as expected over these locations. The condition of Zone 6 is similar to Zone 5.

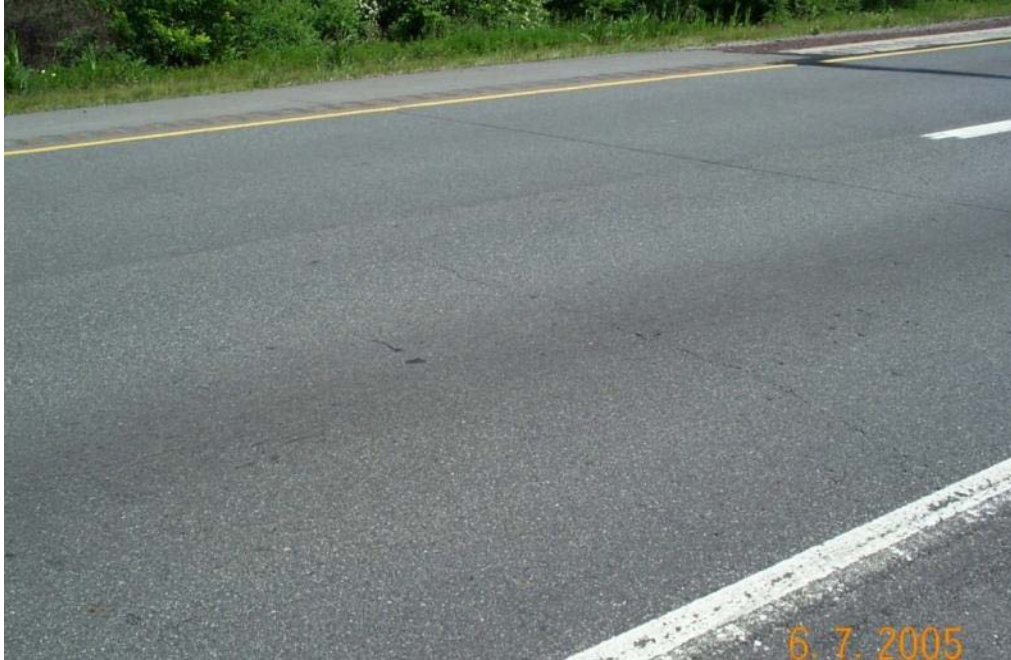
Figure 11.0 Zone 7 - Transverse Cracking at 2244/1791

Figure 11.0 shows transverse crack across both travel lanes. This location was near the end of the bituminous overlay which was terminated at 2244/1801 shown at top right in photo. The condition of Zone 7 is similar to Zone 3. However, transverse cracking was found through the bituminous overlay at 2244/1770 and 2244/1791 over DBR locations. Pre-existing low-severity cracks existed at both of those locations and they were retrofitted with DBR's. The area where the cracks are located was within the paving transition very near the end of the bituminous overlay (2244/1801).
