Deterioration of J-Bar Reinforcement in Abutments and Piers

FINAL REPORT

Kent A Harries, PhD, FACI, PEng
University of Pittsburgh

COMMONWEALTH OF PENNSYLVANIA
DEPARTMENT OF TRANSPORTATION

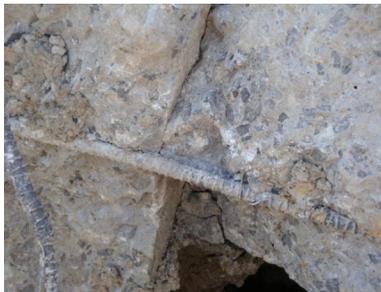
a) lap splice of #5 J-bar and stem wall bar (footing to left and stem wall to right)
(Bridge C, Abutment 2)

Figure 3. Examples of sound concrete and uncorroded reinforcing steel observed during demolition. (See Appendices for larger versions of photographs.)

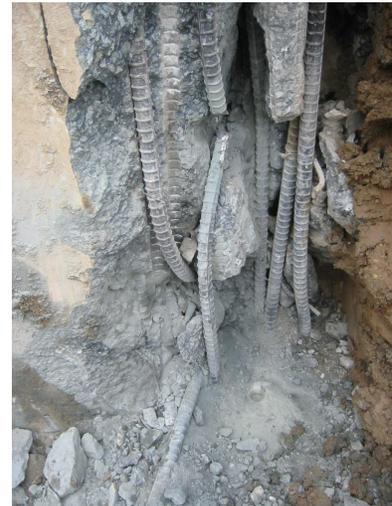
c) Pier-footing interface showing #11 dowels and pier reinforcement.
(Bridge B, Pier 2)

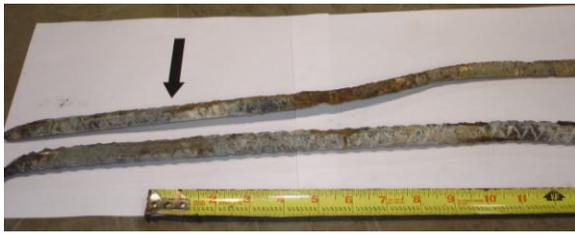
Of the five bridges surveyed, there was only one instance of reinforcing bar corrosion observed (Figure 4). A #4 bar removed from the front of the stem wall of Bridge E was significantly corroded at a location approximately 6 in. **above** the interface (Figures 4a and b). The bar was not corroded at the interface itself. The corrosion was found directly below the location of a significant crack in the stem wall (Figures 4c and d) **and** at location of an apparent honeycomb in the stem wall. A spalled region of stem wall showing considerable corrosion product from the stem wall bars (not the J-bar) is shown in Figures 4e to g. It is believed that the corrosion evident in Figure 4 results entirely from the damage evident to the stem wall and was exacerbated by water leaking through the expansion joint above this abutment.

a) #4 front J-bar (top) and #5 back J-bar (bottom).
(extension into footing to left of arrow; extension into stem wall to right)

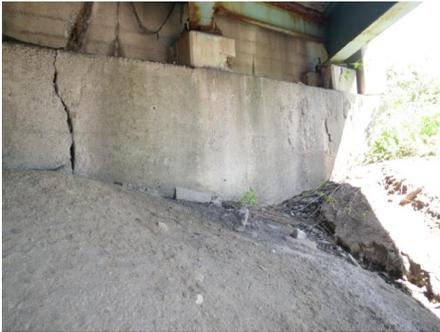
c) detail of North abutment. Samples were taken immediately adjacent crack

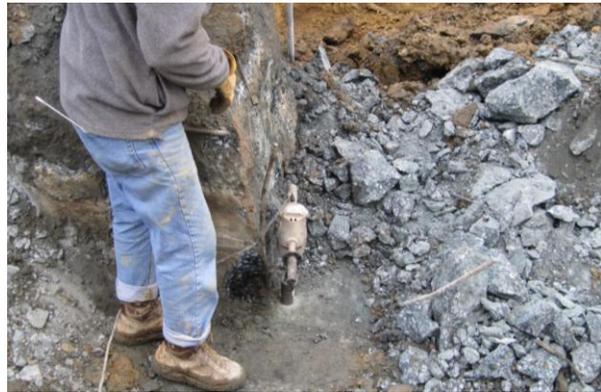
d) North abutment during demolition. Corrosion and spalled region is evident immediately to left of drill.

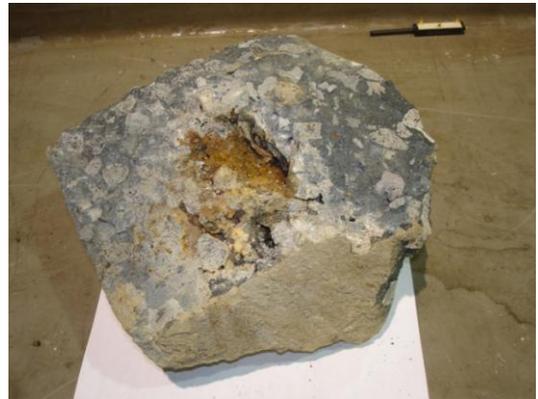
g) void in concrete (front face of stem wall shown, interface to left)

Figure 4. Corrosion evident in Bridge E.

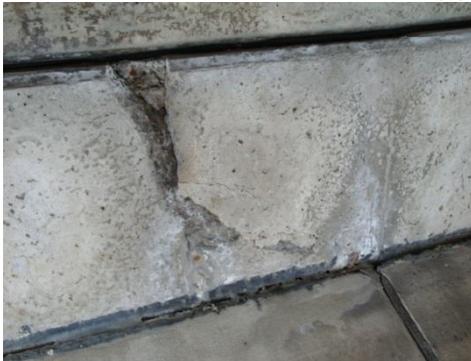
(b) cracking/spalling of stem wall.

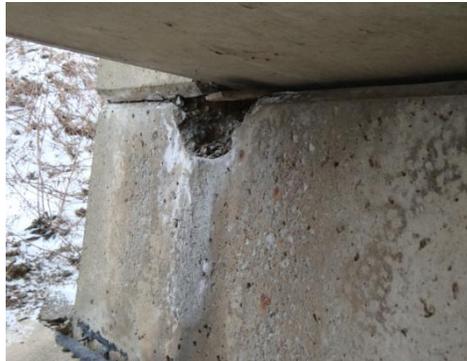
(c) spalling of stem wall at girder bearing.

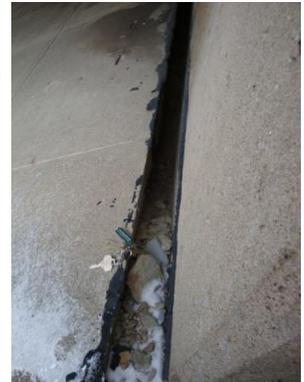
(d) 4 inch separation of embankment slab and stem wall.

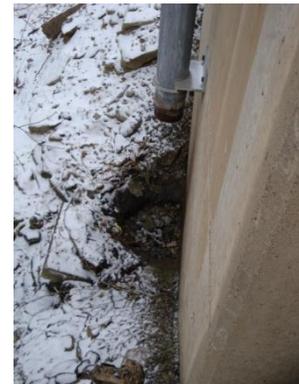
(c) Pier 5; splash pad displaced.

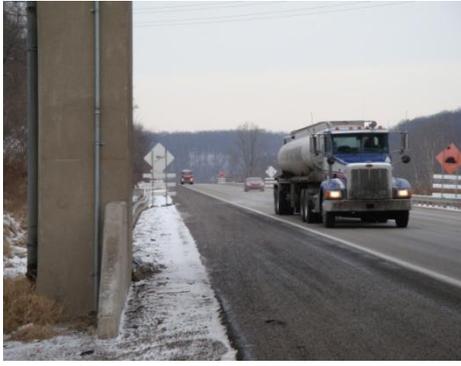
(a) Pier 2 proximity to I-79 SB. Evidence of salt spray and water dripping onto barrier wall from pier cap (right).

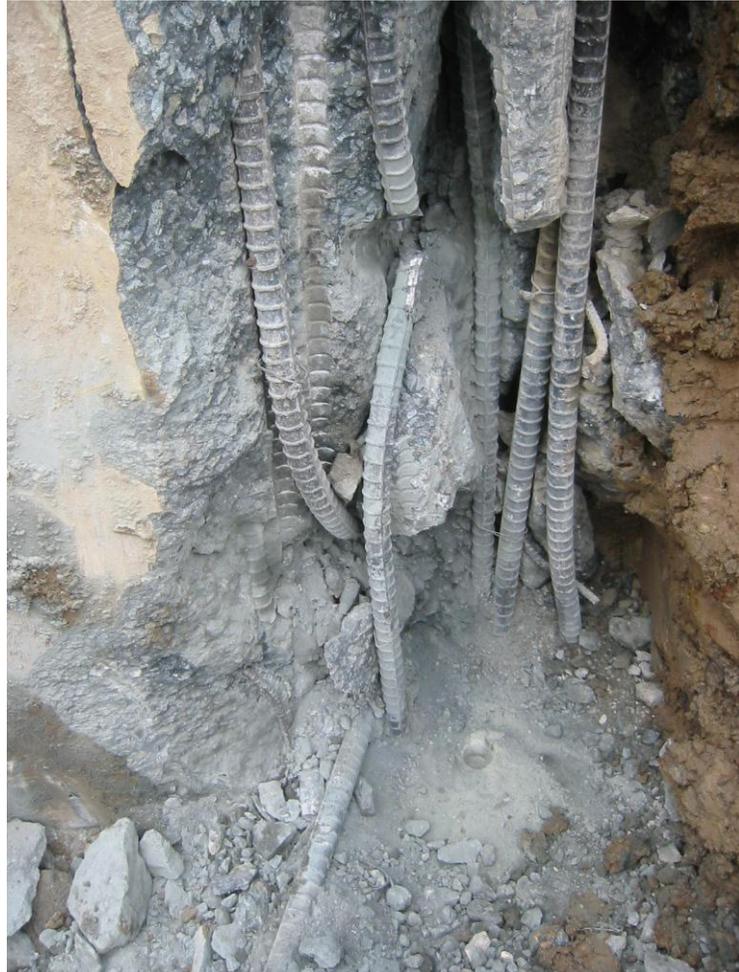
(b) footing-pier interface showing no evidence of deterioration

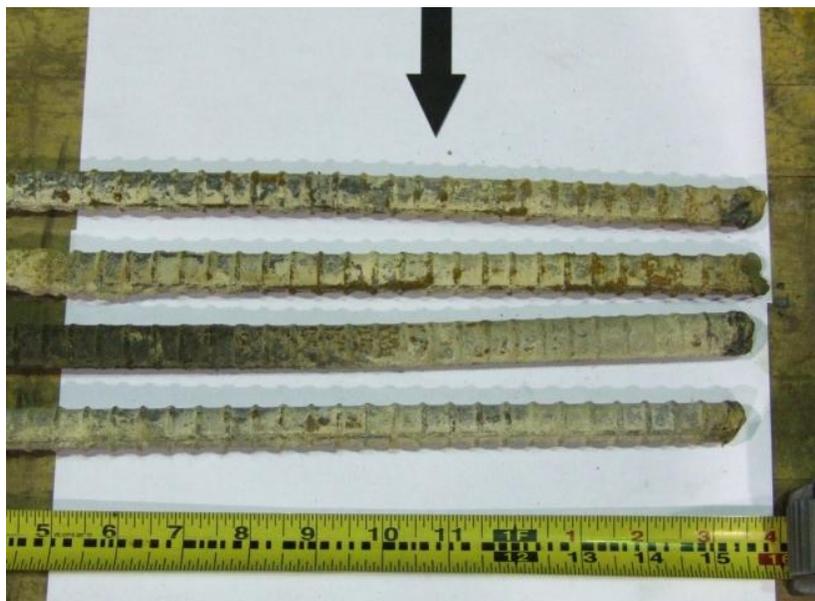
(c) Abutment 2 #5 dowel bars

minor surface corrosion evident although this may have been affected during demolition process

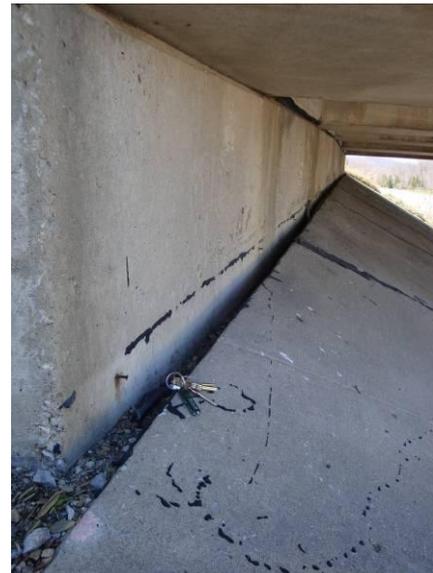
(b) 3 inch separation of embankment slab and South stem wall.

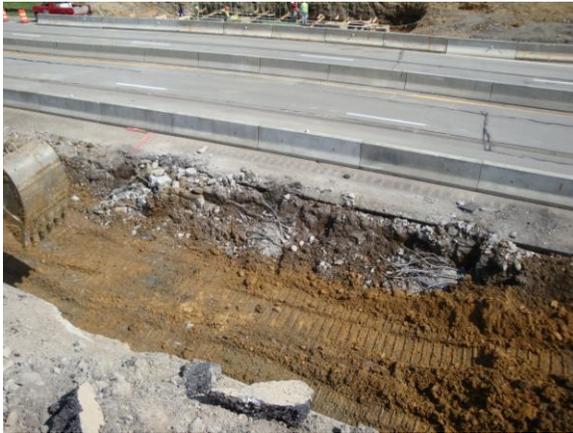
(a) exposed J-bars from [South] Pier 2.

Figure C6 Pier 2 (demolished) J-bars showing no evidence of corrosion.

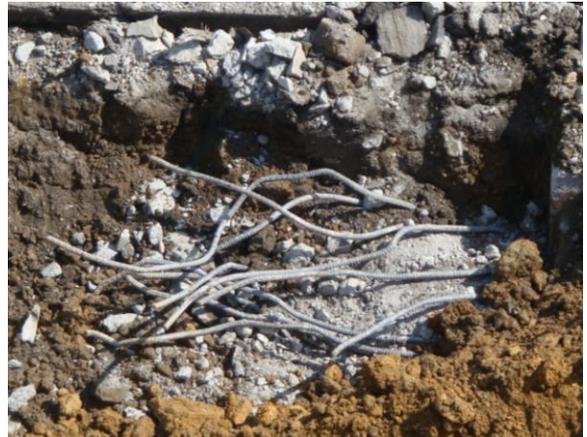
(b) exposed J-bars of East-most pier column

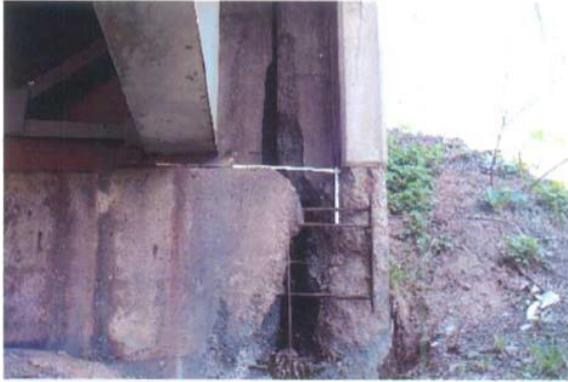
Photo 50 EXTENSIVE CONCRETE SPALLING, EXPOSED REINFORCING, CRACKED, AND SEPARATED JOINT AT WINGWALL, CHECKWALL, AND STEM AT WEST END OF SOUTH ABUTMENT

Figure D3a Separation of wingwall
(from 2008 inspection report)

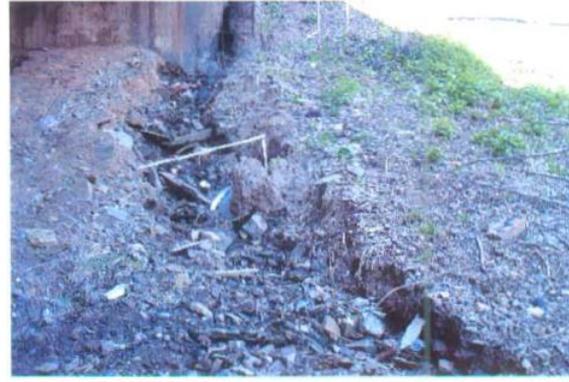
Photo 51 EROSION DITCH IN EMBANKMENT SLOPE AT WEST END OF SOUTH ABUTMENT

Figure D3b Erosion ditch.
(from 2008 inspection report)

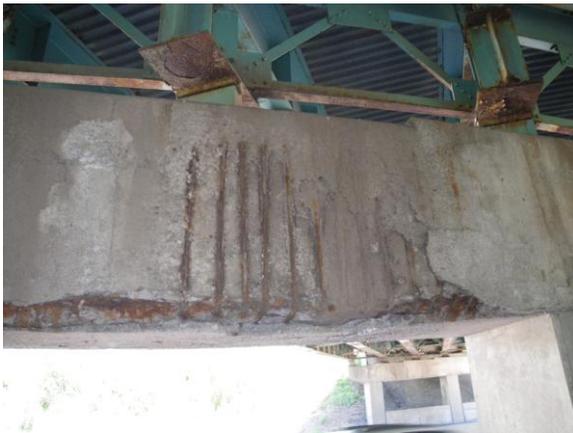
(a) spalling and subsequent corrosion resulting in complete loss of bar section.

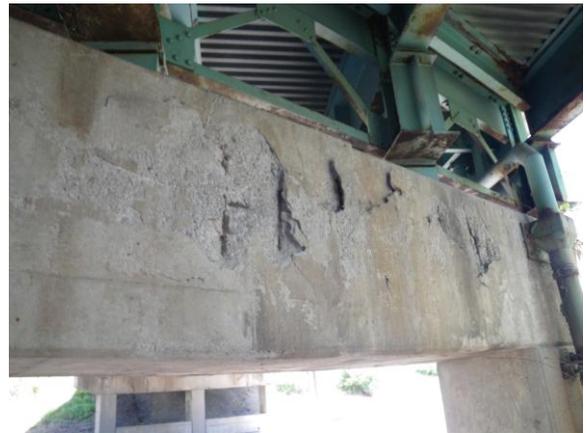
(b) spalling.

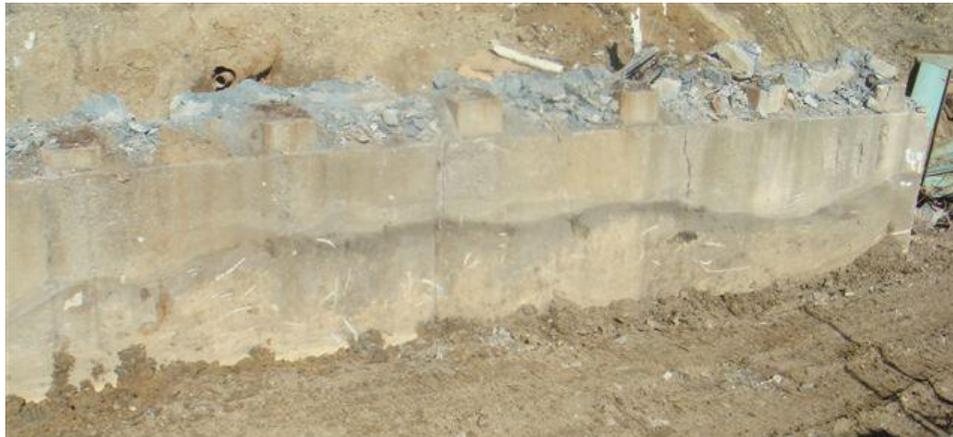
(b) North Abutment during demolition.
large crack can be seen between 2nd and 3rd beam seats from right

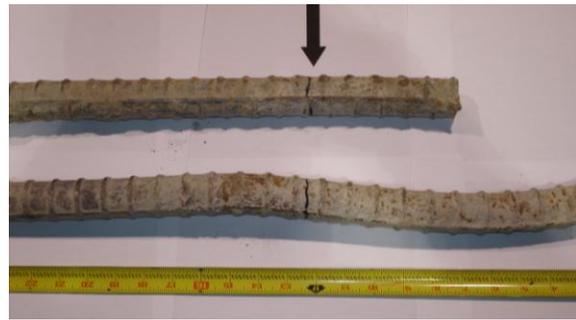
(b) Pier EB3 North column
top: #11 dowel bar from West face
bottom: #11 dowel bar from East face
no corrosion evident

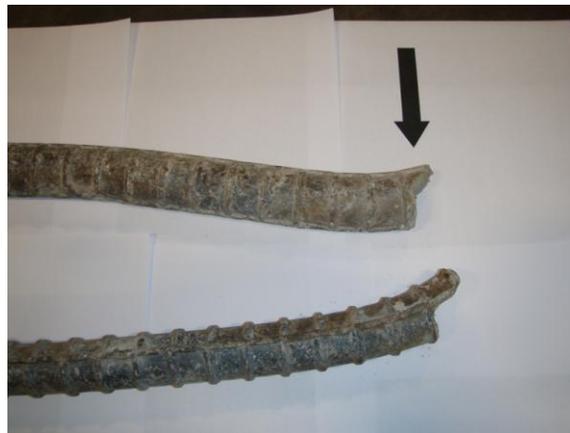
(b) Pier WB3 North column

top: #11 dowel bars; no corrosion evident
