**RESEARCH PROJECT NO. RP 97-052 A & B  
EVALUATION OF MODULAR EXPANSION DAM  
FINAL REPORT**

**May 2008**

**PREPARED BY:  
ROBIN SUKLEY, P.E.**

**Engineering Technology and Information Division  
BUREAU OF CONSTRUCTION & MATERIALS  
PENNSYLVANIA DEPARTMENT OF TRANSPORTATION**

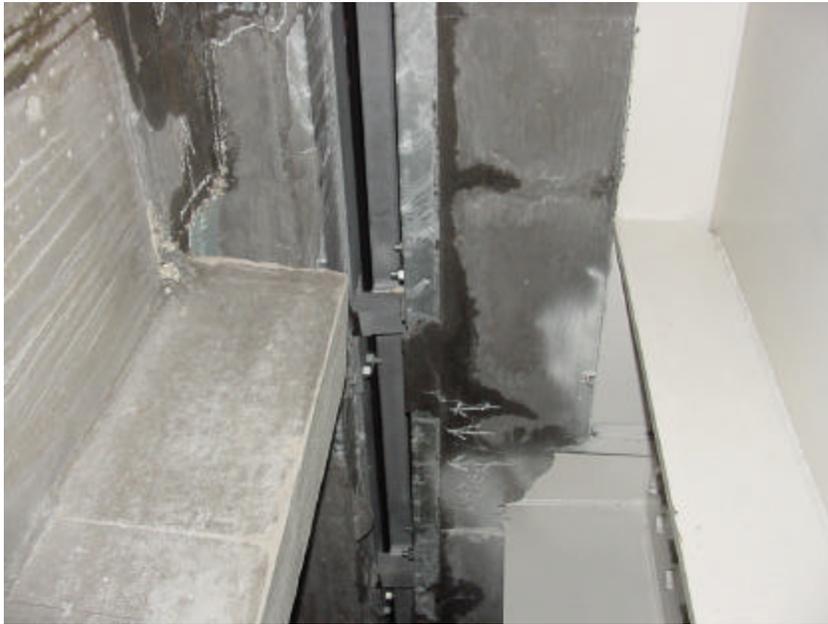
**FIGURE 10 CONCRETE AROUND MEJ SHOWED SOME WET SPOTS**

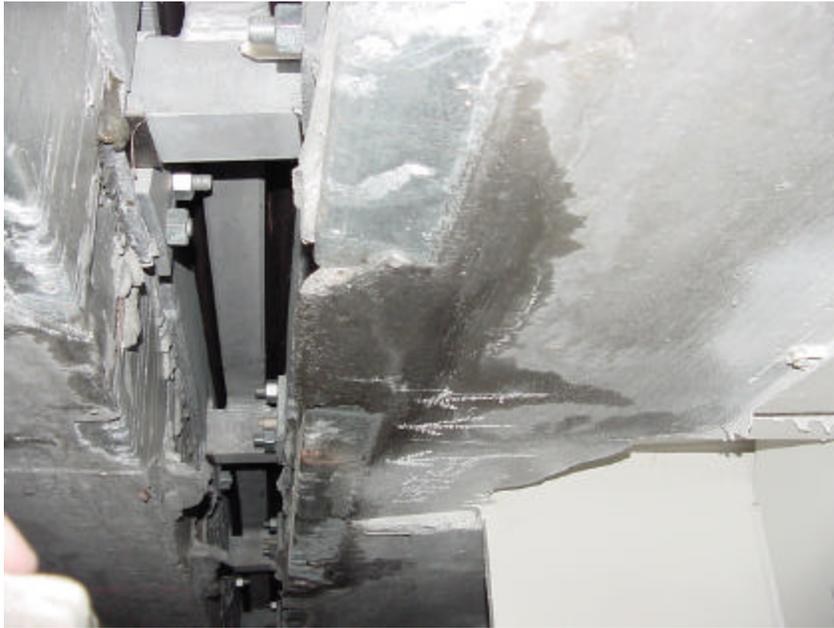
**FIGURE 12 MEJ AGAIN CONCRETE SHOWED WET SPOTS**

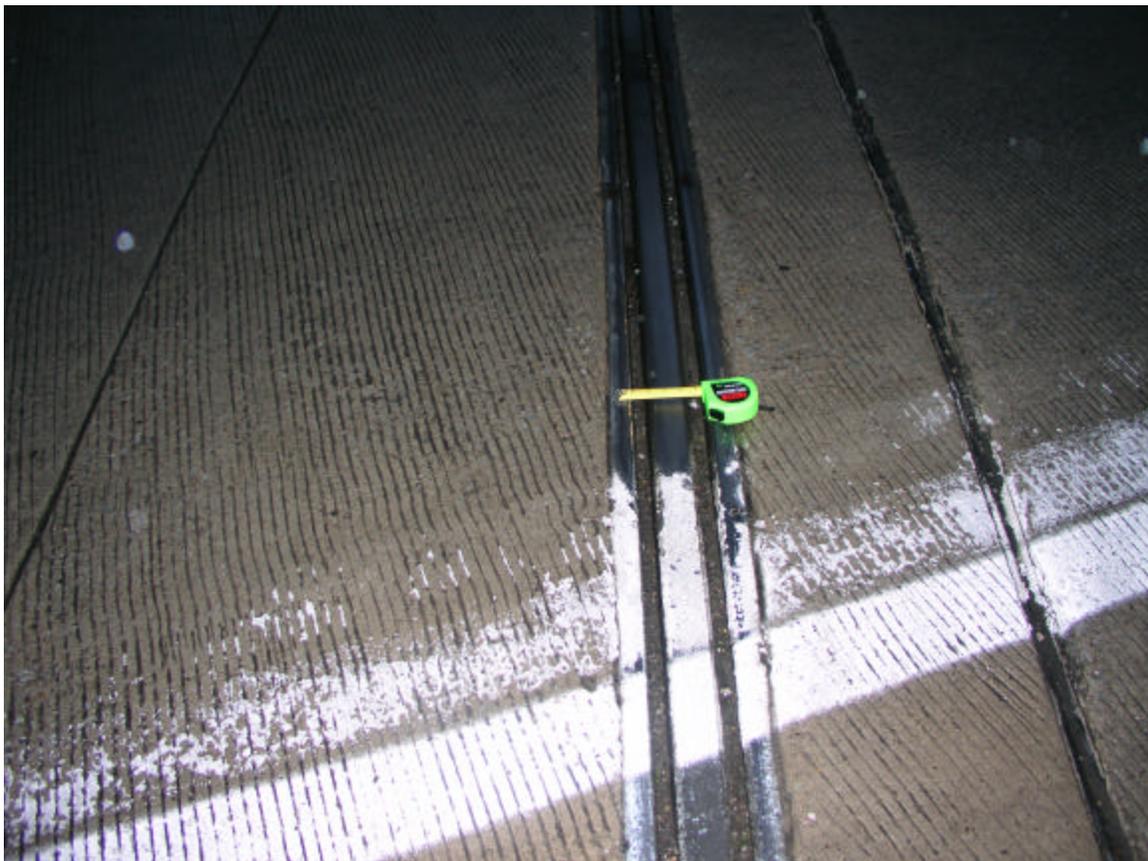
**FIGURE 13 SITE A DECEMBER 2006 SEEMED GOOD PERFORMANCE IN THE RAIN**

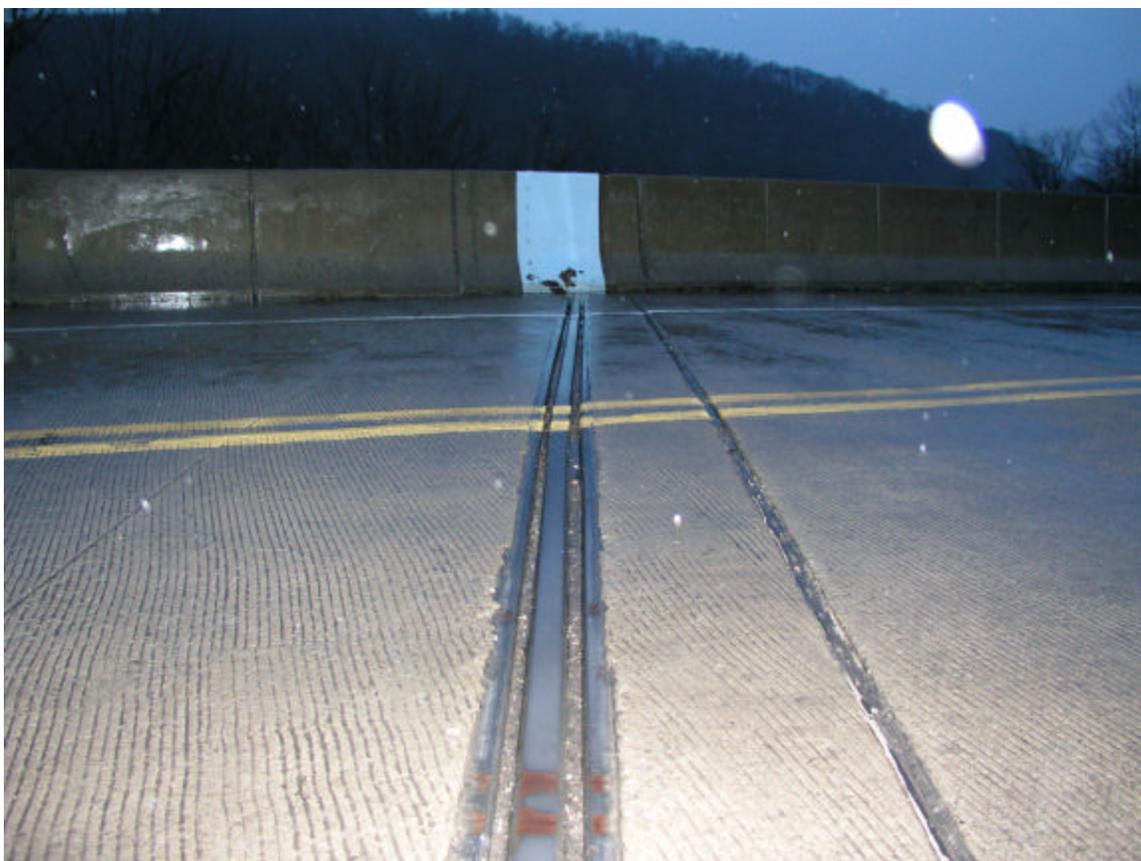
**FIGURE 14 SITE B DECEMBER 2006 GOOD VISUAL PERFORMANCE OF JOINT IN THE RAIN**

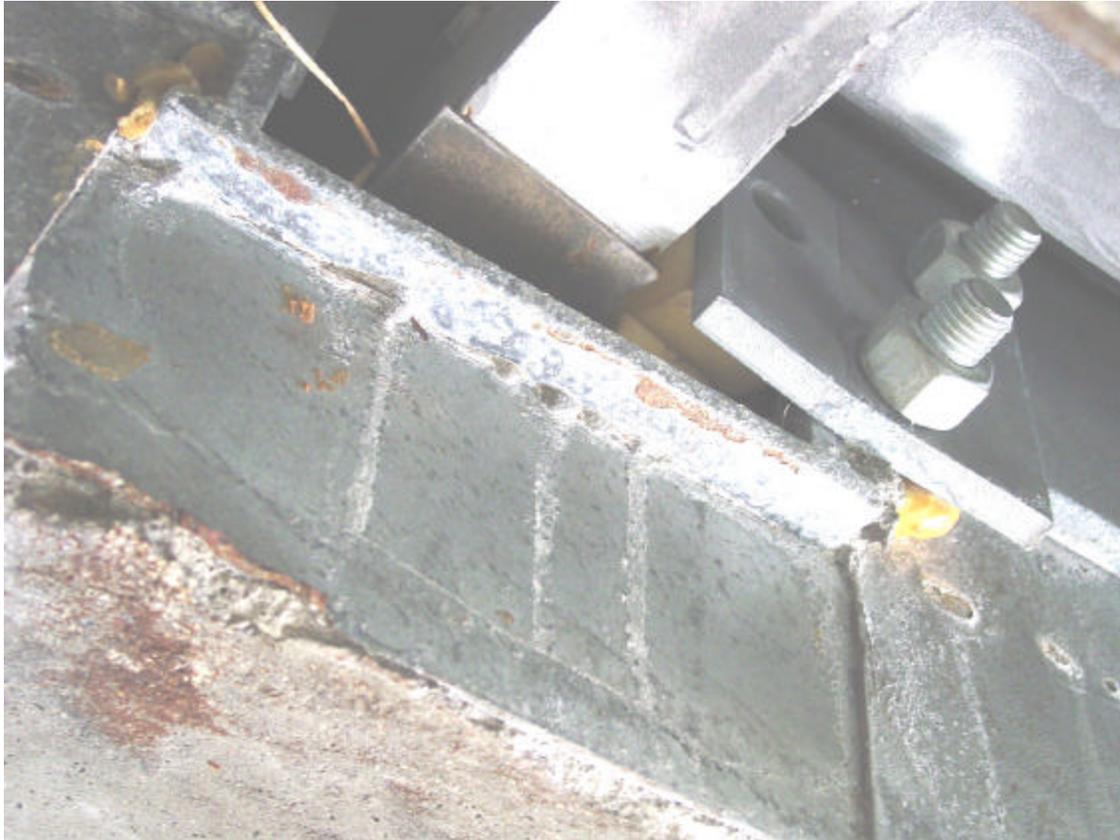
At three locations [of 68 total locations on the two joints] the nylon dowel does not protrude through the hole in the steel plate (see Figure 3 – Photo Showing Empty Hole in Steel Holding Plate). The dowels were visible behind the plate and were still within the urethane spring. The cause of the condition is uncertain but the manufacturer reports that dowels have been known to work out of the hole in the steel plate by a prying action over time. As noted above, the purpose of the dowel is to hold the spring in position. However, because the urethane spring is compressed at almost all temperatures, it is unlikely that the spring would drop completely out of the box due to extreme joint movement. However, it appears that it could work its way out of position over time.

This observation has been discussed with the manufacturer. Based on their review of the photos and the small number of occurrences observed, they advise that there is not an urgent need to re-position the dowels; monitoring the performance of the joint is recommended.

**Figure 3 – Photo Showing Empty Hole in Steel Holding Plate**

Most of the steel boxes of the MEJ extend beyond the edge of the concrete (see Figure 3.) This is not the preferred construction. The concrete formwork should have been set flush with the front of the box and the concrete cast to the edge of the box. However, since no spalling was observed, the constructed condition appears to be adequate to date. Complete support and consolidation of the concrete under the box is critical as the concrete supports the box which in turn supports the joint. This observation should be considered in preparing contract drawings for future MEJ installations.

If the dowel is only slightly out of position and still near the hole it may be possible to work it back into the hole. However, the tight clearances on these small MEJ will make it difficult to get a tool into position. The alternative method of correcting the condition is to remove the bolted holding plate, drive a new dowel into the spring, reinstall the control

spring assembly, use a hydraulic ram to re-compress the spring and bolt the holding plate back in place with the dowel properly positioned.

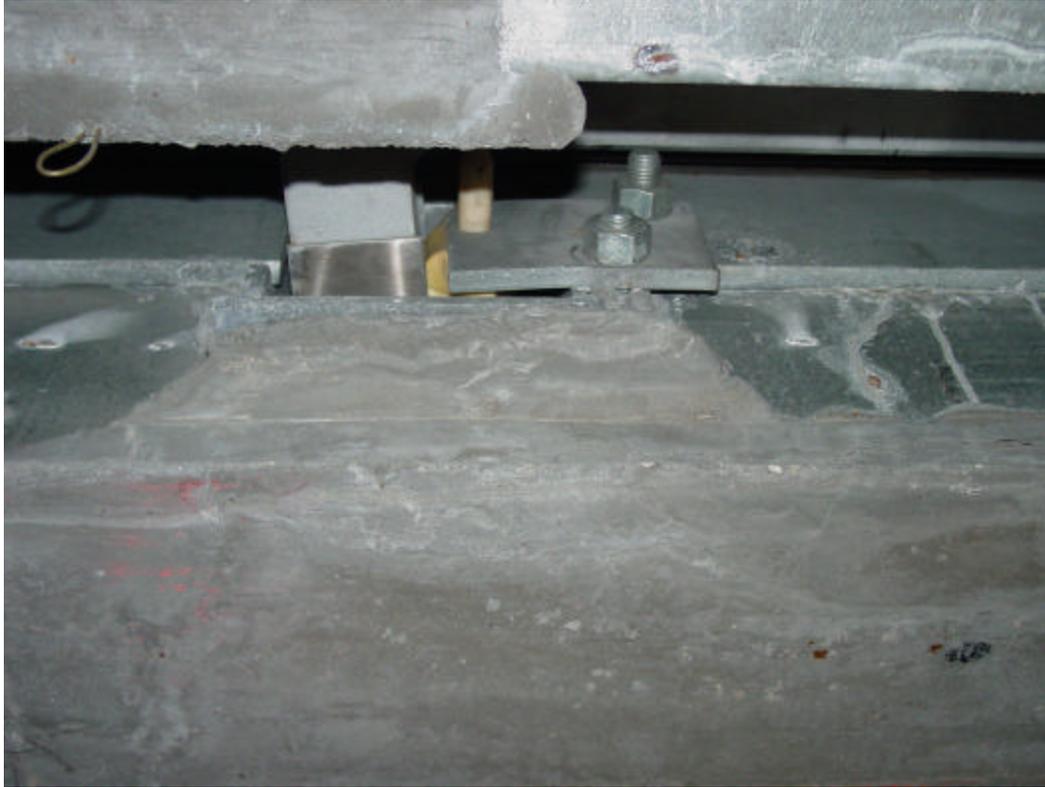
At five locations on the Pier 4 joint the urethane spring is deformed around the side of the bolted plate and is in contact with the side of the support bar (see Figure 4 – Photo Showing Bulging Urethane Spring; Figure 5 – Photo Detail, Bulging Urethane Spring.) This observation has been discussed with the manufacturer. Based on their review of the photos, they advise that the appearance of the spring does not indicate a deteriorated condition and the spring appears to be performing properly. They further advised, based on the small number of occurrences observed, that no remedial measures are required; monitoring the performance is recommended by the manufacturer.

**Figure 4 – Photo Showing Bulging Urethane Spring**

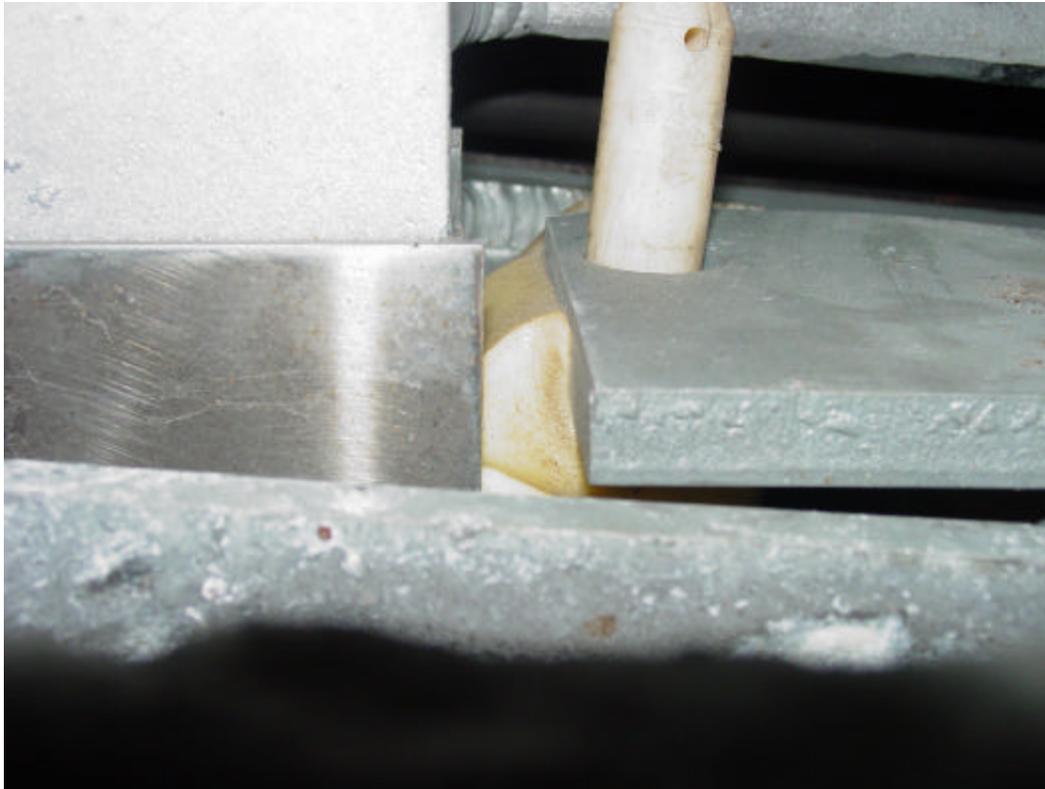
**Figure 5 – Photo, Close-up of Bulging Urethane Spring**

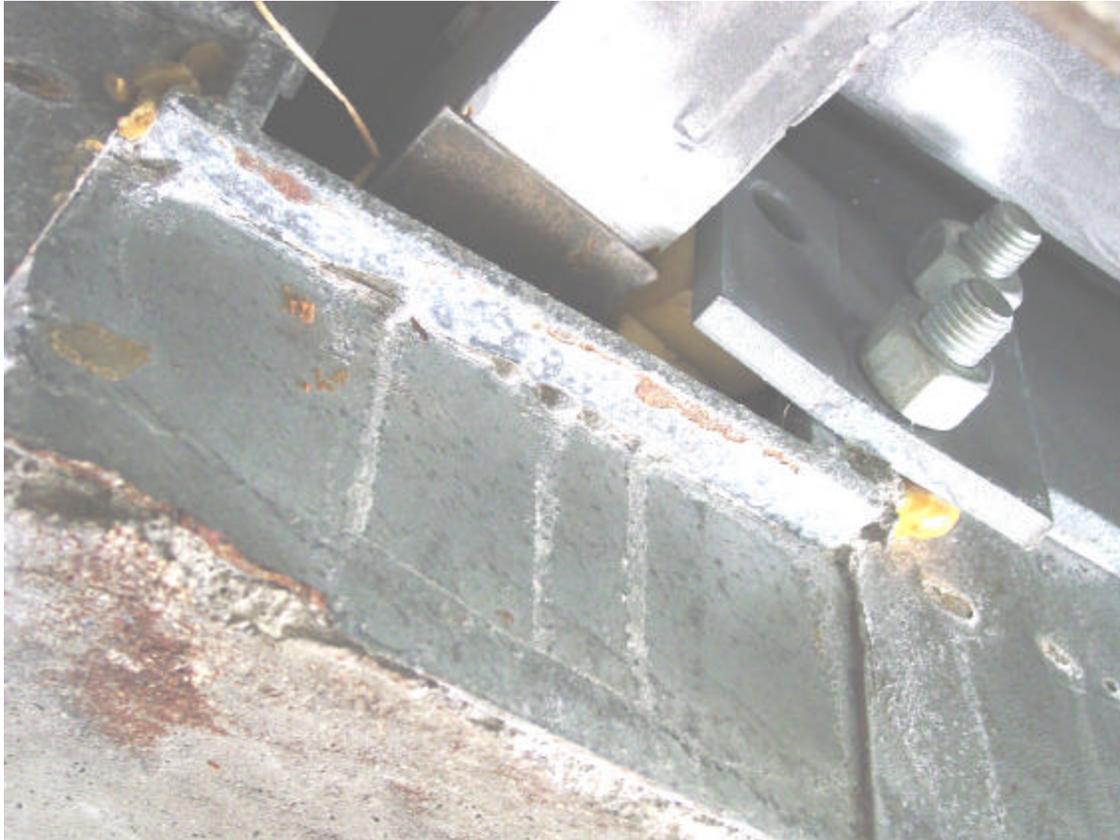
At three locations [of 68 total locations on the two joints] the nylon dowel does not protrude through the hole in the steel plate (see Figure 3 – Photo Showing Empty Hole in Steel Holding Plate). The dowels were visible behind the plate and were still within the urethane spring. The cause of the condition is uncertain but the manufacturer reports that dowels have been known to work out of the hole in the steel plate by a prying action over time. As noted above, the purpose of the dowel is to hold the spring in position. However, because the urethane spring is compressed at almost all temperatures, it is unlikely that the spring would drop completely out of the box due to extreme joint movement. However, it appears that it could work its way out of position over time.

This observation has been discussed with the manufacturer. Based on their review of the photos and the small number of occurrences observed, they advise that there is not an urgent need to re-position the dowels; monitoring the performance of the joint is recommended.

**Figure 3 – Photo Showing Empty Hole in Steel Holding Plate**

Most of the steel boxes of the MEJ extend beyond the edge of the concrete (see Figure 3.) This is not the preferred construction. The concrete formwork should have been set flush with the front of the box and the concrete cast to the edge of the box. However, since no spalling was observed, the constructed condition appears to be adequate to date. Complete support and consolidation of the concrete under the box is critical as the concrete supports the box which in turn supports the joint. This observation should be considered in preparing contract drawings for future MEJ installations.

If the dowel is only slightly out of position and still near the hole it may be possible to work it back into the hole. However, the tight clearances on these small MEJ will make it difficult to get a tool into position. The alternative method of correcting the condition is to remove the bolted holding plate, drive a new dowel into the spring, reinstall the control

spring assembly, use a hydraulic ram to re-compress the spring and bolt the holding plate back in place with the dowel properly positioned.

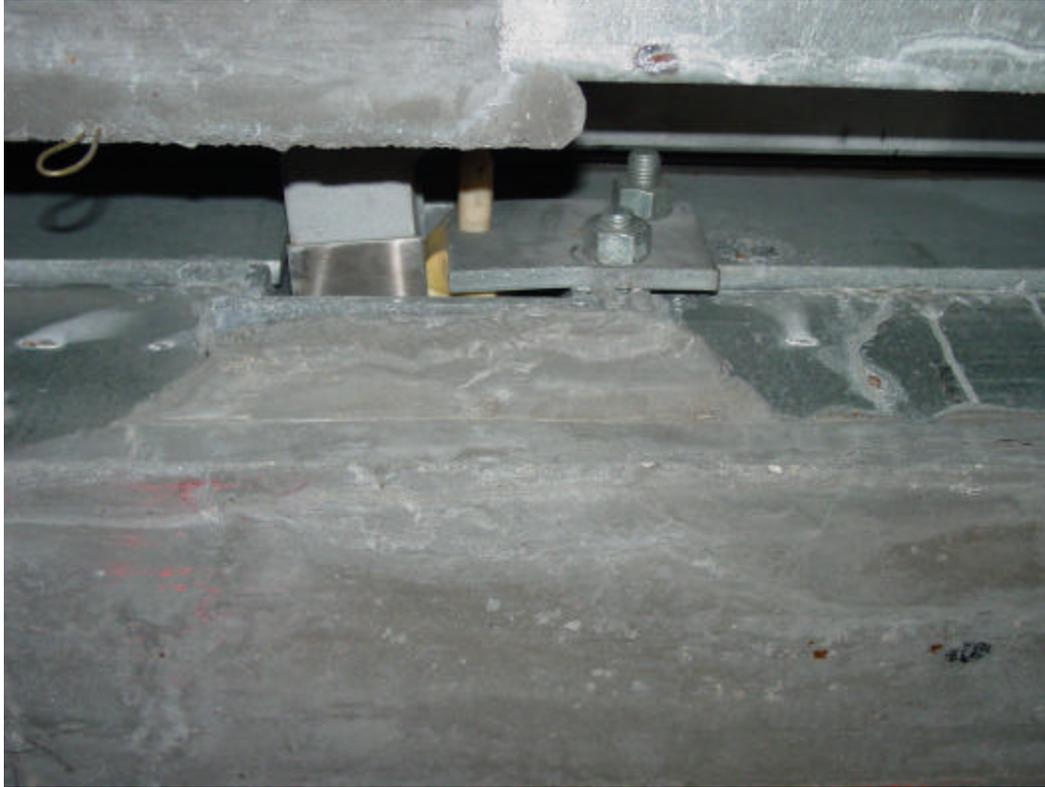
At five locations on the Pier 4 joint the urethane spring is deformed around the side of the bolted plate and is in contact with the side of the support bar (see Figure 4 – Photo Showing Bulging Urethane Spring; Figure 5 – Photo Detail, Bulging Urethane Spring.) This observation has been discussed with the manufacturer. Based on their review of the photos, they advise that the appearance of the spring does not indicate a deteriorated condition and the spring appears to be performing properly. They further advised, based on the small number of occurrences observed, that no remedial measures are required; monitoring the performance is recommended by the manufacturer.

**Figure 4 – Photo Showing Bulging Urethane Spring**

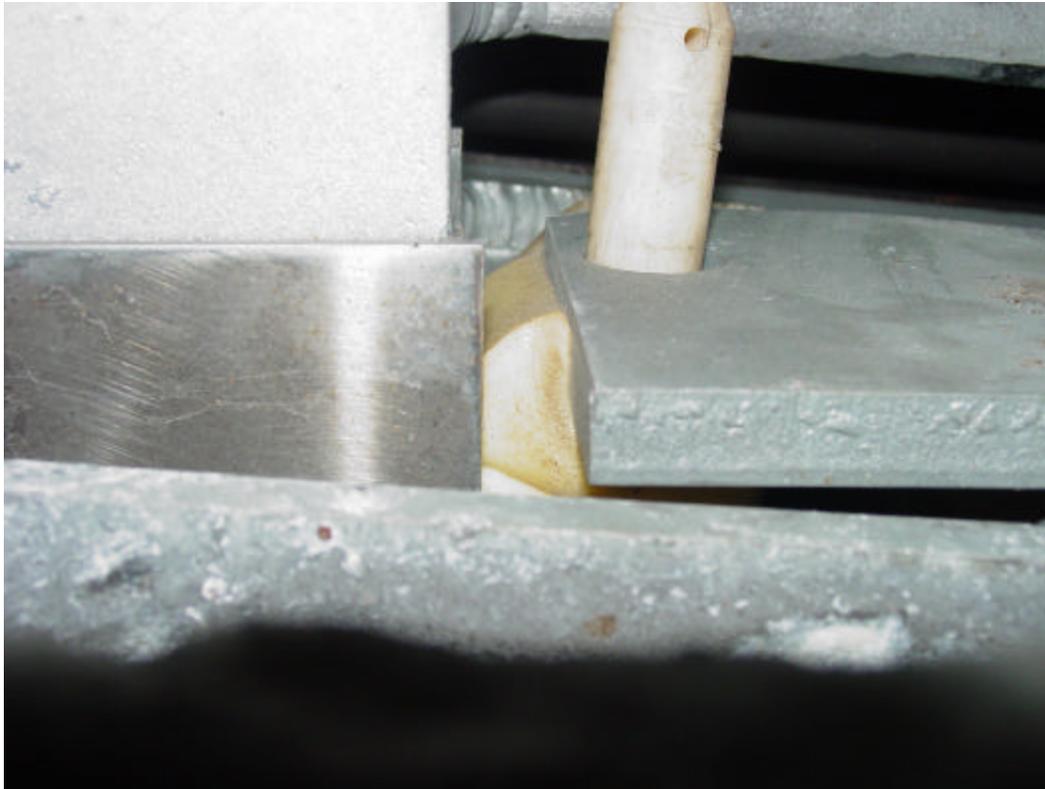
**Figure 5 – Photo, Close-up of Bulging Urethane Spring**

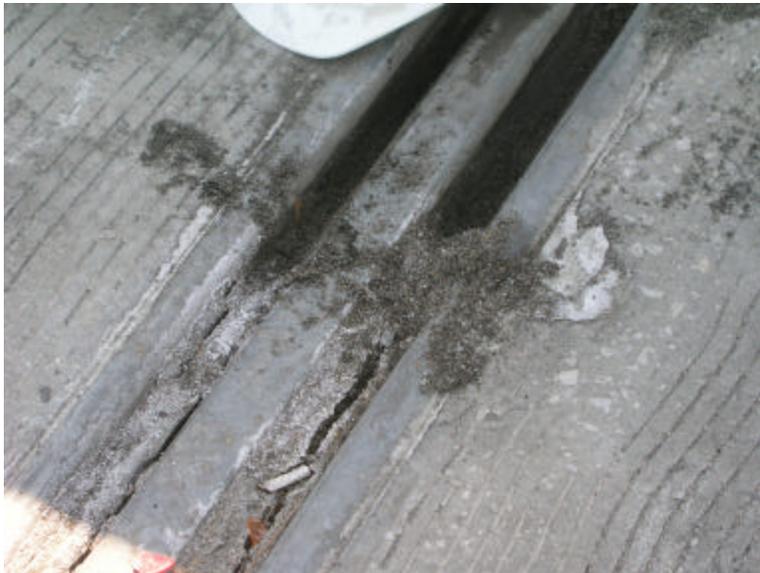
**Photo 1 Pier 4 Joint filled with debris**

The joints were found to be in generally good condition. The only maintenance need is for flushing of both of the joints to remove debris that has collected in the neoprene glands with the largest concentration of debris in the shoulders.

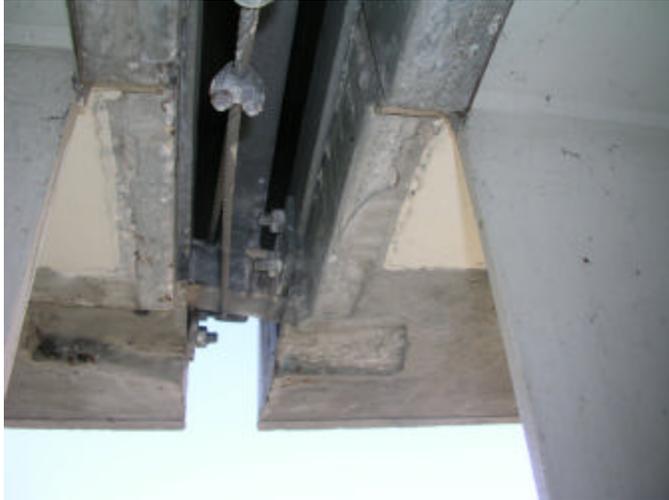
**Photo 3 Pier 2 Box 1**

At four locations [of 68 total locations on the two joints] the nylon dowel does not protrude through the hole in the steel plate (see photo 3 – Photo Showing Empty Hole in Steel Holding Plate). The dowels were visible behind the plate and were still within the urethane spring. The cause of the condition is uncertain but the manufacturer reports that dowels have been known to work out of the hole in the steel plate by a prying action over time. As noted above, the purpose of the dowel is to hold the spring in position. However, because the urethane spring is compressed at almost all temperatures, it is unlikely that the spring would drop completely out of the box due to extreme joint movement. However, it appears that it could work its way out of position over time.

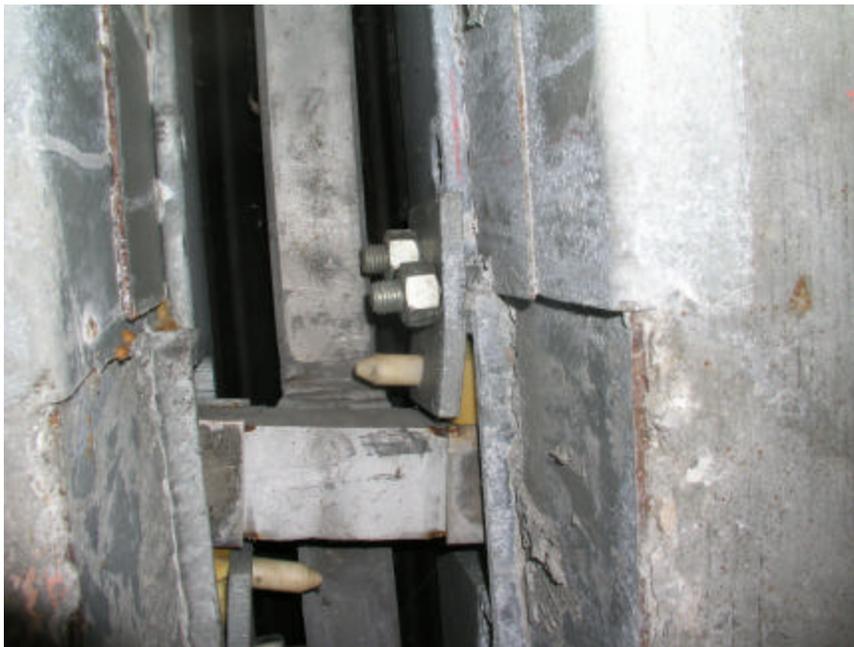
**Photo 6 15 Pier 2 Slight bulge in spring**

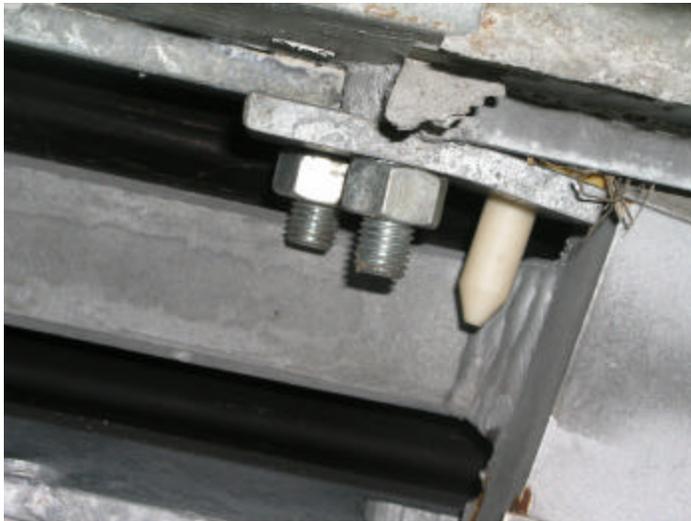
**Photo 7 Pier 2 Bird nesting signs**

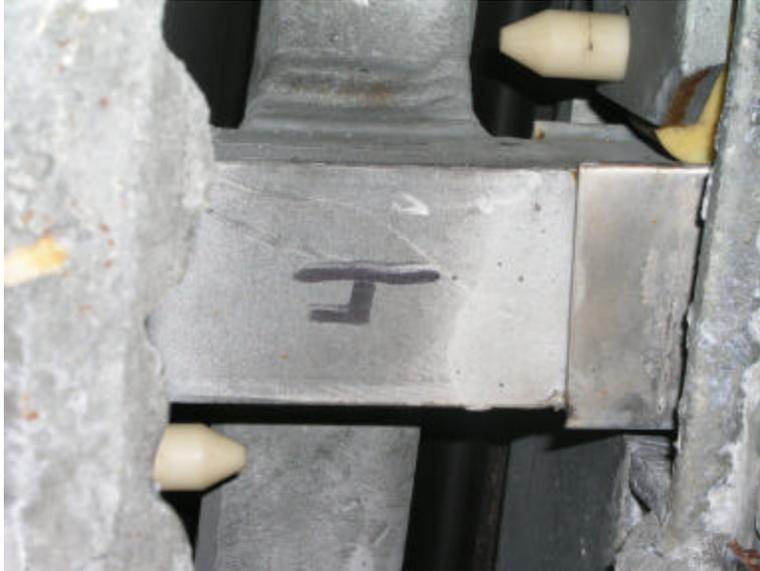
**Photo 9 Pier 4 Box 4 slightly budging spring**

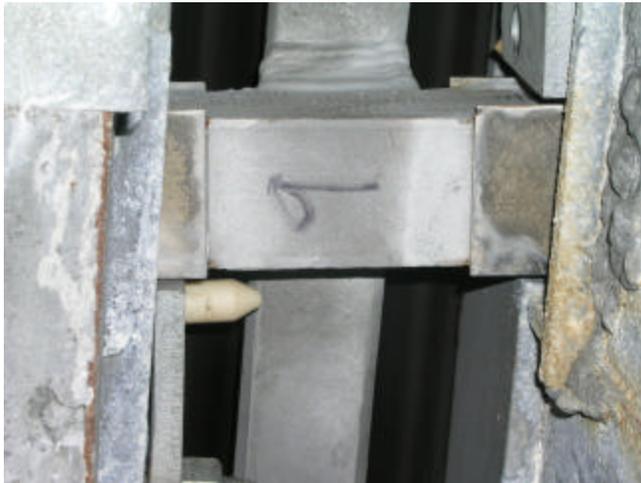
**Photo 10 Pier 4 Missing Nylon Pin**
