Pennsylvania Department of Transportation
Bureau of Planning and Research Project
Contract No. 355I01 / Project No. 070202

Inspection Methods & Techniques to Determine Non Visible Corrosion of
Prestressing Strands in Concrete Bridge Components

Task 2 - Assessment of Candidate NDT Methods

ATLSS REPORT NO. 09-09

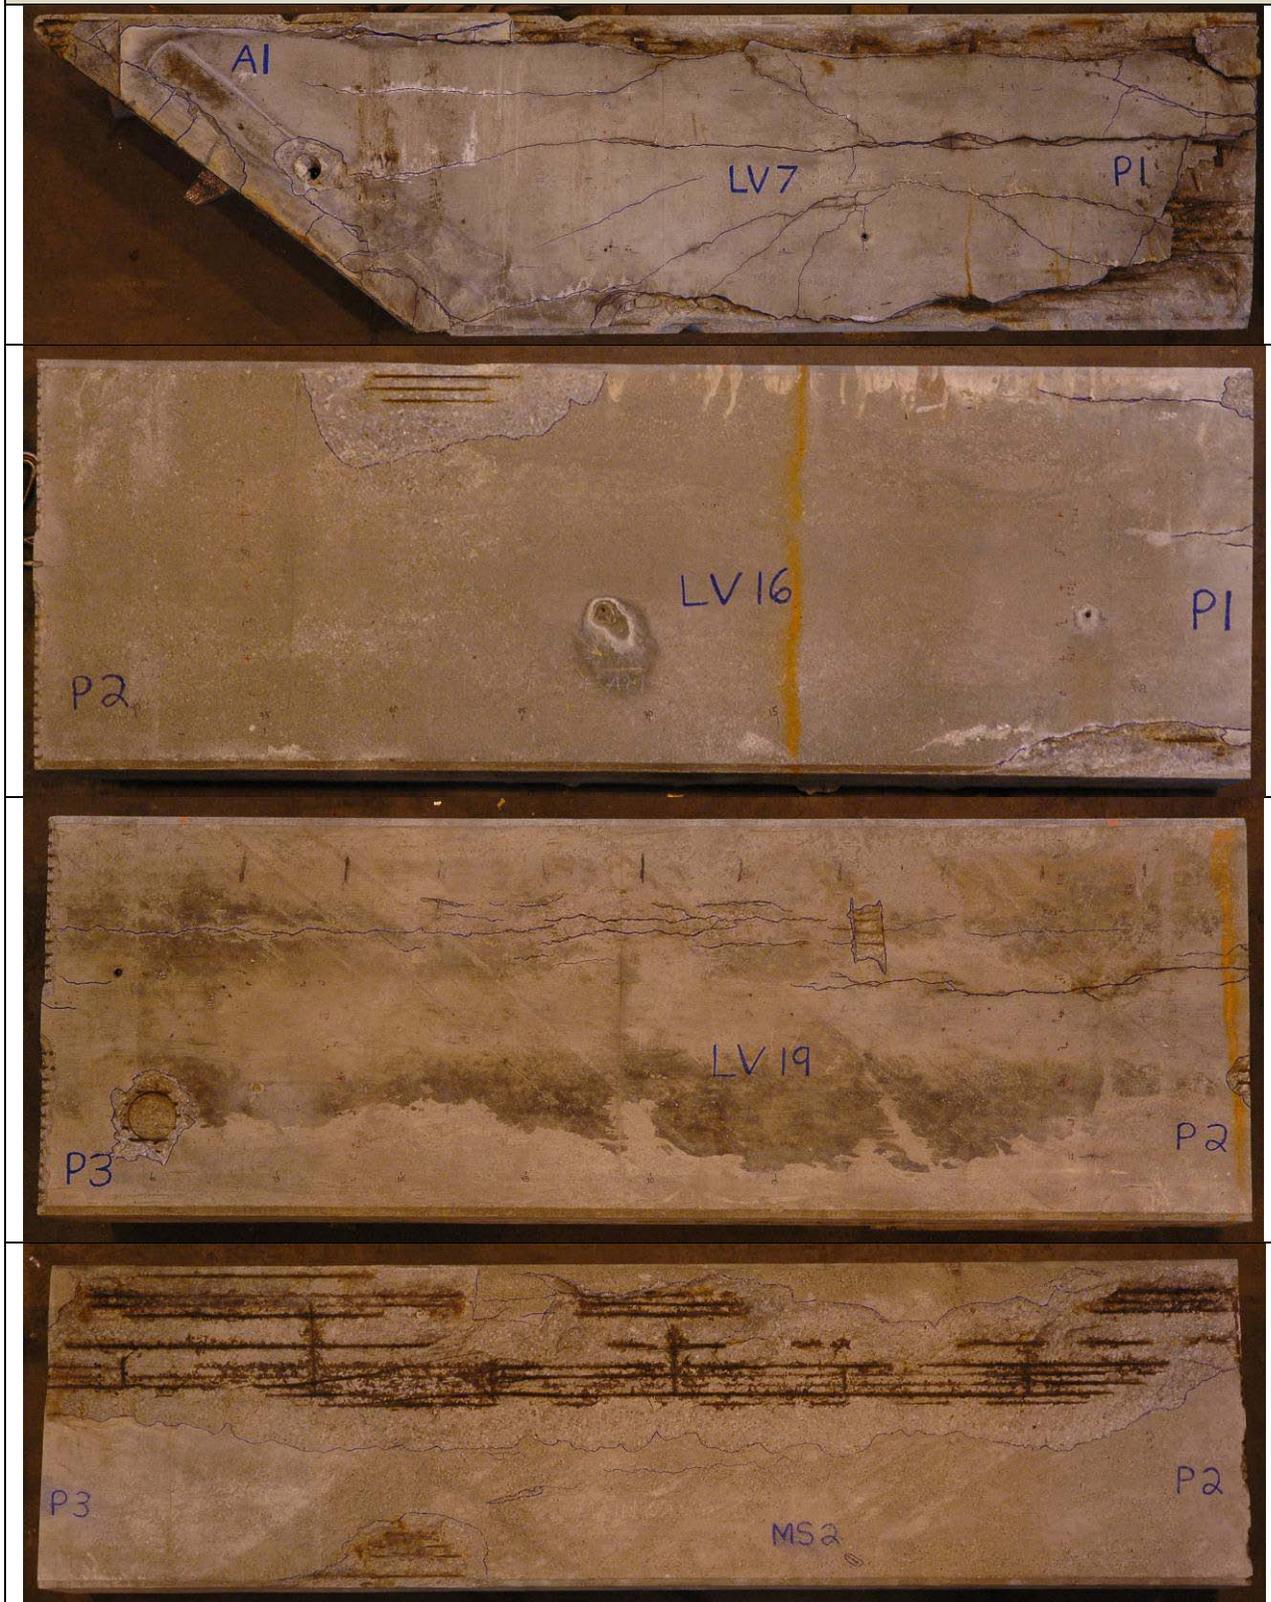
Table 1-2: In-Situ Beam Condition

As noted in Table 1-1, the condition of the selected beams varied so as to represent the spectrum of conditions that may be encountered in the field. Table 1-2 provides images of the beam bottom flange (soffit). As shown, the various beam conditions can be ranked as average – minimal cracking and exterior damage in CC3 and CC4, through poor – concrete spalling, large cracks, and rust staining in LV7.

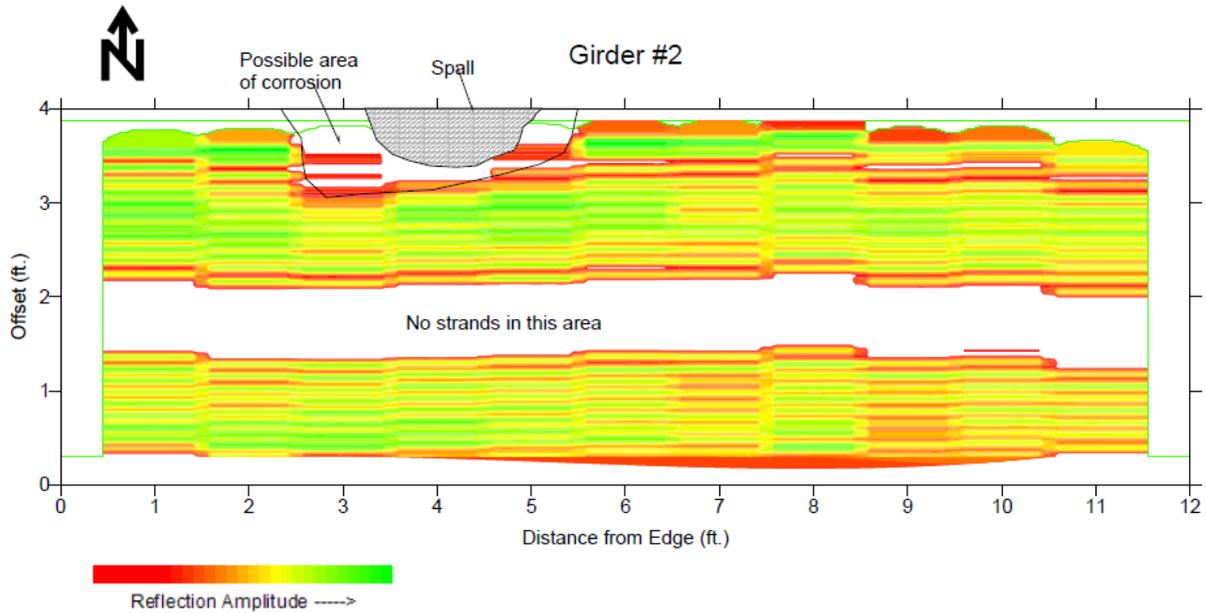
Figure 2-17: Strand Reflection Amplitude Contour Plot for LVD16

The strand reflection amplitude contour plot for LV16, Figure 2-17, shows diminished amplitude around the area of the spall indicating that this is a possible area of corrosion. Along the North edge of the beam, east of the spall, low reflection amplitudes exist. Regions of low reflection amplitude also exist along the south edge of the beam, from approximately five to ten feet.

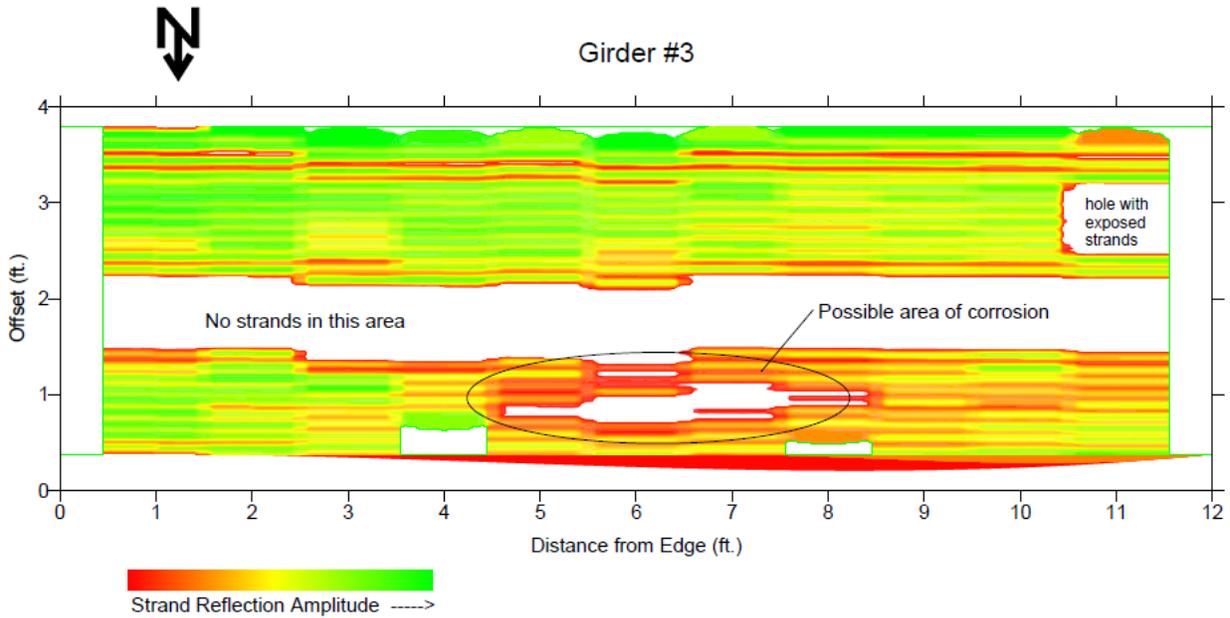
Figure 2-19: Strand Reflection Amplitude Contour Plot for LV19

The strand reflection amplitude contour plot for LV19 (see Figure 2-19) indicates a large possible area of corrosion on the bottom half of the beam. Some of the areas appear white, indicating that no strands were found. Isolated strands can be found in the top half of the beam indicating low reflection amplitude.

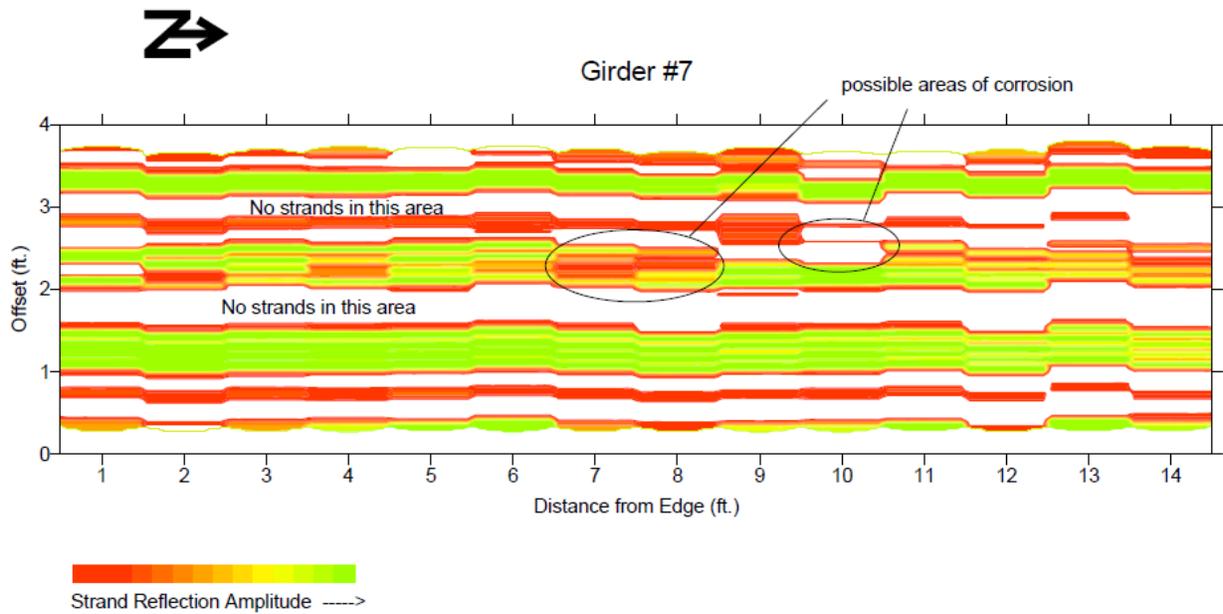
Figure 2-25: Strand Reflection Amplitude Contour Plot for MS3

The strand reflection amplitude contour plot for MS3, Figure 2-25, indicates two possible areas of corrosion on the beam, both on the top half of the beam. There are many strands within this beam that indicate low reflection amplitudes along their length.

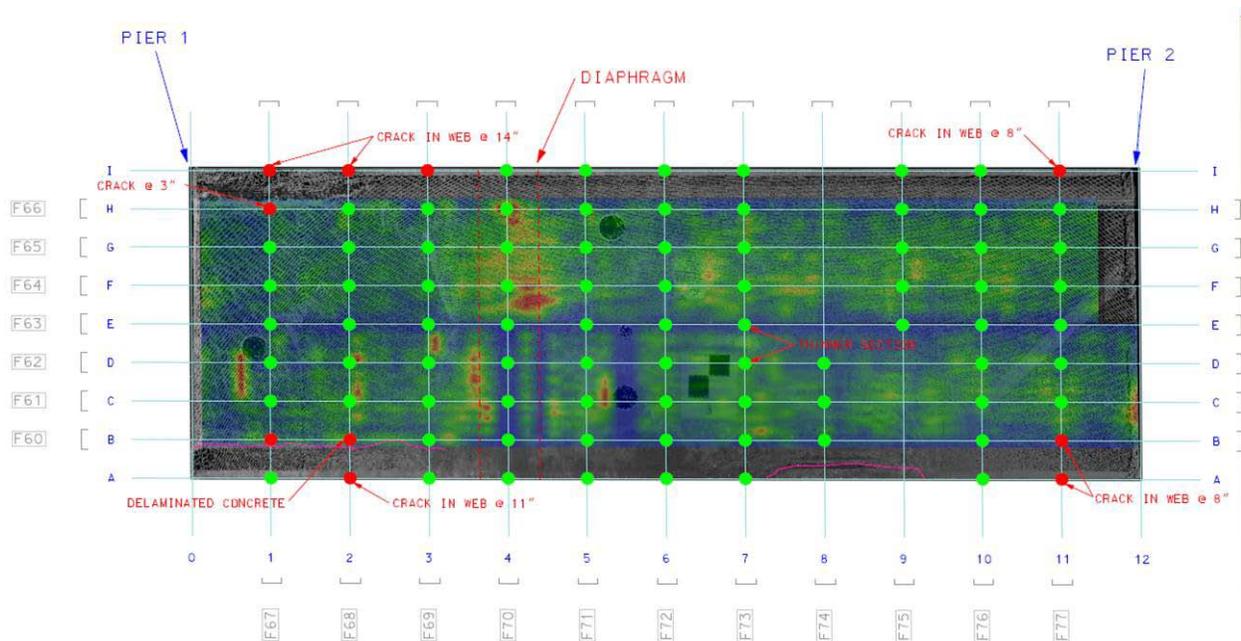
Figure 2-77: Combined NDT Results Superimposed on Beam Surface for LV16

Beam LV16 was subjected to a combination of NDT procedures. The results are shown in Figure 2-77. Of the 89 locations tested by the IE method, 10 were identified as having potential anomalies. GPR technology was applied to this beam, but no diminished reflections were identified. The polygon UST results indicate diminished reflections around the same location as the diaphragm. Some of the anomalies have been listed as: “Crack in Web,” “Crack,” and “Delaminated Concrete.” It is important to note that the methods also picked up the diaphragm located within the void of the beam.

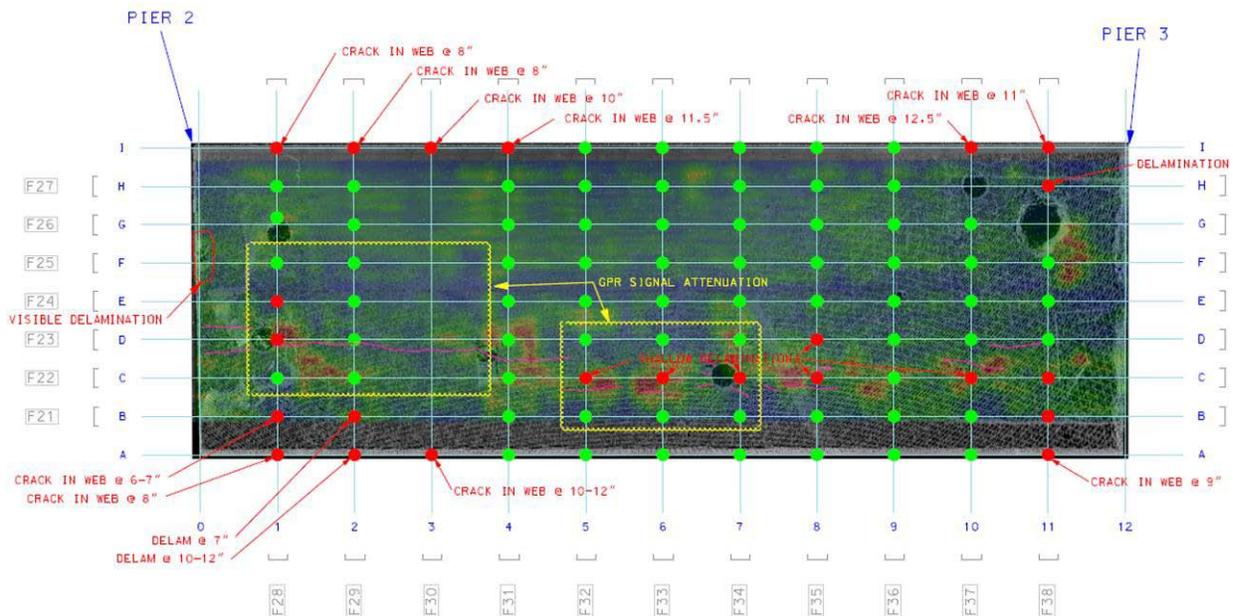
Figure 2-78: Combined NDT Results Superimposed on Beam Surface for LV19

Beam LV19 was subjected to a combination of NDT procedures. The results are shown in Figure 2-78. Of the 90 locations tested by the IE method, 23 were identified as having potential anomalies. GPR technology was applied to this beam, and two areas with diminished reflection are identified, both of which lie above the longitudinal crack present on the beam surface. The polygon UST results indicate diminished reflections around the longitudinal crack. Some of the anomalies have been listed as: “Crack in Web,” “Crack,” and “Delaminated Concrete.”

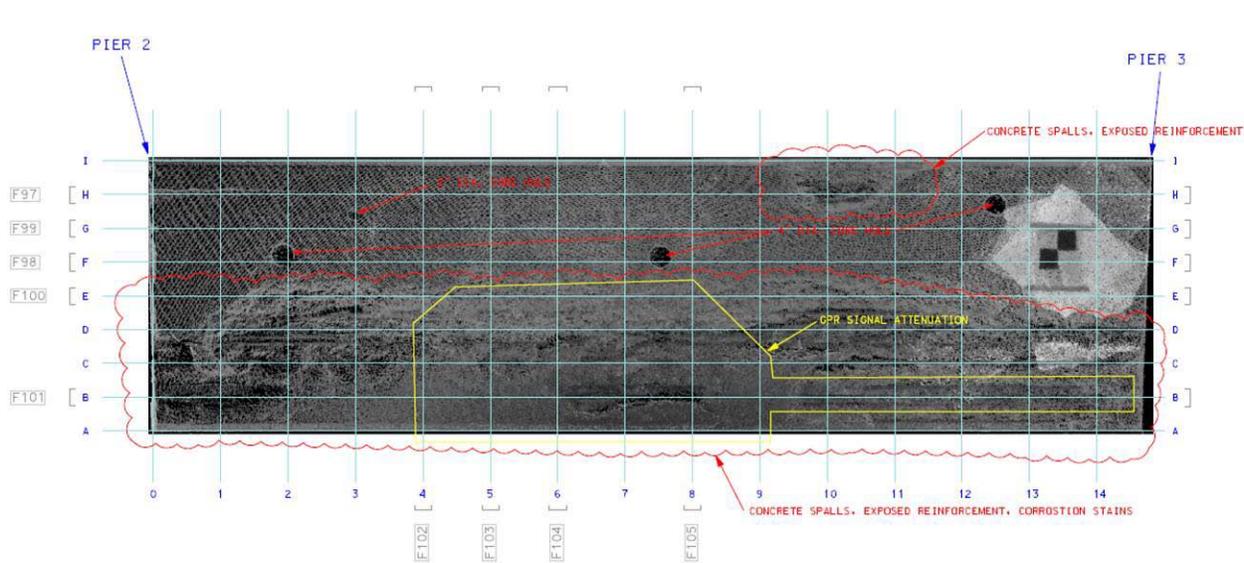
Figure 2-79: Combined NDT Results Superimposed on Beam Surface for MS2

identified. Almost the entire bottom half of the beam is spalled off, leaving the strands corroded and missing in some spots. Despite the seriously adverse condition of the bottom half of the beam, only a portion is picked up as an attenuated signal by the GPR device. The top half of the beam does not show any attenuated signals.

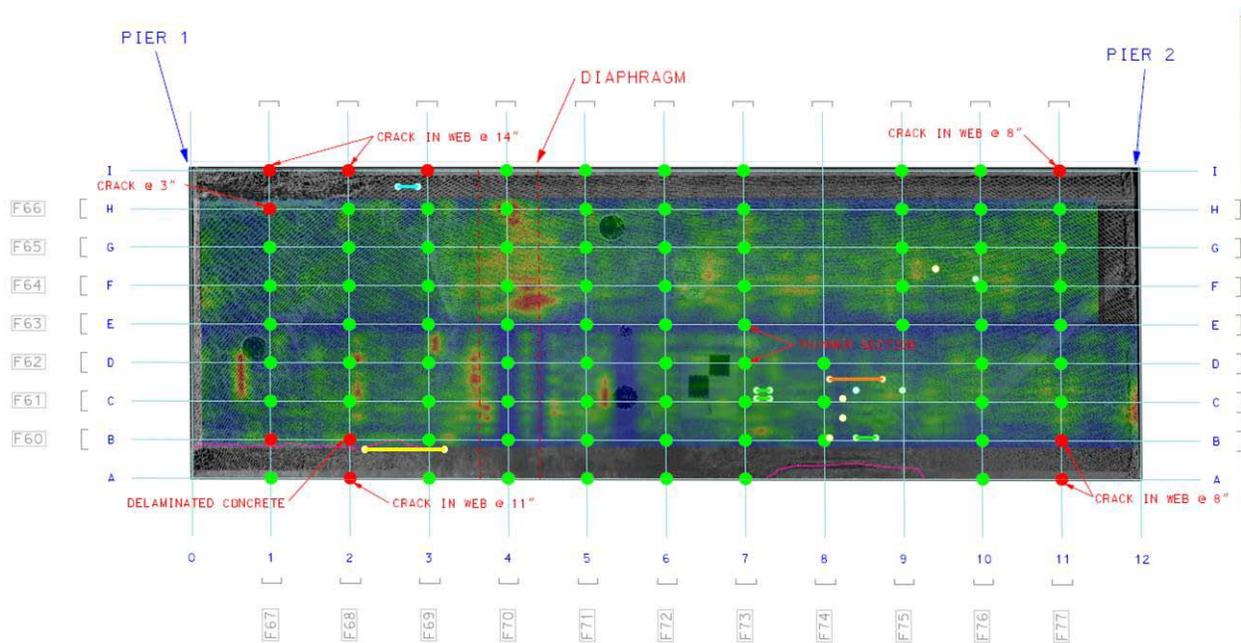
Figure 3-5: Summary of NDT Findings on Beam LV16

Beam LV16 was scanned using the aforementioned NDT procedures and Figure 3-5 was produced. The combination of NDT technologies did not pick up the single case of wire loss or the single case of heavy pitting. Of the 10 overall anomalies identified through IE, corrosion was not found at any location; a 0% success rate. Further, the GPR technology did not detect the single cases of heavy pitting or wire loss. The Polygon UST showed no correlation with strand damage.

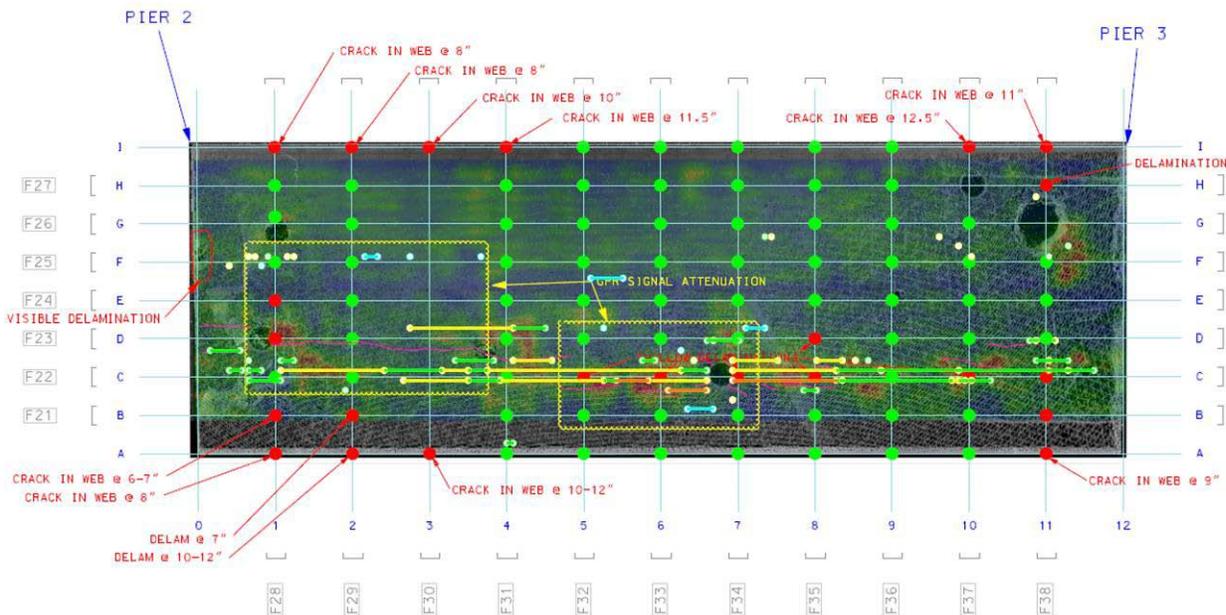
Figure 3-6: Summary of NDT Findings on Beam LV19

Beam LV19 was scanned using the aforementioned NDT procedures and Figure 3-6 was produced. The combination of NDT technologies picked up cases of wire loss and heavy pitting. Of the 23 overall anomalies identified through IE, corrosion was found at six locations; a 26% success rate. The GPR technology had signal attenuations in two areas on the beam surface; both were confirmed to have corrosion in the form of Heavy Pitting and Wire Loss. However, the areas identified with GPR signal attenuation were very large. The Polygon UST had moderate correlation with strand damage in some locations, and no correlation in other locations.

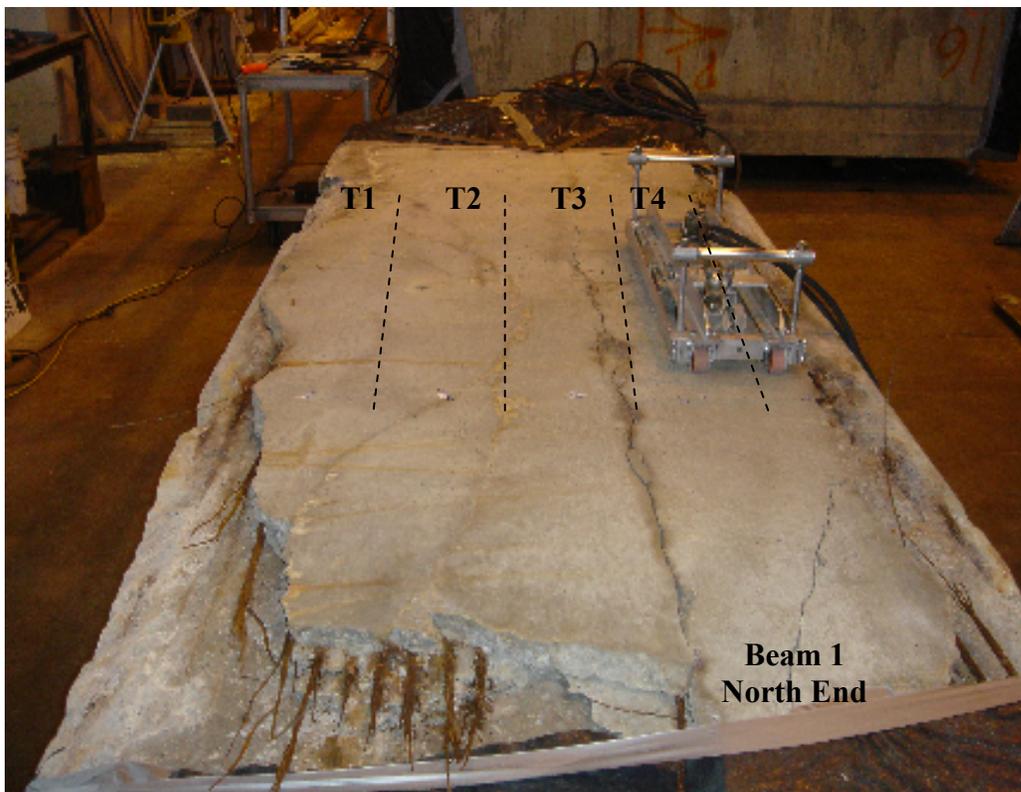
Beam 1 was located at the north end of the laboratory and it was oriented in the south to north direction. There was extensive damage in the beam including concrete spall, concrete fracture, and steel corrosion. As such, only a relatively small part of the surface of the bottom flange was suitable for the MFL test. In the area that the MFL tests were conducted, there were longitudinal cracks in the concrete but no significant corrosion stain was observed. Four MFL test scans were performed (tracks T1 to T4) for this beam and each test was along the south to north direction. Each test was started at 99 inches and stopped at 39 inches from the north end of the beam. Also, due to the damage, the first track, T1, of the testing had to be performed at approximately 10 inches clear from the east edge and the fourth track, T4, of the testing was at about 6 inches clear from the west edge of the beam. Figure 3 shows the condition of the bottom flange of Beam 1 as well as the centerlines of the MFL test scans or tracks T1 to T4.

Figure 3 – Appearance of the bottom flange of Beam 1 and the centerlines of MFL tracks T1 to T4

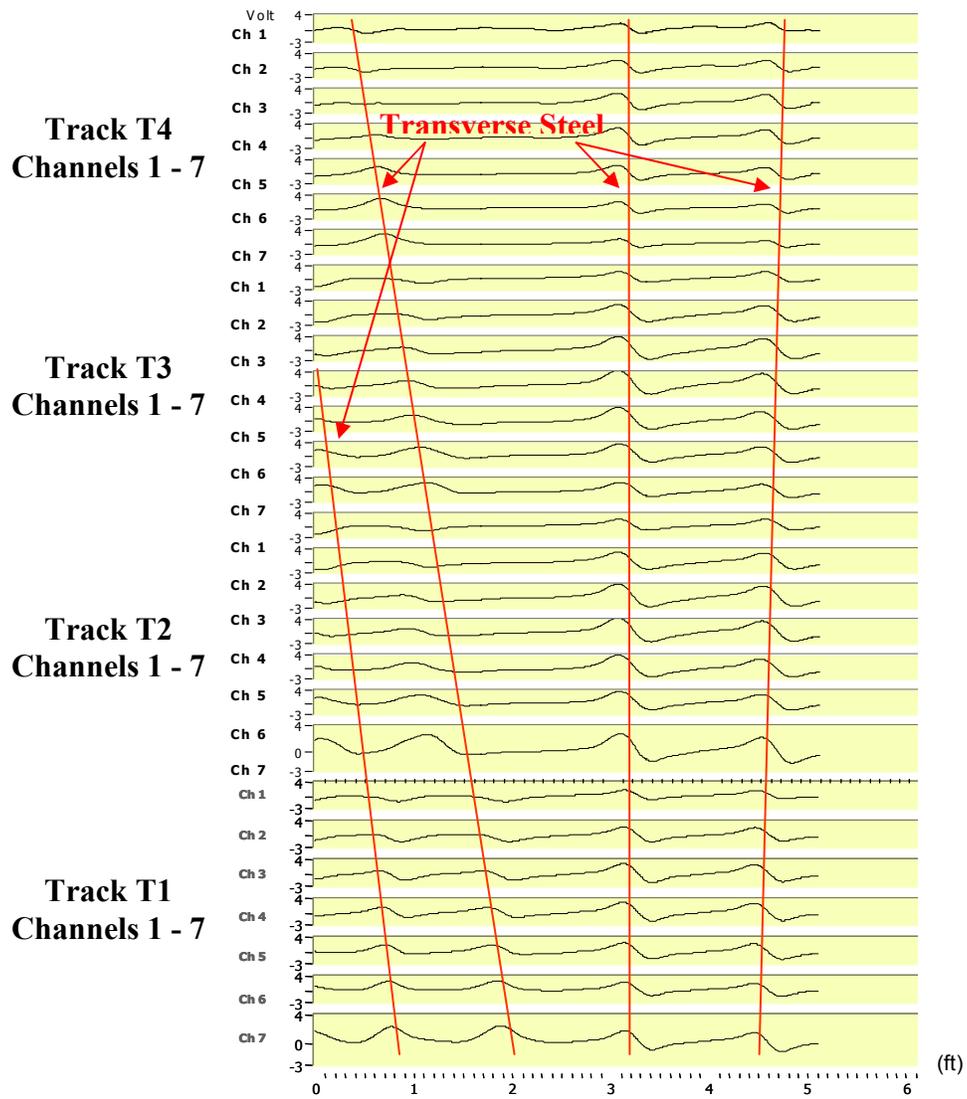
The MFL test results from the four tracks that were taken over the specified surface area of the lower flange for Beam 1 indicated evidence of general surface corrosion of the prestressing steel and the transverse reinforcing bars. No indications of wire breaks or fracture of the strands were observed. Figure 4 shows the side-by-side results from the MFL testing of the 4 tracks in the beam. Please note that the left end of each graph corresponds with the beginning of each test (the south end of the beam). The MFL tests also showed irregularities in the placement/orientation of the transverse reinforcing steel bars in the beam. The large local amplitude variations in the figure (4 indications along the east edge and 3 indications along the west edge of the beam) represent the location of the transverse steel bars in the beam. The red lines in the figure indicate the locations of the transverse reinforcing bars in the beam. It is clear from the figure that the first 2 transverse steel bars are not perpendicular to the sides of the beam and are embedded deeper inside concrete at the west edge.

Figure 4 – Longitudinal MFL scans shown for 4 Tracks in Beam 1
(Scan results are laid out side-by-side)

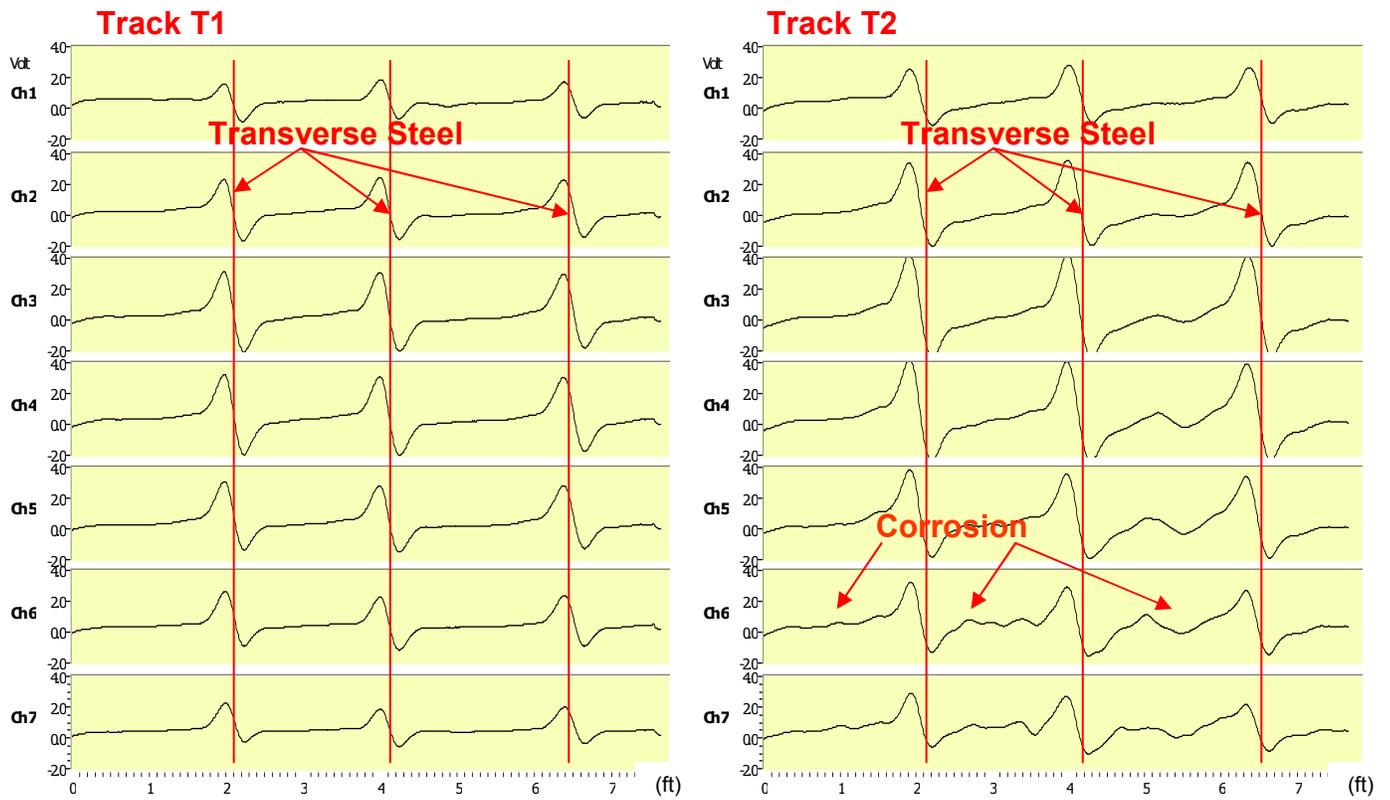
Figure 7 – Longitudinal MFL scans shown for Tracks T1 (left) and T2 (right) in Beam 3 (Indications of corrosion can be seen in the data between transverse steel bars in track T2)

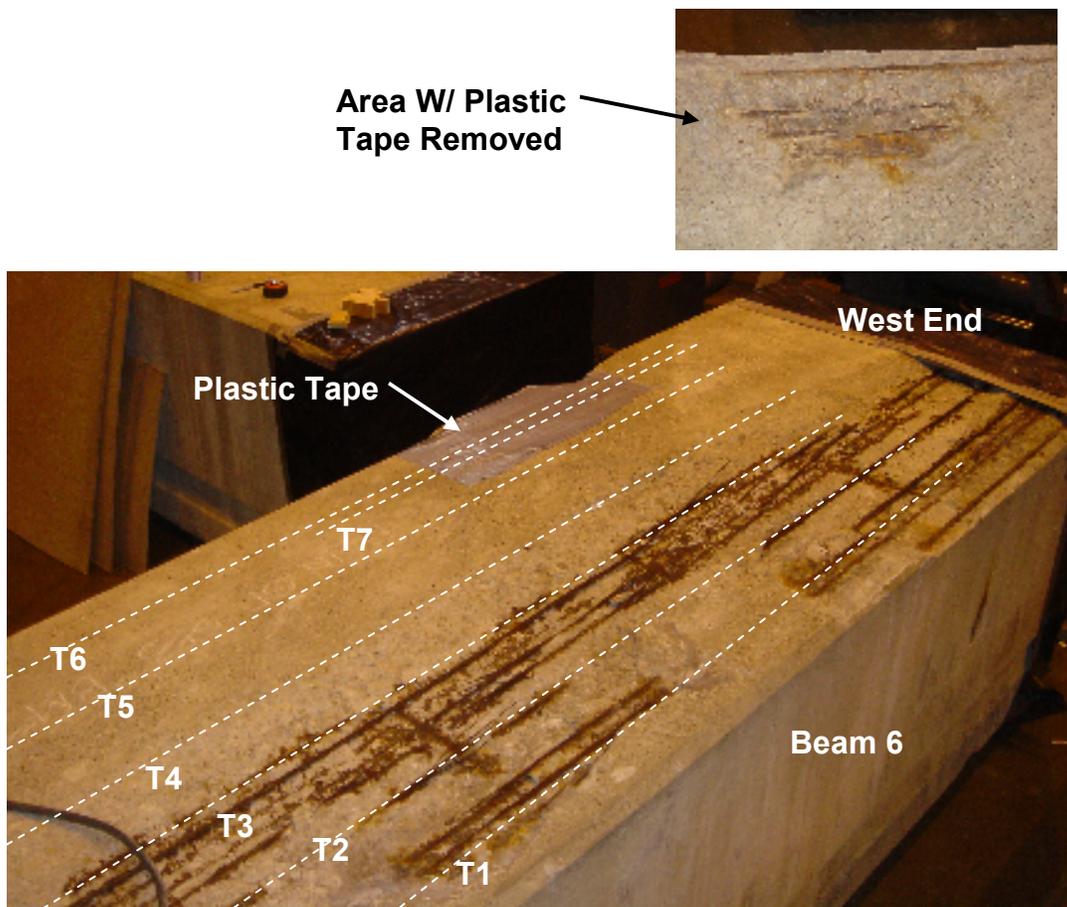
Figure 10 – Photo showing extensive corroded steel and the centerlines of the MFL test tracks in Beam 6

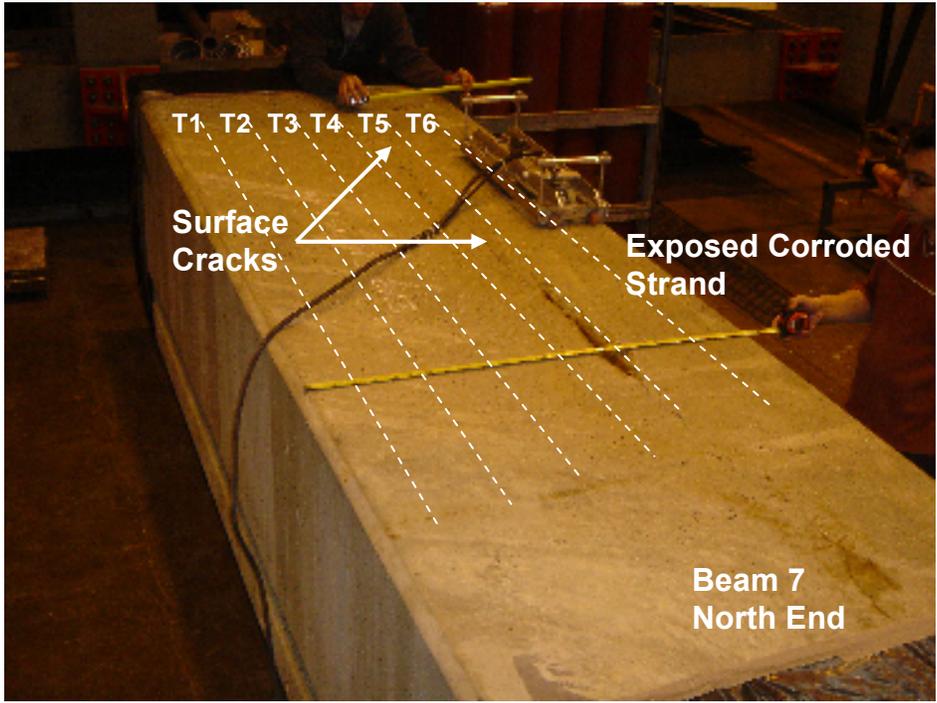
Figure 15 – Surface condition for the lower flange of Beam 7

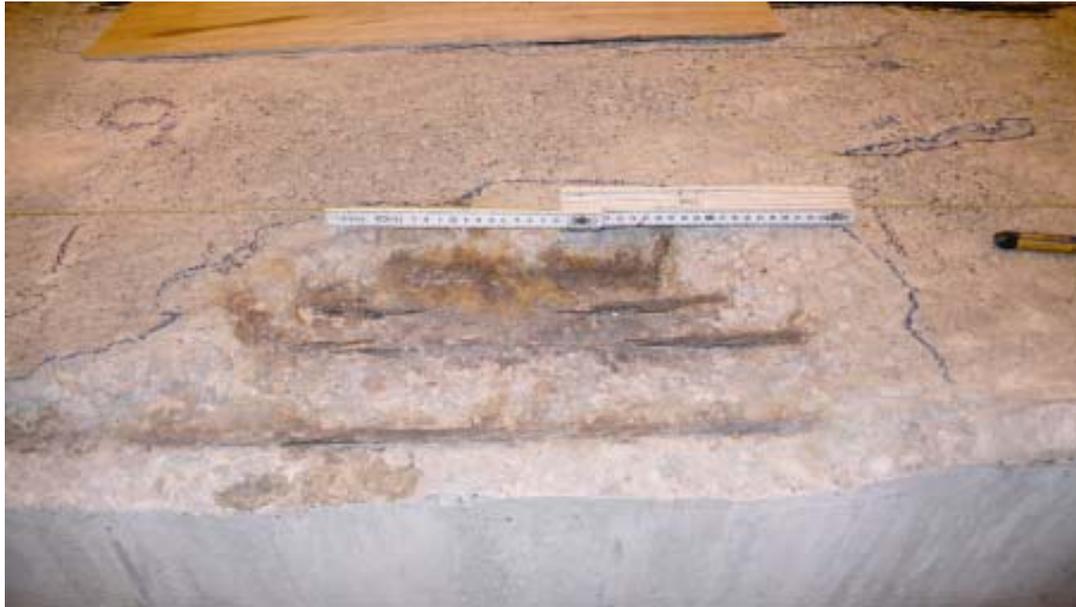
Figure 4: Corroded section of a box girder (MS2, line 1) with destruction of the tension wires over a length of 20cm.

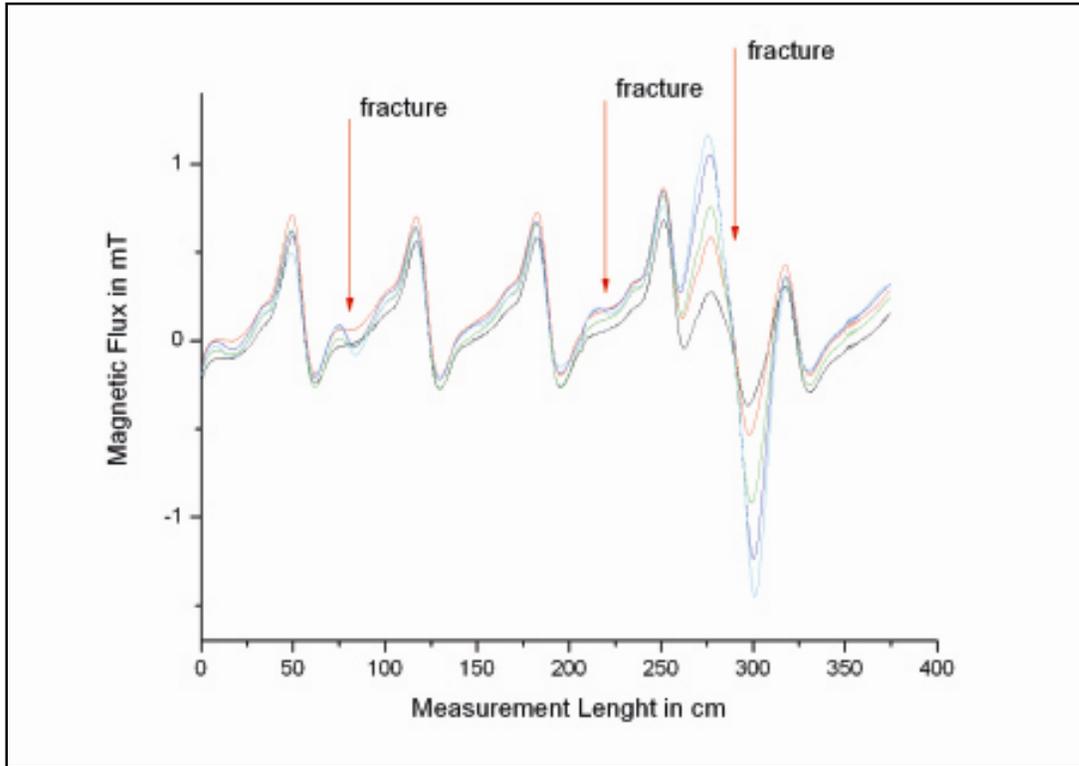
Figure 5: Measurement of the total length of the tension wires of the box with a strong fracture signal at 270cm. This signal is from the fracture, as shown in Figure 4.

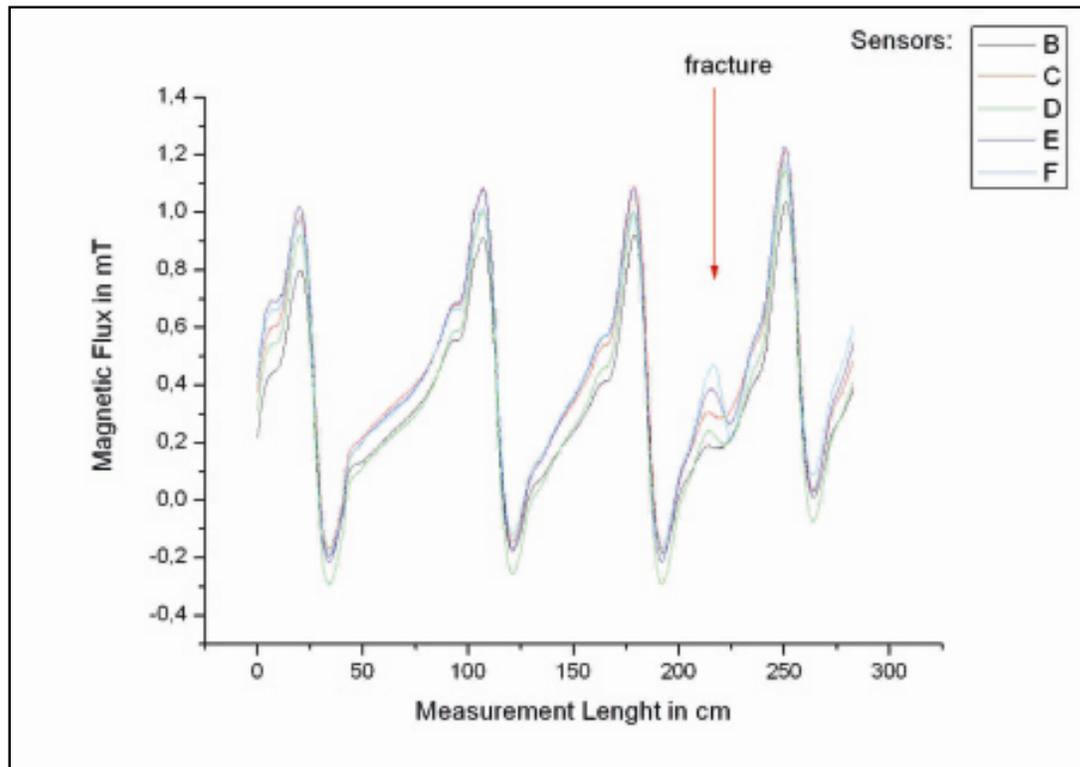
Figure 21: Box Girder LV16, line 5; fracture signal (at about 225cm) measured in the active magnetic field

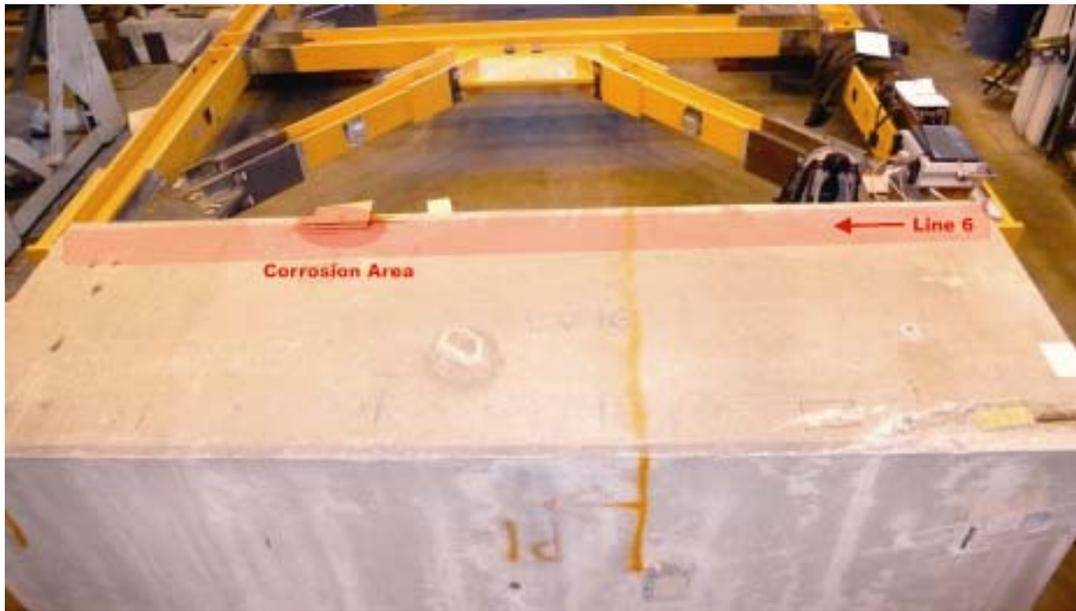
Figure 22: Box girder LV16 with markers of line 6 and open lying corroded prestressing wires

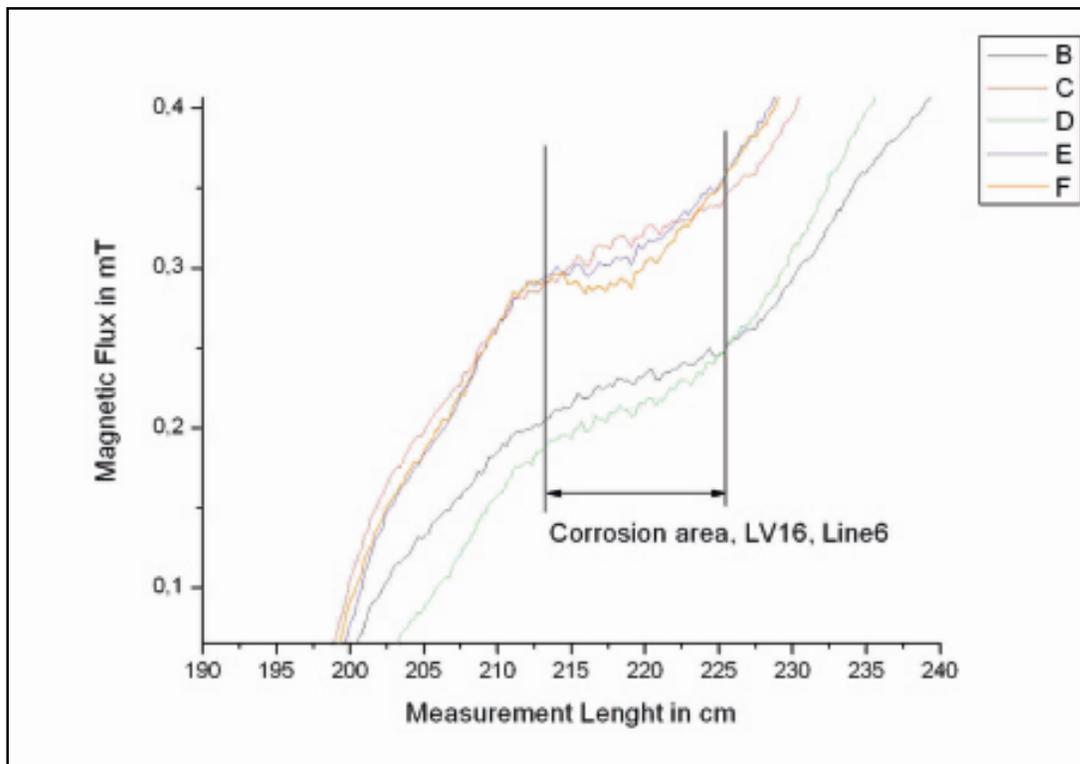
Figure 23: Box girder LV16, line 6; signal scattering in the area of corroded wires at measurement in the active magnetic field

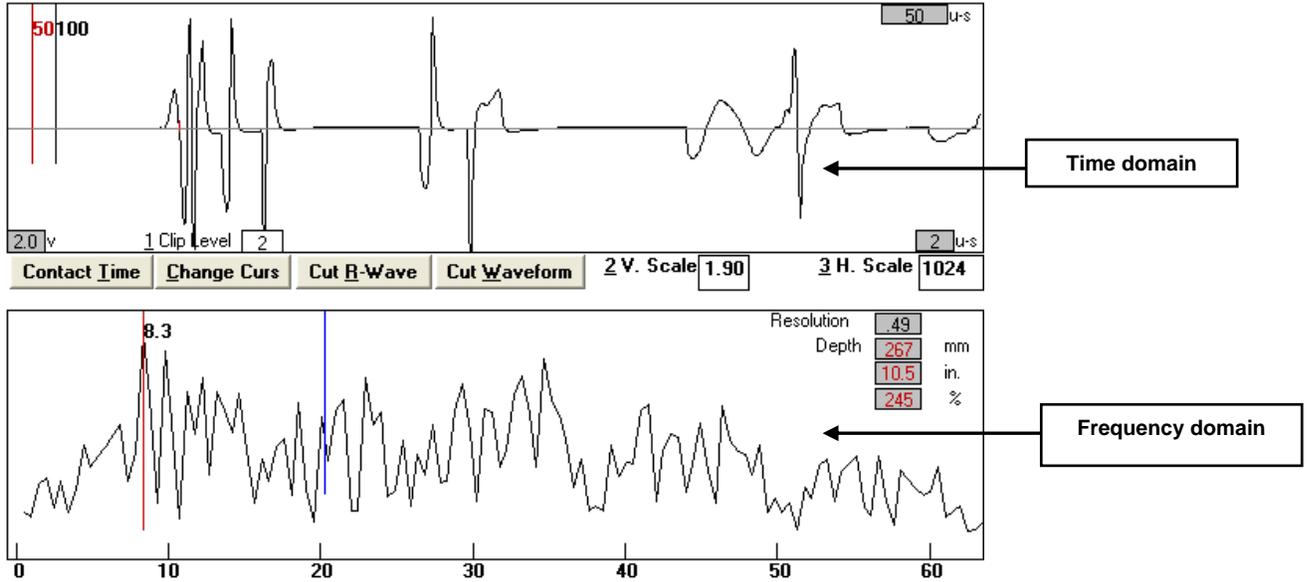
Figure 19- IE test result showing a shallow delamination at Beam 7, Grid Point D11

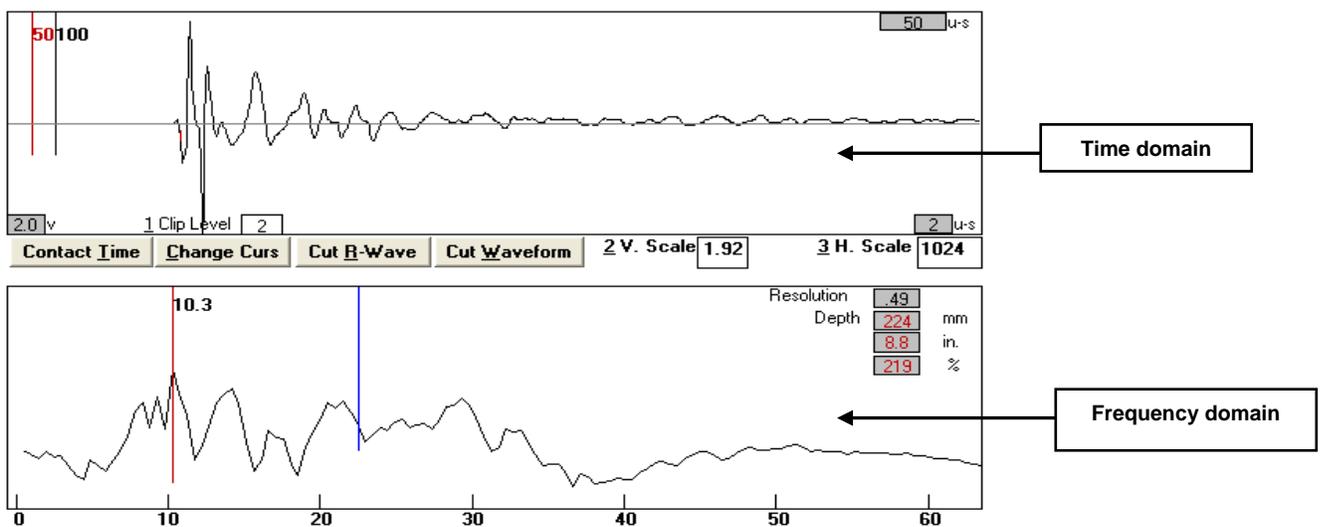
Figure 20- IE test result showing a reflection (10.3 kHz) from a web crack at depth of 9 in. (Beam 3, Grid Point A1).

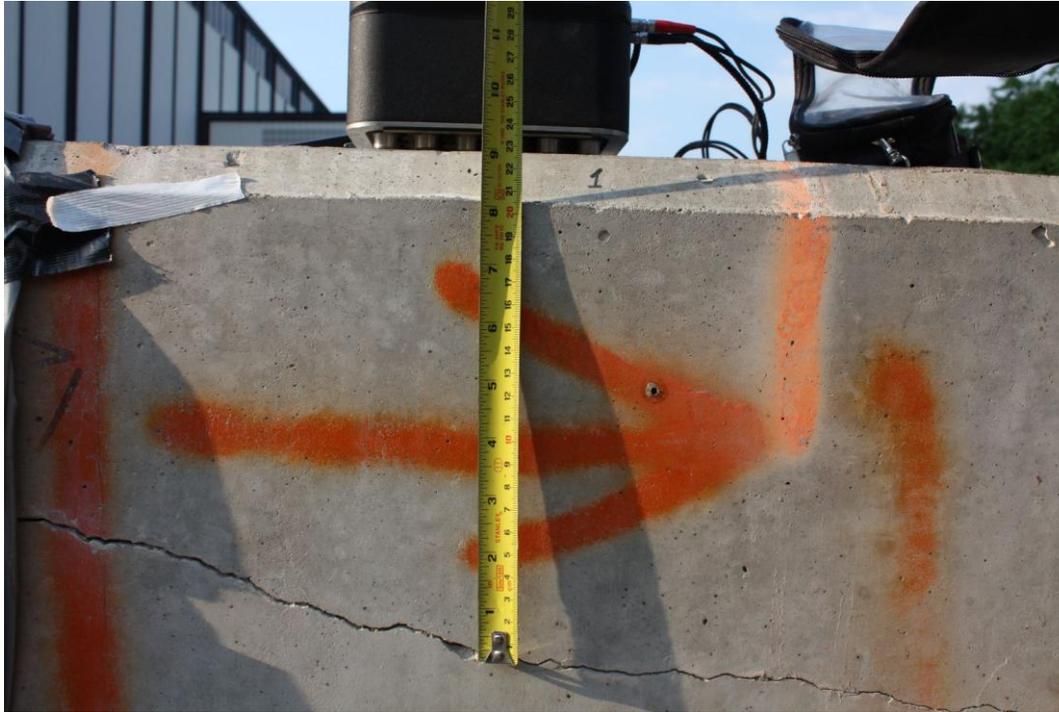
Figure 21- View of a shear web crack, Beam 3 at about 9 in. below the top surface.

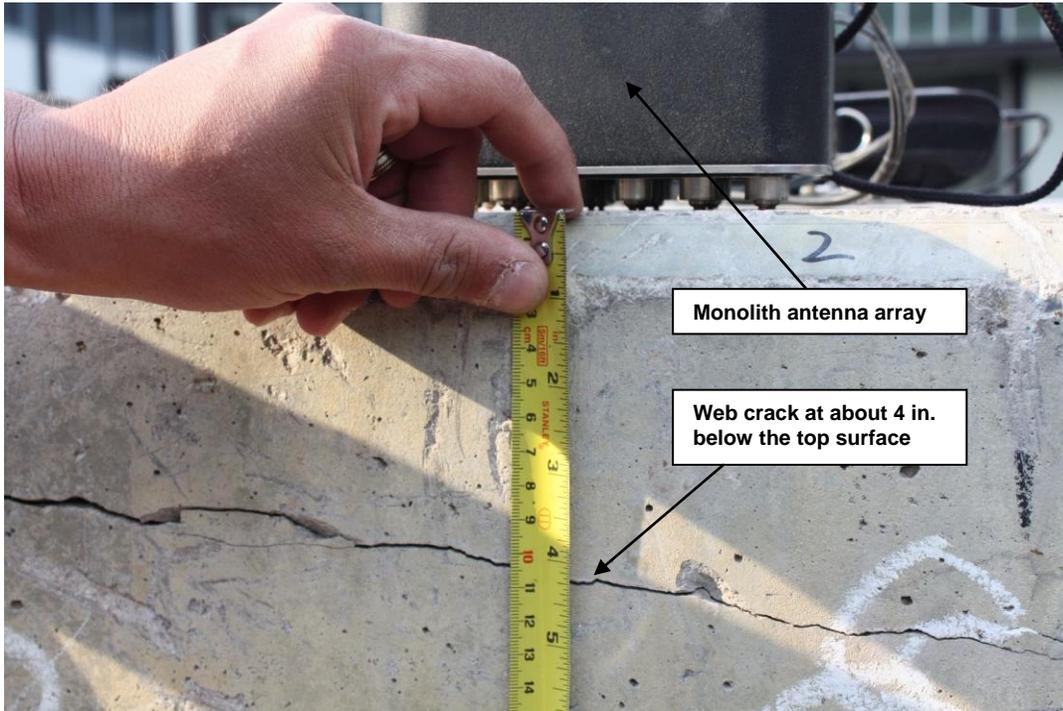
Figure 23 - View of web crack at nominally 4 in. deep.

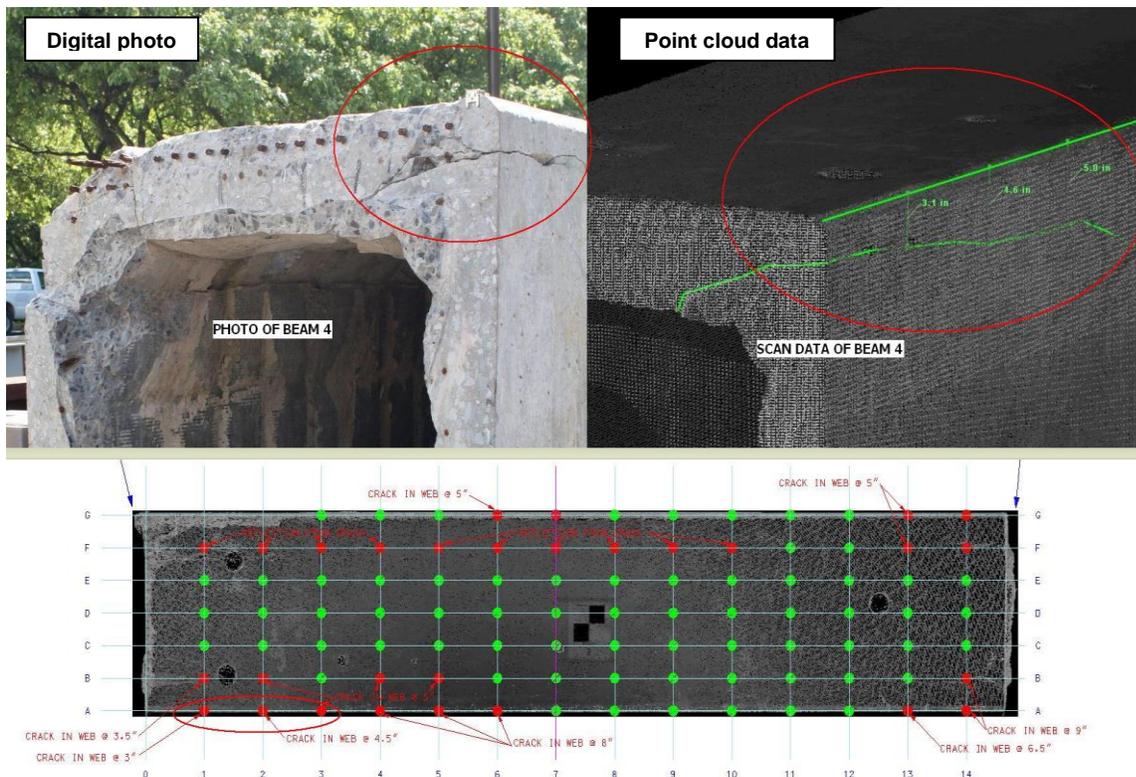
Figure 34 – View of a crack in Beam 4 documented using the 3-D laser scanner
