## Premature Deterioration of Jointed Plain Concrete Pavements

FINAL REPORT

Date April 2011

By (PI) Dr. J. M. Vandenbossche, P.E.  
University of Pittsburgh

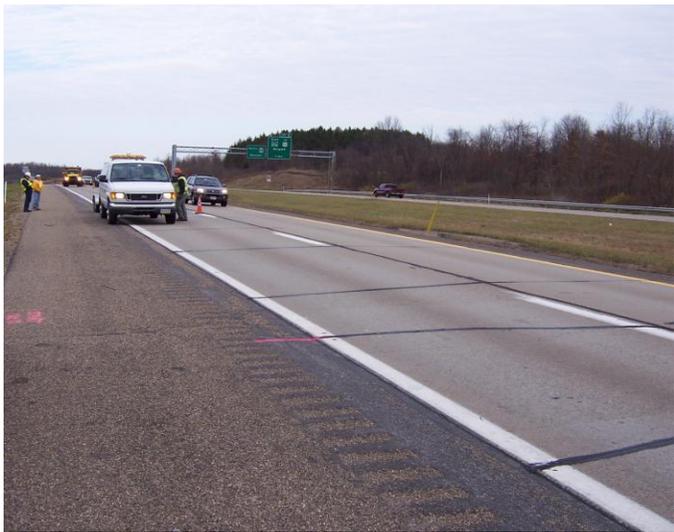
Figure 4: Overall Condition of SR 60 Segment 323 Southbound (Distressed Section)

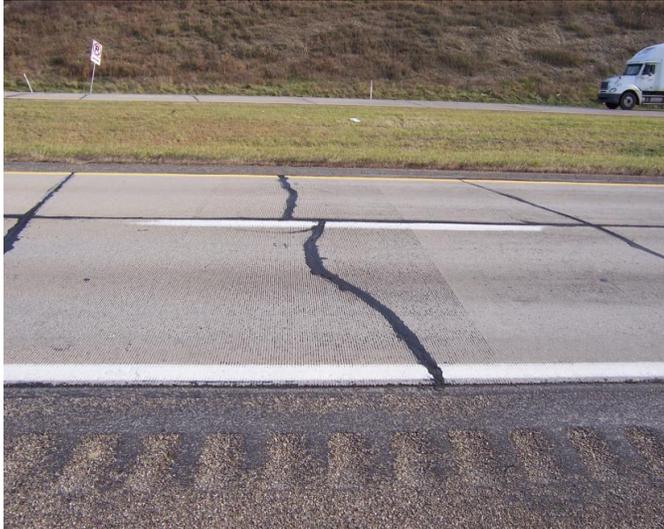
As mentioned previously, the major distress observed for both sections was mid-panel transverse cracking. An example is presented in Figure 6. According to the distress identification manual, the transverse cracks were categorized based on their severity level. The severity level is a function of the size of the crack and the size of the spalling around the crack, if any. A breakdown by severity shows that 74 percent of slabs exhibit high severity cracking and 14 percent of slabs exhibit medium severity cracking for the Distressed section. For the Control section, 4 percent of the slabs exhibited low severity cracking, 12 percent of the slabs exhibited medium severity cracking and only 4 percent of the slabs exhibited high severity cracking. Section 2.13 of this report explores the marked difference in the transverse cracking between the Distressed and Control section for SR 60 while Section 8 discusses how the overall performance of the pavement is related to performance of the OGS base layer used in the Distressed section.

*Figure 6: Mid-slab Transverse Cracking for SR 60 Segment 323 Southbound, Slab 5 (Distressed section).*

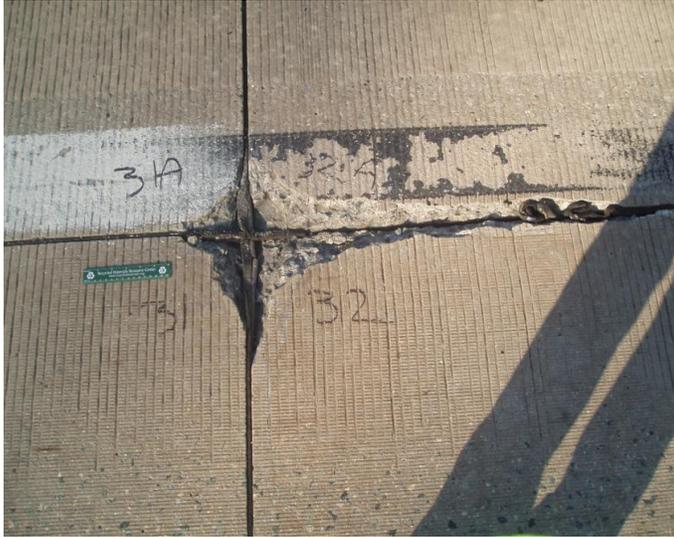
The major distress observed in the section was spalling at the intersection of the longitudinal and transverse joints. A typical manifestation of this distress can be seen in Figure 36 and Figure 37. This type of distress is present in 94 percent of the slabs. A further breakdown of the data reveals that the severity of the spalling is high in 44 percent of the slabs, moderate in 35 percent, and low in 15 percent of the slabs.

*Figure 36: Joint Intersection between Adjacent Lanes of SR 202 Segment 440 Northbound Slabs 31 and 32.*

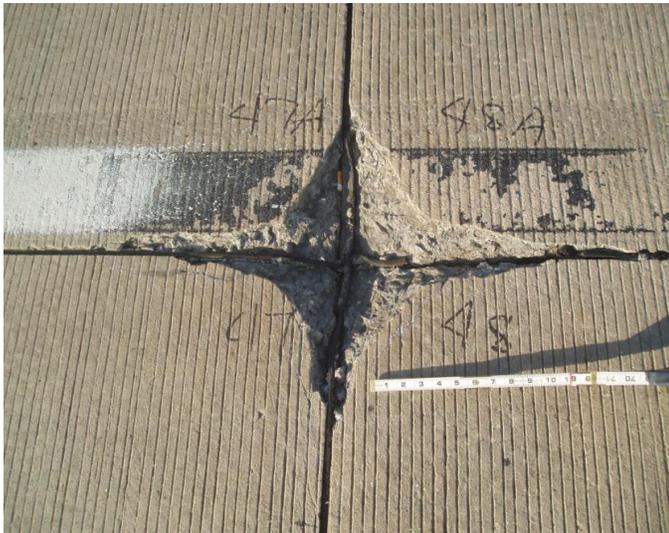
*Figure 37: Joint Intersection between Adjacent Lanes of SR 202 Segment 440 Northbound Slabs 47 and 48.*

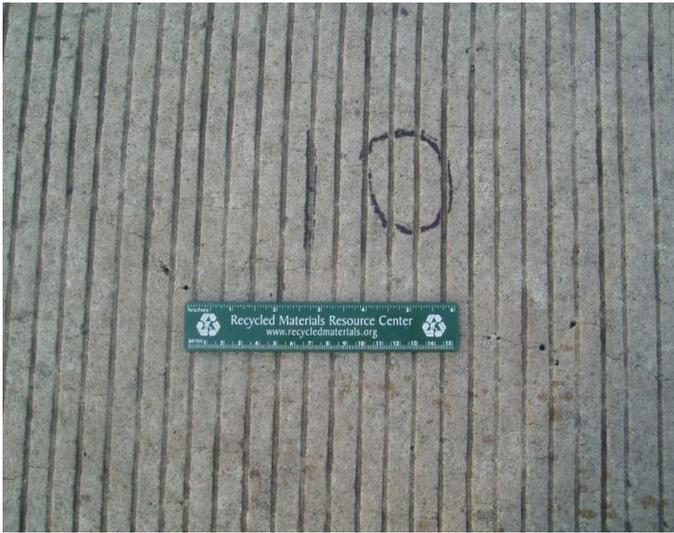
Map cracking was the other major distress observed in Segment 440. Map cracking over the entire surface of the slab was observed in 55 percent of the slabs. The microcracks within the map cracked areas are mainly oriented in the longitudinal direction of the slabs and are interconnected by finer cracks randomly distributed as shown in Figure 38 and Figure 39.

Figure 38: Close-up of Fine Microcracking of SR 202 Segment 440 Northbound, Slab 10.

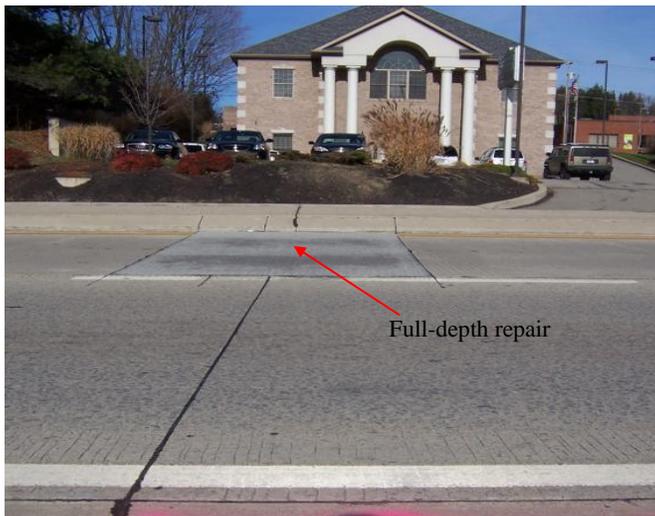
Although the passing lane was not part of the distress survey, it was noted that in addition to the driving lane, the adjacent passing lane also exhibited several full-depth repairs as well as extensive diamond grinding. Unlike the driving lane, the areas in which full depth repairs were performed to repair corner breaks for the passing lane were distinguishable based on visual observation and not based on observed base type. This can be seen in Figure 51

*Figure 51: Full Depth Repair in the Passing Lane of US-22 Murrysville Segment 50 Eastbound.*

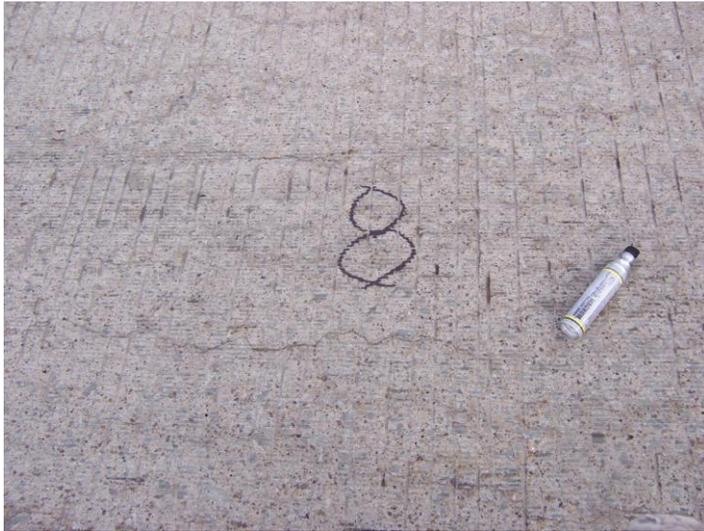
*Figure 53: Slab Close up of Midslab Longitudinal Cracking from US-22 Murrysville Segment 50 Eastbound, Slab 8.*

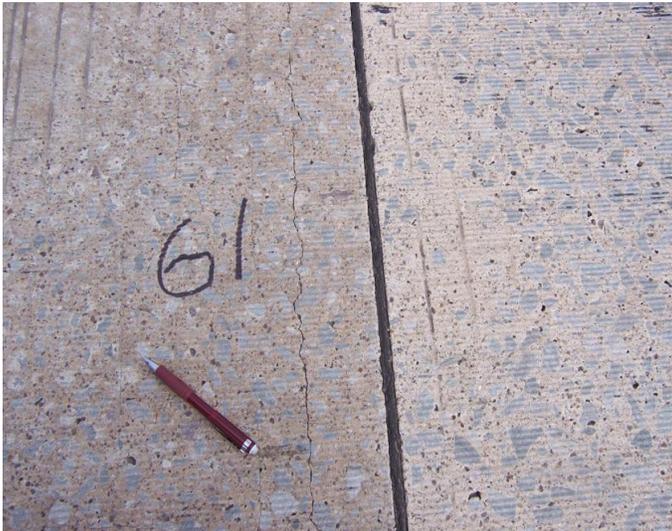
Figure 54: Joint Close-up of US-22Murrysville Segment 50 Eastbound, Slabs 61 and 62.

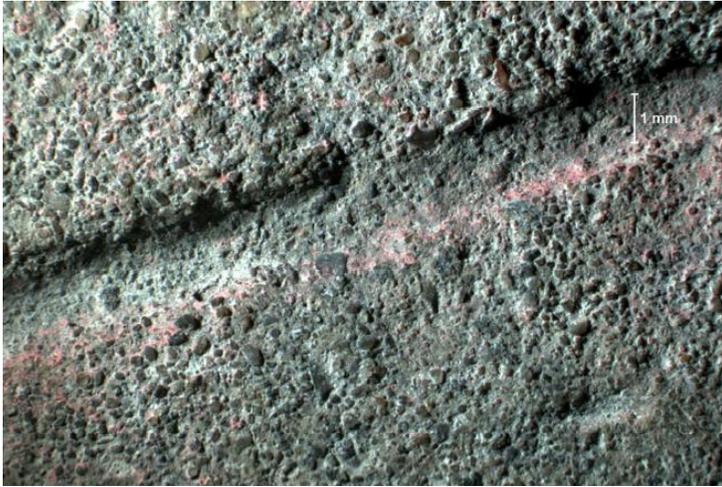
Drying shrinkage cracking and carbonation was identified at the surface. There was also erosion/wear at the surface throughout the section indicating a non-abrasion resistant paste. This can be seen in Figure 65. This can be the result of inadequate finishing/curing practices or a concrete mixture with a high water to cement ratio.

*Figure 65: Wear/Erosion of the Pavement Surface as Seen on the Surface of Core C34-MS22.*

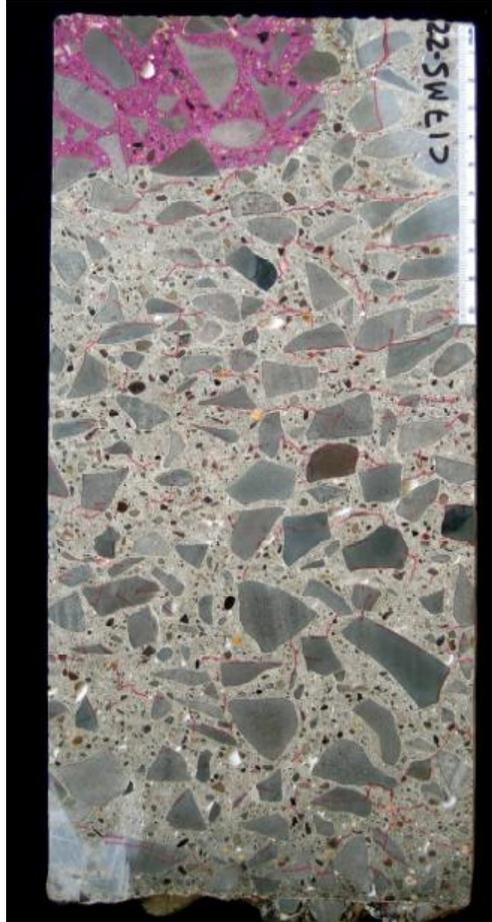
*Figure 66: Development of ASR Gel in Carbonate (Coarse) Aggregate at Depth in Core C17-MS22 of US-22 Murrys ville, Westmoreland County Segment 50 Eastbound.*

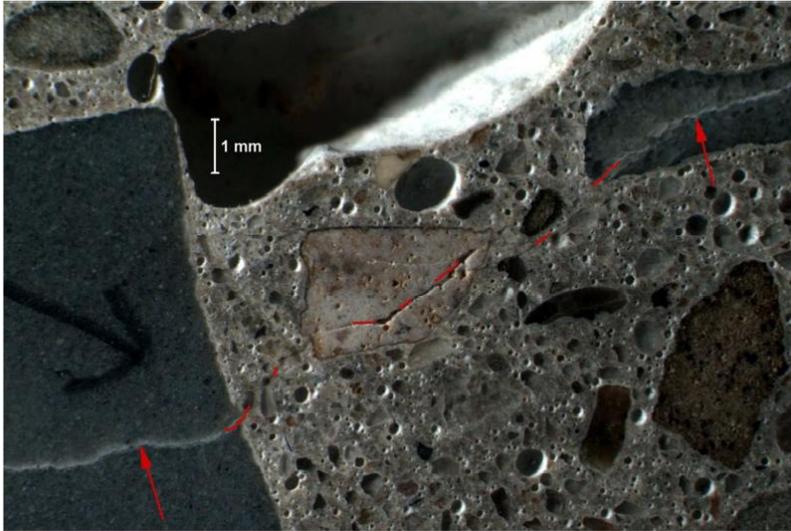
*Figure 68: Influence of ASR on Microstructure of Concrete in Core C17-MS22 of US-22 Murrysville Segment 50 Eastbound. Magnification 10x*

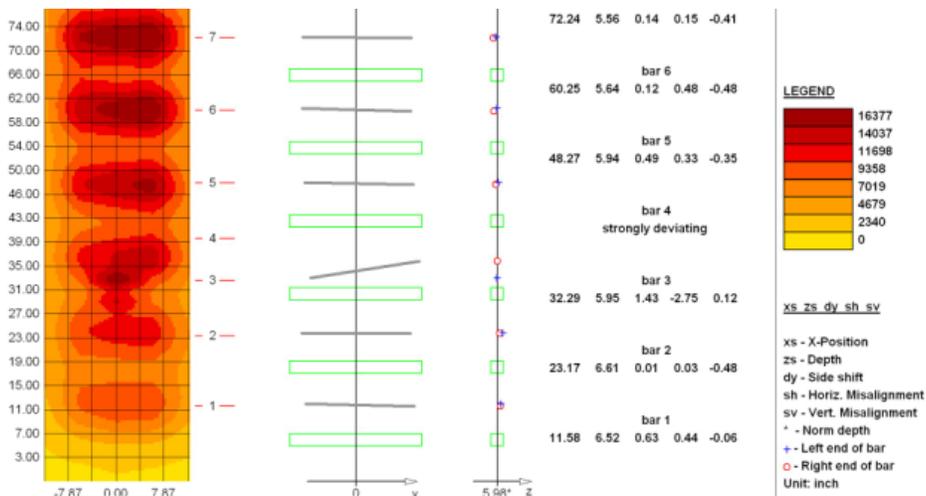
Figure 76: MagnoProof Output Illustrating Misaligned Dowel at Joint 14 of US-22 Murrysville for Segment 50 Eastbound

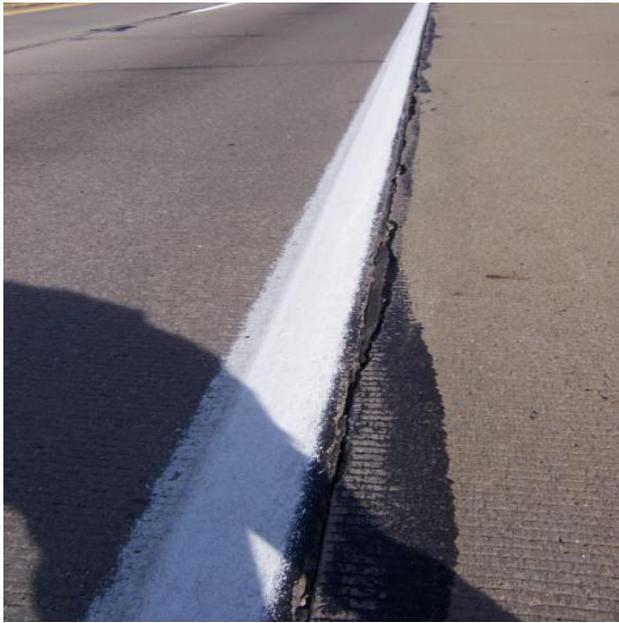
*Figure 86: Lane-to-Shoulder Joint of I 79 Segment 470 Northbound (Distressed Section)*

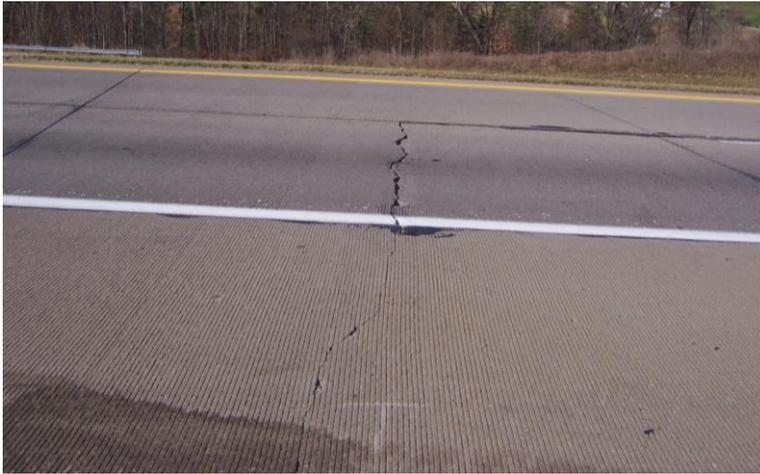
*Figure 87: High Severity Transverse Crack of I 79 Segment 470 Northbound (Distressed Section)*

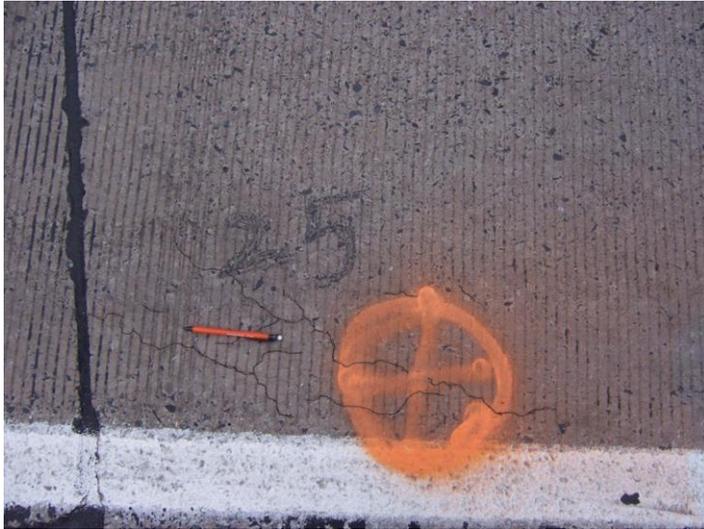
*Figure 125: Digitally Enhanced Map-cracking of I 80 Segment 1914 Eastbound (Distressed Section)*

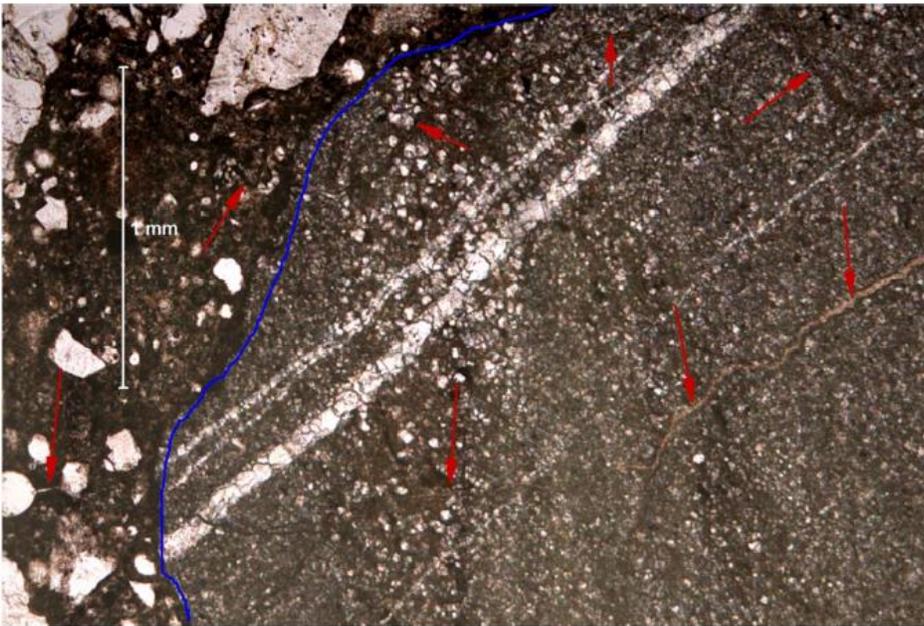
Figure 145: Development of ASR gel in Carbonate (Coarse) Aggregate of I 80. Magnification
