Repair Method for Prestressed Girder Bridges

FINAL REPORT

June 2009

Kent A. Harries, Ph.D., F.A.C.I., P.Eng.
Jarret Kasan
Can "John" Aktas
University of Pittsburgh

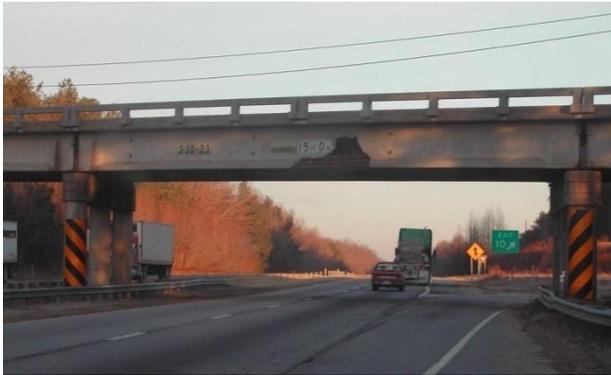
Figure 1.1 Loss of section of AASHTO girder due to vehicle impact (Harries; not taken in PA).

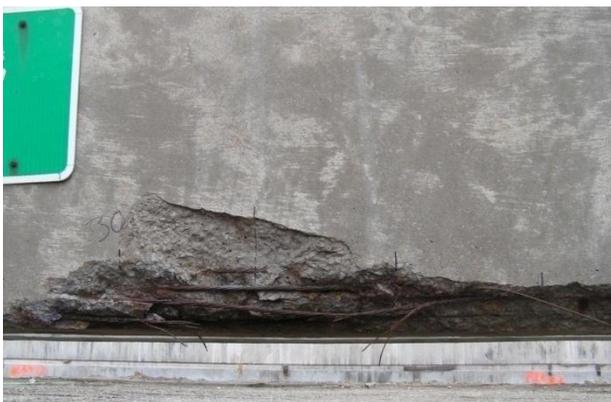
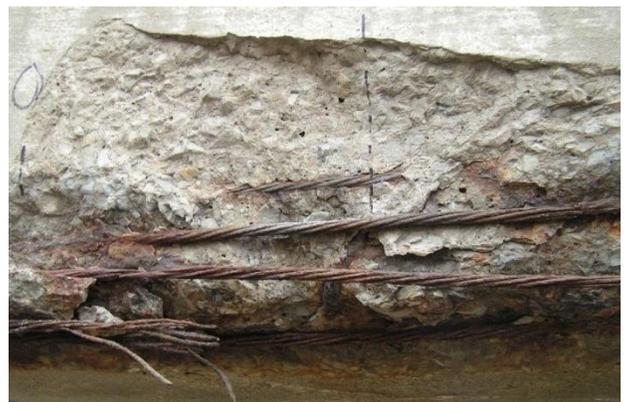
Figure 1.4 Exposed and ruptured strand due to vehicle impact (Lake View Drive Bridge; Harries 2006).

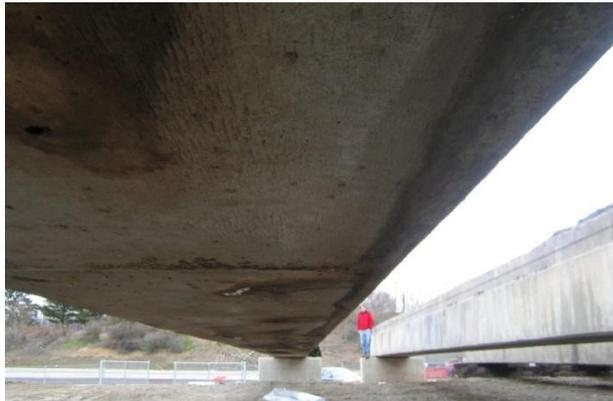
(a) water coming down exterior face of adjacent box girder (Harries 2006).

Figure 1.6 Evidence of water on soffits of adjacent box girders.

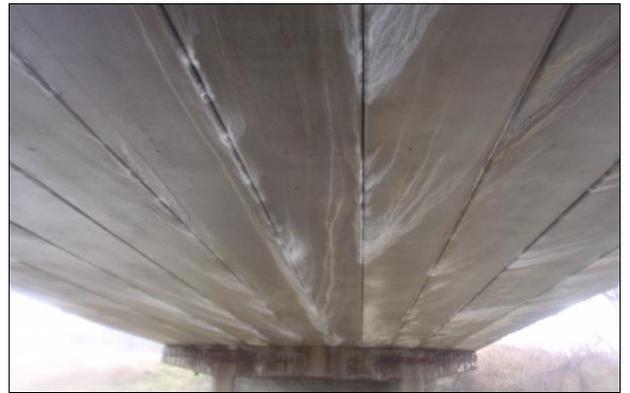
(b) water leaking between adjacent box girders (PennDOT).

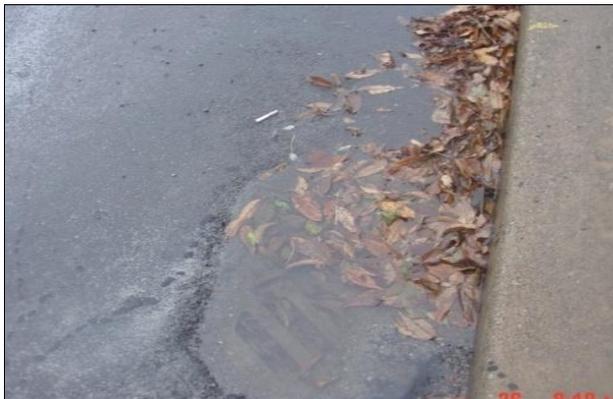
(a) water pooling due to clogged deck drain (PennDOT).

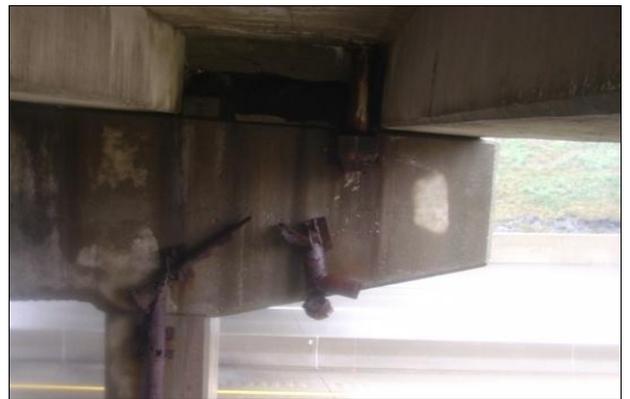
(b) damaged drain system resulting in water affecting superstructure (PennDOT).

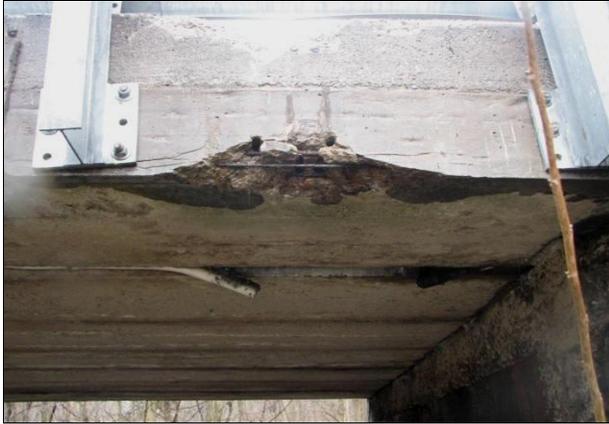
(a) spalling at original attachment and possible future damage at sight of new attachment

Figure 1.8 Damage to strands caused by relocating barrier supports (PennDOT).

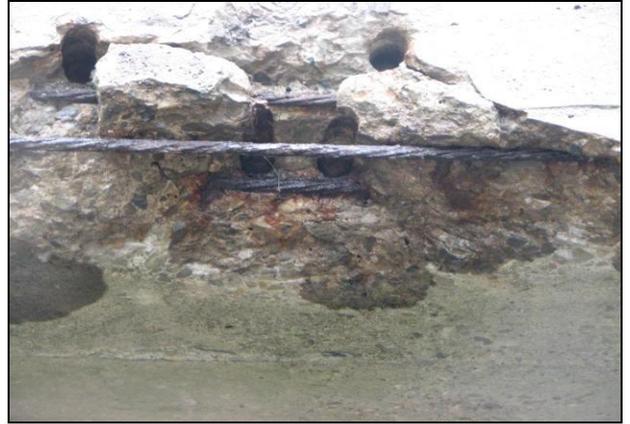
(b) unpatched holes at sight of original attachment result in exposed strands.

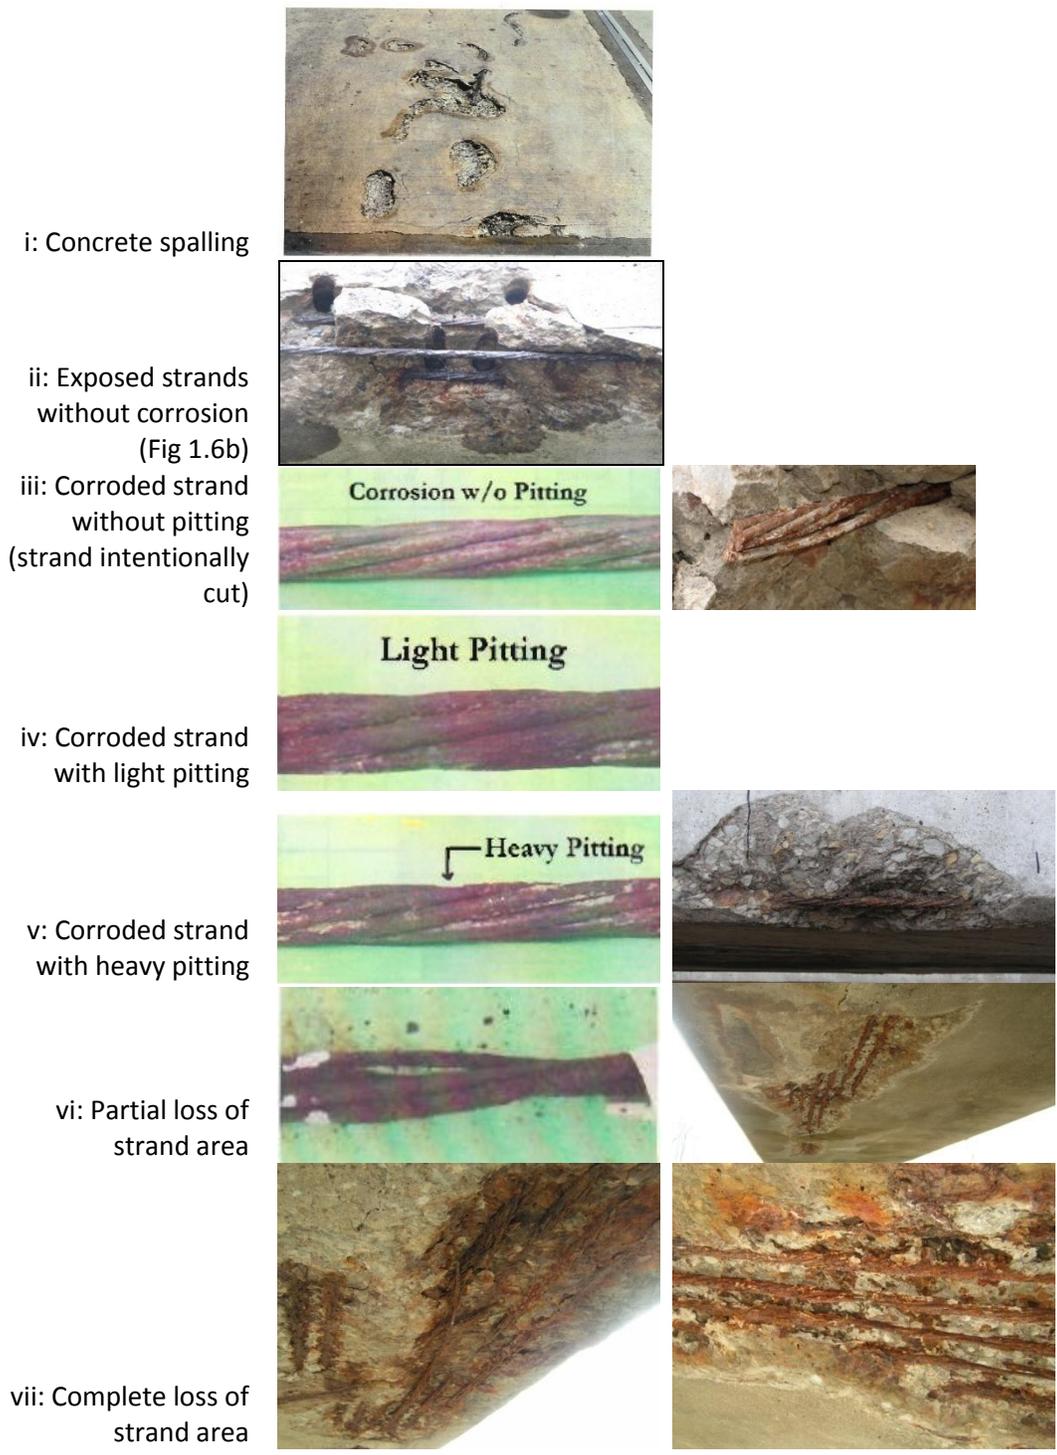
Figure 1.11 Continuum of corrosion damage (Naito et al 2006; Harries 2006)

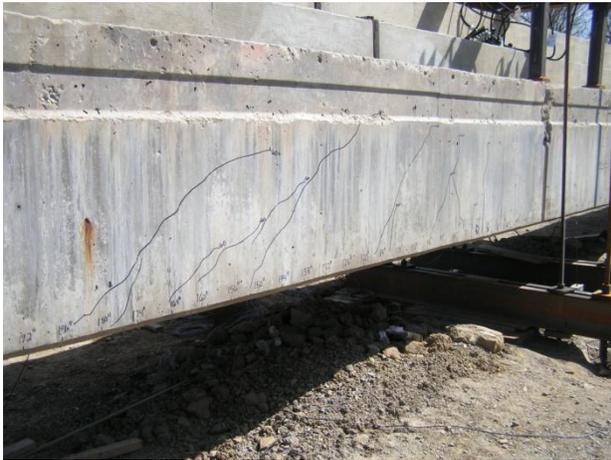
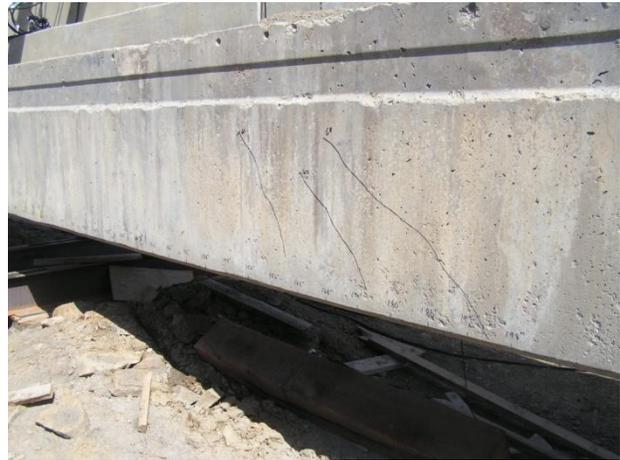
Figure 1.12 Representative shear distress (Lake View Drive EXTERIOR test girder; Harries 2006).

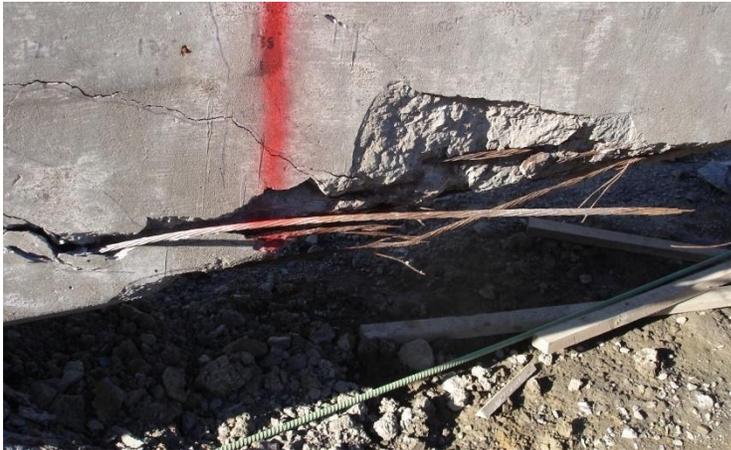
Figure 7.1 Strand following induced failure of Lake View Drive girder. The 3/8" strand is entirely lost to corrosion at right of image. At left of image, where it was pulled out of sound concrete (left of red paint line) the strand is 'bright steel' with no section loss. (photo: Harries)

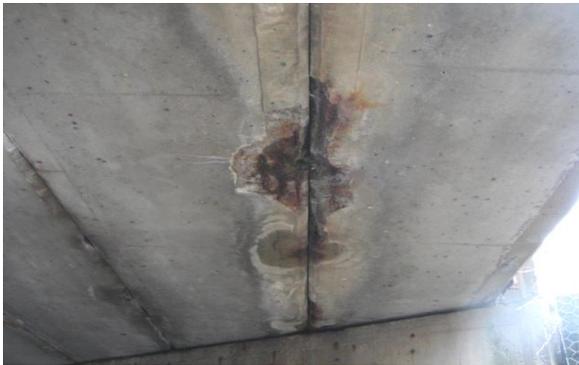
Beam 8 – Spalling, exposed strands and rust on side

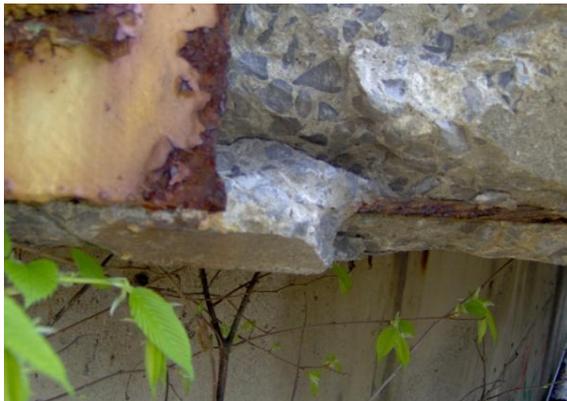
Spalling and strand exposure at beam end

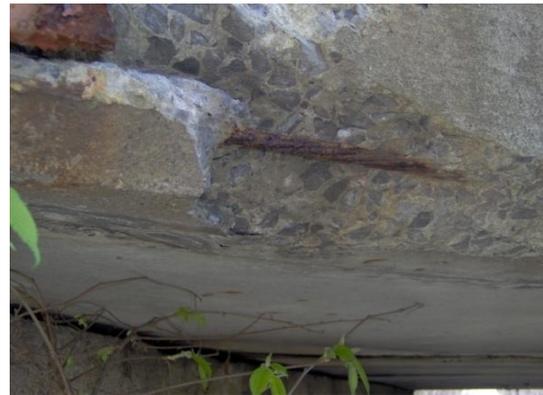
Continuation of spalling and strand exposure

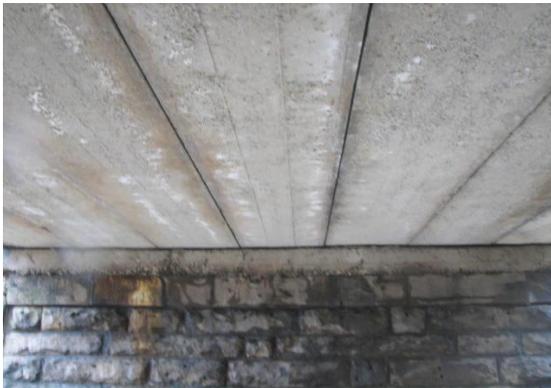
Underside of bridge with moisture and staining in between beams

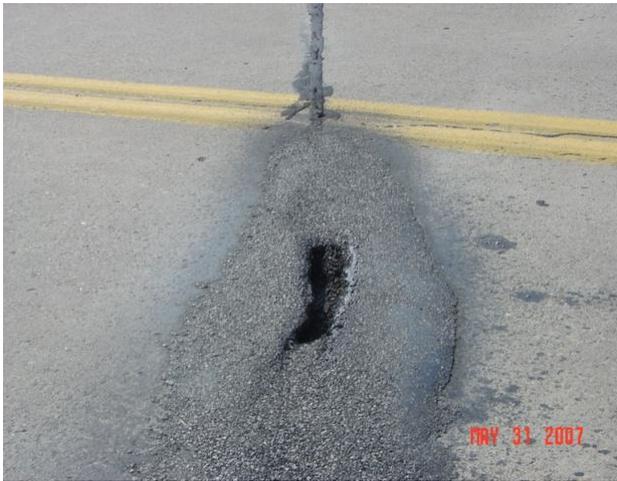
Hole in joint over pier

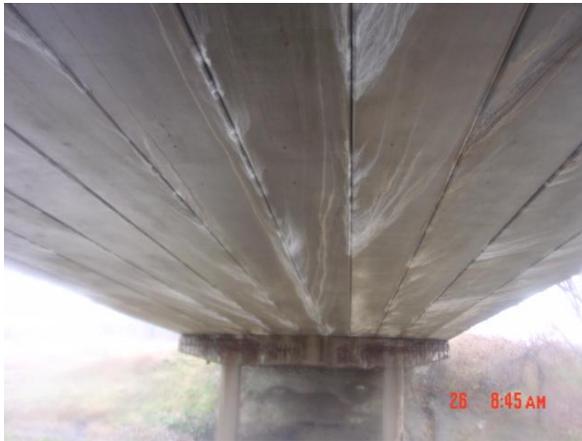
Heavy leakage between beams in Span 2

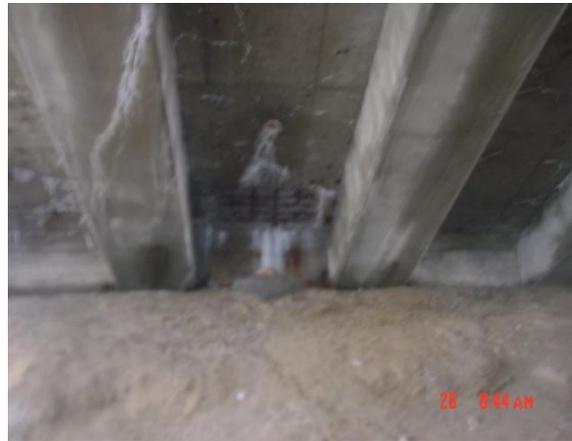
Exposed rebar in the underside of the deck between beams 4 and 5

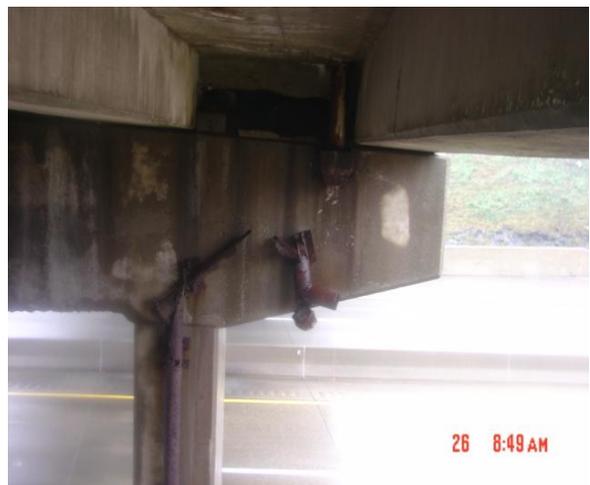
Poor downspout condition, typical for all on this bridge

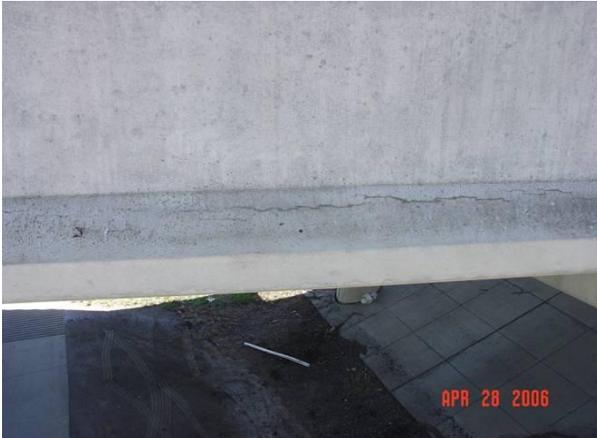
Longitudinal cracks in the bottom flange of B1

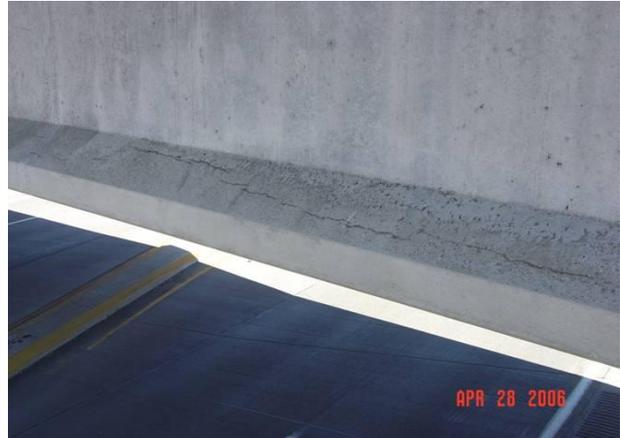
Longitudinal cracks in the bottom flange of B1

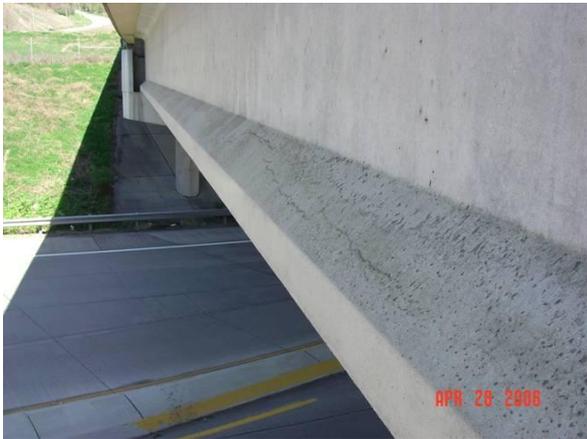
Longitudinal cracks in the bottom flange of B1

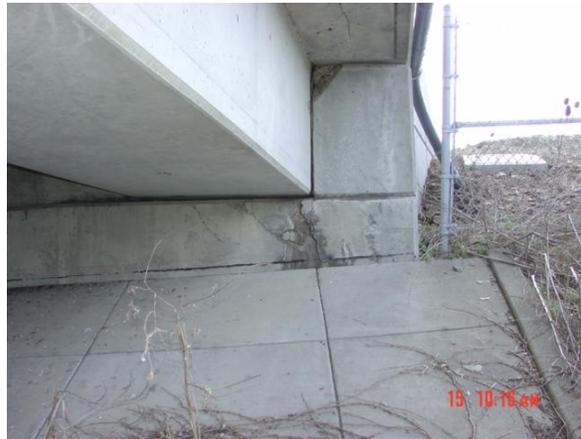
Spalling under B1 at NAB

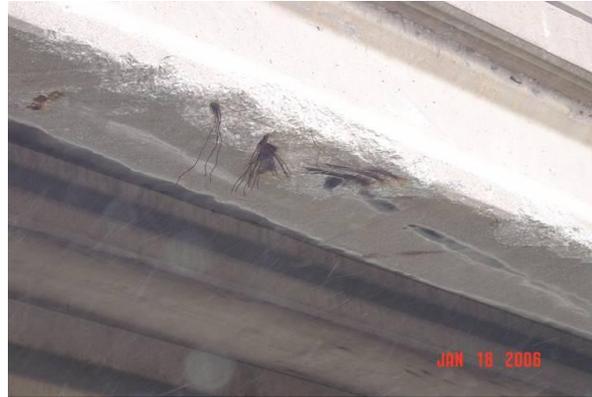
Span 3, Beam 8 – close up

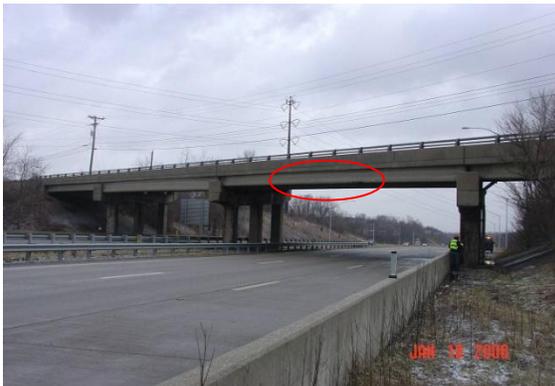
Location of collision damage on Beam 8

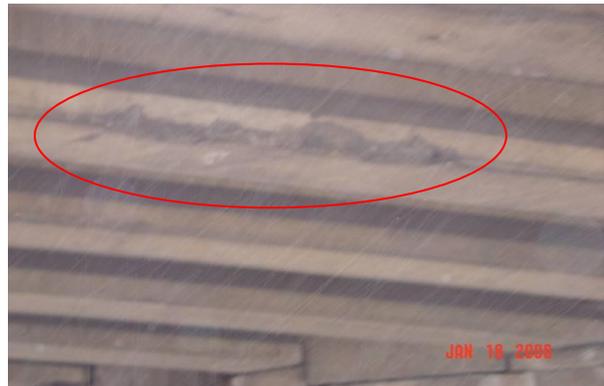
Span 3, Beam 6 – collision damage with spalling

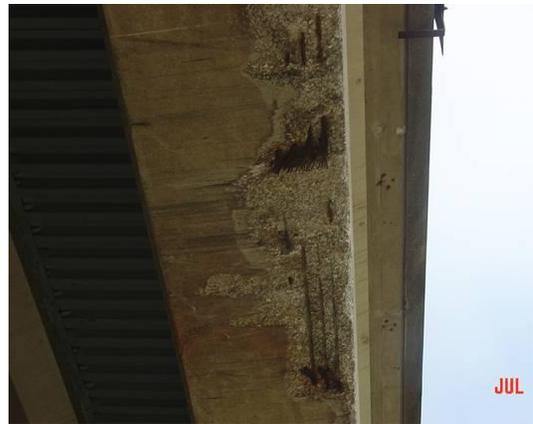
4 broken strands in Beam 1 at location of collision damage

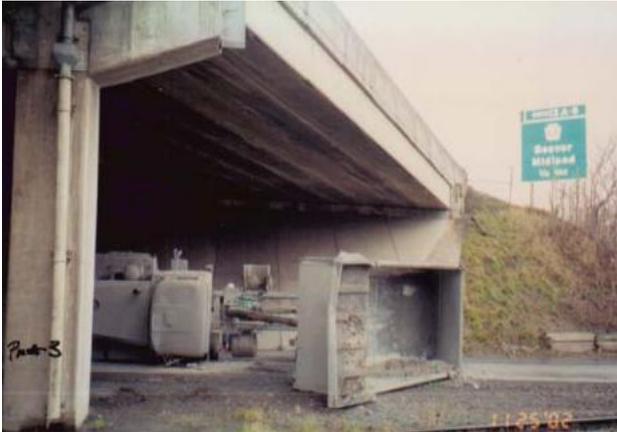
Collision damage

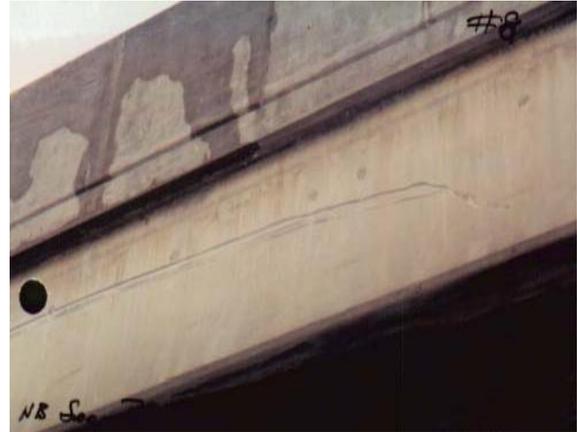
Longitudinal crack from impact damage

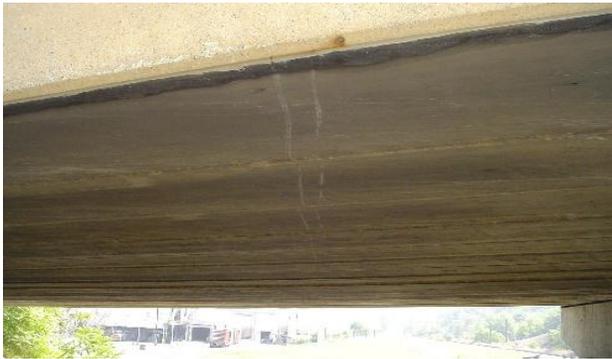
Scraping on underside of Span 4

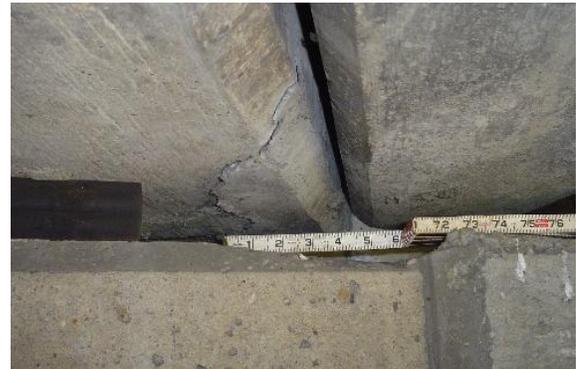
Bottom corner of beam S7, cracked and delaminated at pier
