# STRUCTURAL EVALUATION OF SLAB REHABILITATION BY THE METHOD OF HYDRODEMOLITION AND LATEX MODIFIED OVERLAY

FINAL REPORT

December 2013

Kent A Harries, PhD, FACI, PEng  
Matthew McCabe, BSCE  
Michael Sweriduk, BSCE  
University of Pittsburgh

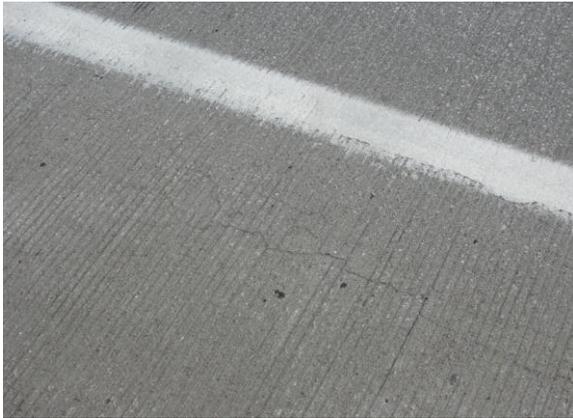
a) minor hairline cracks (Bridge A)

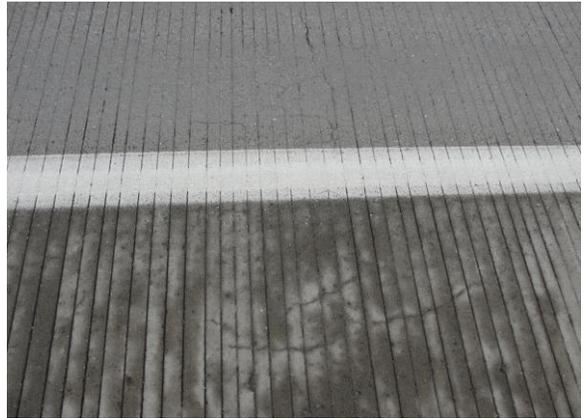
b) minor hairline cracks (Bridge B)

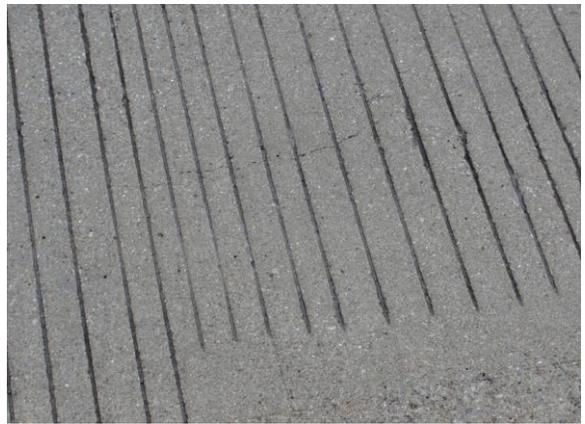
d) minor hairline cracks (Bridge D)

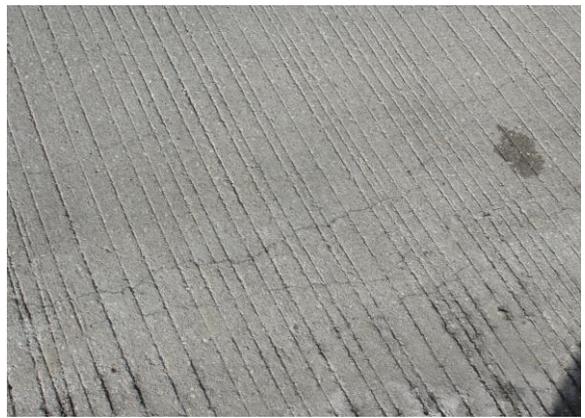
f) hairline longitudinal cracks (Bridge F)

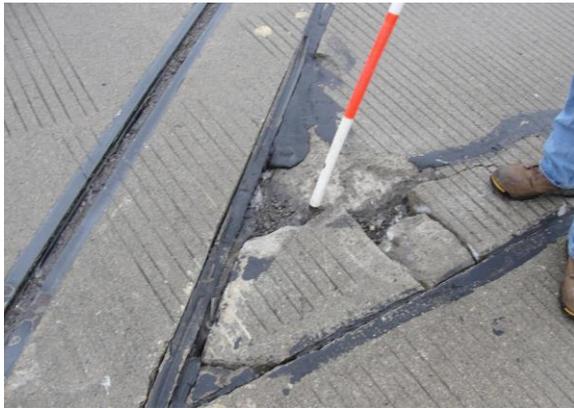
a) damage to LMC overlay at location of acute skew (Bridge D)

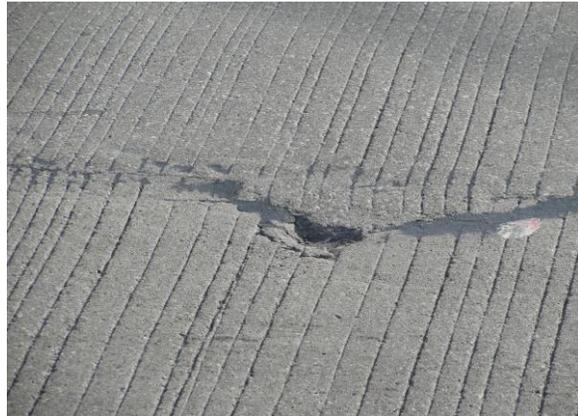
b) apparent pop-out of LMC (Bridge F)

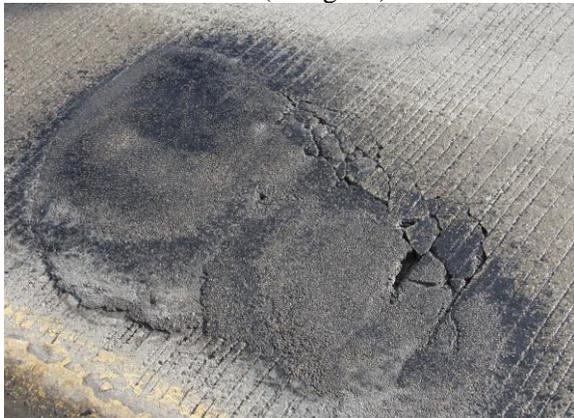
c) mortar patch of LMC (Bridge F)

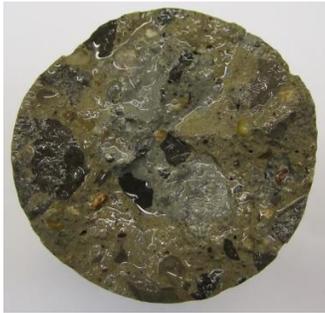
a) failure mode I having %LMC  $\approx$  50%.

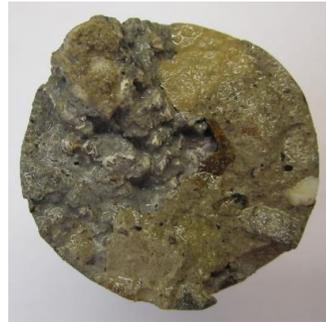
b) failure mode I having %LMC  $\approx$  50%. Poor bond or void at interface of LMC is evident near center of specimen.

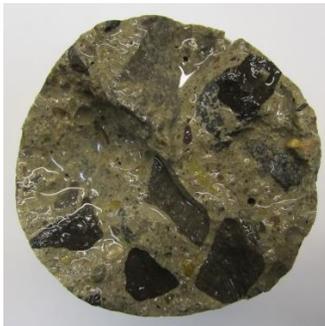
c) failure mode S – failure is entirely in substrate; fractured aggregate is evident indicating that this failure is *not* an I failure with %LMC = 0%.

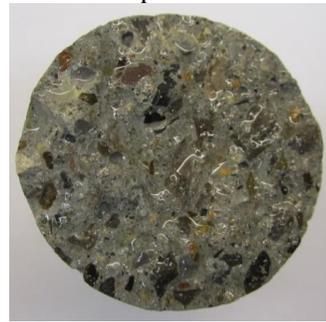
d) failure mode L – failure is entirely in overlay as evident by fracture of small aggregate.

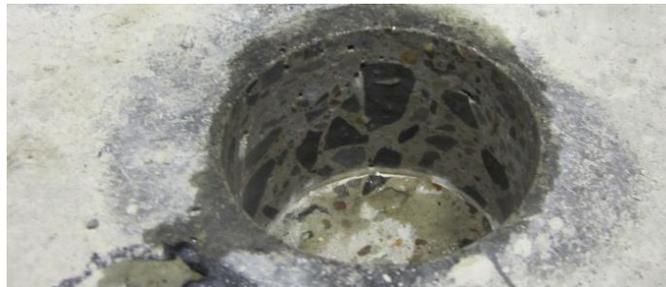
e) core hole following test (Slab B, test 20) clearly showing interface region delineated by small aggregate in LMC and large aggregate in substrate concrete. Failure is mode S, well below the interface level at the bottom of the cored hole.

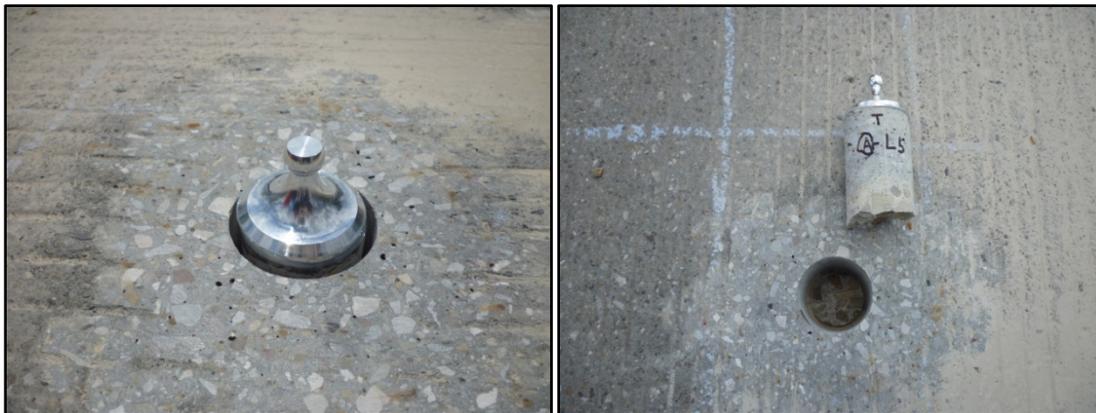
**Figure 1. Pull-off test at Bridge A-L5. Rigid disc attached to the drilled core (Left); Core failed at substrate during pull-off testing (Right).**

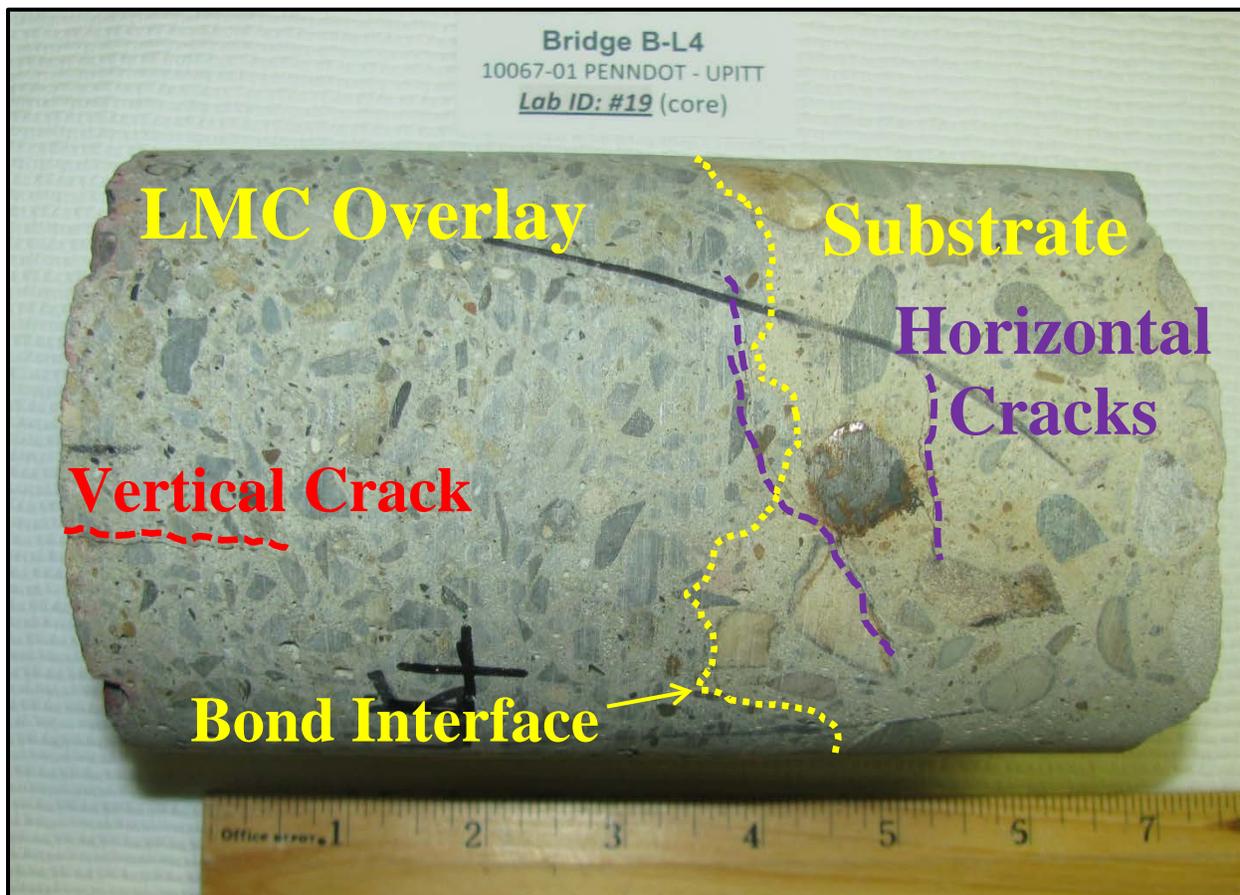
The bond quality appeared good in 17 of 24 cores. Of the remaining 7 cores, 4 exhibited complete or partial failure at the bond interface during pull-off testing, and 3 (out of 10 4-inch cores with rebars) exhibited cracking due to reinforcement corrosion, see Figure 3.

Figure 3. Core with vertical crack and horizontal cracking due to reinforcement corrosion.

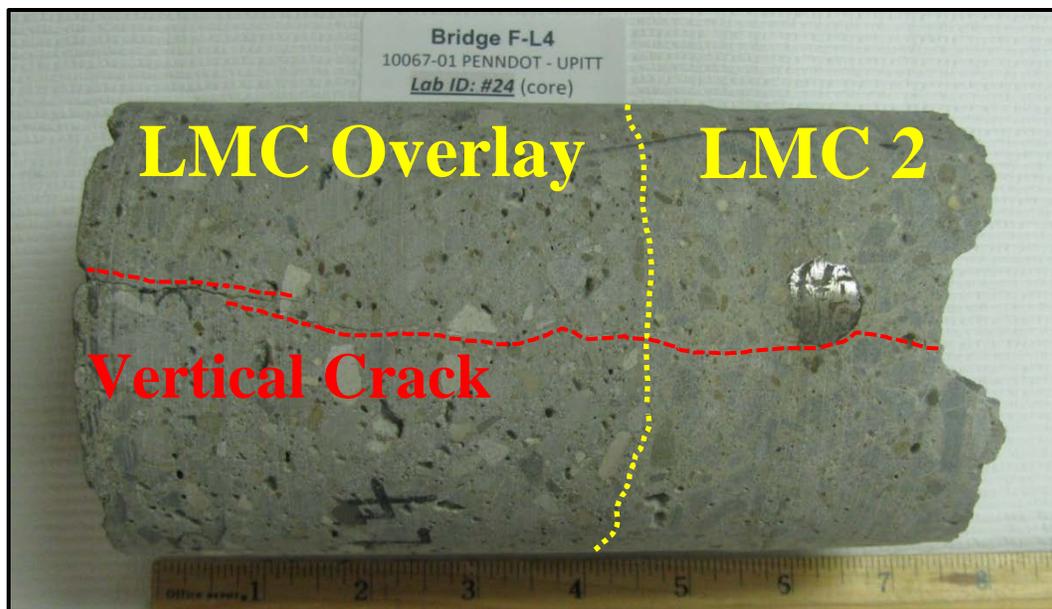
The entire core F-L4 (6.8" long) had only overlay material. No original concrete was a part of this core. The rebar from core F-L4 was centered along a vertical crack. Though the vertical crack extended past the rebar, the core was extracted without any horizontal cracking at the rebar level. This indicates that the crack may be structural in nature and that it allowed for corrosion product expansion without delamination. Even though the rebar had a significant section loss (25%), the core was extracted intact. This is due to the fact that corrosion product present on the rebar prior to overlay placement was removed during repairs/overlay placement.

Figure 4. Core with two layers of LMC and full depth vertical crack.
