### Longitudinal Joint Repair – Mill & Fill vs. Microsurfacing PennDOT District 11 – Lawrence County

# MICROSURFACING VS. MILL & RESURFACE JOINT REPAIRS

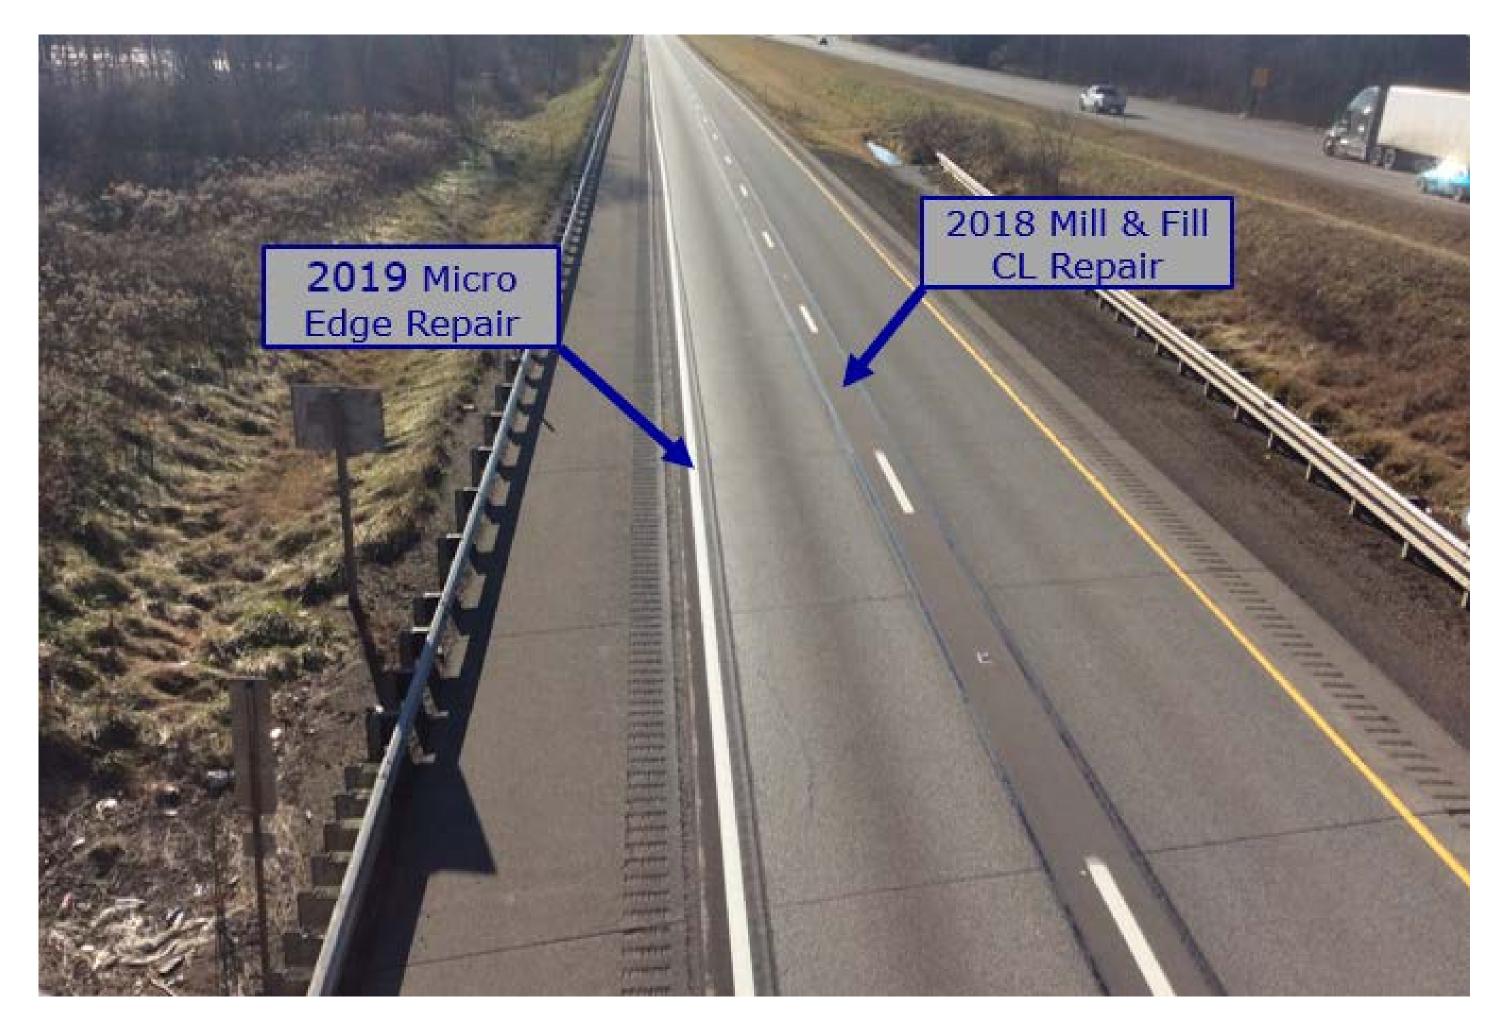
# MICROSURFACING VS. MILL & RESURFACE JOINT REPAIRS

## **Microsurfacing Joint Repair**

- Work Ordered into Crack Sealing Contract, 2019
- Length of Repair is 9.10 miles
- Width of Repair is 24 inches
- Depth of Repair is 1" to 4"
- Width of distresses ranged from ½" to 8"
- Material: Micro-Surfacing
- 3 Working Days
- Cost: \$2.39/LF
- No Joints to Seal & Maintain

# Mill and Resurface Repair

- Stand Alone Bid Project, 2018
- Length of Repair is 10.78 miles
- Width of Repair is 36"
- Depth of repair is 2"
- Width of distresses ranged from ½" to 8"
- Material: 9.5mm Superpave
- 5 Working Days
- Cost: \$10.13/LF
- Results in two longitudinal joints to seal and maintain
