▶ Paint Testing Using IR-CIS

Presented By:
Joshua Charnosky

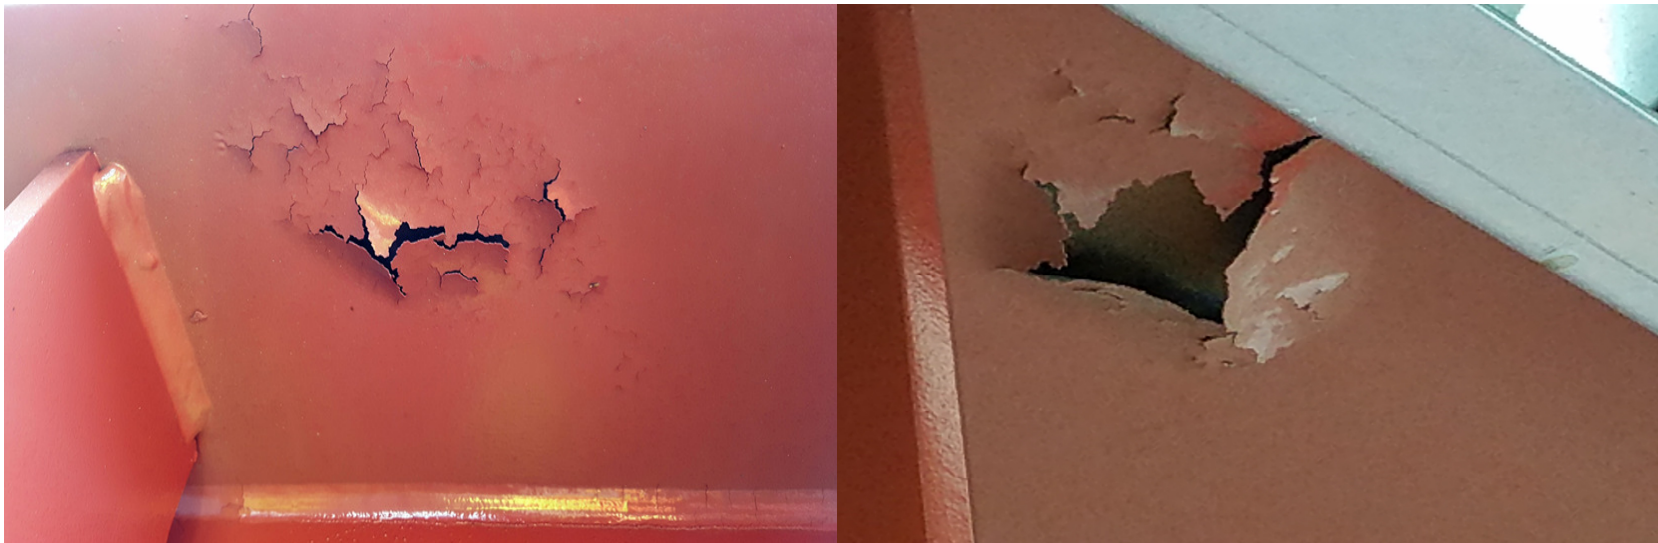
- Spots of cracking/flaking paint were noted by the field inspector
- Due to time constraints with the project girders were erected anyway

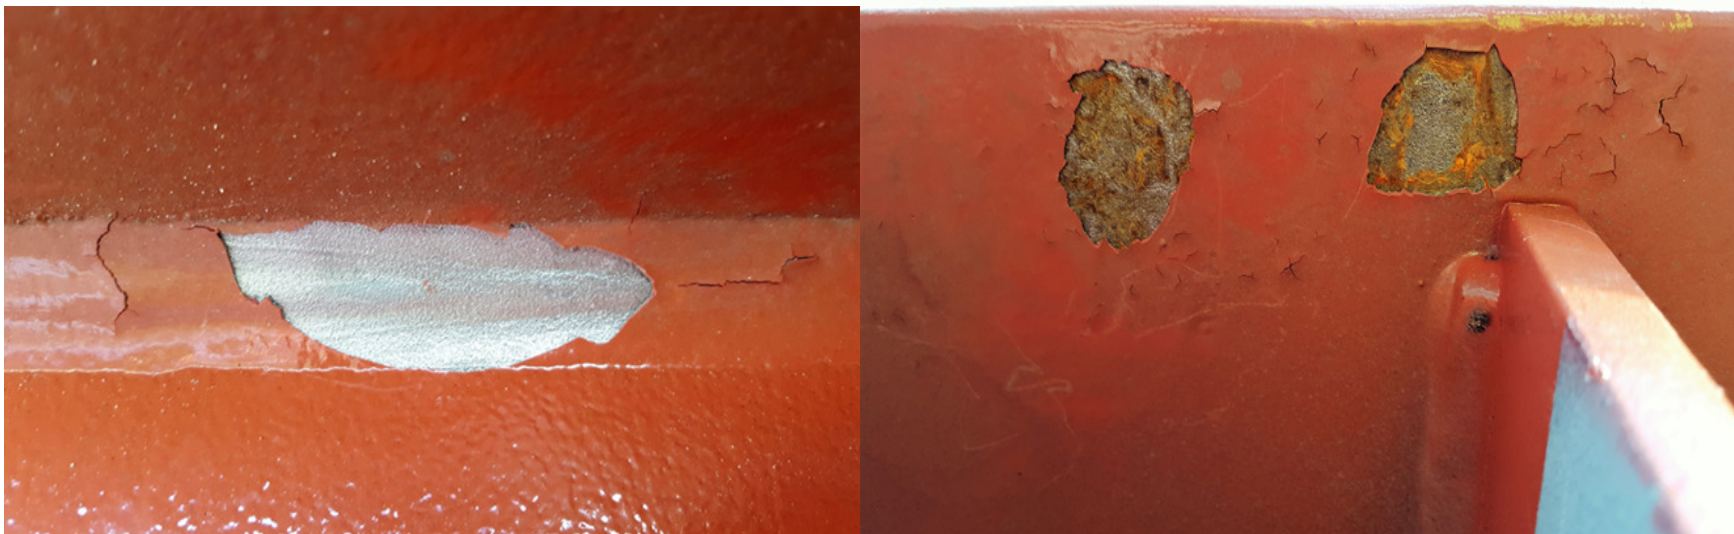
- Locations: Underside of the top flange, web to flange weld (top flange) and crossframes
- Review of fabrication inspection records noted 6 girders having adhesion issues

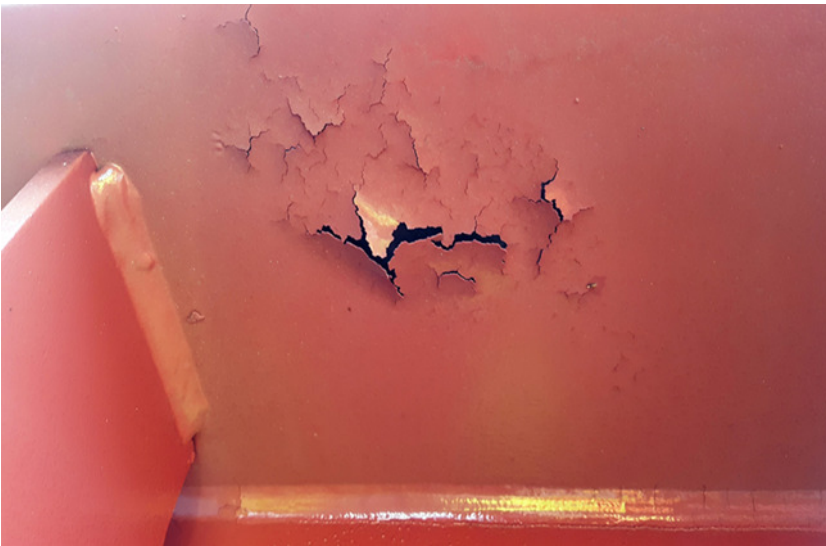
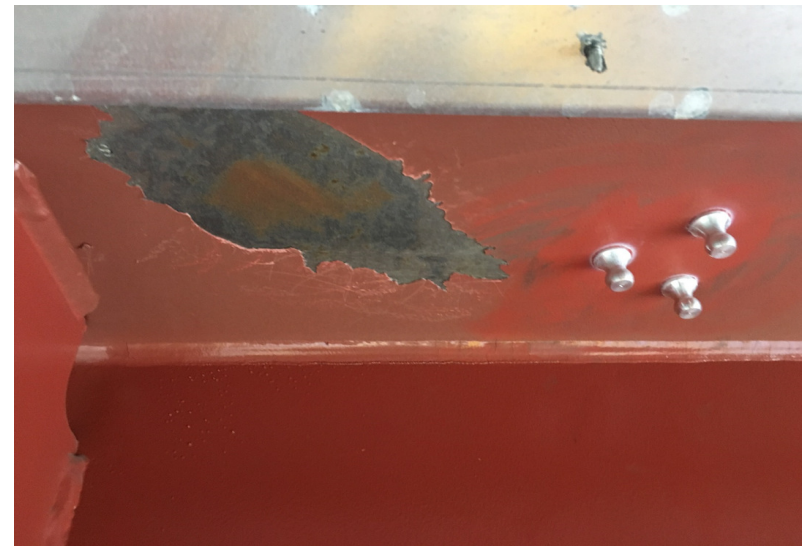
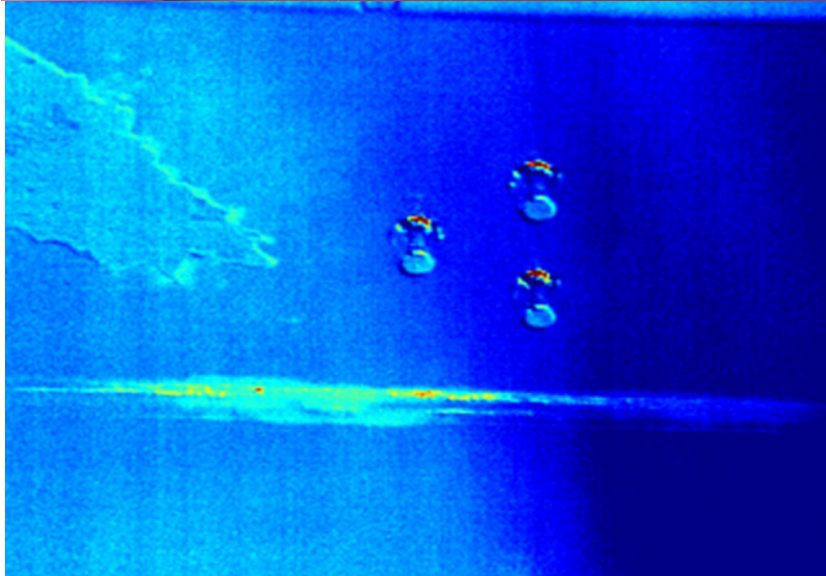
Testing Results (Underside of Top Flange)

Dollies	PSI	Comments
1	882	100% Adhesive
2	79	Device Error (Invalid Reading)
3	809	100% Adhesive
Average:	846

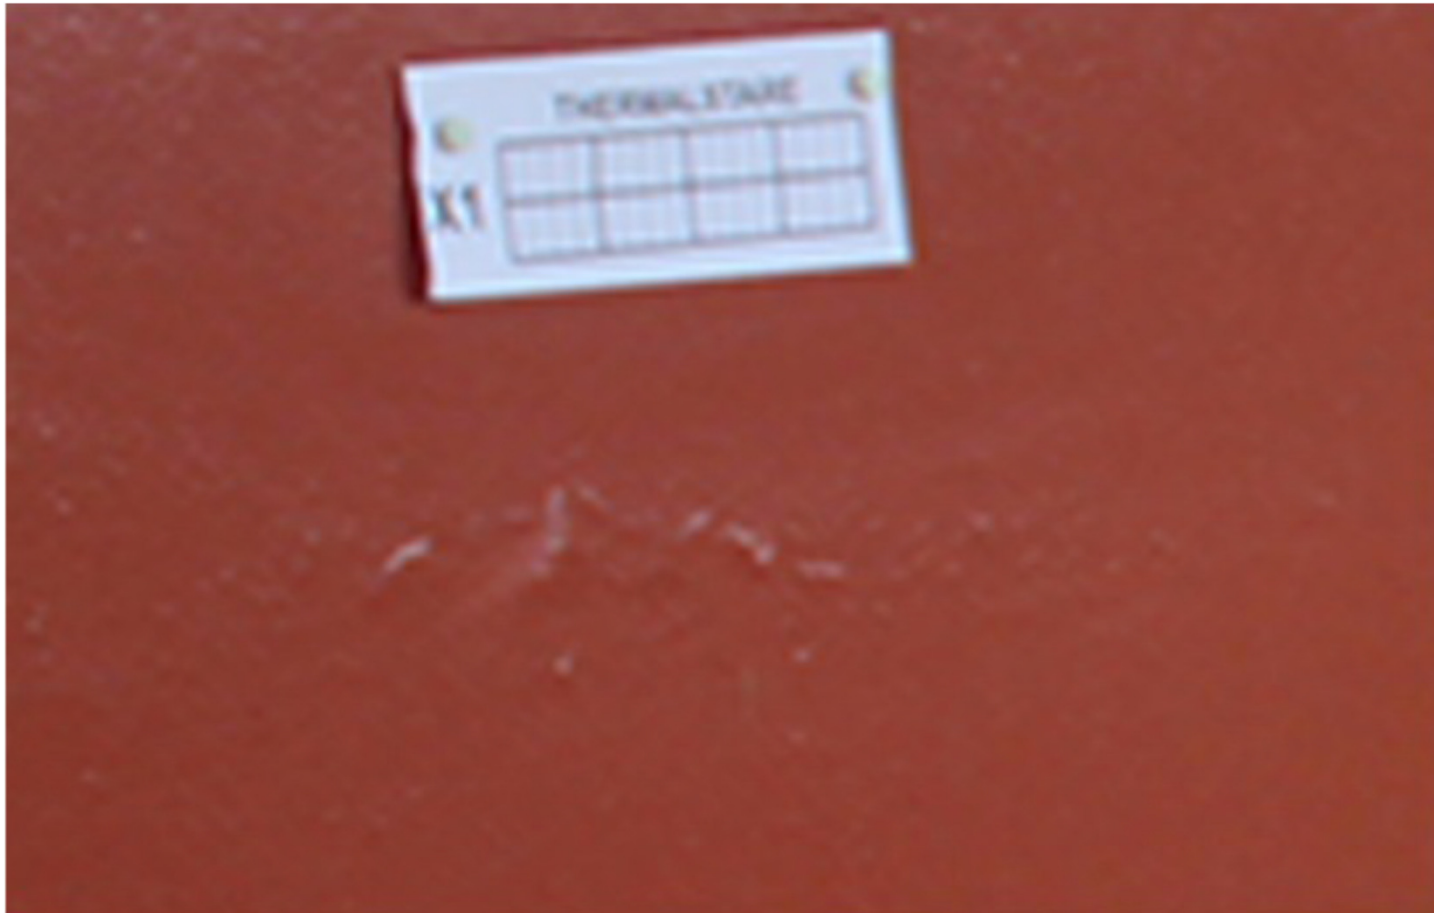
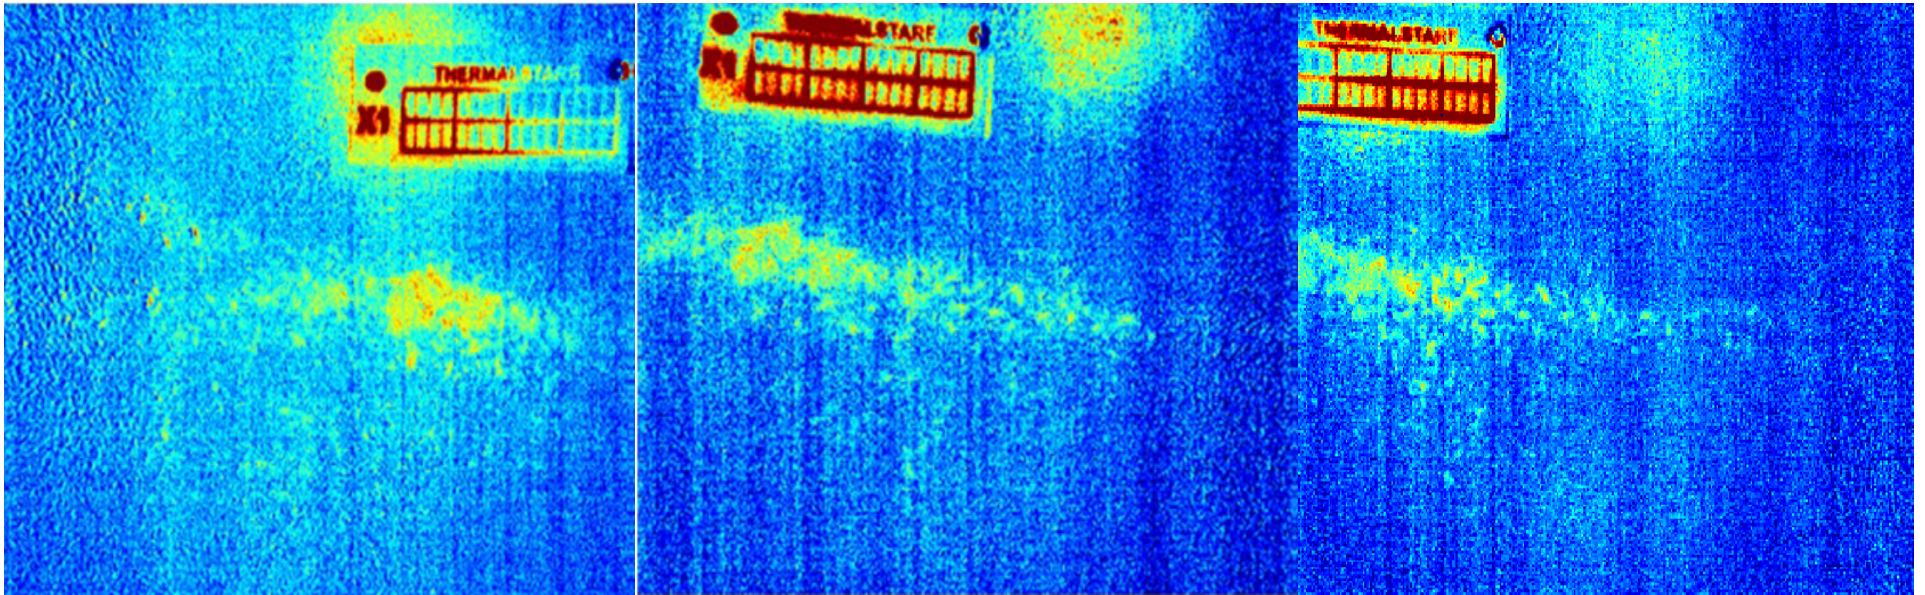
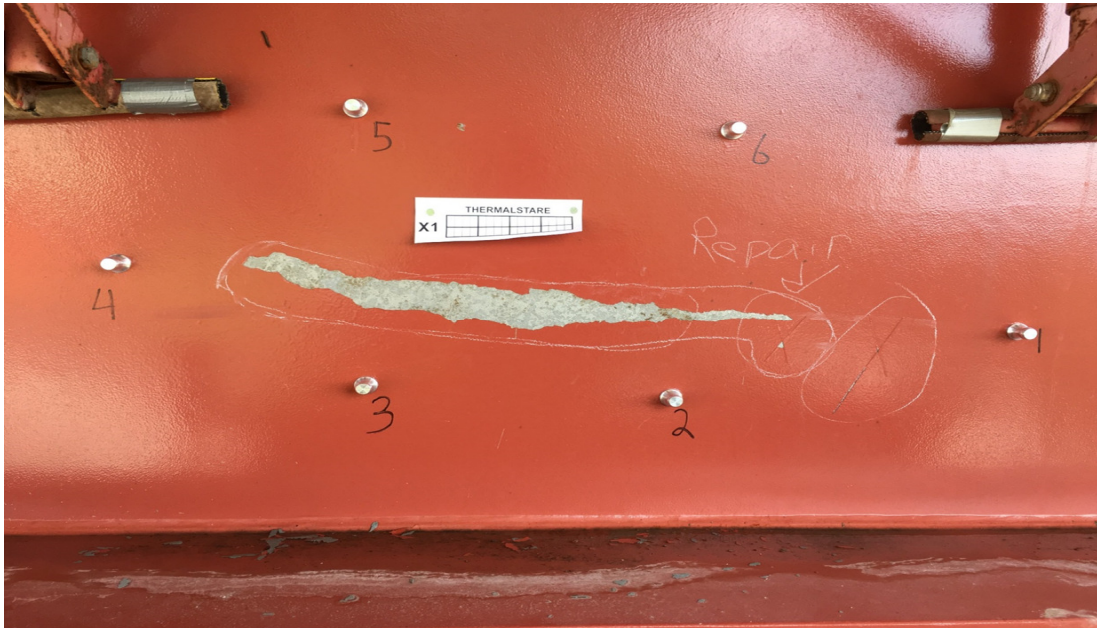
Testing Results (Fascia Girder Web Defect)

Dollies	PSI	Comments
1	465	75% Substrate/Primer, 25% Adhesive
2	249	100% Adhesive
3	145	100% Adhesive
4	623	95% Substrate/Primer, 5% Adhesive
5	661	98% Substrate/Primer, 2% Adhesive
6	912	90% Substrate/Primer, 10% Adhesive
Average	509

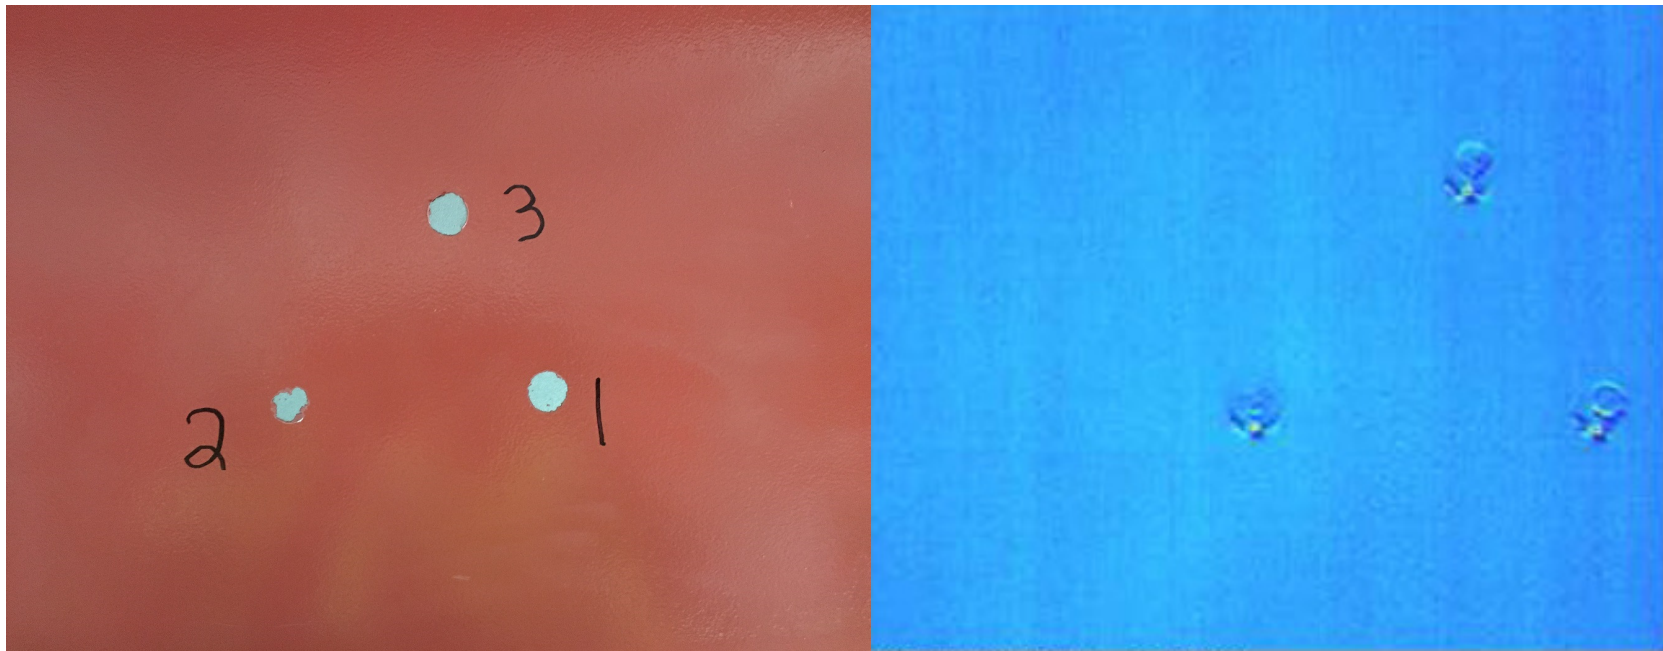
Testing Results (Interior Girder Web)

Dollies	PSI	Comments
1	1642	98% Substrate/Primer, 2% Adhesive
2	938	80% Substrate/Primer, 20% Adhesive
3	1439	99% Substrate/Primer, 1% Adhesive
Average:	1340

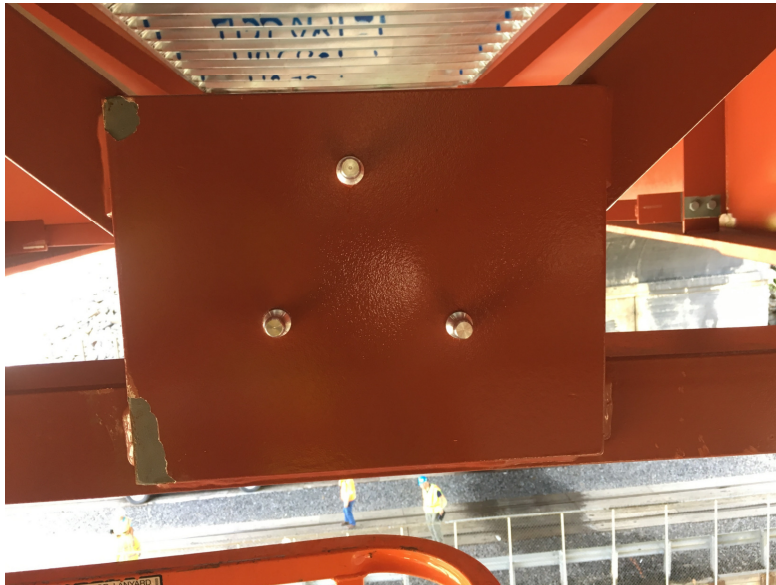
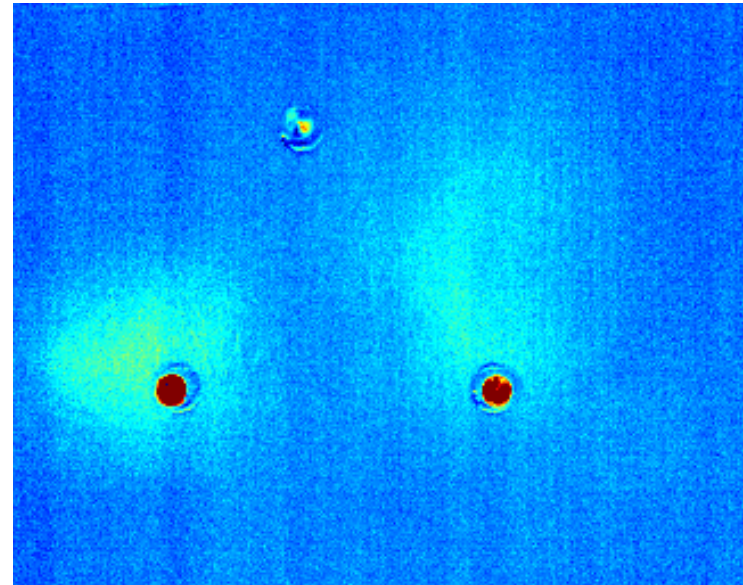
Testing Result (Cross Frame Gusset Plate)

Dollies	PSI	Comments
1	550	5% Substrate/Primer, 95% Adhesive
2	603	100% Adhesive
3	1018	95% Substrate/Primer, 5% Adhesive
Average:	724
