Quality Painting

2020 Mid-Atlantic Quality Assurance Workshop

**Presented By: Joshua Charnosky
PennDOT, NACE Level 3**

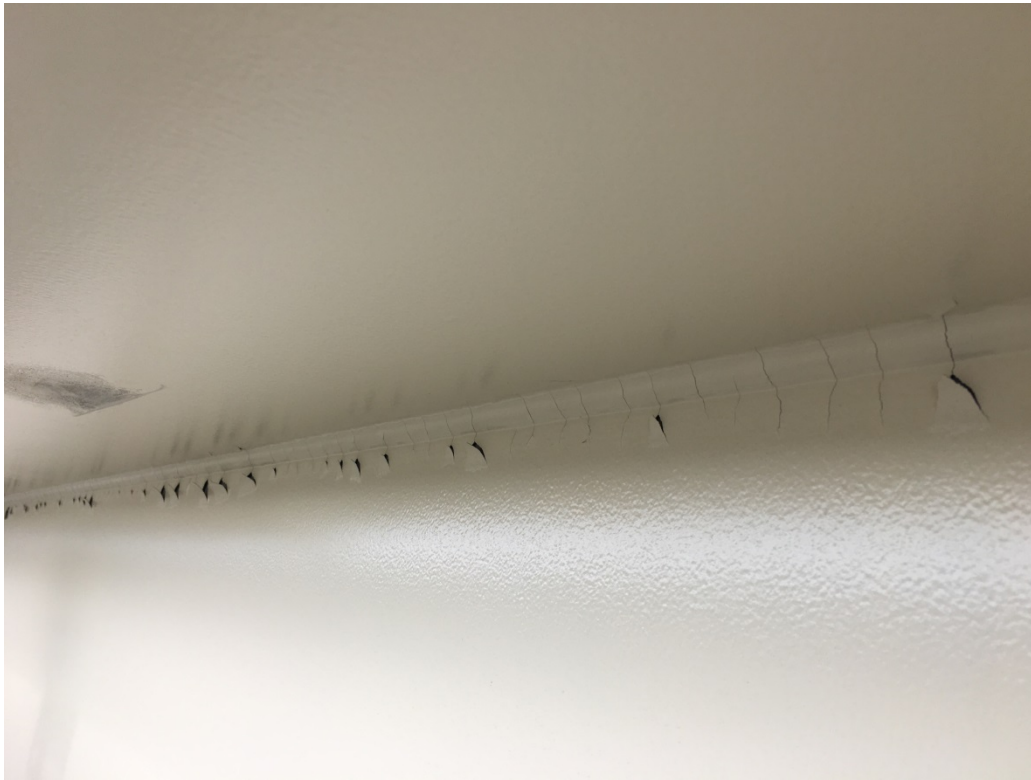
- Case #1: Paint Cracking and Flaking Off

- Traditional 3 Coat Inorganic Zinc Rich coating system was used
- Coating operations were conducted in the fall and winter months
- Failures were first noted in the storage yard early to mid summer
- Location of the failure was in the top flange to web weld area
- The delamination was from the IOZ to the substrate

- Based upon the investigation the main contributing factor to the failure was excessive film thickness in the Zinc layer
- The excessive thickness would have lead to extended cure times
- The adhesion of the zinc would have been further impacted by stresses from the epoxy intermediate as it cured.

- All Beams in question were thoroughly evaluated and all loose paint was removed by either mechanical means or blasting
- Feathering edging of 2 inches into the intact coating was done
- Proper cure of the Organic Zinc primer was done according to ASTM D5402 with the following passing criteria
 - Reducer #58, 25 Double Rubs, No more than 1.5 mil loss

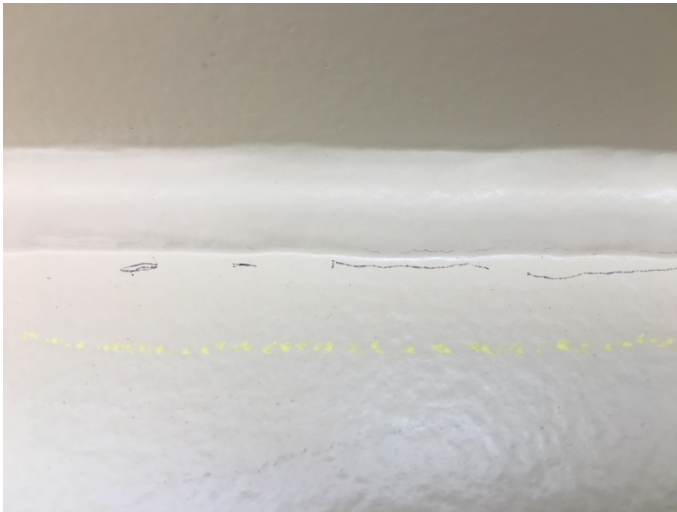
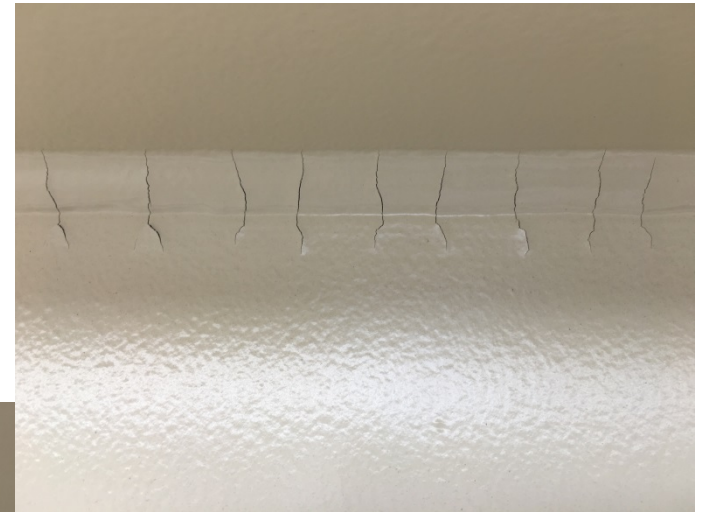
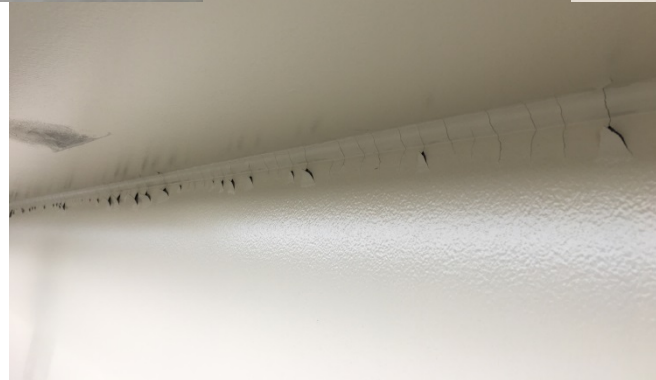
- Visual inspection of the coating noted varying levels of coating failure

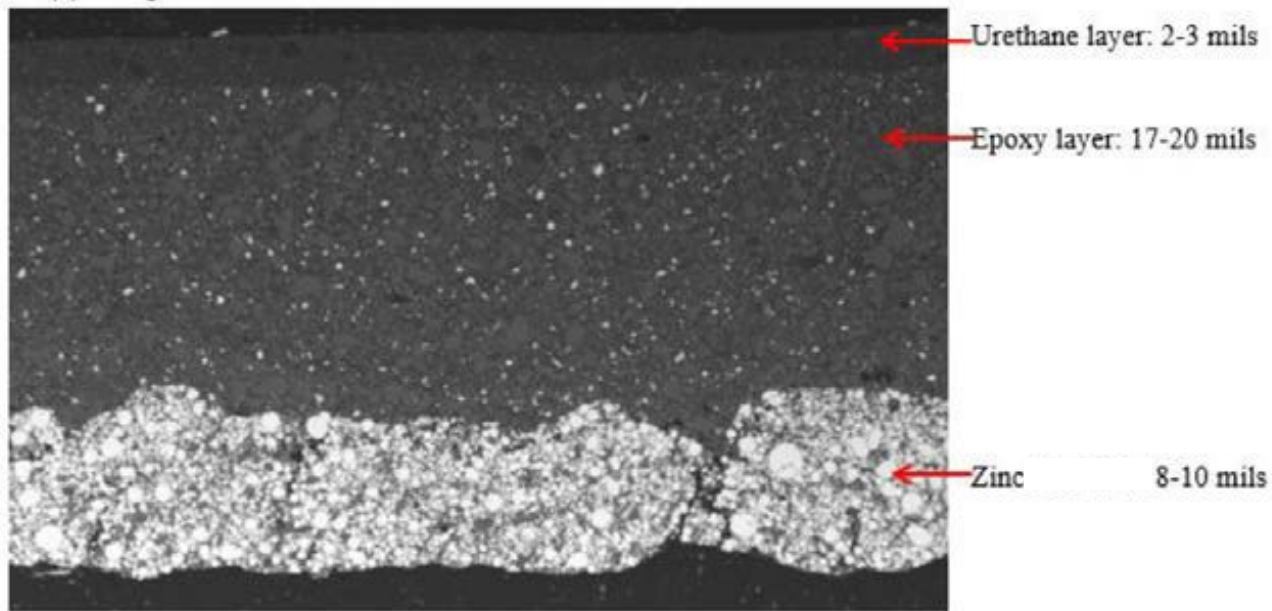
- Paint Chips were collected and analyzed using FTIR, Optical Stereomicroscopy and SEM/X-Ray

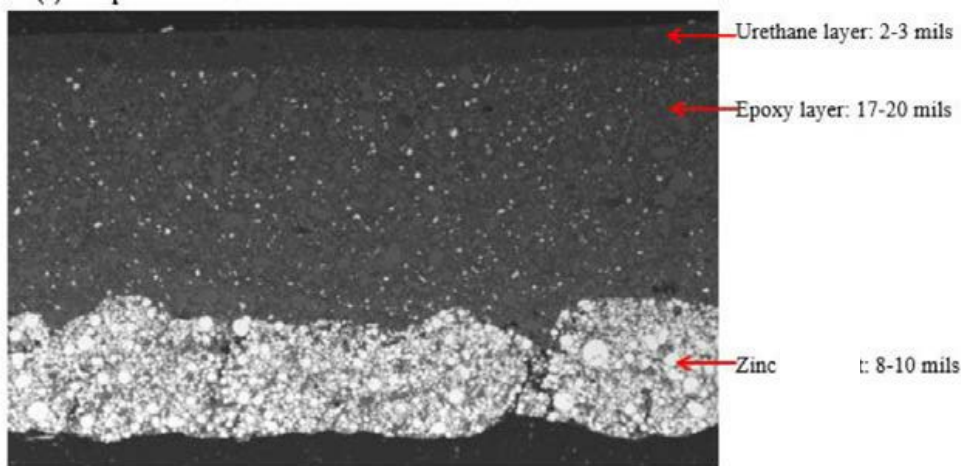
- Dry film thickness of randomly collected samples showed average DFT values for the Zinc Layer were 8-10 mils
- Manufacturer's Technical Data Sheet specify a thickness of 2-4 mils

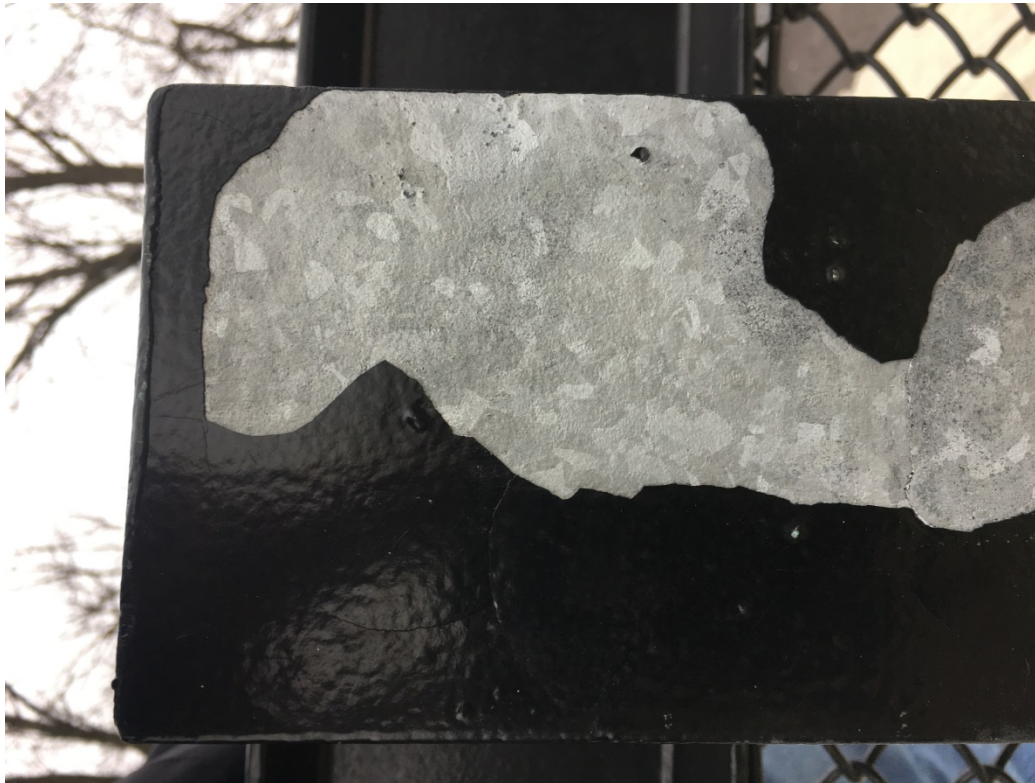
- Case #2 Paint Peeling and Falling Off Galvanizing

- Rail-Trail Bridge
- Coating system consisted of single coat Polyaspartic Urethane paint over top of galvanized steel
- Issue first discovered during final construction inspection prior to opening bridge in early December
- Delamination of top coat from underlying galvanizing

- Bridge sat through the winter and was reevaluated in the spring
- All areas of delamination were identified and all loose coating was removed into intact coating
- Surface preparation was done using a Bristle Blaster to produce a min 2 mil profile
- All repair areas were then cleaned with a Clean N' Etch product and allowed to thoroughly dry before application of the top coat

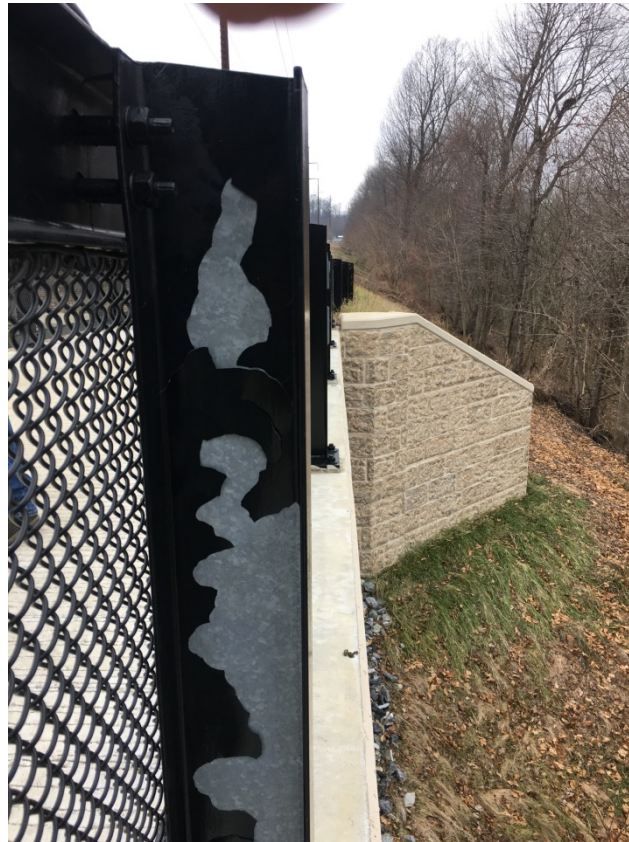
- A field investigation was conducted of the entire bridge with the original focus on the pedestrian rail posts

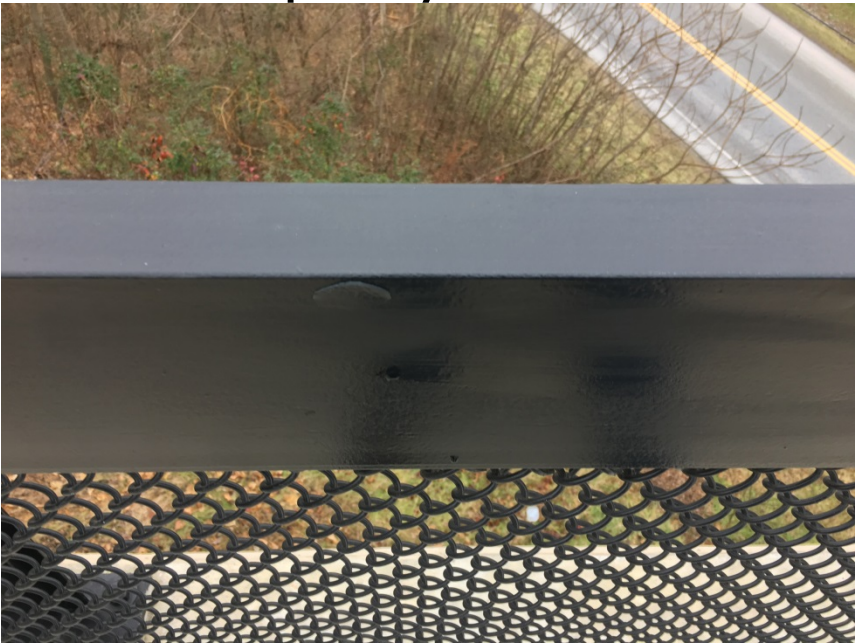
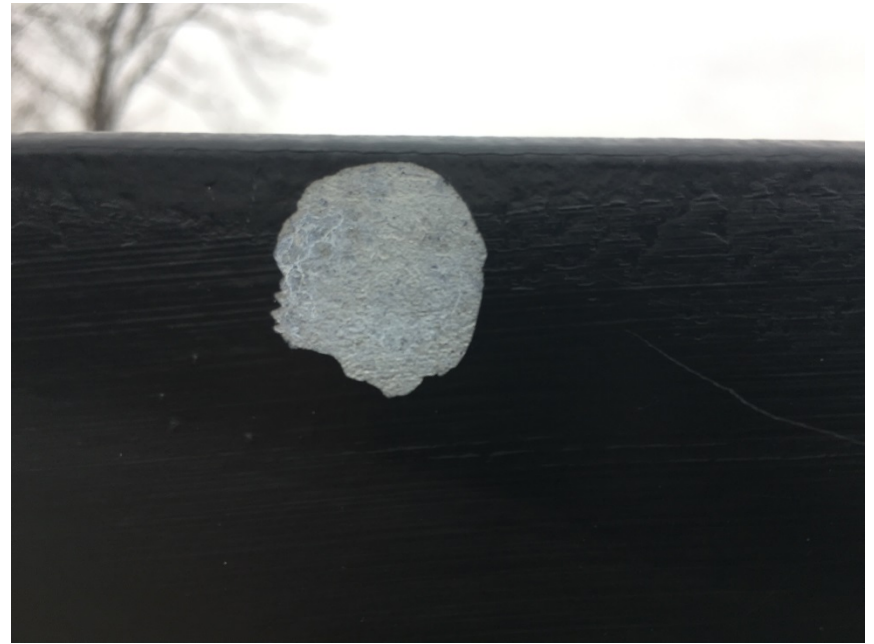
- A closer examination revealed spots that had not yet broke loose but could easily be removed with a dull putty knife

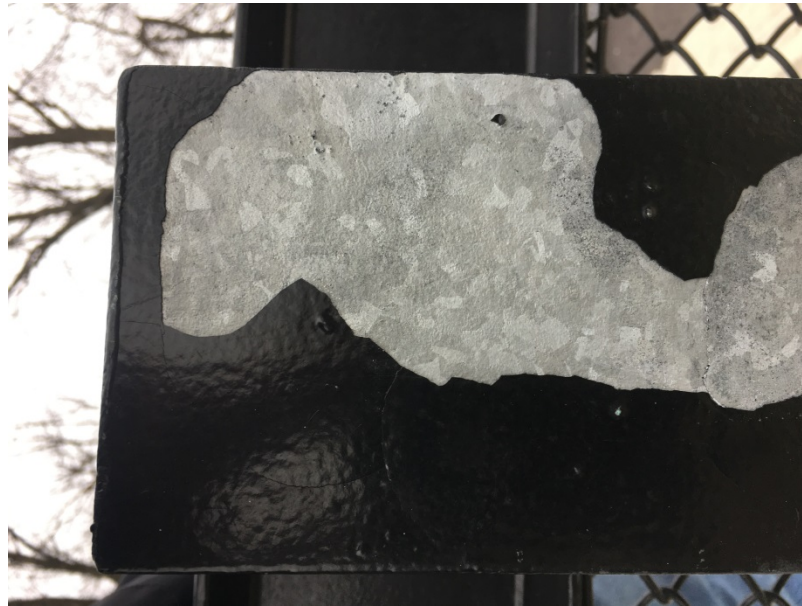
- After examination and reviewing of fabrication records it was clear that no surface preparation was done to the galvanized surface prior to top coating

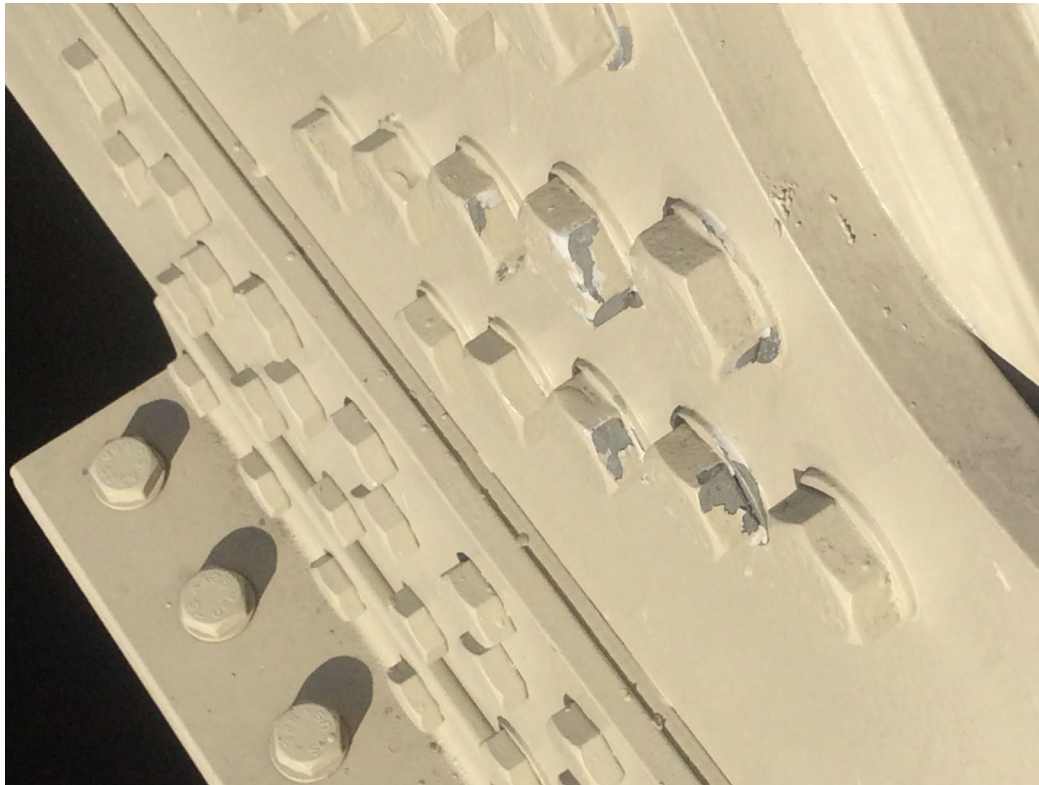
- Case #3: Paint Not Sticking to Bolts

- Truss bridge spanning between PA and NY
- Brand new construction with a shop applied IOZ system with all field splices getting painted in the field
- Coatings failures seems to originate from the bolt heads down to bare steel

- At the time of completing this presentation I was not able to perform any failure analysis in the field.
- I was only given the photos for review
- However based upon what is seen in the photos start by looking into improperly cleaning of lubricant and preparation of the bolt surfaces
