# Alkali Carbonate Reaction An Ongoing Study

51<sup>st</sup> Annual Mid-Atlantic Quality Assurance Workshop

National Concrete Pavement  
Technology Center

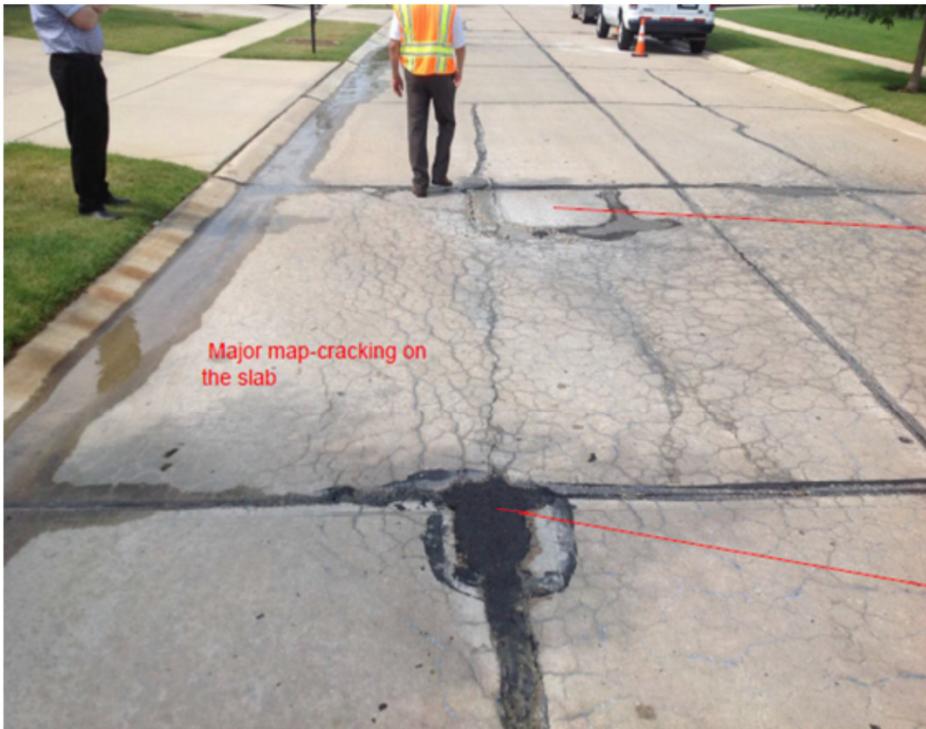
June 30, 2016

Major map-cracking on the slab

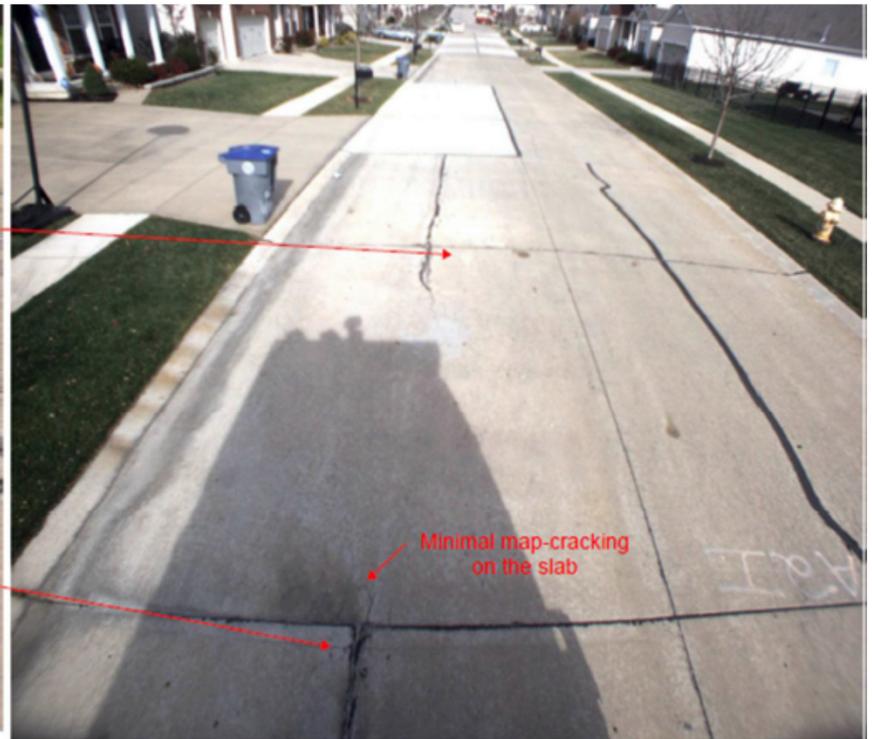
Late 2013

Minimal map-cracking on the slab

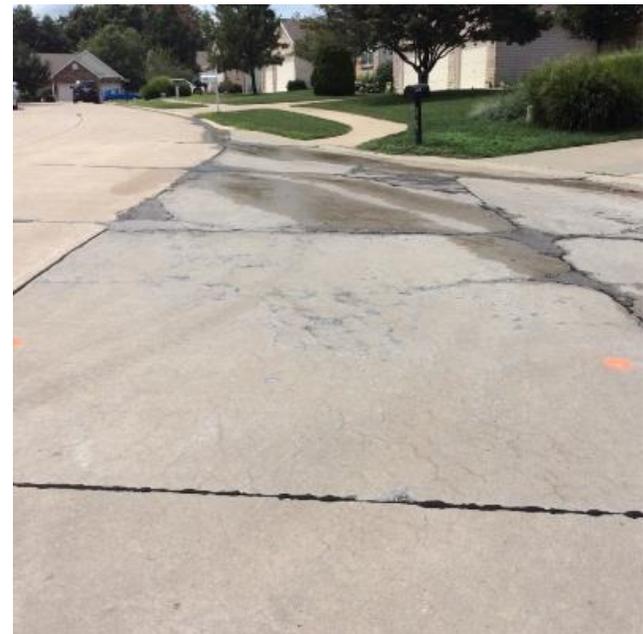
Abundant water

Damage is not at the low points

Curbs, driveways and sidewalks are fine

Localized distress

Considerable slab movement

Faulting

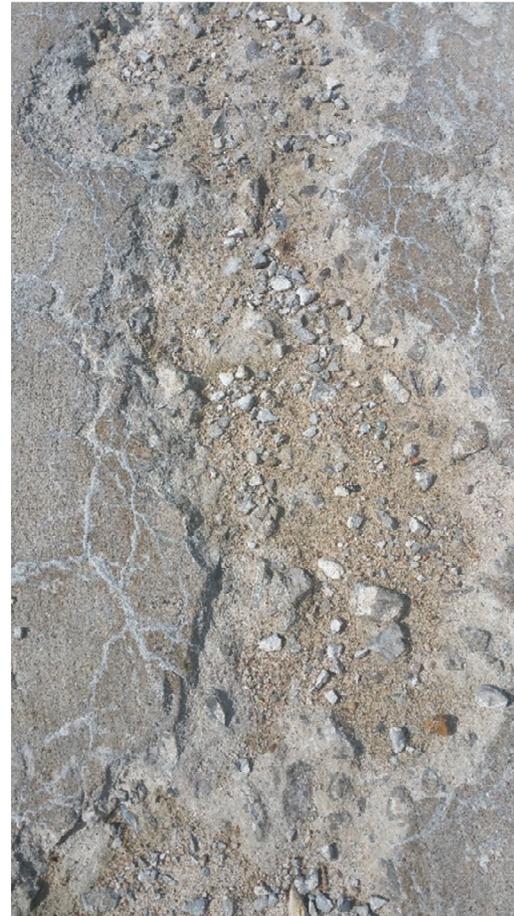
- Map cracking
- Surface discoloration/calcite
- Concrete loss
  - Cracks go around aggregates
  - Abundant calcite/gel

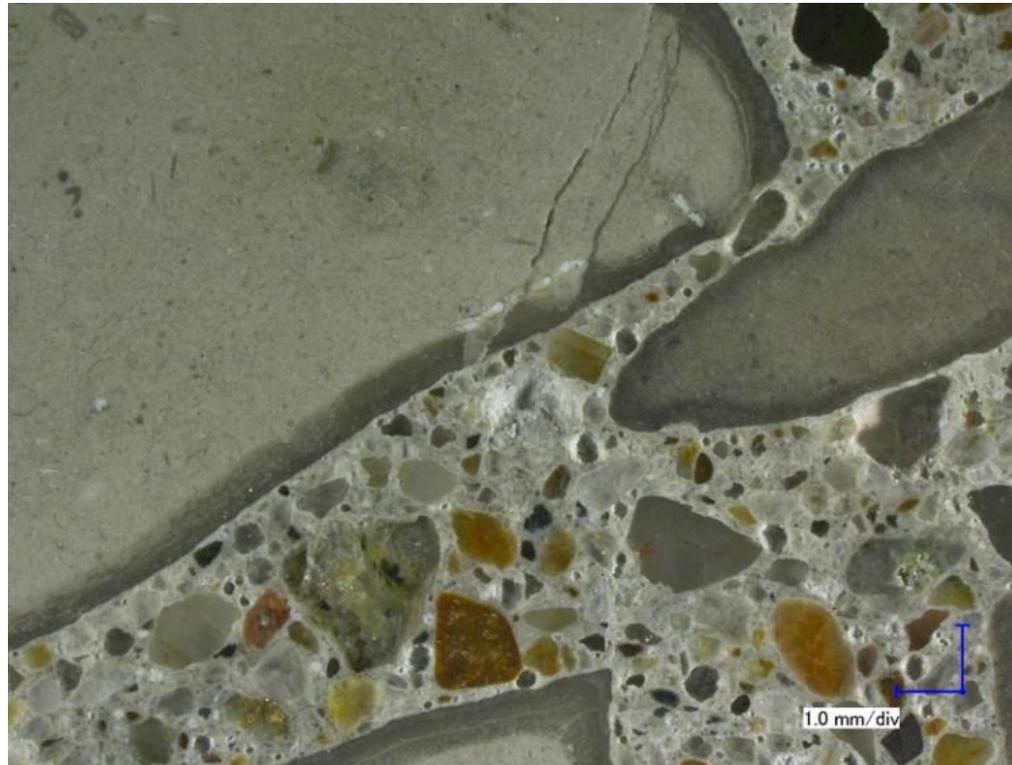
- Rim around the dolomitic aggregate
- Crack in the aggregate

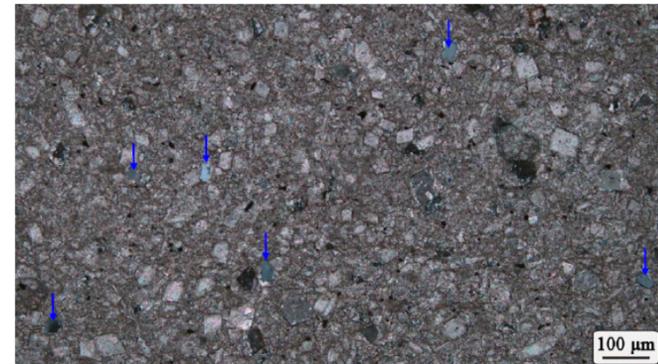
- Rhombic aggregate
- Fly ash does not help
- No gel
- Mechanism is debated
- Tough to detect in the aggregate

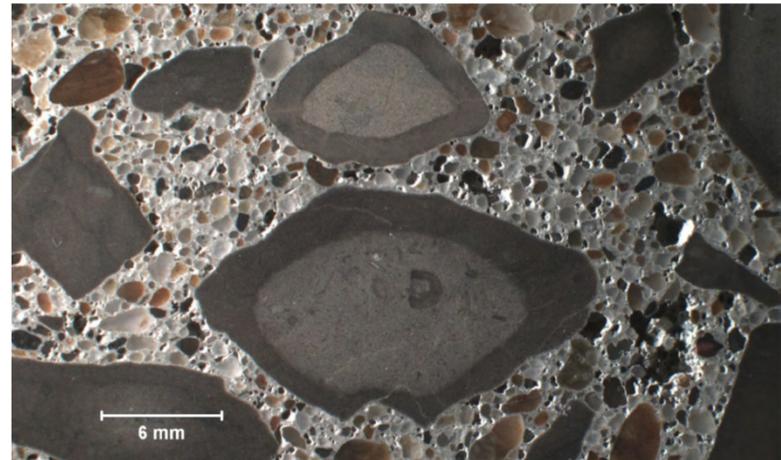
Aggregate sample received – similar to that in the cores:

- Clay content = high
- Void size distribution = poor
- ASTM C 1260 = pass

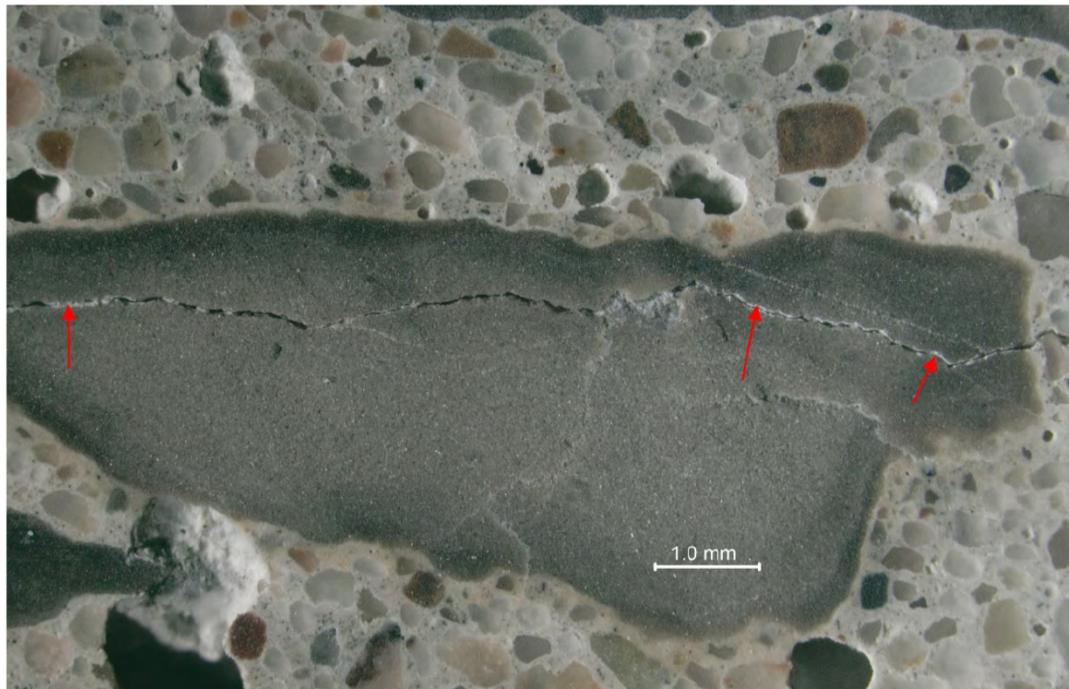
Cracks start in aggregate  
Gel deposits

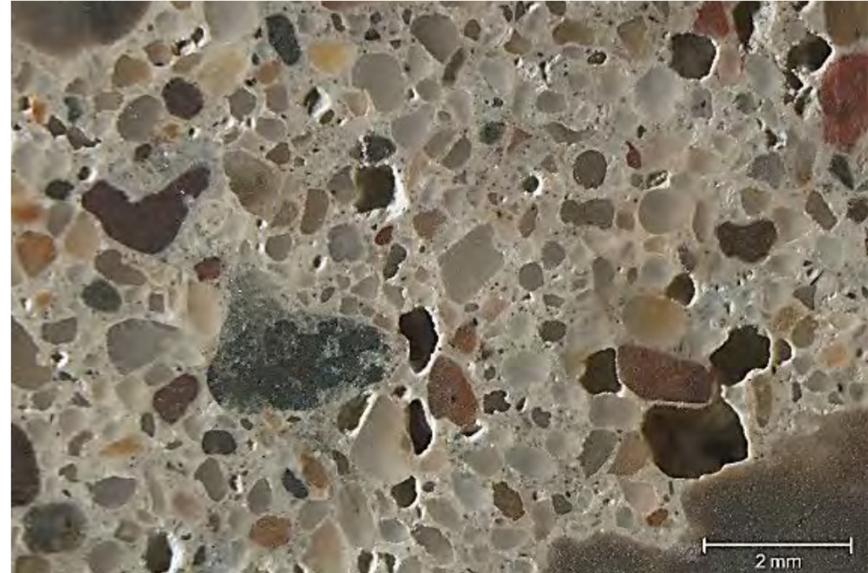
Air void system varies

- Air content 4 to 8%
- Spacing factor: 0.021 & 0.013 inch ( $>0.008$ )

w/cm varies

- 0.42 to 0.60

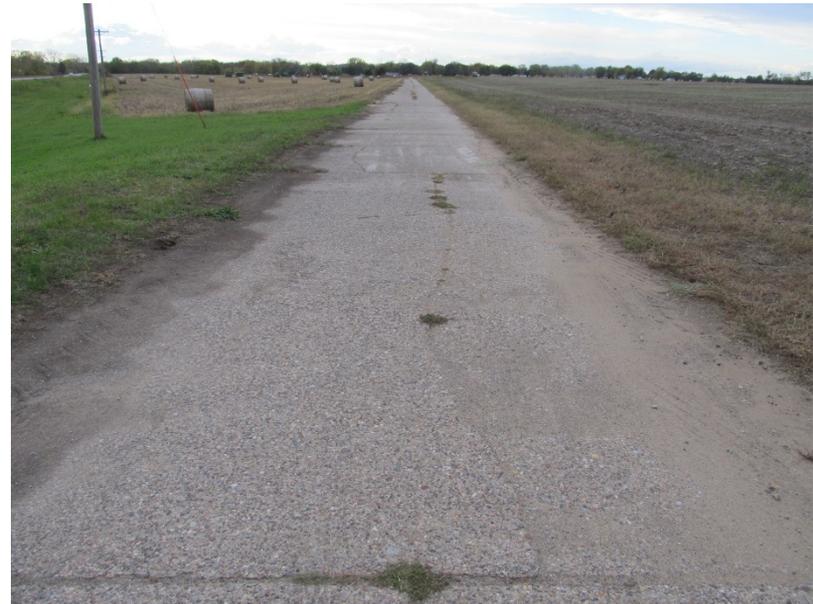
Fredonia, Iowa  
Hanson, IDOT 2017

## Convict Road

- Built in 1914
- \$30,000/mile
- 6"- 8" thickened edge
- 1.5 miles
- 16' wide
- 20 man crew
- 40 cents/hour
- First use of Baker-type expansion joint at 30' spacing
