OVERVIEW OF VDOT REFLECTIVE CRACKING MITIGATION RESEARCH

Hari Nair, Ph.D., P.E.
Senior Research Scientist

53rd Mid-Atlantic Quality Assurance Workshop
February 11-13, 2020

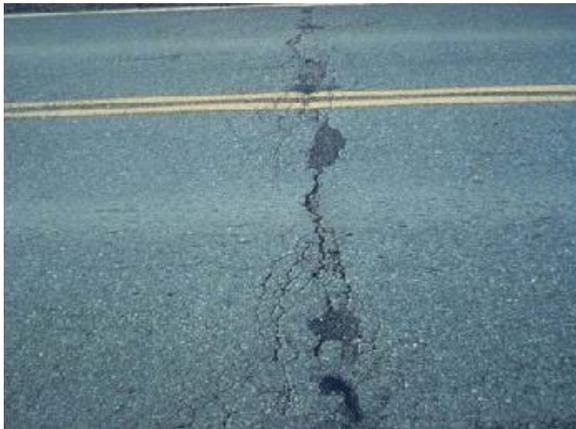
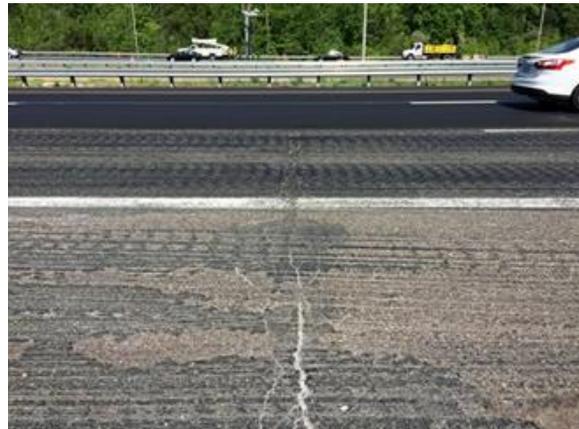
Reflective cracking over jointed concrete is a major problem in Virginia.

Result of horizontal and vertical movements at the joints and cracks in the underlying PCC

Reflective cracks allow water into the pavement

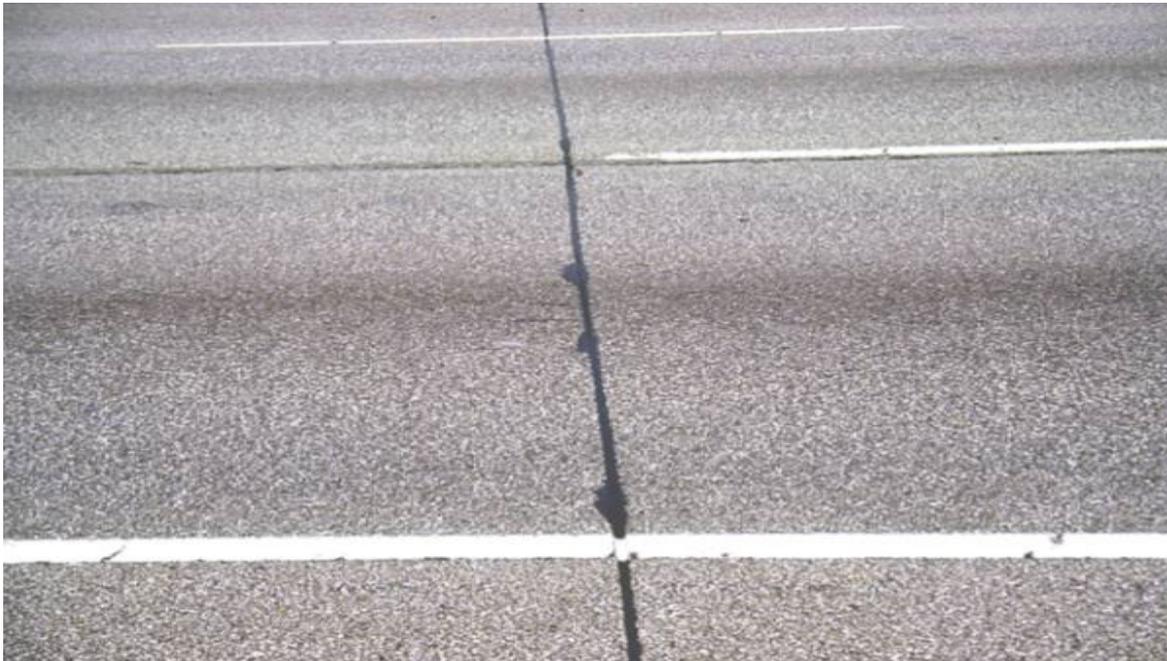
Saw and Seal

- Involves making saw cuts in the overlaying asphalt, (above the concrete joints) and sealing them with a compressible rubberized low modulus material

Economical option for controlling reflective cracking

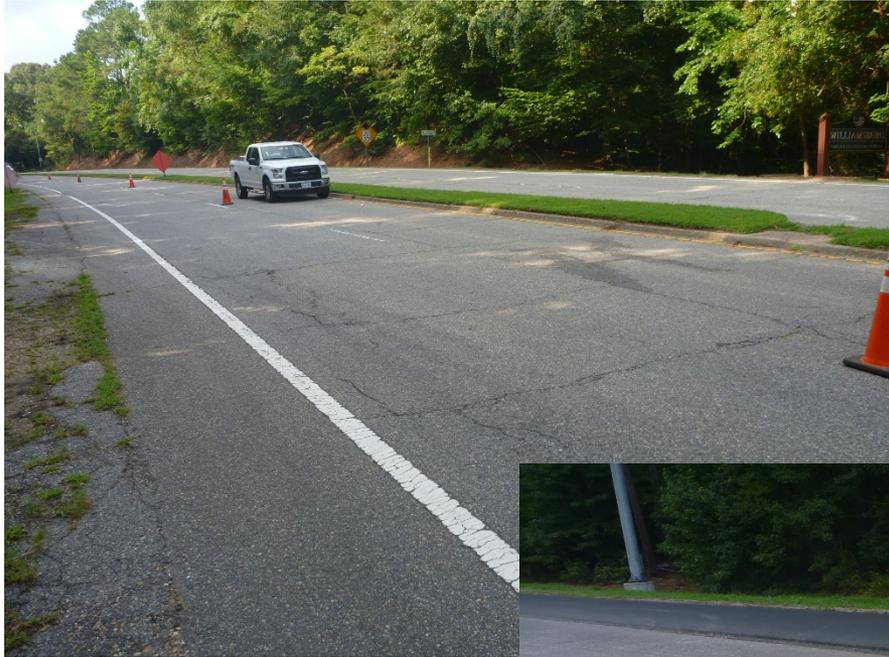
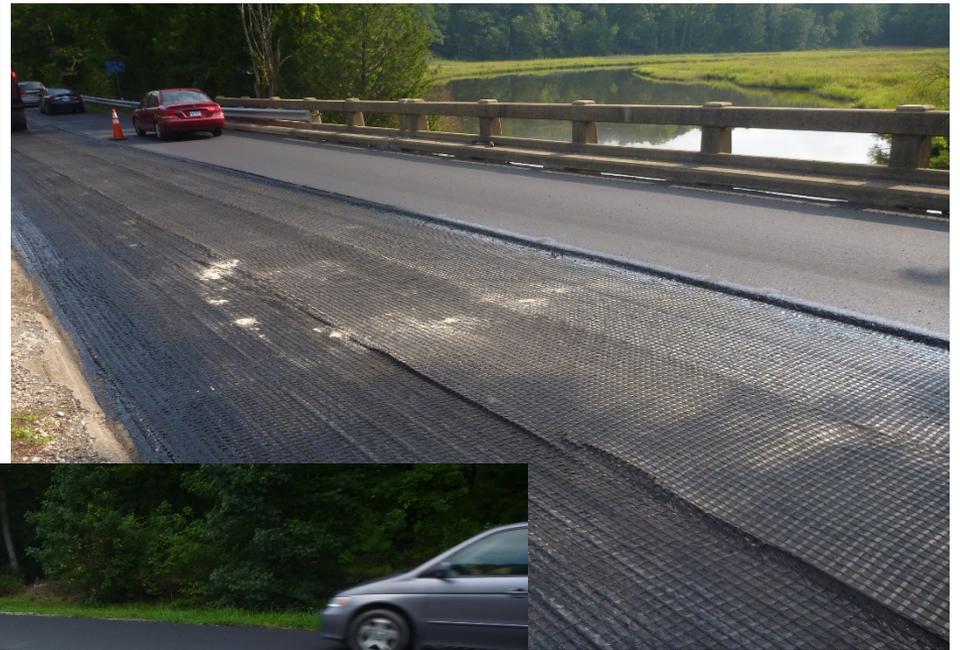
Route 143 NB & SB, York County

Paving Grid Type III on milled asphalt pavement over jointed concrete, with 1.5" overlay of SM-9.5D.

Tack Coat: PG 64-22
Application rate of 0.13 gallon/yd²

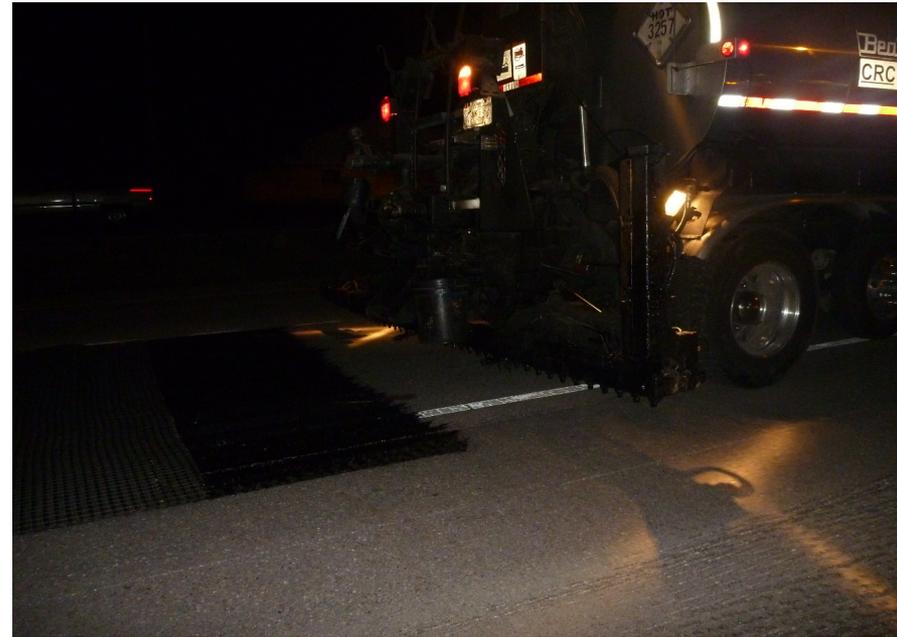
US Route 17 SB, York county

Paving Grid Type III directly on existing asphalt pavement over jointed concrete, with 2" overlay of SM-12.5D.

Tack Coat: PG 64-22 -application rate of 0.11 gallon/yd²

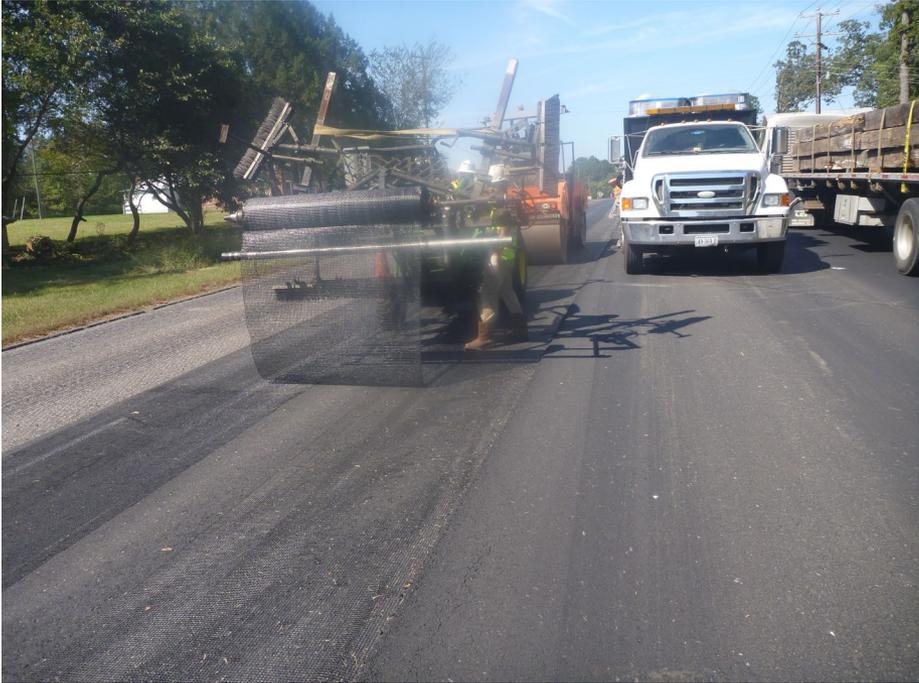
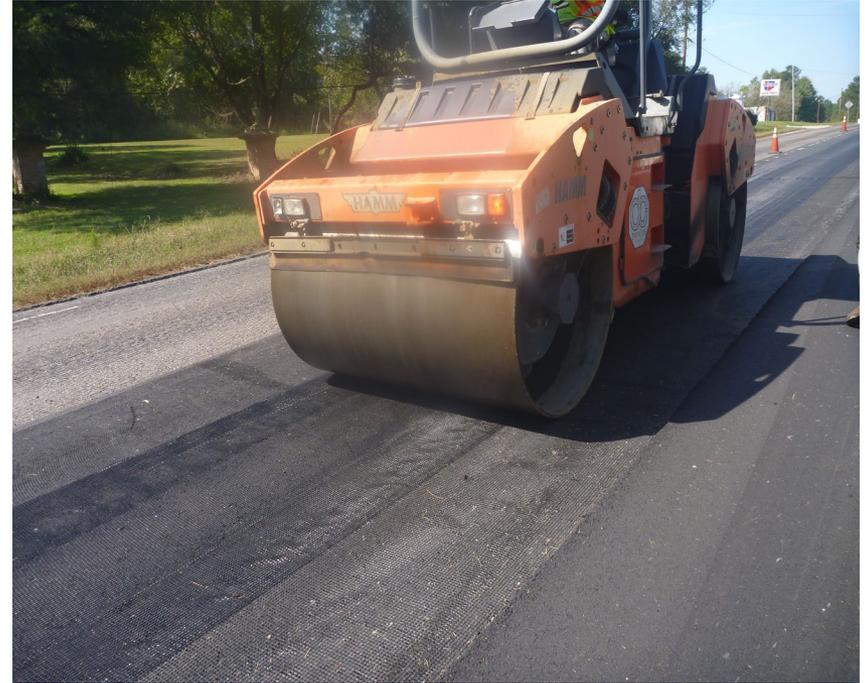
US 460 Wakefield

1.12 mile long, 2" overlay

Fabric Length: 328 ft.

Width: 5 ft.

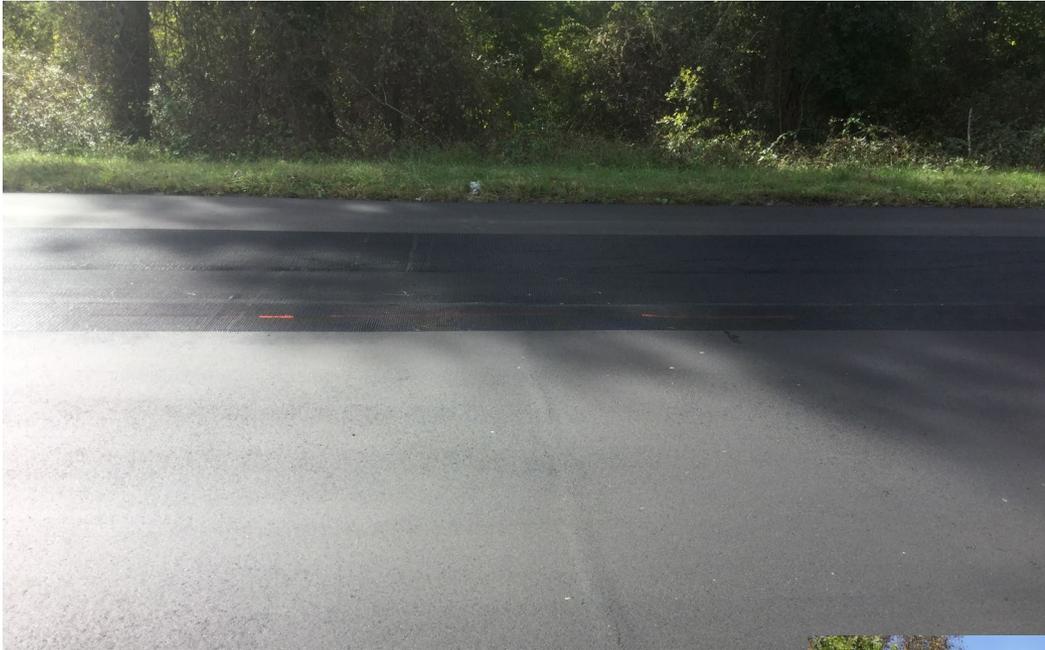
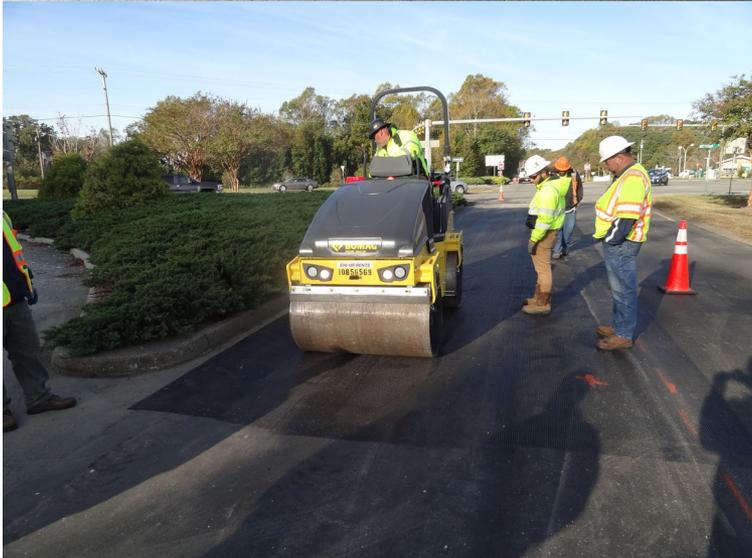
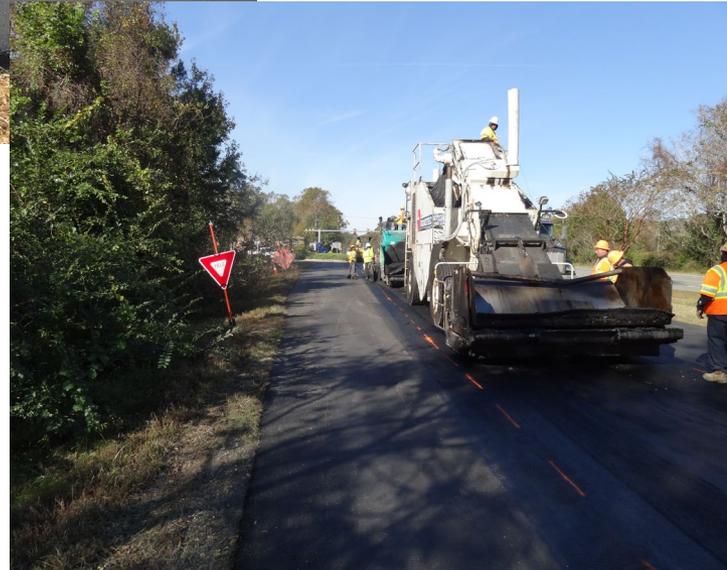
Rte. 30, York County

- Concrete patching
- Joint seal
- SM 4.75 (1")
- Fabric placement
- Overlay (1.5")

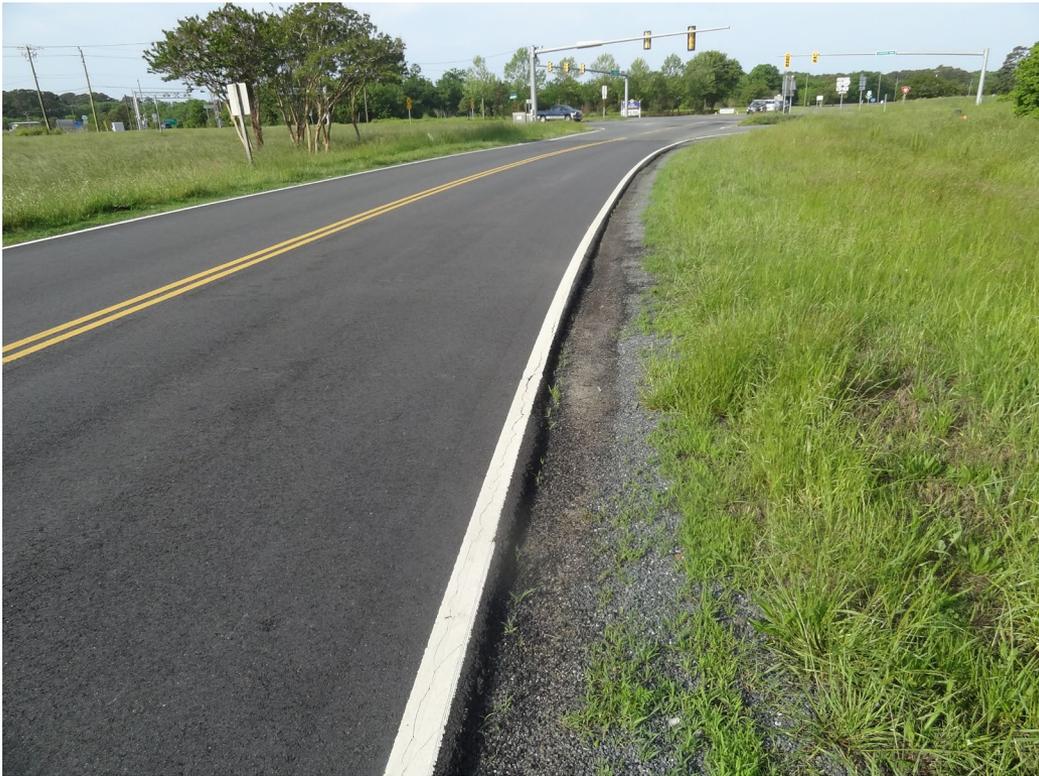
US13, Hampton Roads

Fiber reinforced chip seal (Fibermat) interlayer + AC overlay

Jointed concrete pavement

Fibermat + SM 9.5D overlay in year 2017

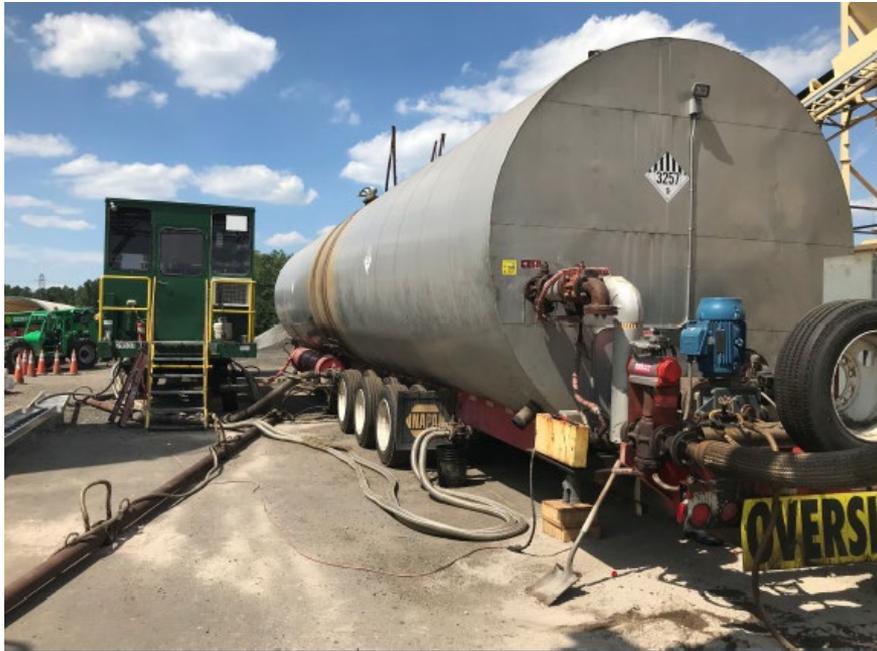
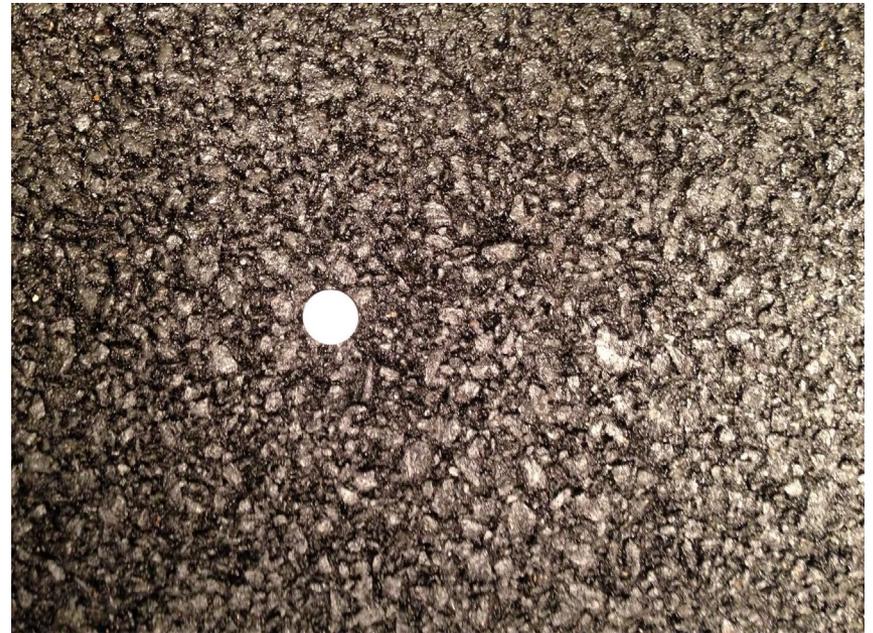
I-85, Richmond district

2. Asphalt Rubber Gap Graded Mixture (AR-GGM12.5)

Wet Process

Total Asphalt content: 8.1%, RAP content: 10%
Rubber Content: 17.5%

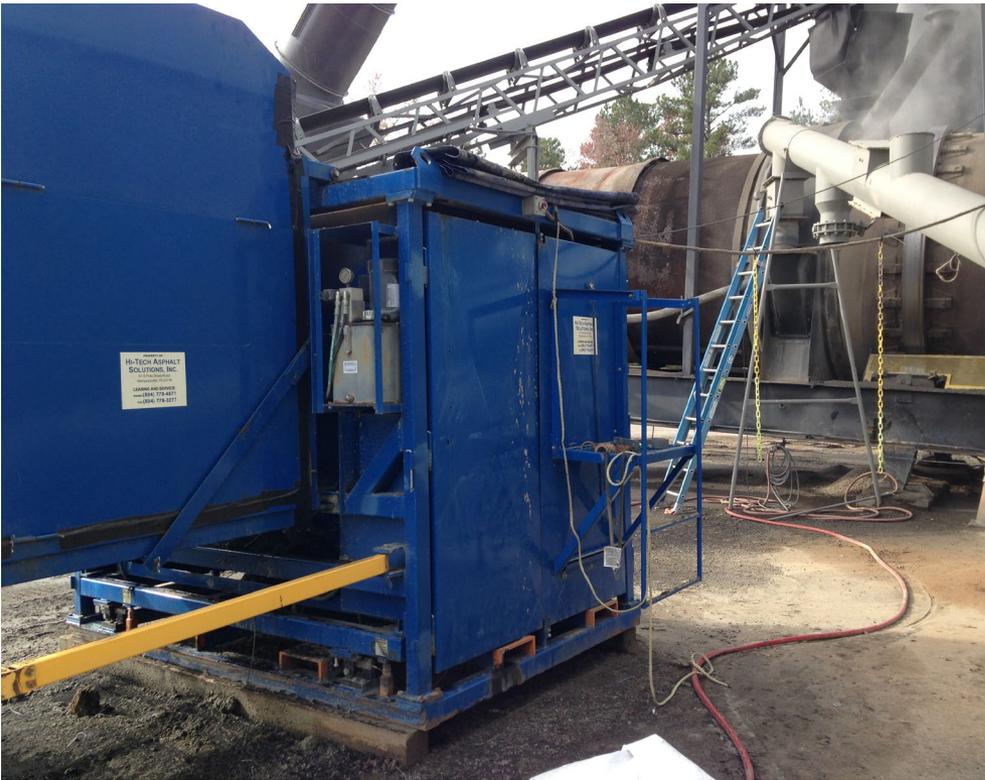
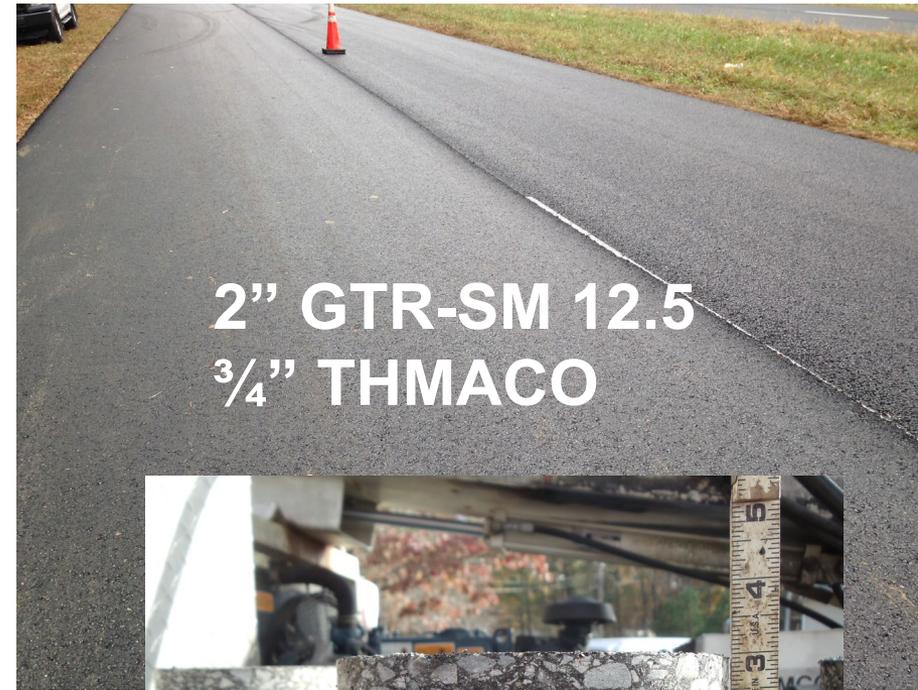
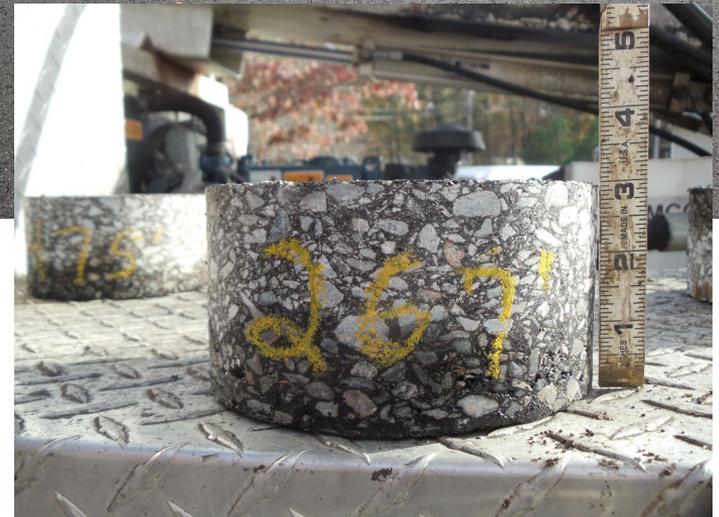
US 60, Richmond district

3. GTR Modified Asphalt Surface Mixture, GTR-SM 12.5E

Dry Process

2" GTR-SM 12.5
3/4" THMACO

Total Asphalt Content: 6.5%
GTR: 10%

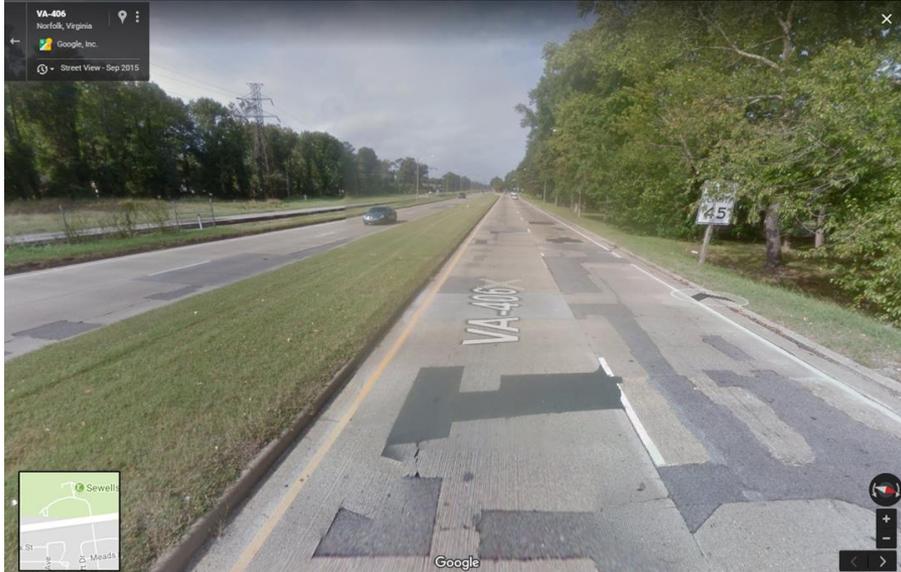
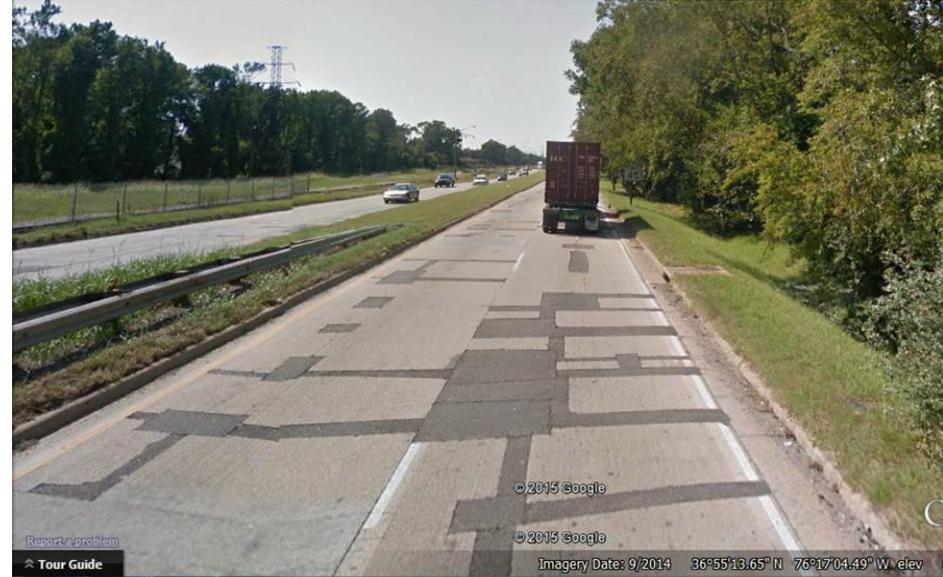
Terminal Boulevard (SR 406) Concrete Rubblization

Mainline

2.0" SM-12.5E

4.0" IM-19.0E (two lifts of 2")

8" Rubblized Existing Concrete (CRCP)

12.0" Existing Cement Treated Sub-Base

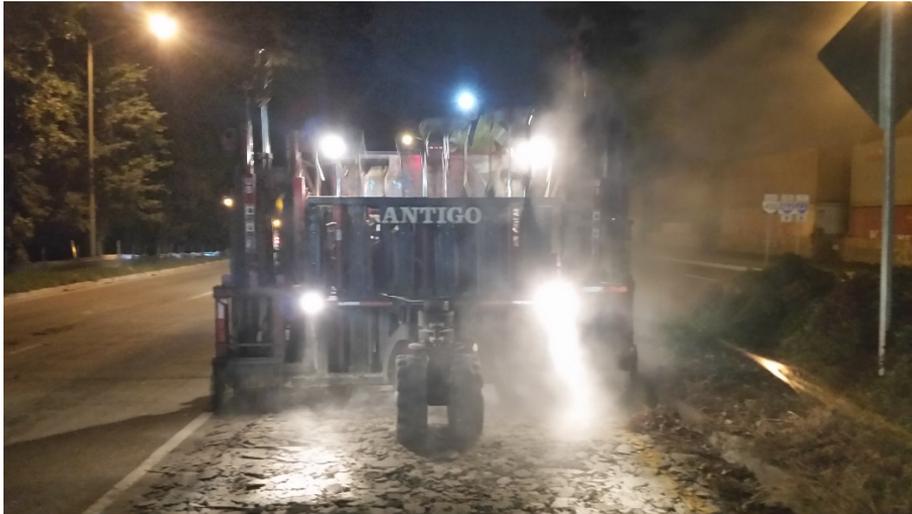
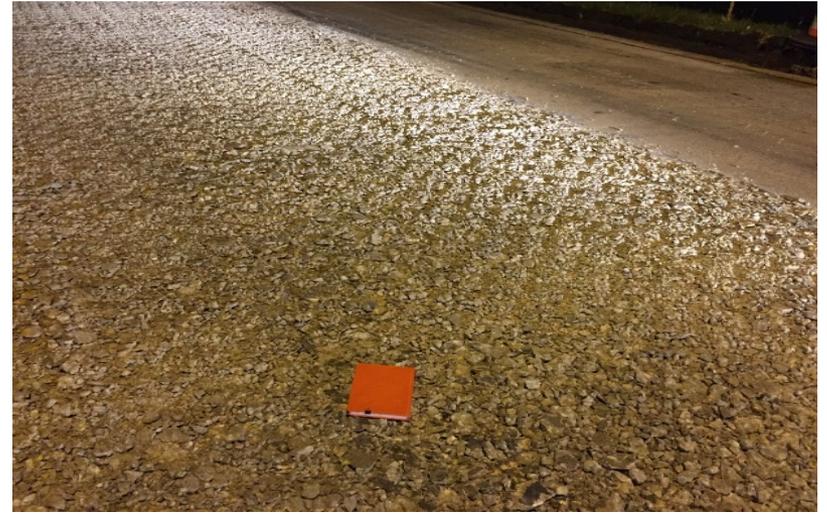
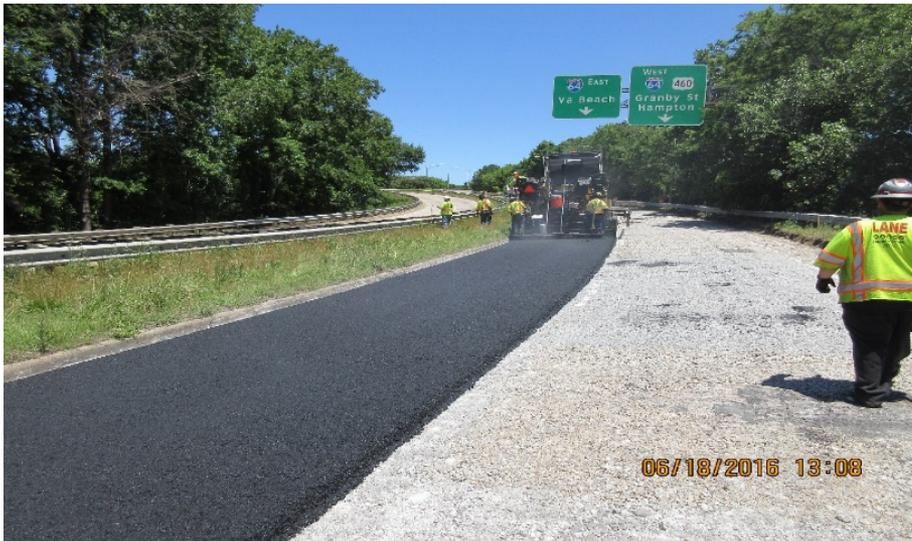
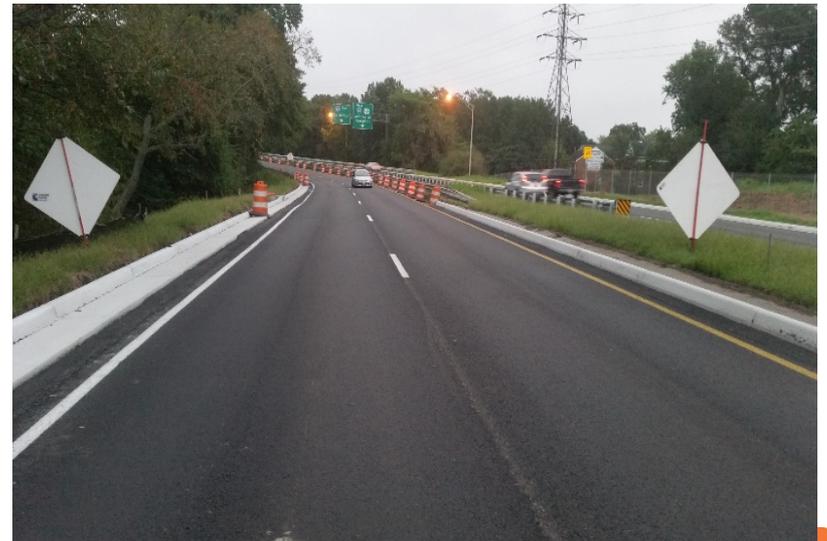
Terminal Boulevard (SR 406)

Year	Mile points	IRI (in/mile) Average	Rut depth (inch), Average	CCI Average
EB	2018	0-1.33	97	0.13	97
	2017	0-1.33	95	0.09	99
WB	2018	1.33-0.052	107	0.17	-
	2017	1.33-0.048	99	0.09	-

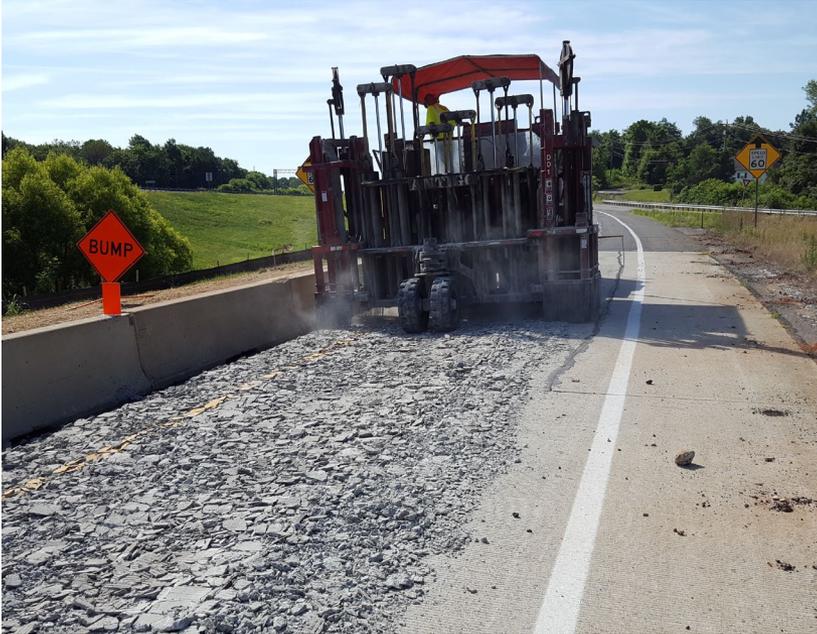
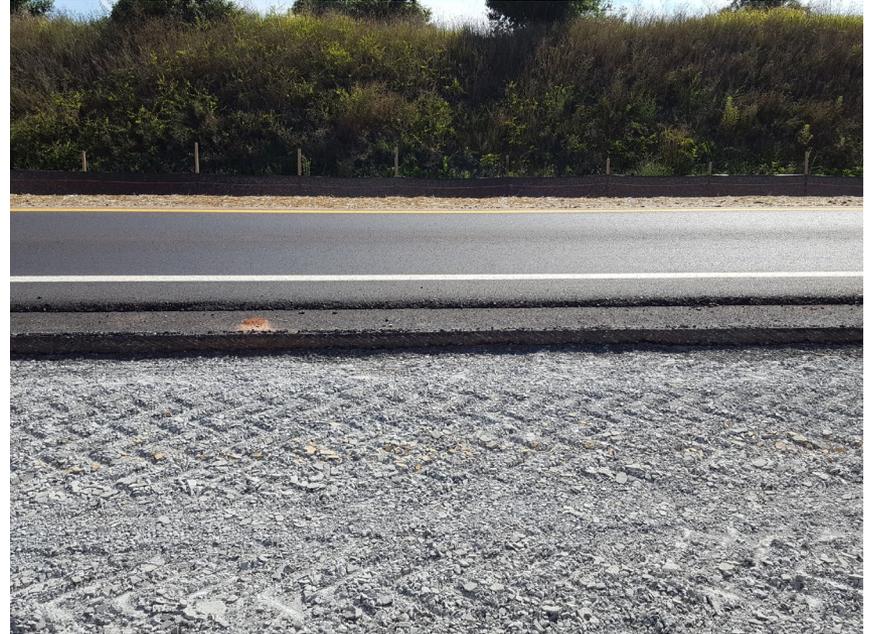
US 460 Appomattox By-Pass Concrete Rubblization

SM 12.5D-1.5"

IM 19.0D- 2"

BM 25.0D+0.8 - 4" HMHB

Rubblized Existing Concrete (9-inch JPCP)
