Phased Array Ultrasonic Testing  
Initial Trials Using D1.5 Annex K  
*and*  
A Look at NCHRP 14-35 / Report 908

Ronnie Medlock, VP Technical Services  
High Steel Structures  
QAW  
15 February 2020

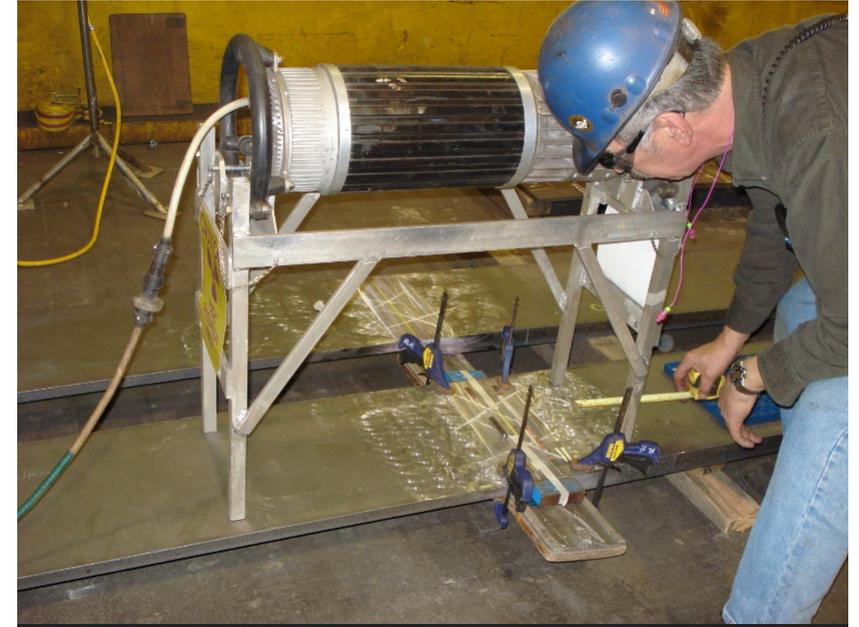
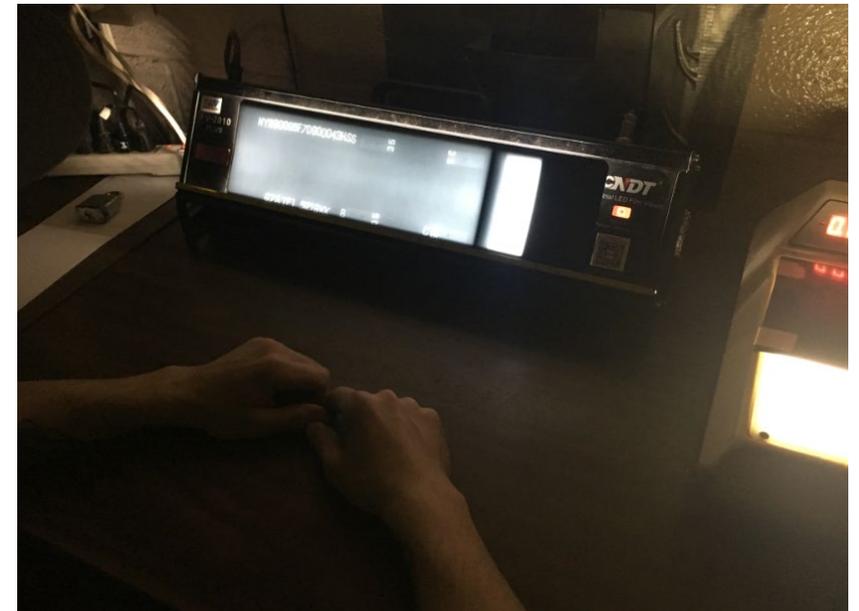
- Bridge Welding began in the 50s / 60s
- RT acceptance criteria adopted
  - Workmanship based – i.e., the acceptance criteria are based on the quality that can be expected from a welder
  - Not based on fitness for purpose
- Successful performance of millions of flange and web splices
  - No weld that passed the acceptance criteria has ever cracked
  - One weld is known to have cracked from a weld defect – the I-79 bridge; however, that weld had a huge defect (from an improper repair) that would not have met acceptance criteria

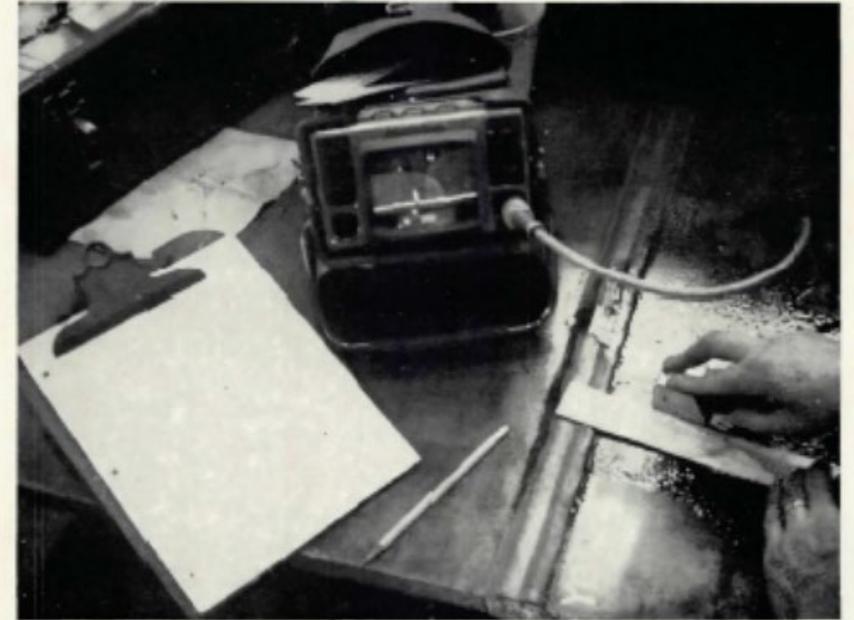
Application of ultrasonic testing to a groove weld

- Adopted in the late 60s
  - D1.0-69
  - D2.0-69
- Sound is sent through the weld
  - If the sound strikes a discontinuity, it bounces back
  - Acceptance is based on the amount of sound that comes back
  - Acceptance is also dependent upon the scanning angle (originally to adjust for the fact that you cannot send sound through the weld at 90 degrees to the weld)

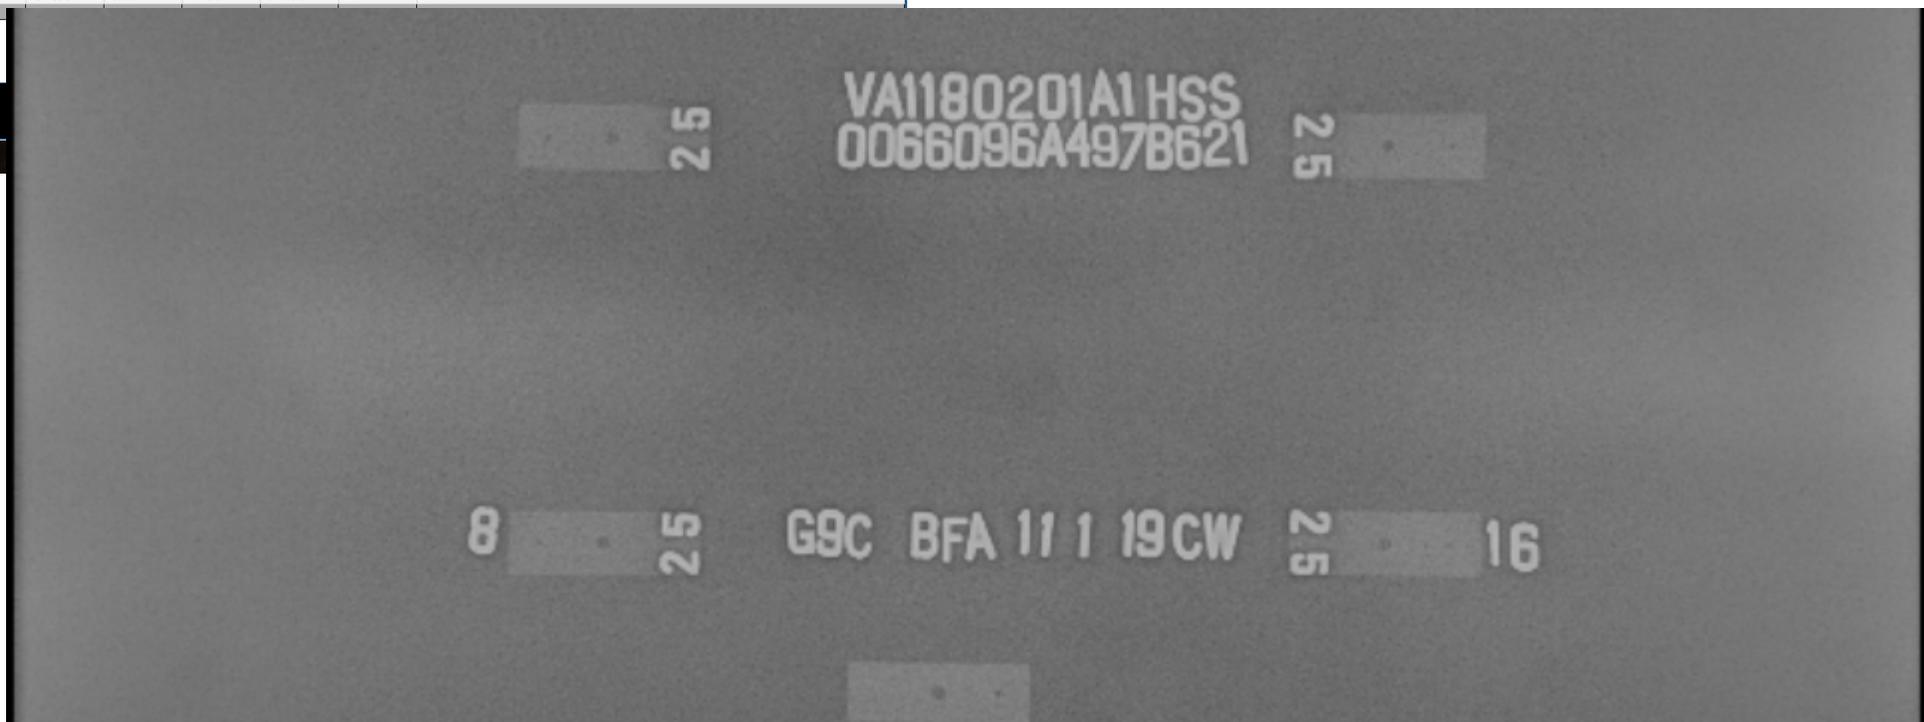
G9C BFA  
(A1)

- RT result: not found
- PAUT result
  - Annex K: class D, 14.5%
  - NCHRP: 23%, raster
- UT result: not tested

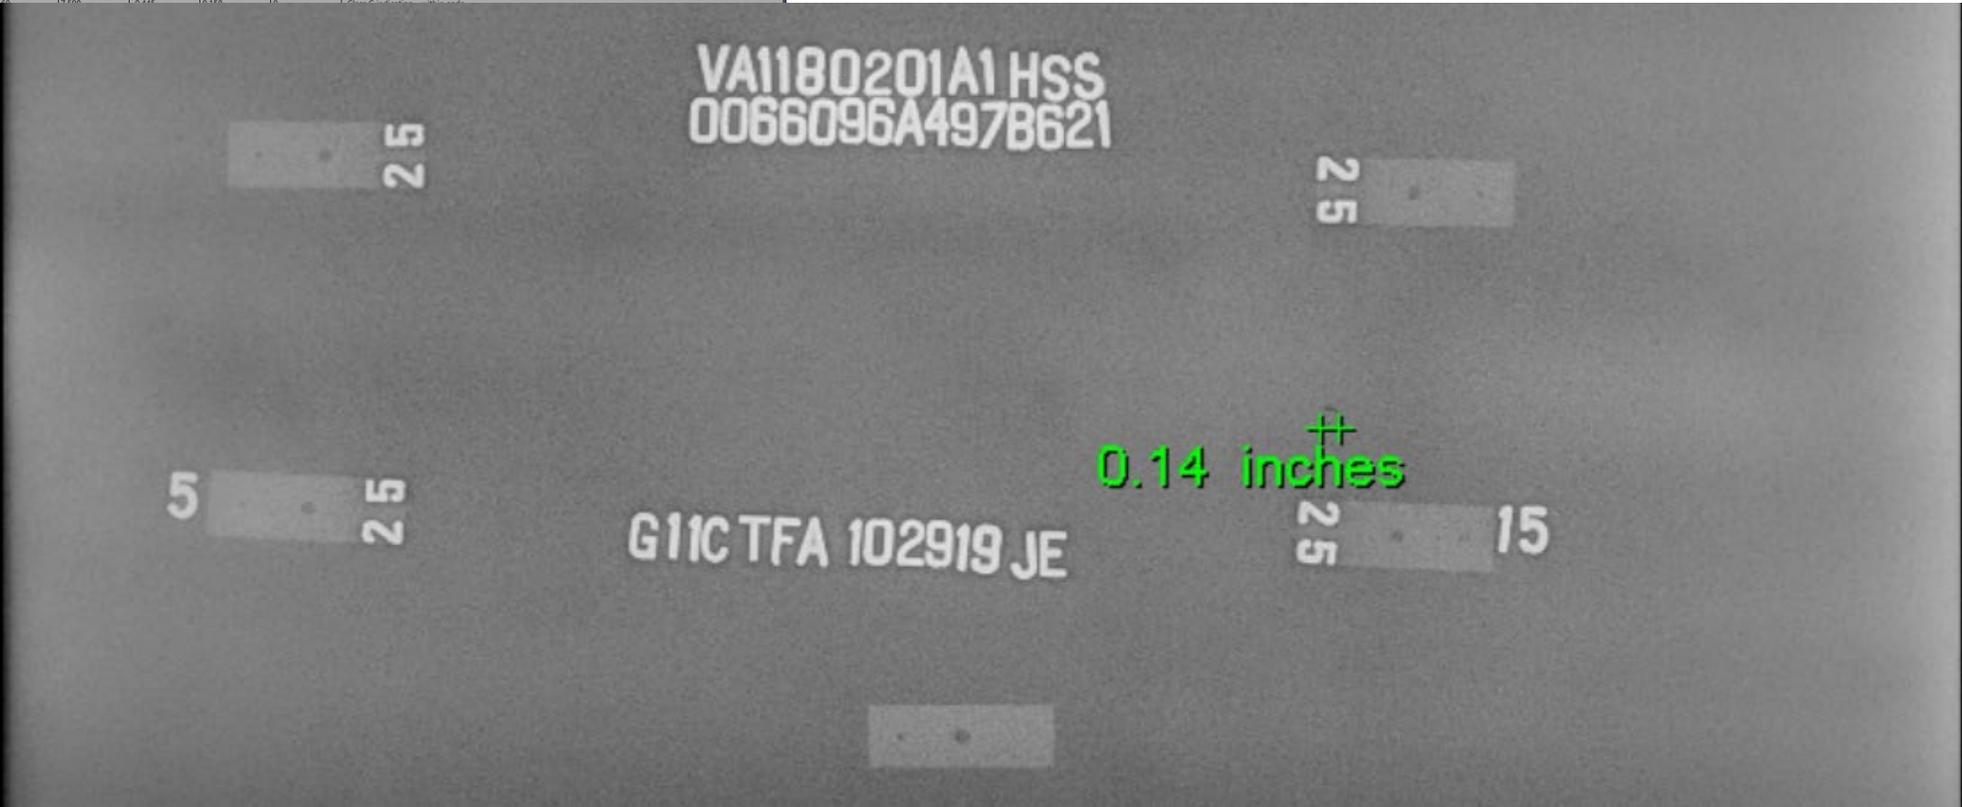
G11C TFA  
(A1)

- RT result: Acceptable
- PAUT result
  - Annex K: class D, 14.5%
  - NCHRP: 23%, raster
- UT result: not tested

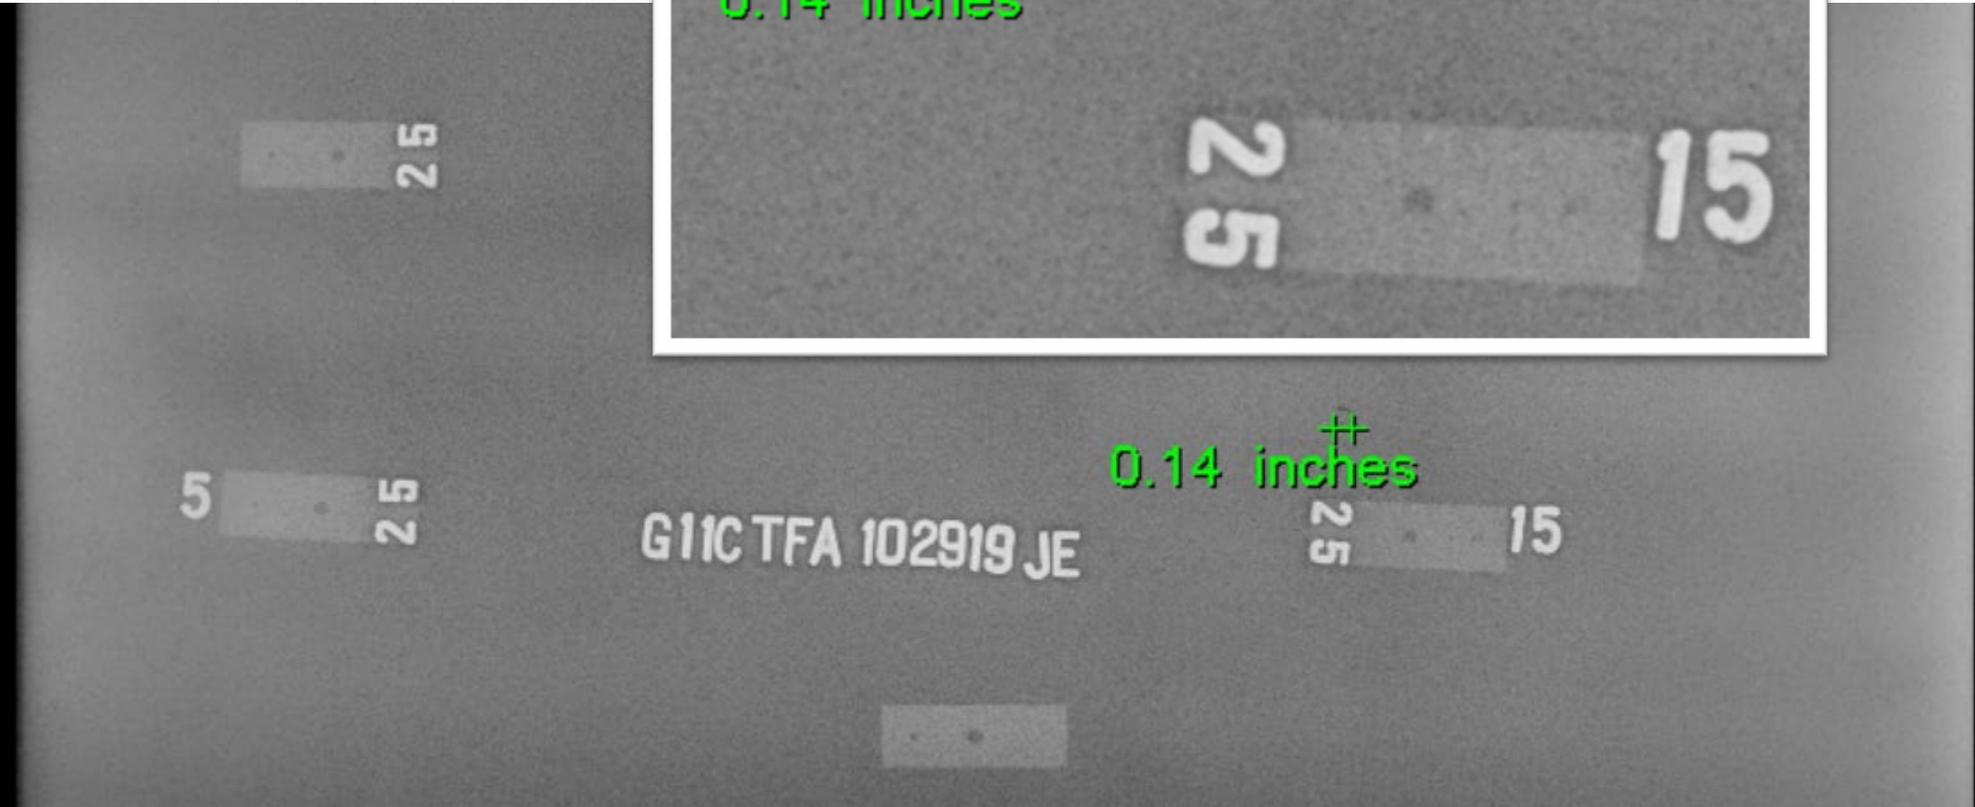
G11C TFA  
(A1)

- RT result: Acceptable
- PAUT result
  - Annex K: class D, 14.5%
  - NCHRP: 23%, raster
- UT result: not tested
