Appropriate Treatments and Techniques for the Maintenance and Rehabilitation of Historic Bridges

PennDOT District 6-0, April 24, 2018

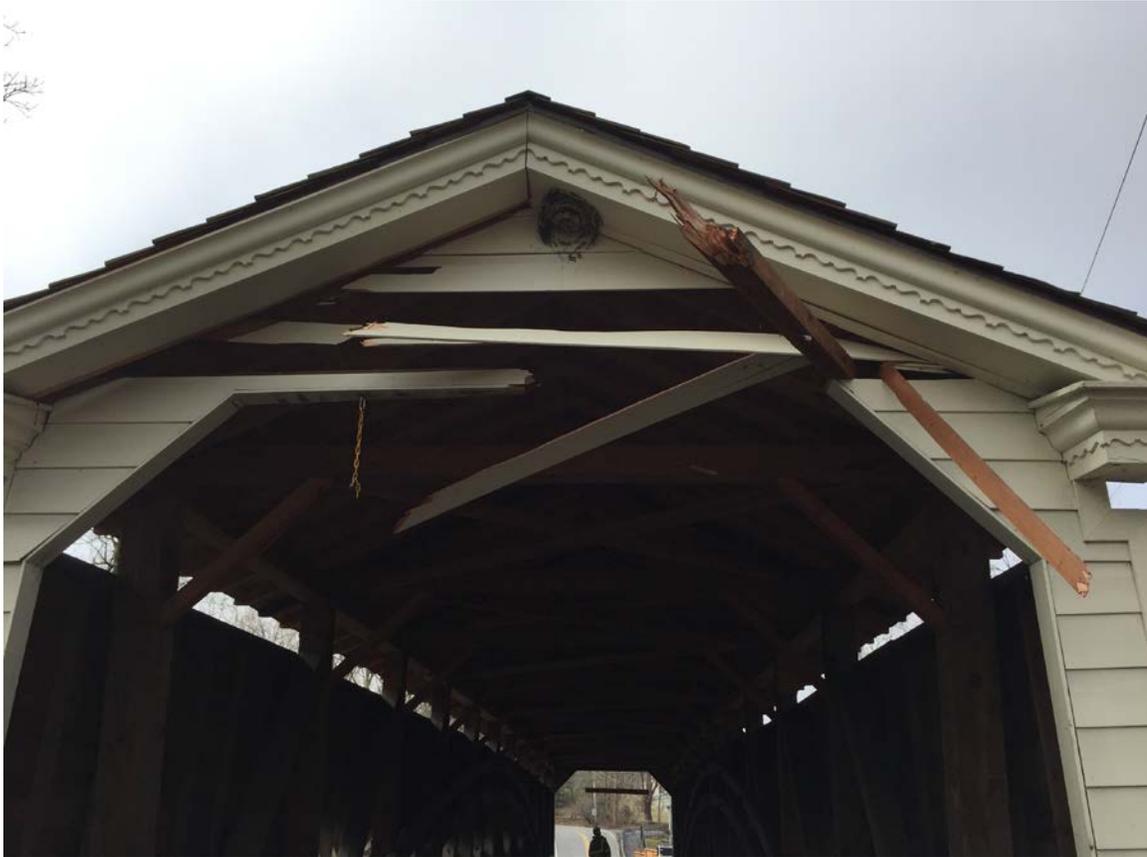
Covered Bridges Maintenance Collision Damage

On 3/29/2018 Oversized vehicle hit Rapps Dam Road over French Creek in East Pikeland Township.

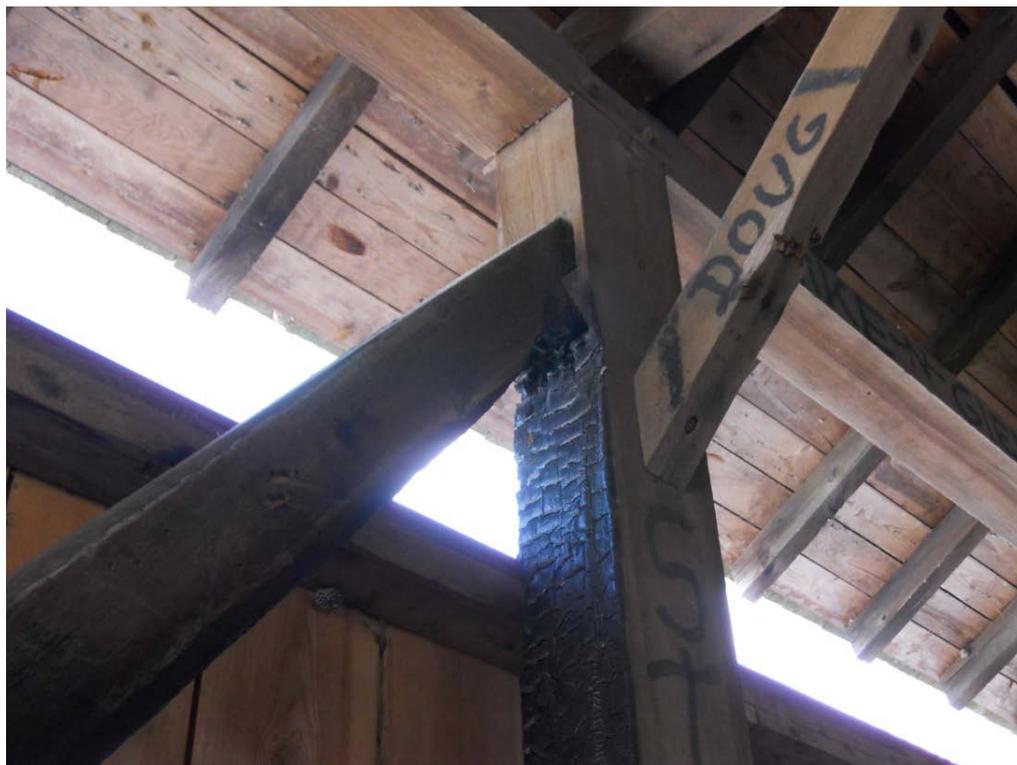
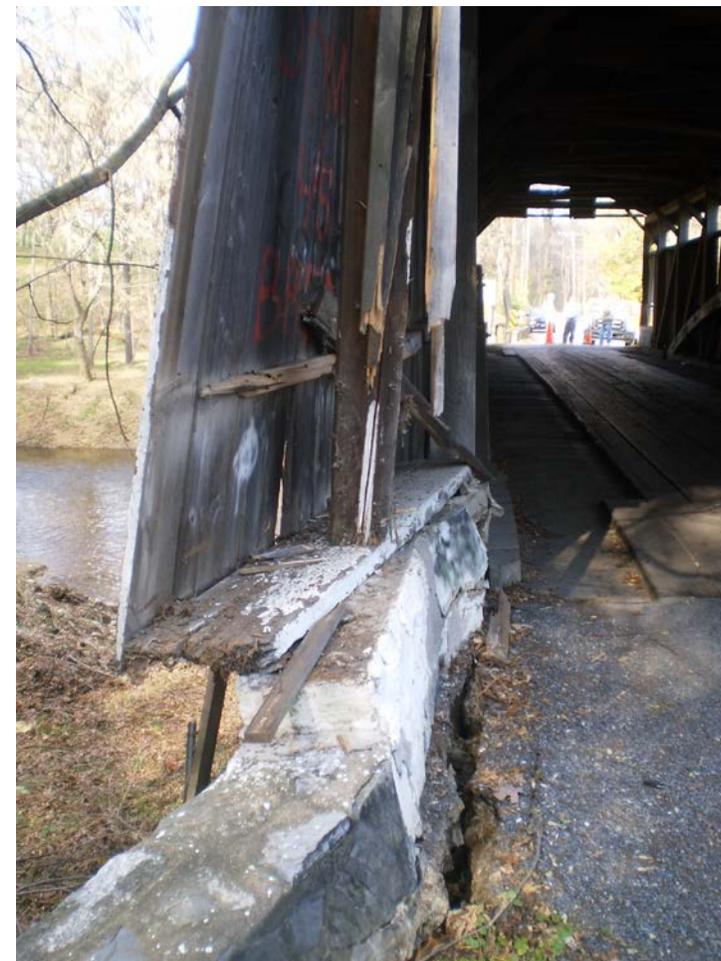
Pre Rehabilitation Conditions

Bridge sustained fire damage in 2004 and closed in 2011 when tractor trailer collided with it.

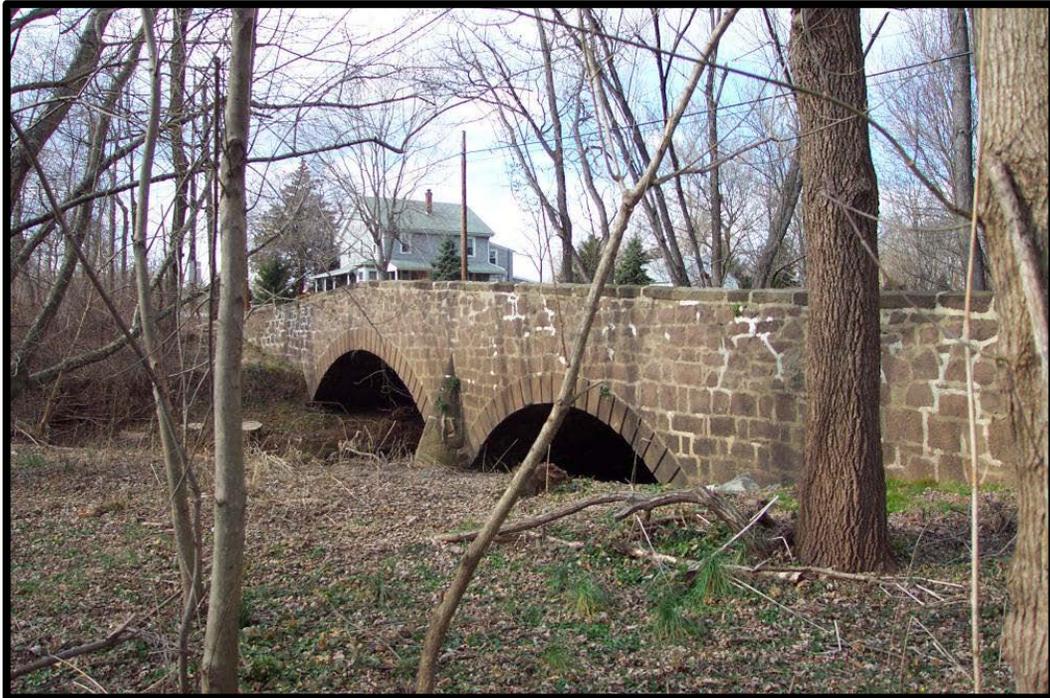
Poorly repointed

Repointed in part with Portland Cement

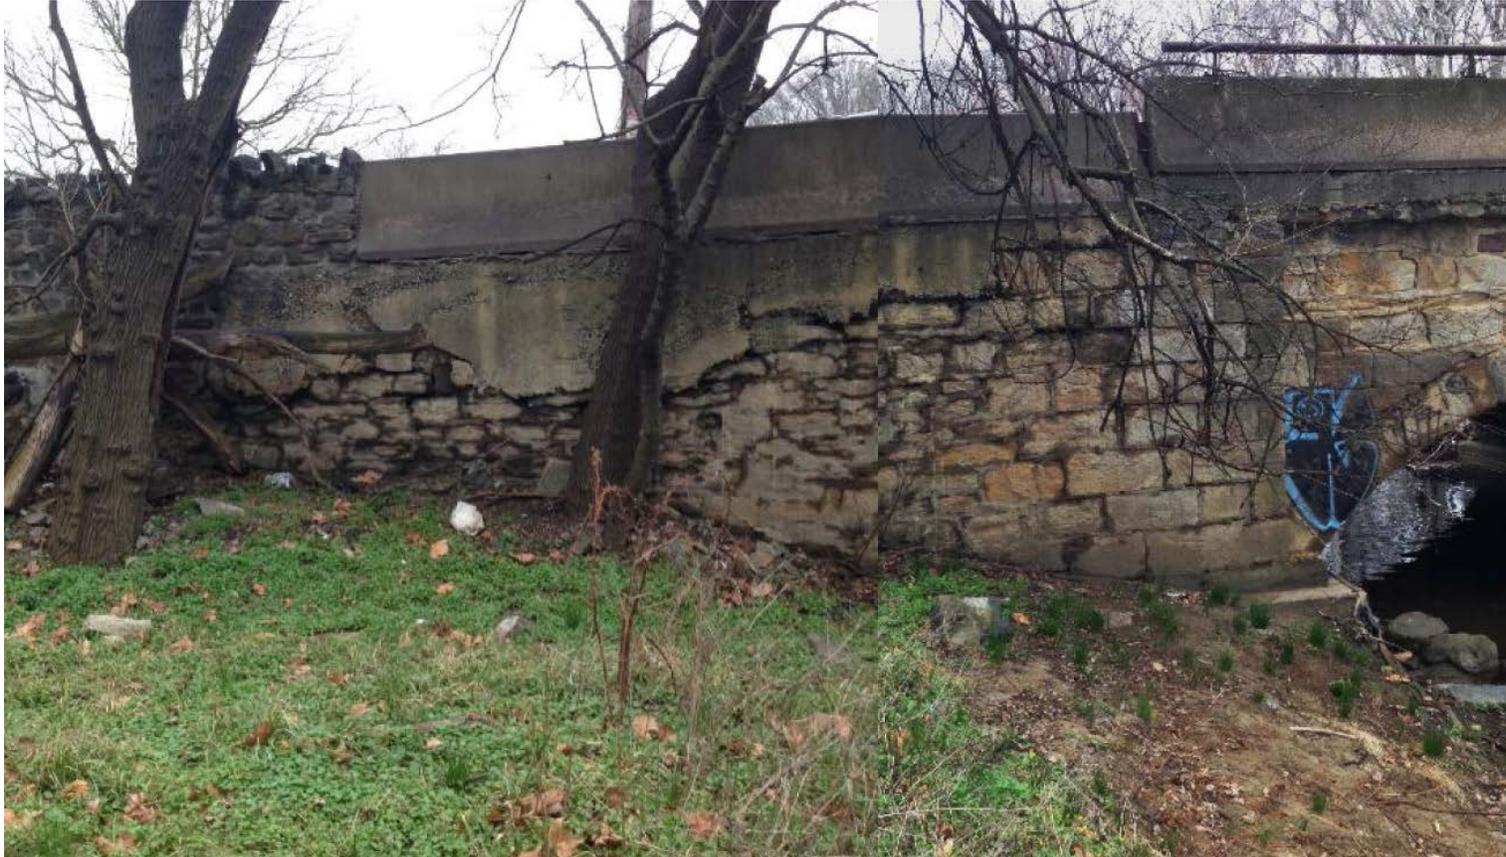
Wing and Spandrel Wall Reconstruction

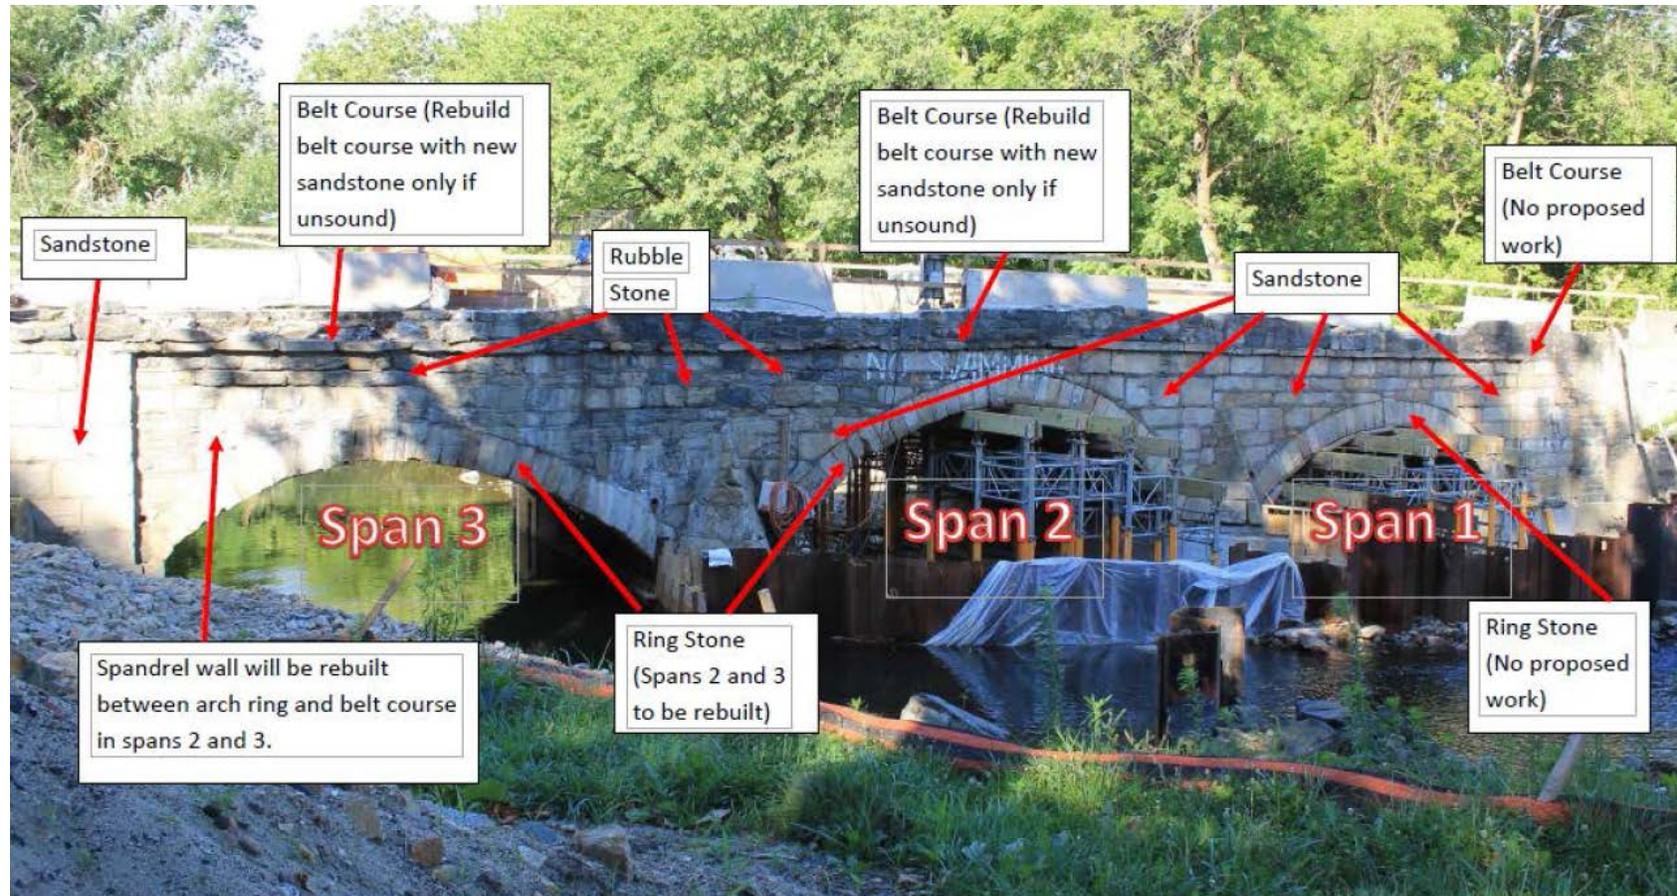
Upstream (North) Elevation with proposed scope of work

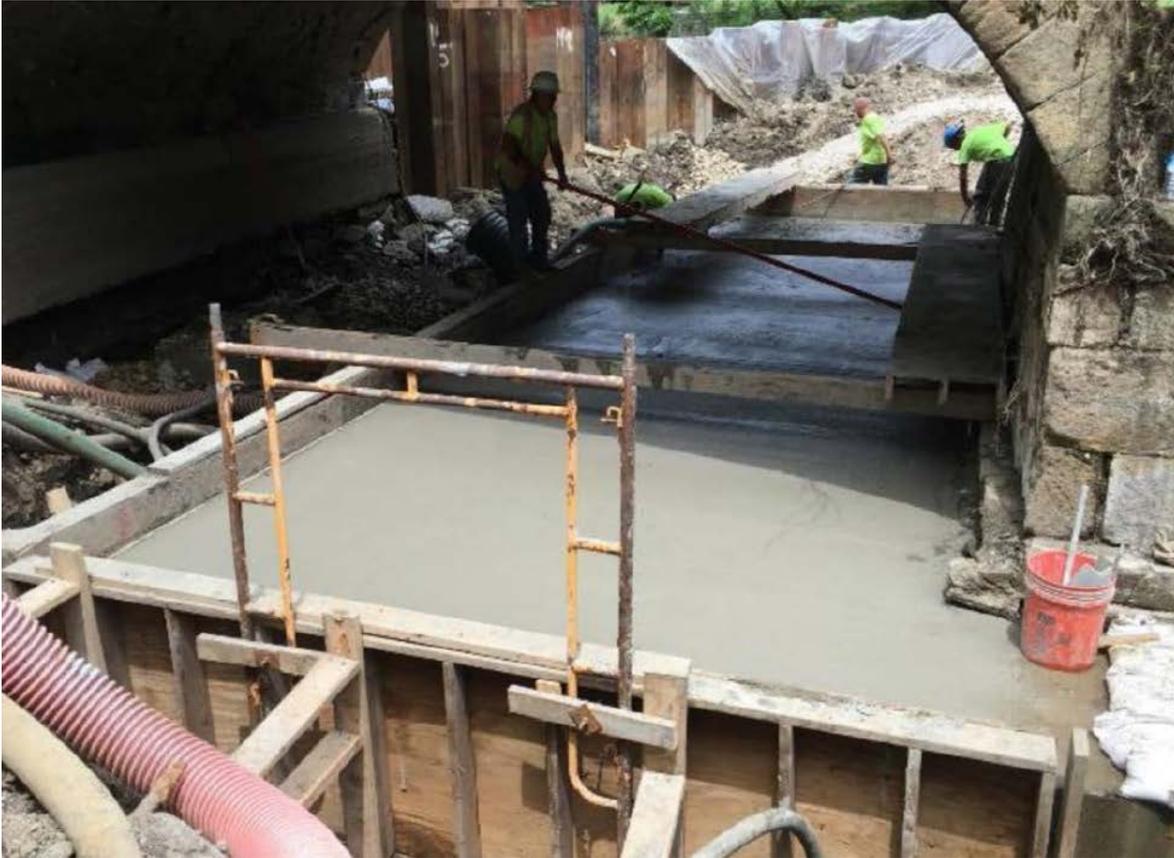
Mud Slab Placement

Reinforced Concrete Apron

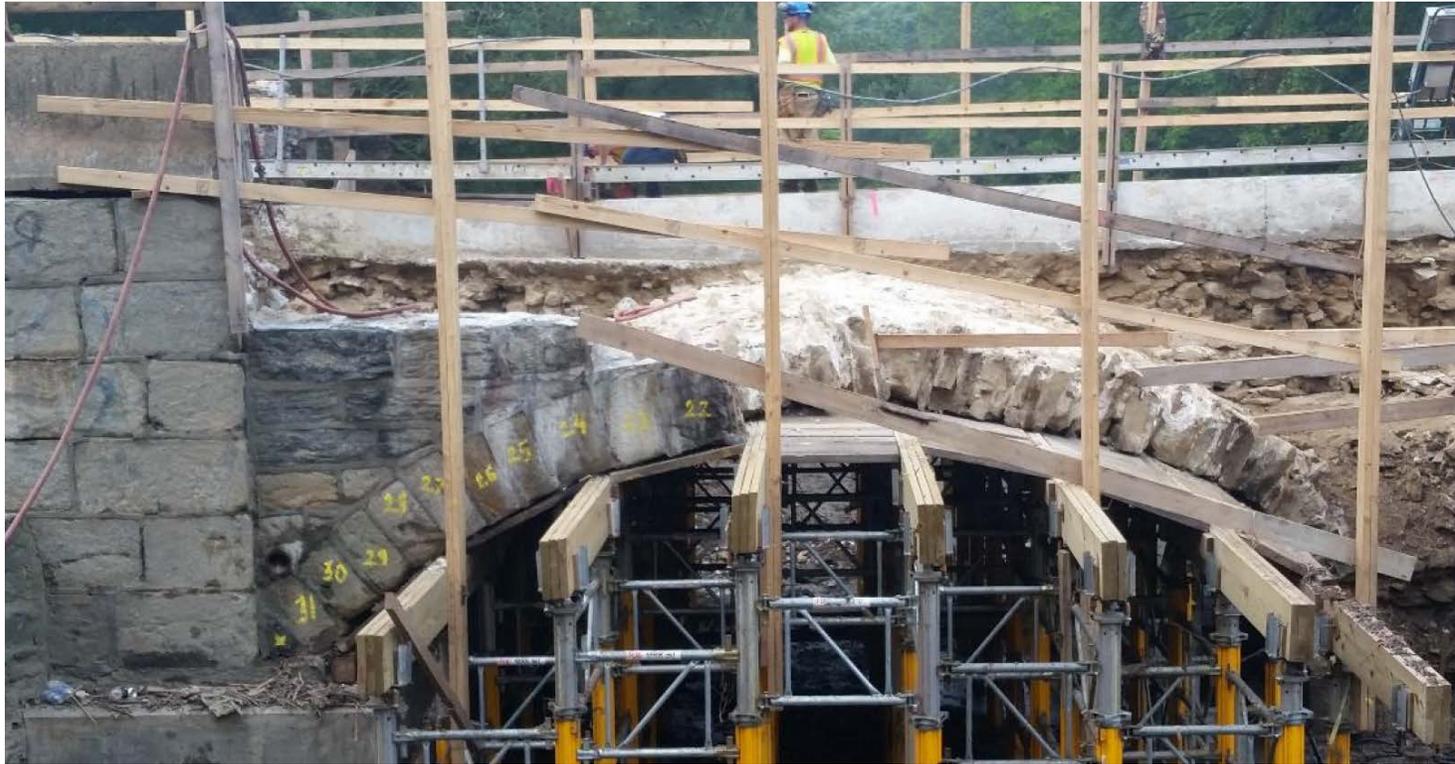
Arch Reconstruction

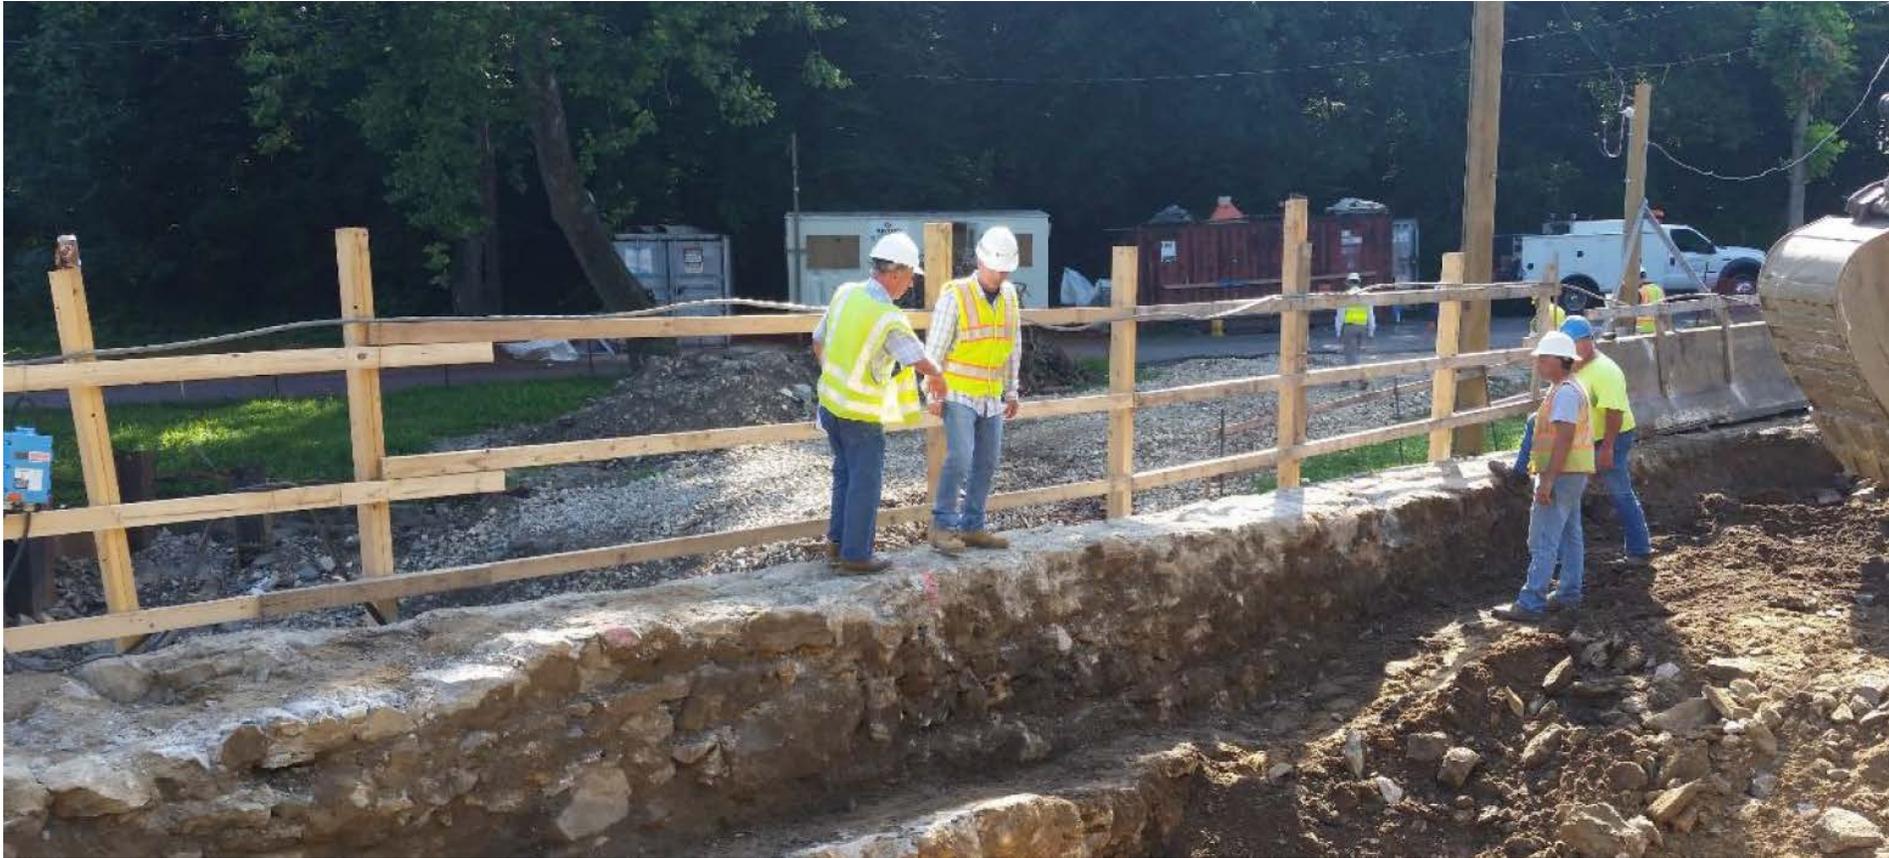
Spandrel Wall Reconstruction

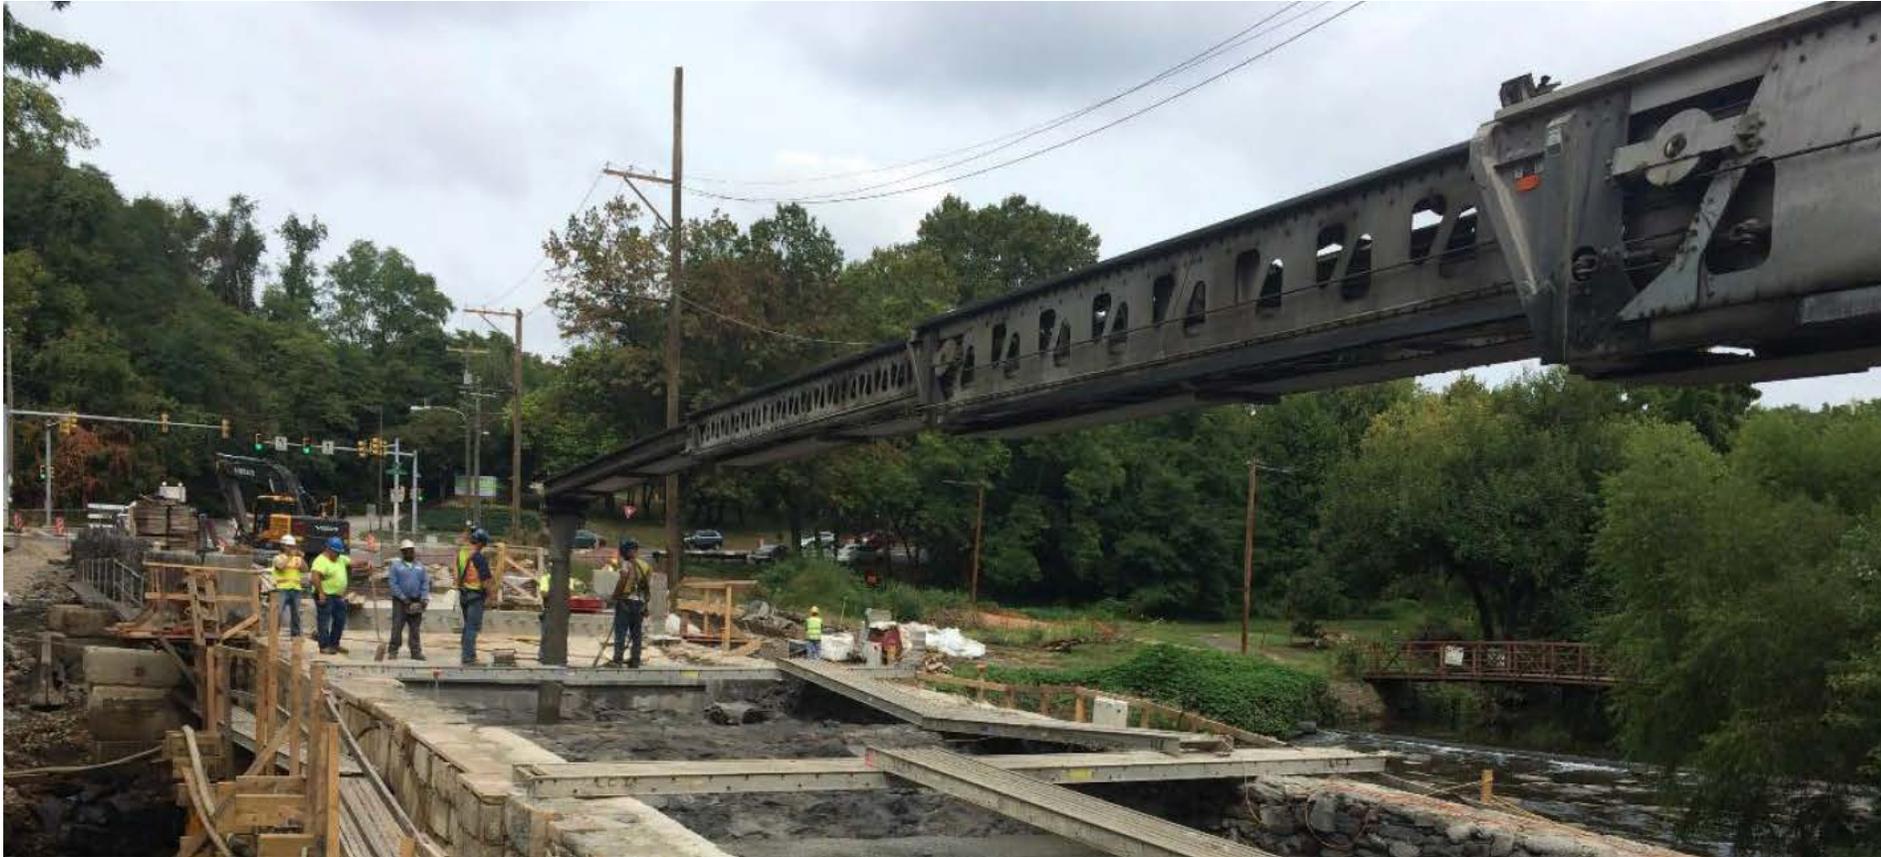
Lightweight concrete fill Install

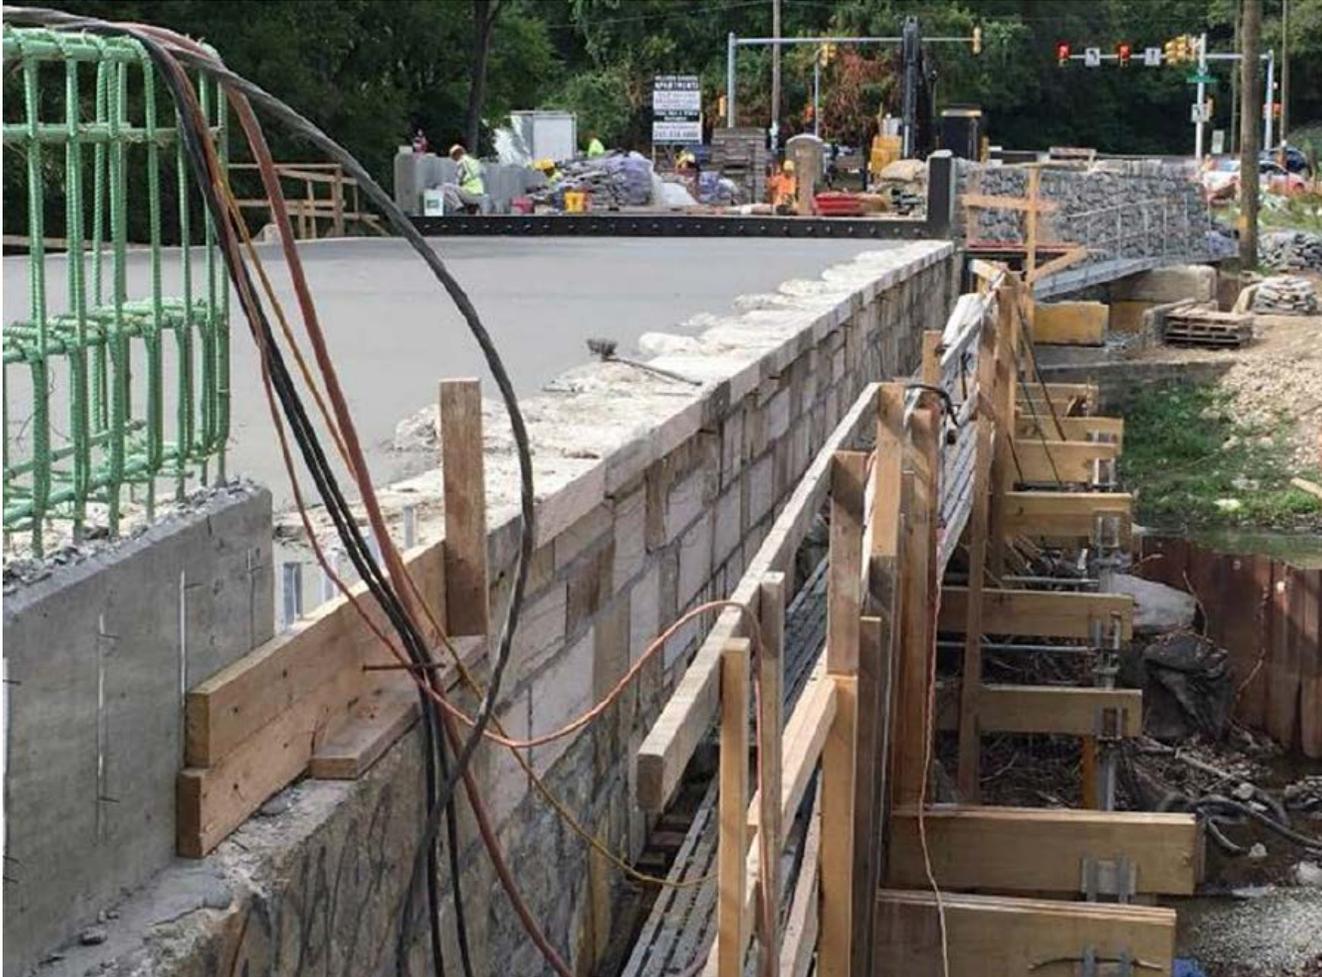
Lightweight Concrete Fill, Belt Course and Spandrel Wall

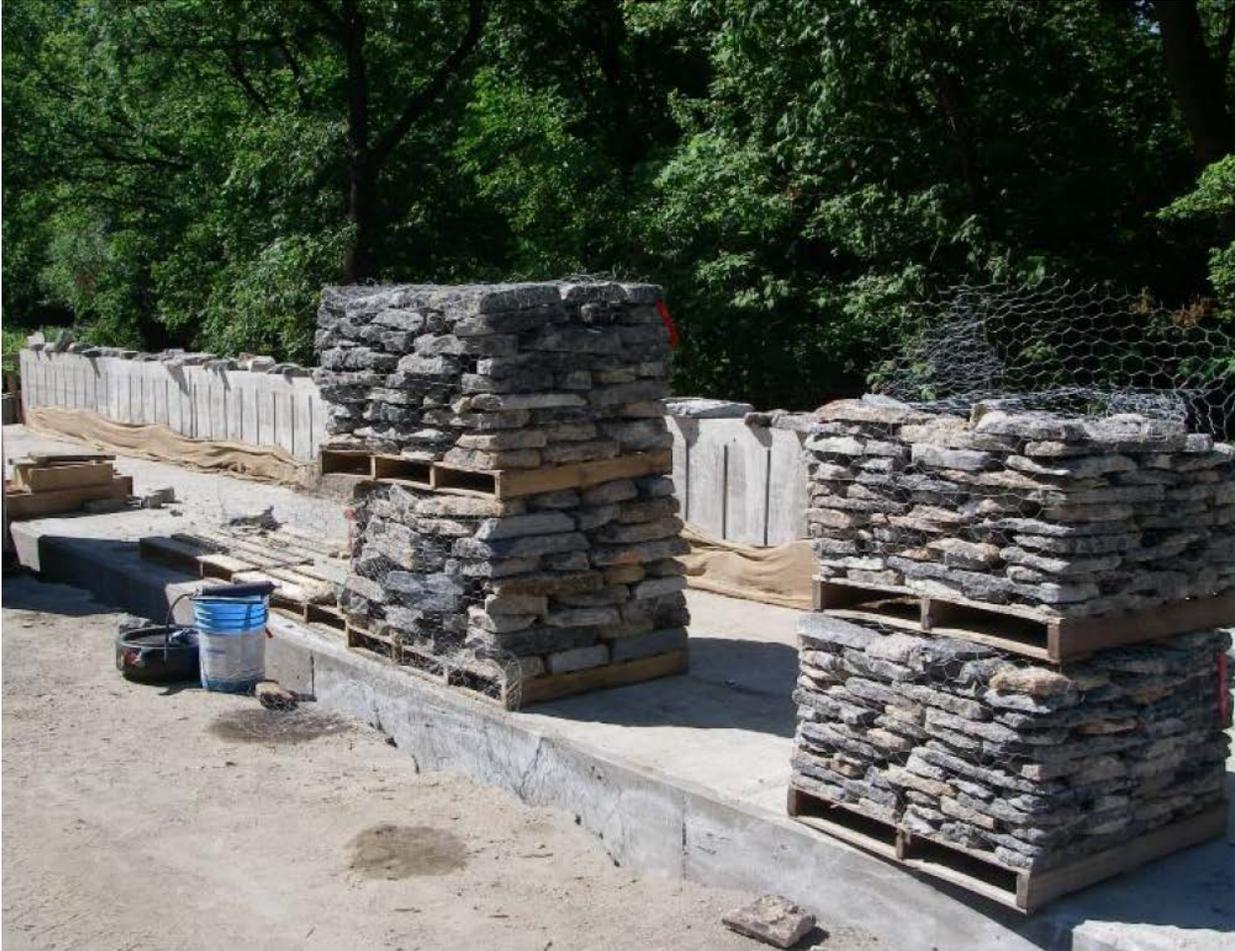
Salvaged Existing Stone for Facing

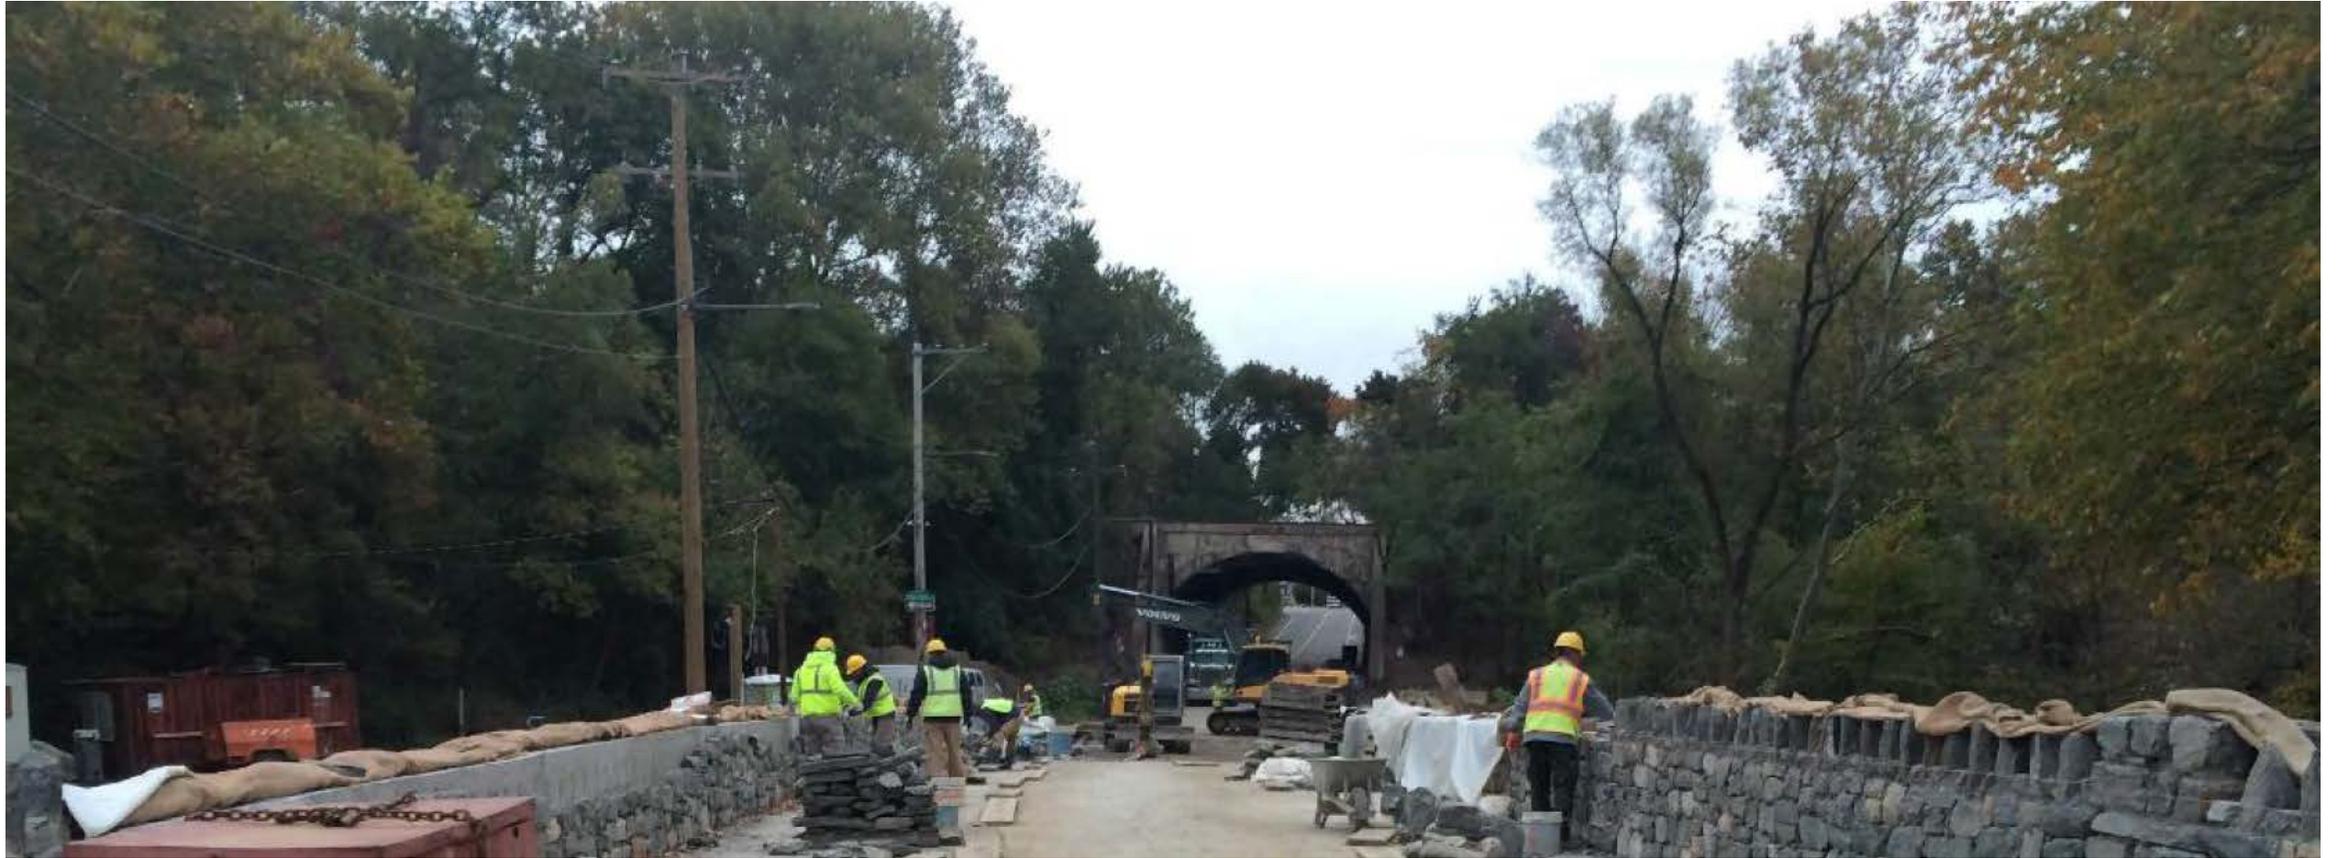
Moment Slab and Concrete Core with Stone Facing during Construction

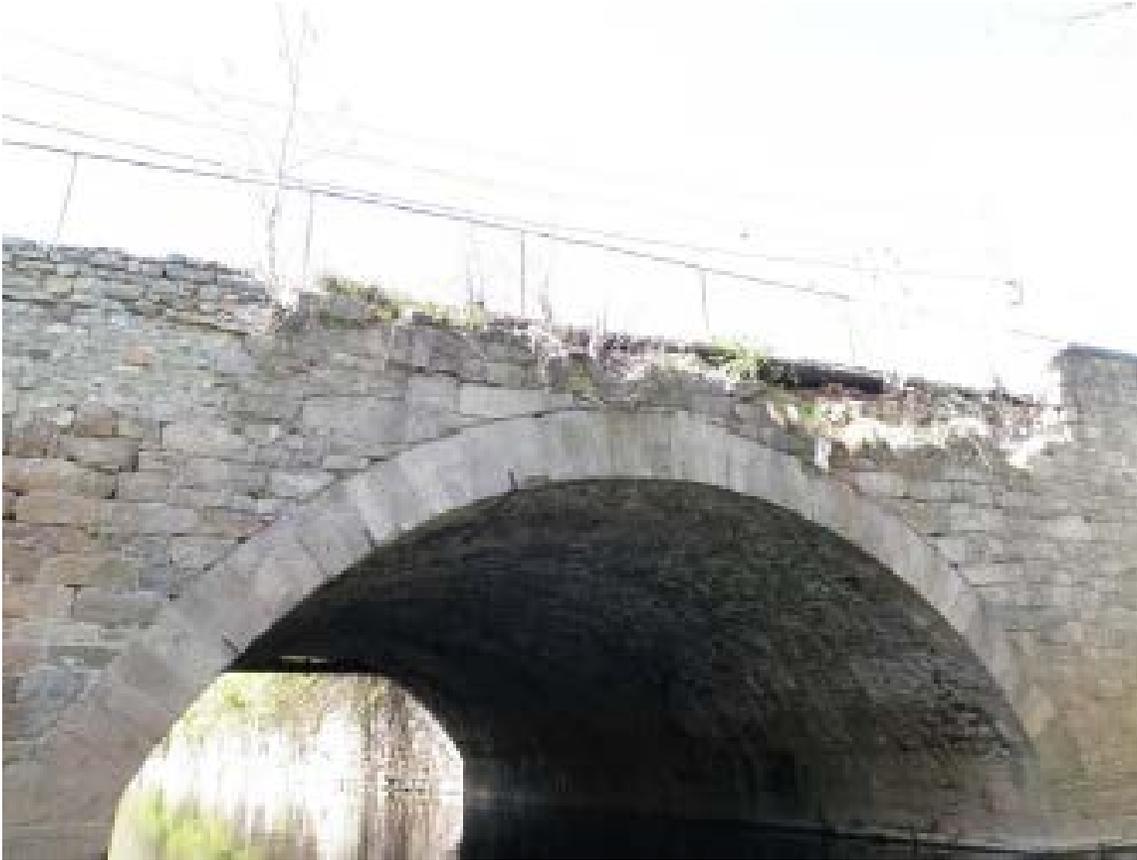
Approximately 80 LF of capstone was missing on north parapet due to partial collapse of the parapet into the creek.

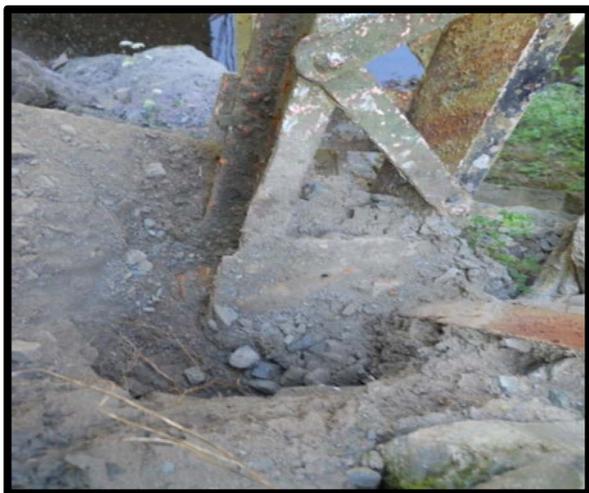
Truss Bearing Covered with Dirt and Debris

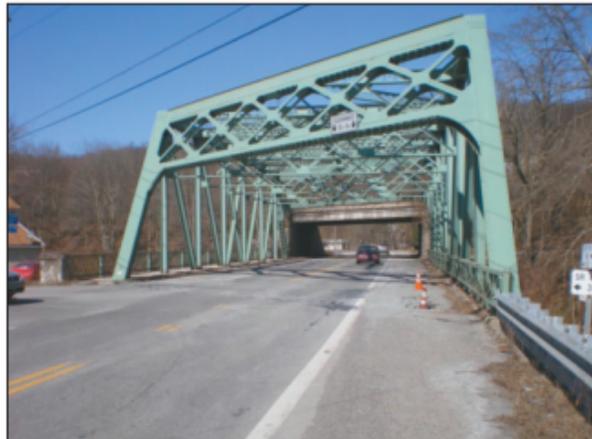
Steel Stringer End Connection

Stringer Support Bracket

PennDOT District 12-0
Westmoreland County
S.R. 993 over Brush Creek
Single span thru truss bridge, stringer ends repaired by installing steel support bracket. Rehabilitation performed to avoid a weight limit posting.

(1) Original design would repair deficient stringers at 5 locations and reduce the bridge's effective width. This design did not consider that this would prevent access to the bridge from a private business with a driveway adjacent to the bridge.

(2) Maintenance forces proposed 4 additional locations to avoid reducing the bridge width. Additional expense and time was minimal and provided a reasonable and cost effective solution.

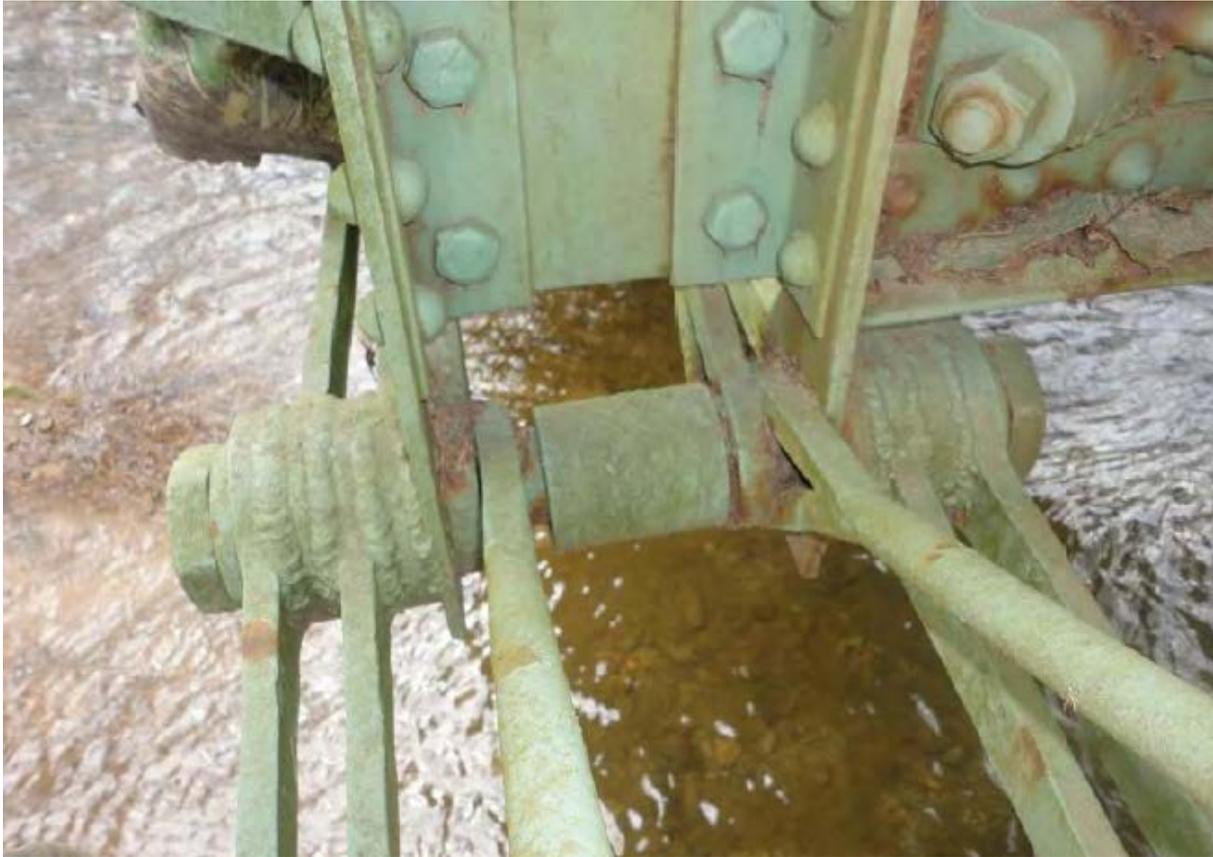
Welding of pinned connections

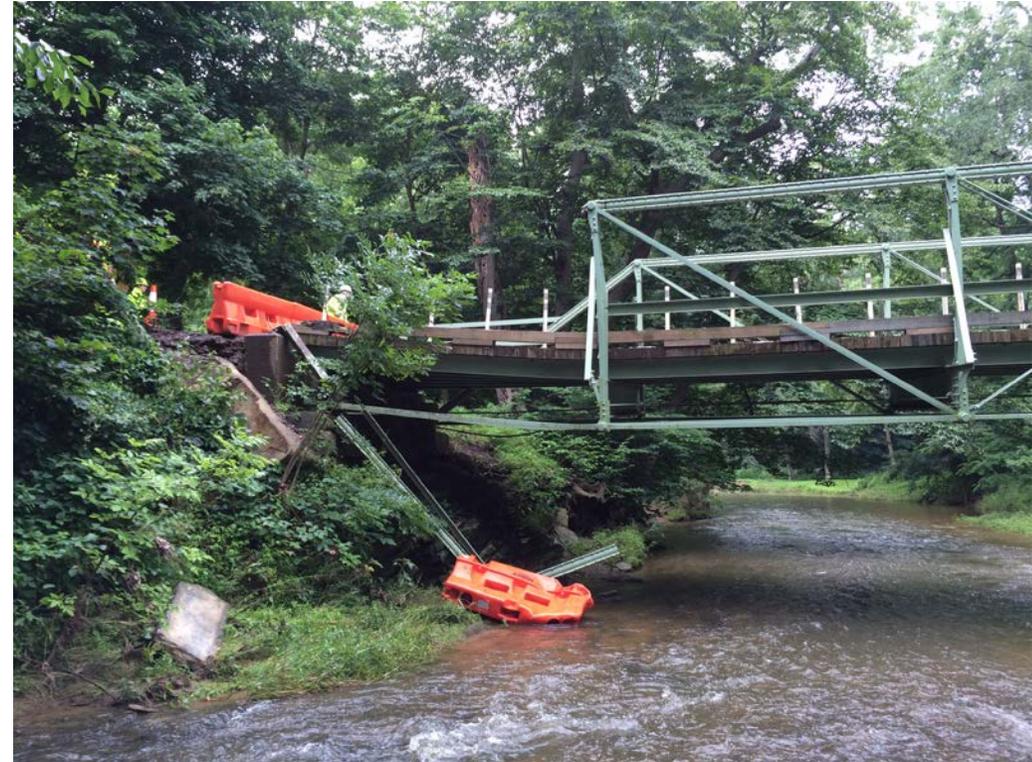
Bridge closed on July 1, 2015, when the upstream truss of the bridge was struck by a truck. The impact resulted in complete fracture of the upstream truss upper chord east end post and partial failure of the bridge.

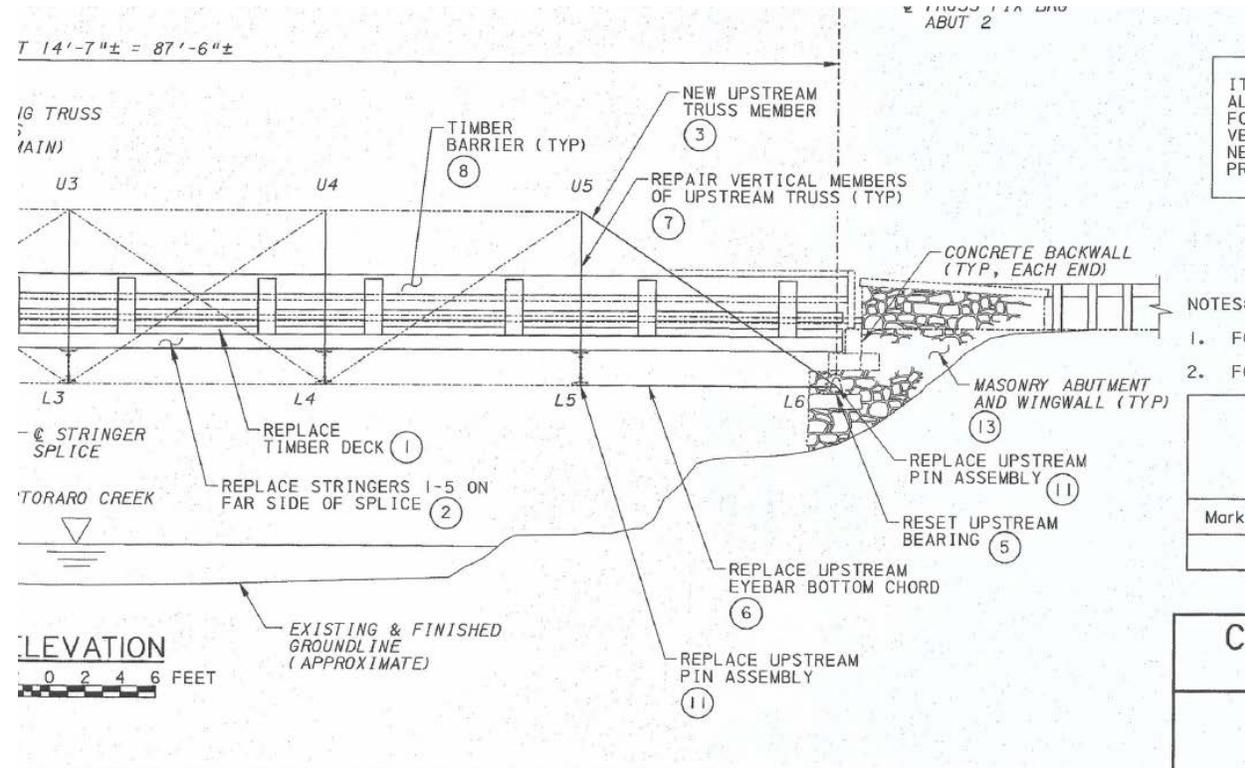
Replace timber deck.

Replace Stringers 1-5.

Replace top chord U5-L6 on upstream truss.

Replace bottom chord L5-L6 on upstream truss.

Reset bearing for upstream truss.

Replace existing timber curb w/timber
barrier.

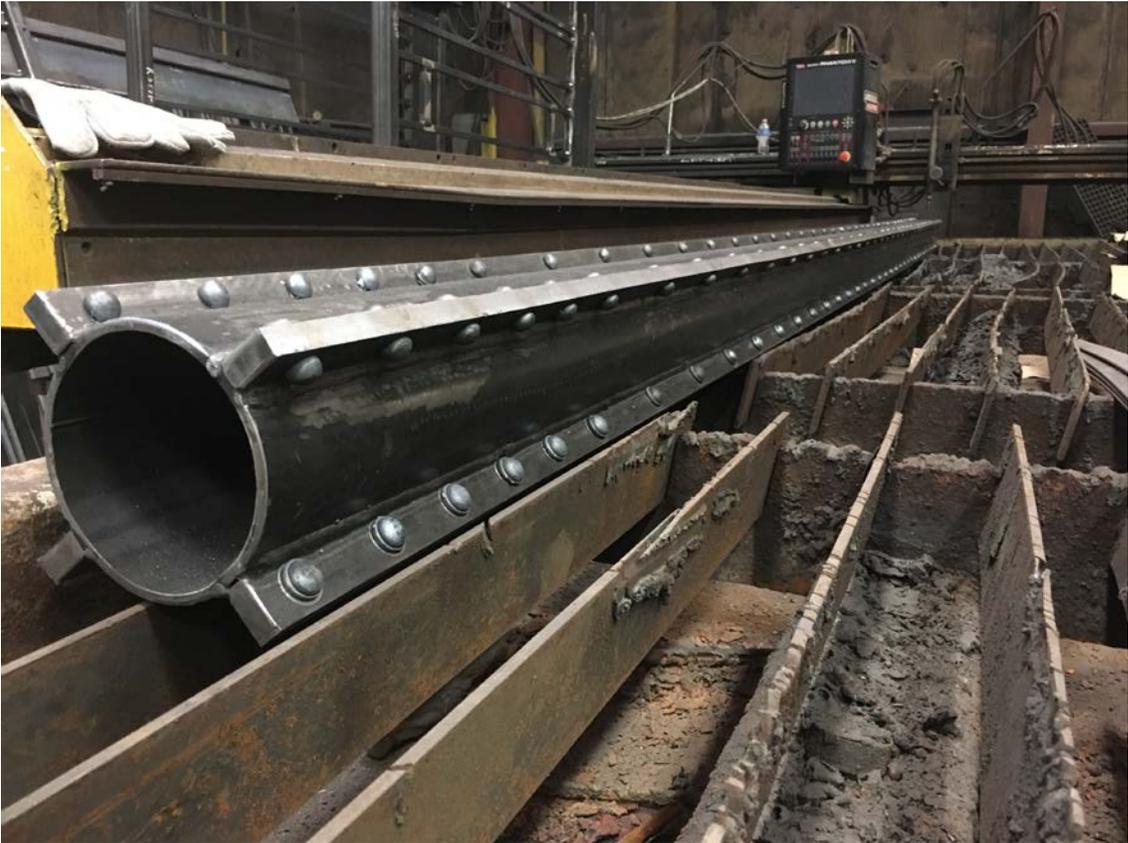
Replicating character defining features – Phoenix Column Section

Ross Fording Road Bridge SR 3052

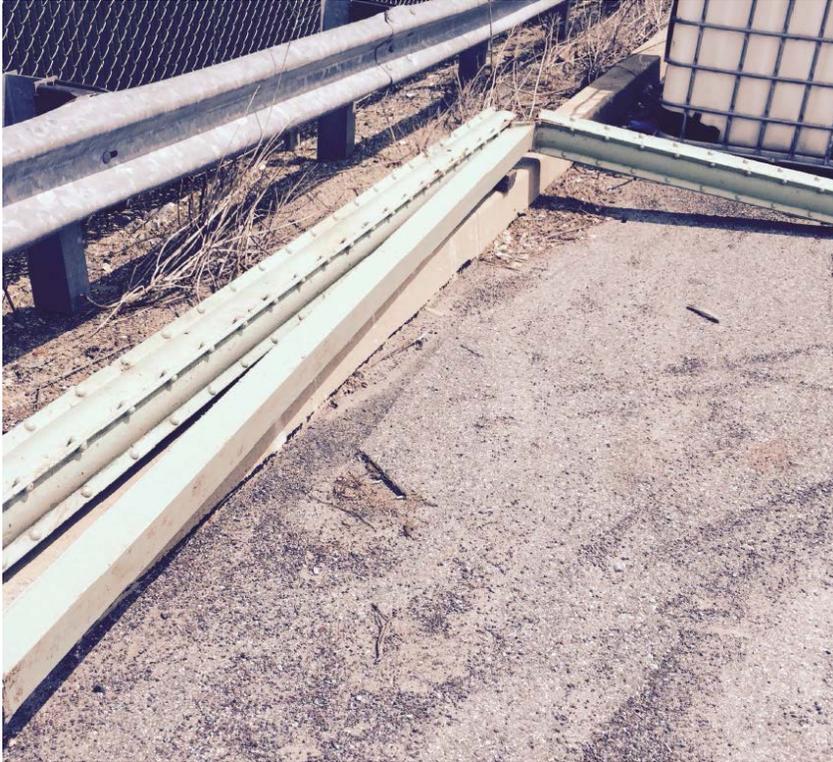
Phoenix Column storage – proper storage of significant character defining feature.

After vehicle impact Chester County Maintenance indicated they would save fractured truss section, however it was lost and scraped at the Chester County Maintenance yard.

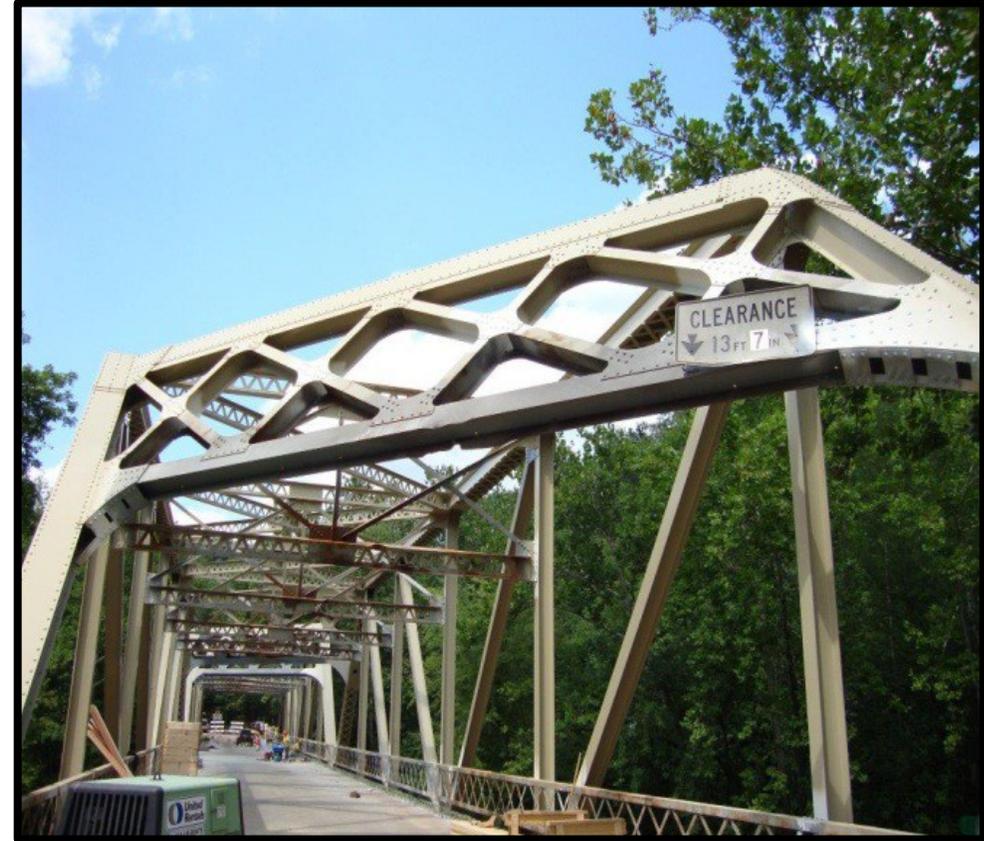
Substandard Vertical Clearance with Portals and Bracing Existing Collision Damage
