Appropriate Treatments and Techniques for the Maintenance and Rehabilitation of Historic Bridges

PennDOT District 6-0, April 24, 2018

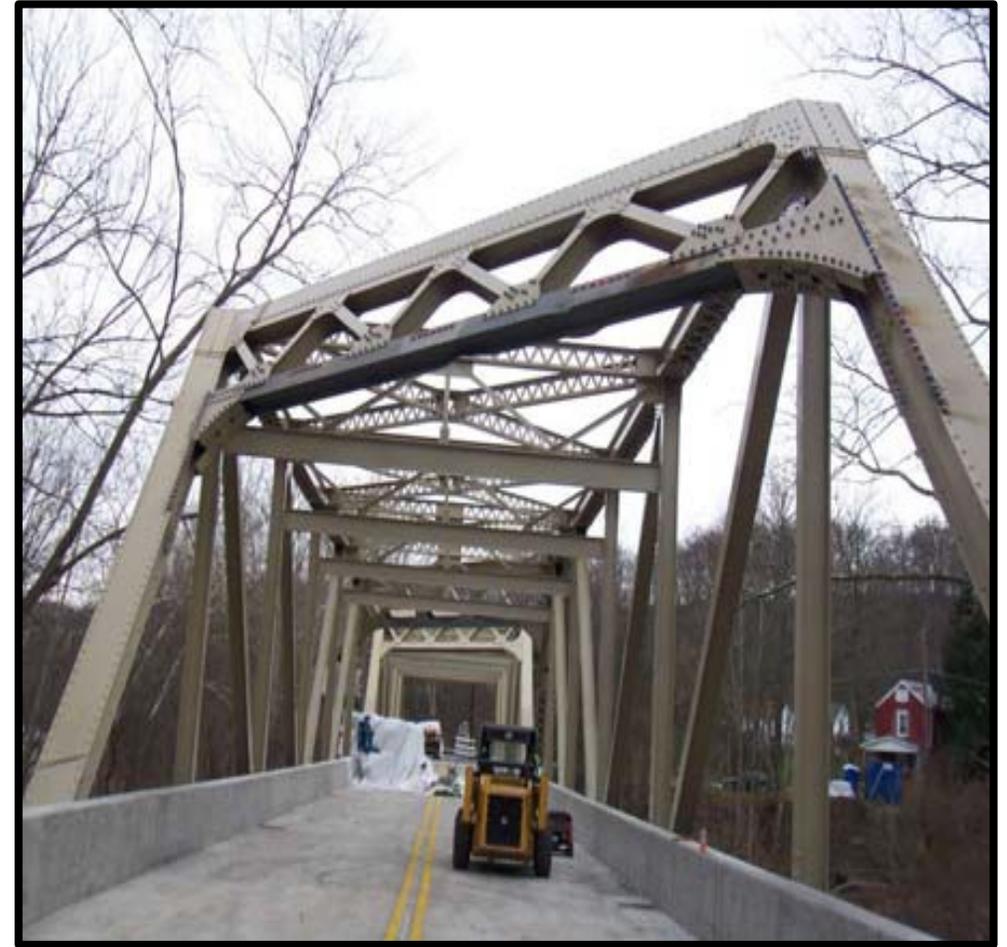
Modified Portal and Sway Bracing System Modified
