Assessing the Presence and Potential
Habitat for Reintroduction of Priority
Freshwater Mussel Species in the
Shenango River

FINAL REPORT

U. S. Geological Survey
Kearneysville, WV 25430

COMMONWEALTH OF PENNSYLVANIA
DEPARTMENT OF TRANSPORTATION

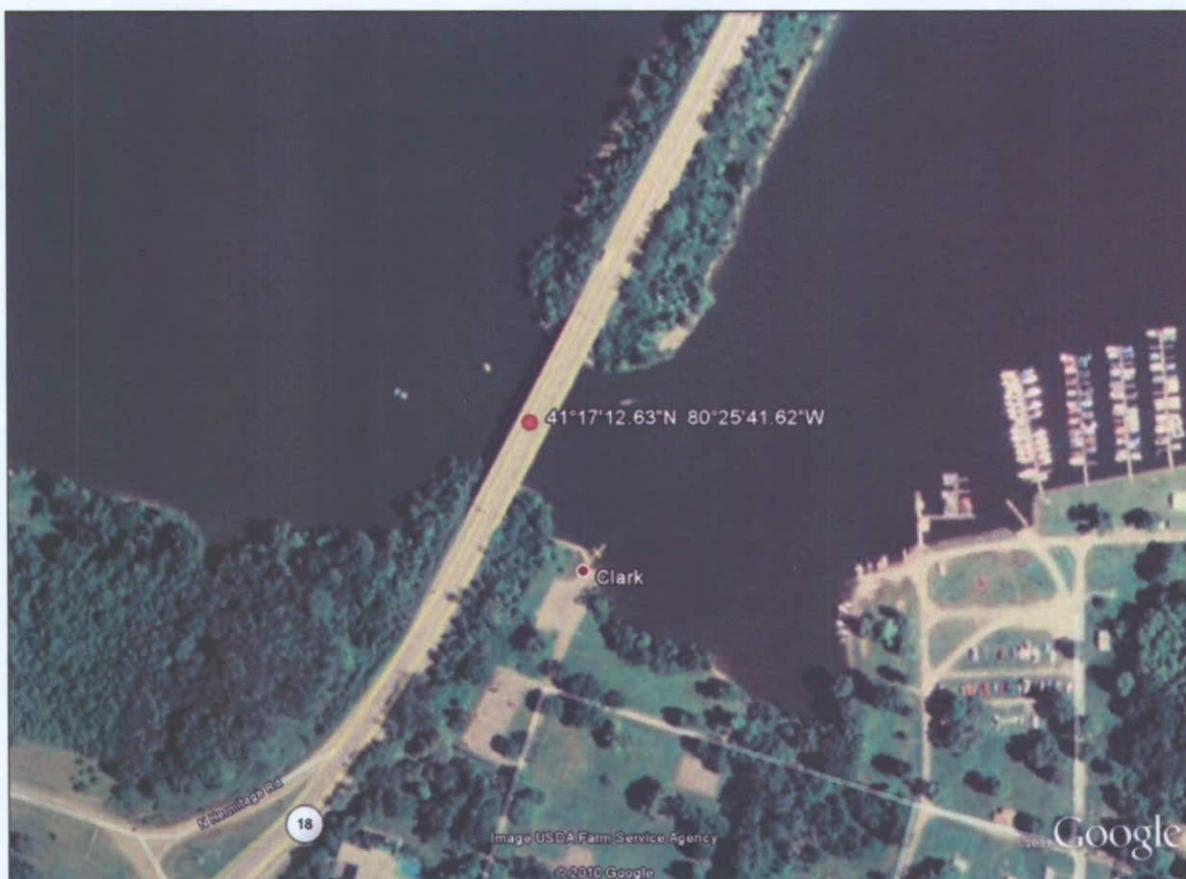
Figure 4. State Route 0018 location in red with coordinates.

State Route 18 spans a narrow section of the Shenango River Lake. It is situated between the primary boat launching area and a large marina. The shorelines have been reinforced with large boulder rip-rap. Directly beneath the bridge a no wake ordinance is enforced. Both banks are steep at the water's edge and water depth is over 6 meters deep less than 5 meters from either shore. The main channel is deeper to allow for boat traffic to pass through safely. Most mussels prefer shallower water therefore, given the depth at the bridge, a typical snorkel survey was not conducted. Instead a small, hand-deployed dredge was used to take random samples of the lake bottom throughout the channel. Samples were taken to just short of the buoys marking the no wake zone which are approximately 15 meters from the bridge's center line. No live animals or shell material was found.

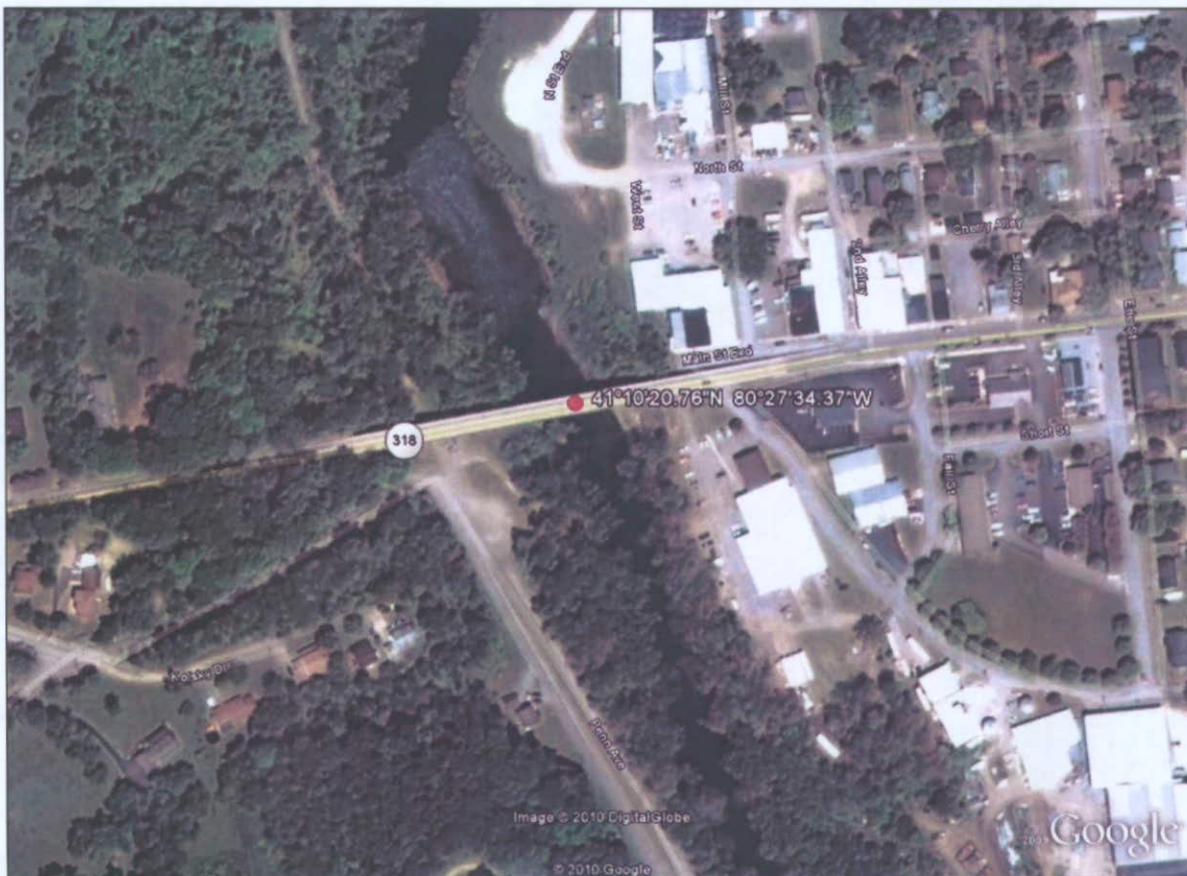
Figure 6. State Route 0318 Bridge location in red with coordinates.

State Route 318 is locally known as Buckeye Drive and is located in West Middlesex. The right descending bank is the steeper of the 2 shorelines with large cobble and boulder substrate. The majority of the flow is confined to this side. The channel is bowl shaped with the deepest portion, 1.5 meters, found in the mid-channel. Downed trees and woody debris have collected in the silt substrate found in the mid-channel. The left descending bank is less steep and made up almost entirely of silt and organic material. The water, when the survey was conducted, was turbid and visibility reduced significantly. Three mussels were found during the survey which extended 20 meters in either direction from the center line. One *Lampsilis siliquoides* (fatmucket) was found on the right descending bank under the bridge where a small stream enters the river. On the left descending side and just below the bridge a *Lampsilis radiata* (eastern lampmussel) was collected. An *Amblema plicata* (threeridge) was found slightly above the bridge on the same side. None of the species found are listed federally or by Pennsylvania.
