## **BRIDGE RAIL ANALYSIS AND CRASH TESTING**

Contract No. P2004010-PDOT (430137)  
Report/Test No. 401301-2  
Test Date: April 2, 2007

Sponsored by  
**Pennsylvania Department of Transportation**

**TEXAS TRANSPORTATION INSTITUTE  
THE TEXAS A&M UNIVERSITY SYSTEM  
COLLEGE STATION, TEXAS 77843**

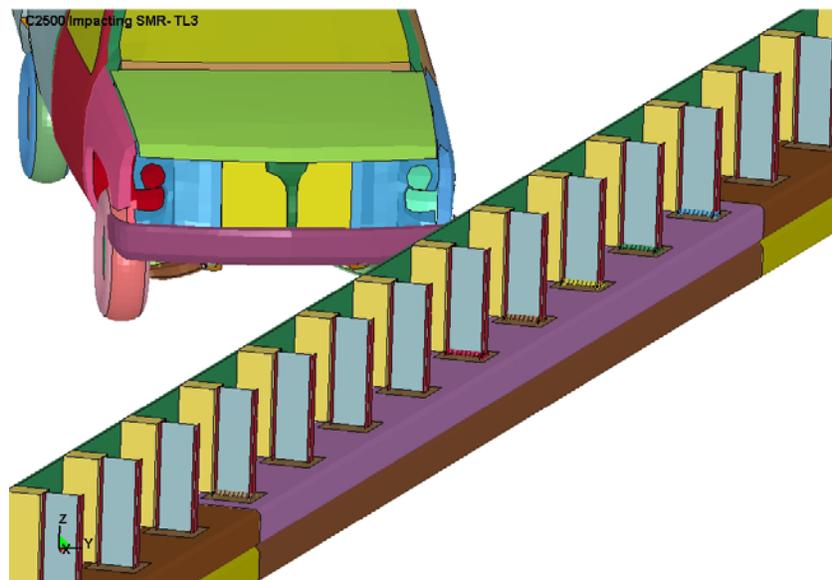
The rail, posts, rub-rail, deck, steel reinforcement and connections were modeled. The model was constructed using 281,336 nodes and 241,196 elements. The system model had 23 different components. Different parts were modeled explicitly, including the curb, deck, reinforcement, anchor bolts, posts, base plates, blockouts, W-beam rail, rub-rail and connections. Material properties were assigned to each part based on available tests and/or data from the literature. Contacts were also defined to account for inter-part interactions to simulate physical contact among the parts. The different colors of the model represent different parts of the rail and the truck as shown figure 1. The outer ends of the deck and the curb sections were assumed rigid to reduce computational time. However, the middle section of the curb and the deck (impact region) was assigned deformable material behavior with embedded reinforcements.

Figure 1. Model representation.

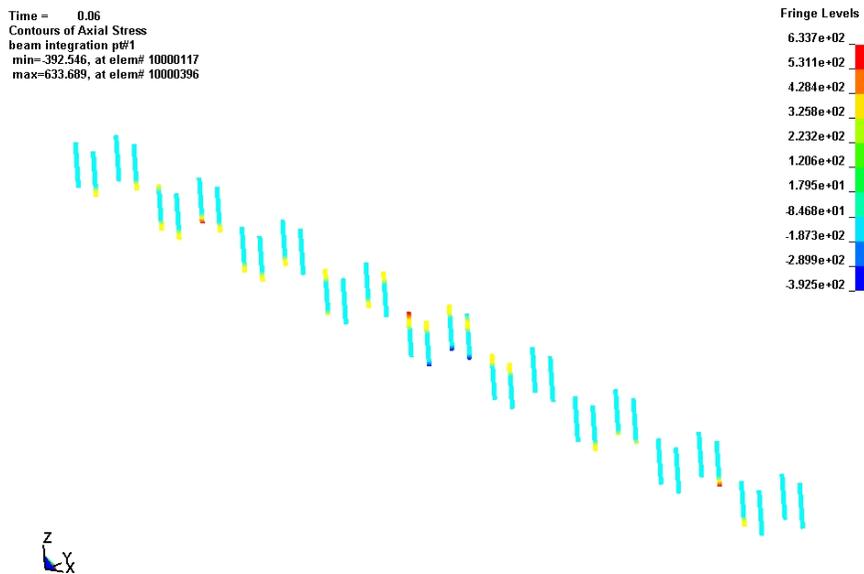
Once the simulation was completed, several variables were post-processed to evaluate the bridge rail performance under these impact conditions. The threshold for a 7/8 inch A325 anchor bolts is 90 ksi (yield) and 120 ksi (ultimate). In the simulation, the axial stress in the anchor bolts reached its peak value at 0.06 seconds. The analysis indicated a few spots would reach a maximum axial stress of 91.8 ksi (633.7 MPa). Although this value is slightly above the yield point, it was limited in terms of its distribution along the bolts and its duration. This indicated a low probability of yielding of the anchor bolts. Figure 2 shows an overall distribution of bolt stresses at 0.06 second after impact.

Figure 2. Axial stress in the anchor bolts.

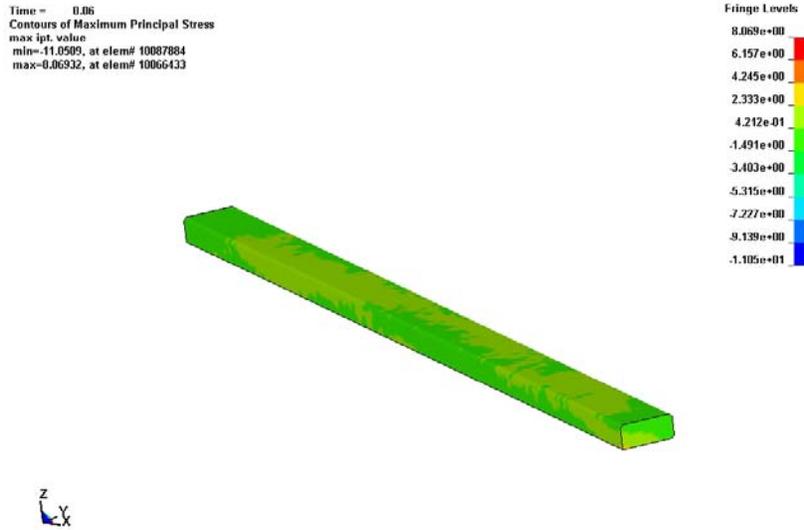
The tensile stress state in the concrete curb and deck was also examined. Figure 3 shows the contour of the maximum principle stress which is an indicator of the state of tensile stresses in the curb. Concrete can develop cracking and fracture under very low tensile stresses. For the concrete specified, a maximum of 8 MPa was reached at a point in the end corners. These end values are due to the boundary condition approximation used to model continuity of the rail. The mean value is approximately 337 psi (2.33 MPa). This is less than the estimate splitting tensile strength of 443 psi obtained using the formula:  $f_{split} = 7\sqrt{fc'}$ , where  $fc'$  is the concrete compressive strength which is 4000 psi.

Figure 3. Contour of maximum principle stress in the curb.

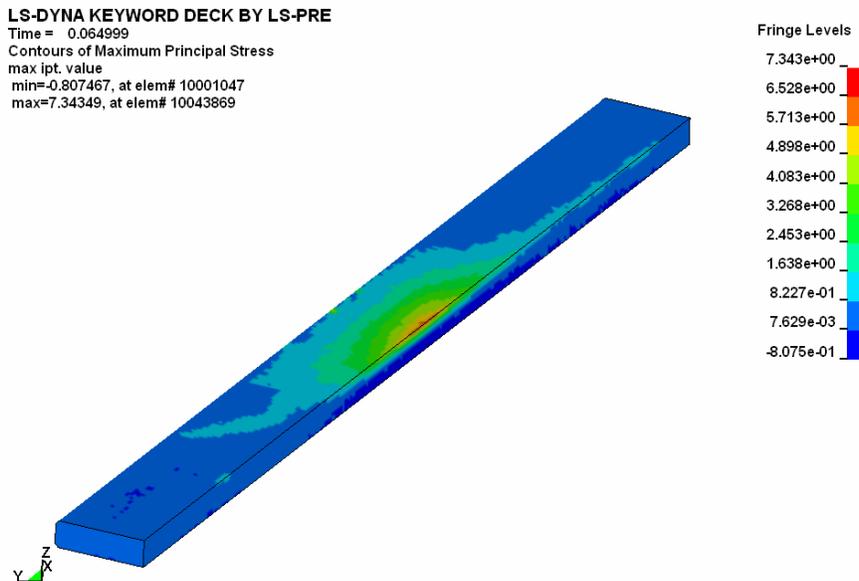
Similarly, figure 4 shows maximum principal stress fringe which is an indicator of the tensile stresses in the deck. These stresses were highest in magnitude at 0.065 sec. The tensile stresses are indicators of the probability of cracks or fracture. A maximum of 1,064 psi (7.34 MPa) in the middle of the top traffic side edge of the deck was reached, which is more than the estimated splitting strength of 443 psi. However, this edge is artificially constrained by boundary conditions to represent the continuation of the deck, and the maximum stress occurs in a very limited area. This means that the deck has a low probability of having cracking if this loading condition is achieved.

Figure 4. Maximum principle stress in the deck.

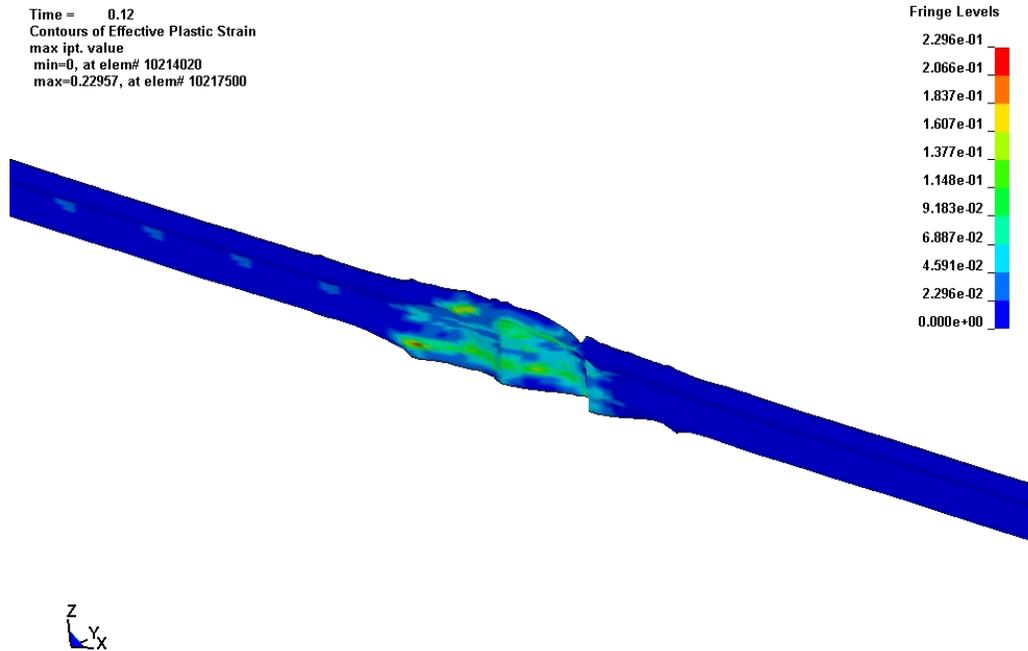
Figure 5. Rail rupture at 0.12 sec.

Strain in the W-beam rail element was also analyzed. The simulation indicated that the rail elements in the barrier exhibit pronounced pocketing and a high probability of tearing or rupture in-between posts in the impact region. Two indicators were used to predict this mode of failure. First, the plastic strain in the rail reached the ultimate true strain of the W-beam steel in the impact region of the rail. Secondly, the development of rail pockets in the impact region will increase the probability of rail tearing or rail rupture. Rail rupture and/or severe vehicle snagging was estimated to occur at 0.12 sec due to the pocketing profile and effective plastic strain as shown in figure 5. The maximum ductility specified in the AASHTO M-180 material specification for the W-beam rail is 12%. Testing of W-beam rails commonly results in rupture strains of 18% to 25%.

Based on the results from the simulation effort, it was concluded that the original Structure Mounted Guide Rail design with posts spaced at 1 ft-6-3/4 inches on center using a single W-beam rail element would exhibit poor crash performance with respect to *NCHRP Report 350* TL-3 requirements. The strength of the rail was increased by adding two TS4x3x3/16 tube members behind the W-beam rail member. In addition the C6x8.2 rub-rail was blocked out to closely match the original Structure Mounted Rail profile. With the addition of the tubular rail elements, the Structure Mounted Rail closely resembled the Texas Department of Transportation (TxDOT) Type T101 Bridge Rail. In addition, the post spacing for the Structure Mounted Rail was increased to 6 ft-3 inches like the T101 Bridge Rail. Details of the new SMR Bridge Rail design are presented in figures 6 through 14.

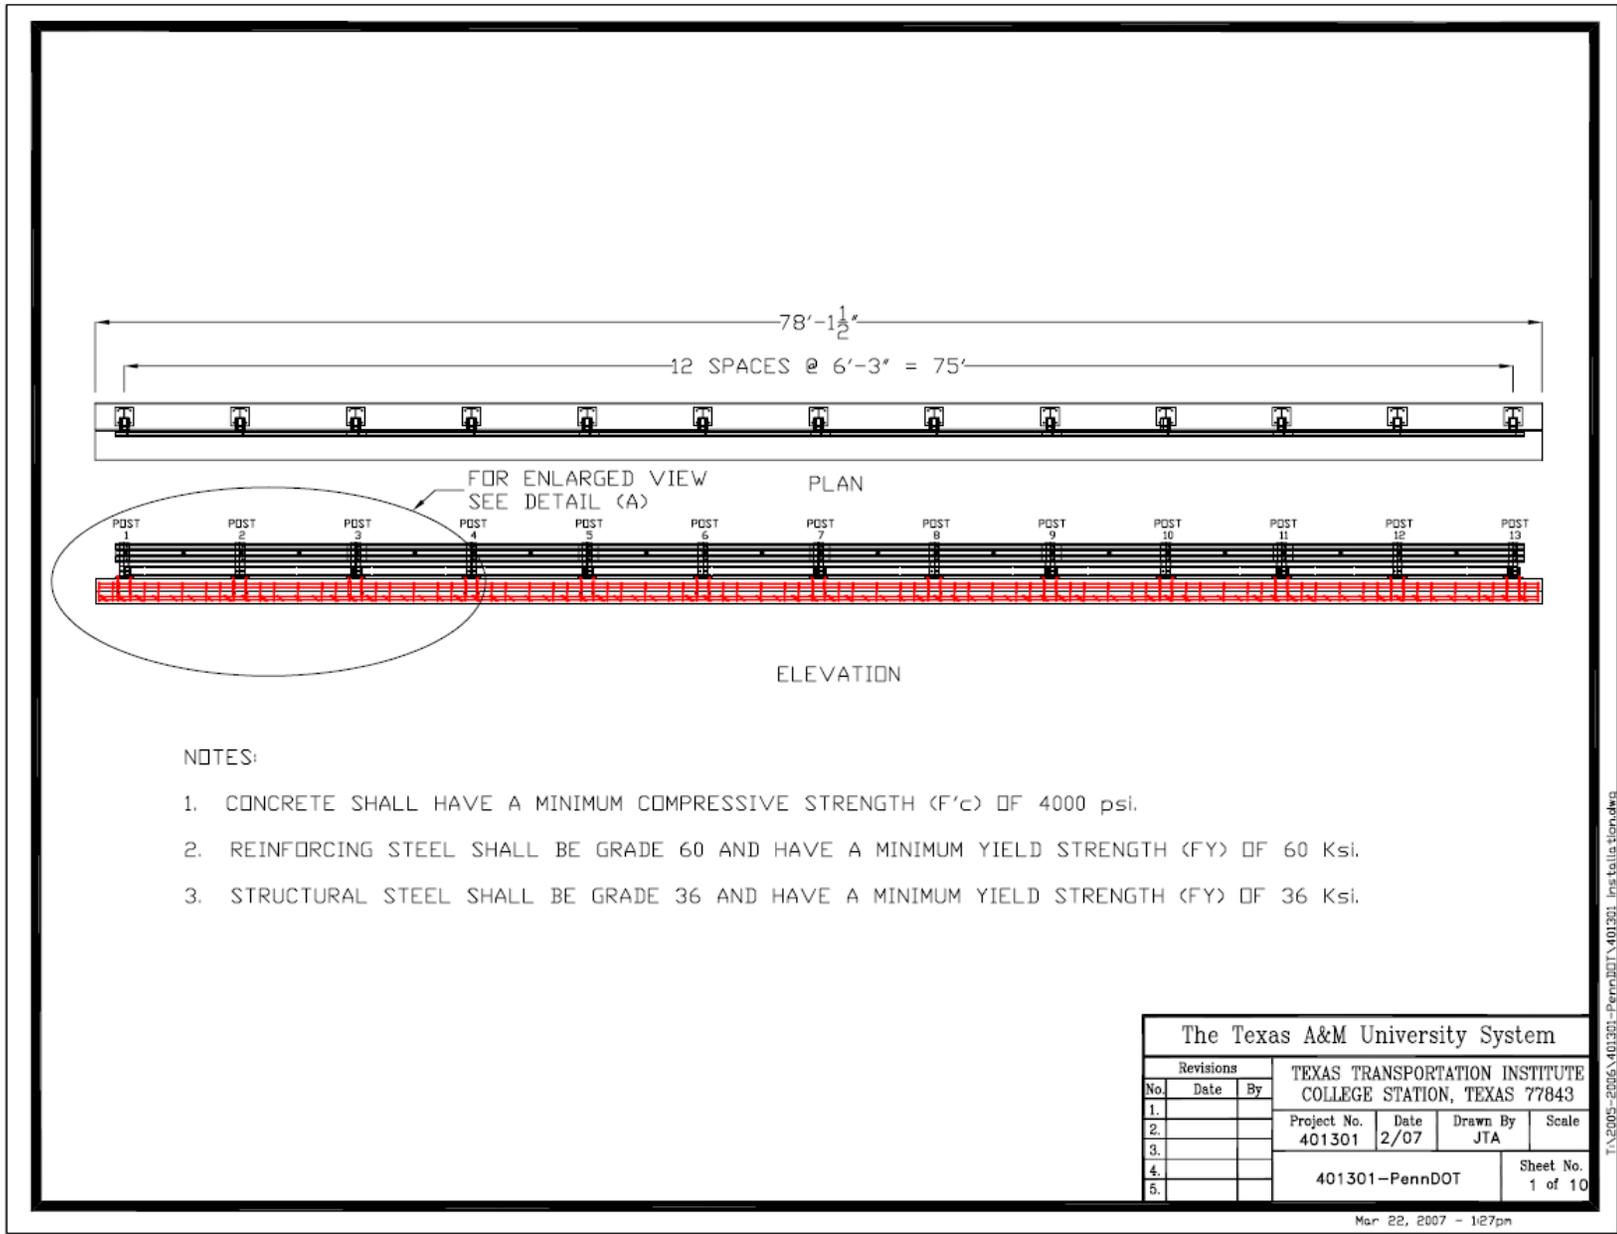
Figure 6. Layout of the PENNDOT Structure Mounted Guide Rail Barrier.

The modified SMR 2-Tube Bridge Rail tested for this project consisted of two TS4x3x3/16 (TS192x76x4.8) structural tubes with a w-beam rail element and a C6x8.2 (C150x12) channel rubrail. The total height of the bridge rail was approximately 31-3/8 inches (797 mm). Mid-height of the rubrail was approximately 13 inches (330 mm) above the pavement surface and was blocked out with TS7x3x1/4 (TS178x76x6.4) tubular blockouts that were 6 inches (150 mm) long. The steel posts were spaced 6 feet-3 inches (1905 mm) on centers and were fabricated from W6x20 (W150x30) structural shape. The bridge rails were attached to the posts using two 5/8 inch (16 mm) diameter A307 hex head bolts at each post location. The steel posts were welded to 12 inch (305 mm) by 12 inch (305 mm) by 1 inch (25 mm) thick base plates. The posts were anchored to the 8-inch (203 mm) high concrete curb and 8-1/2-inch (216 mm) thick deck using four 7/8-inch (22 mm) diameter ASTM A325 Anchor Bolts. These bolts were anchored to #6 (#19) Richmond Threaded Anchor (hook anchor) inserts cast within the deck. The tubular rails, w-beam and rubrail were blocked out from the steel posts using 6x6x22-1/4 (150x150x565) wood blockouts. For additional information on the bridge rail please refer to figures 6 through 14. The SMR 2-Tube Bridge Rail tested for this project was supplied to TTI by GSI Highway Products, Hutchins, Texas.

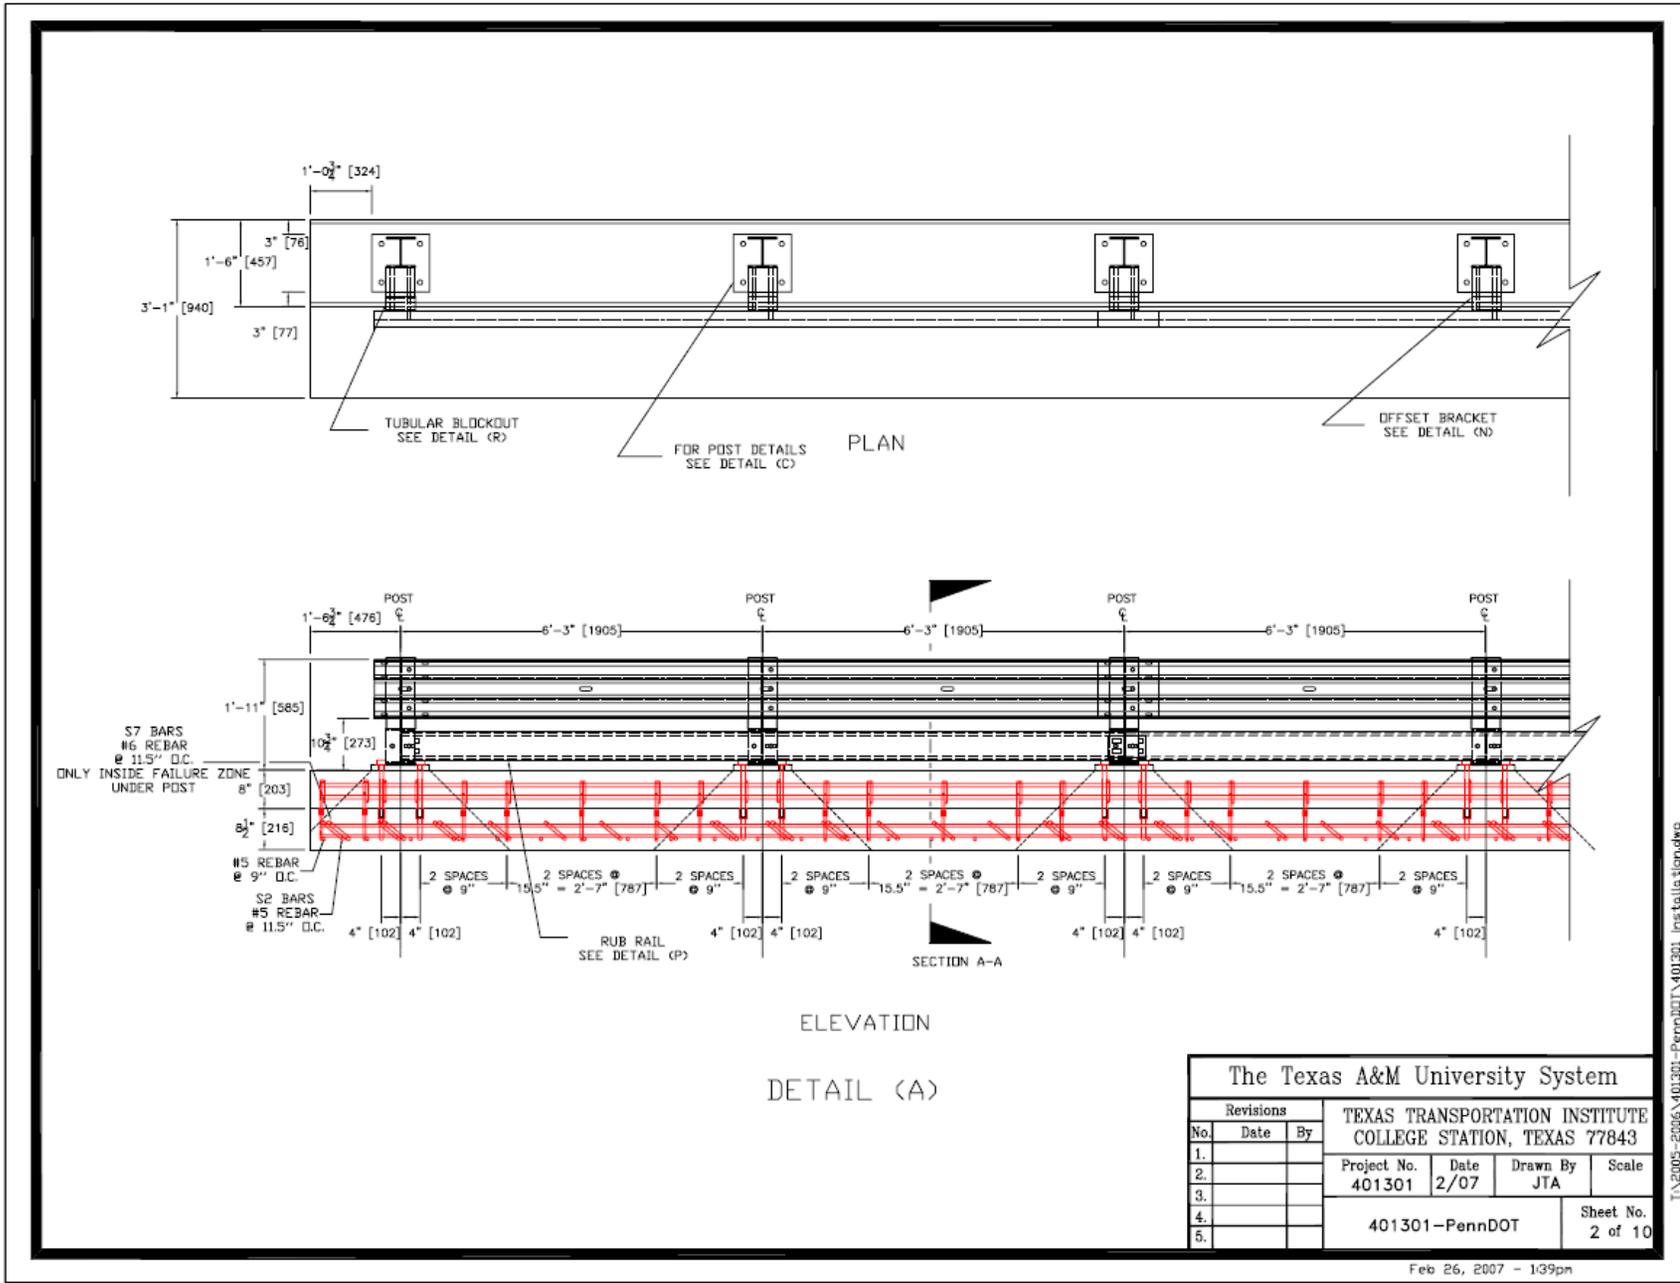
Figure 7. Details of test installation.

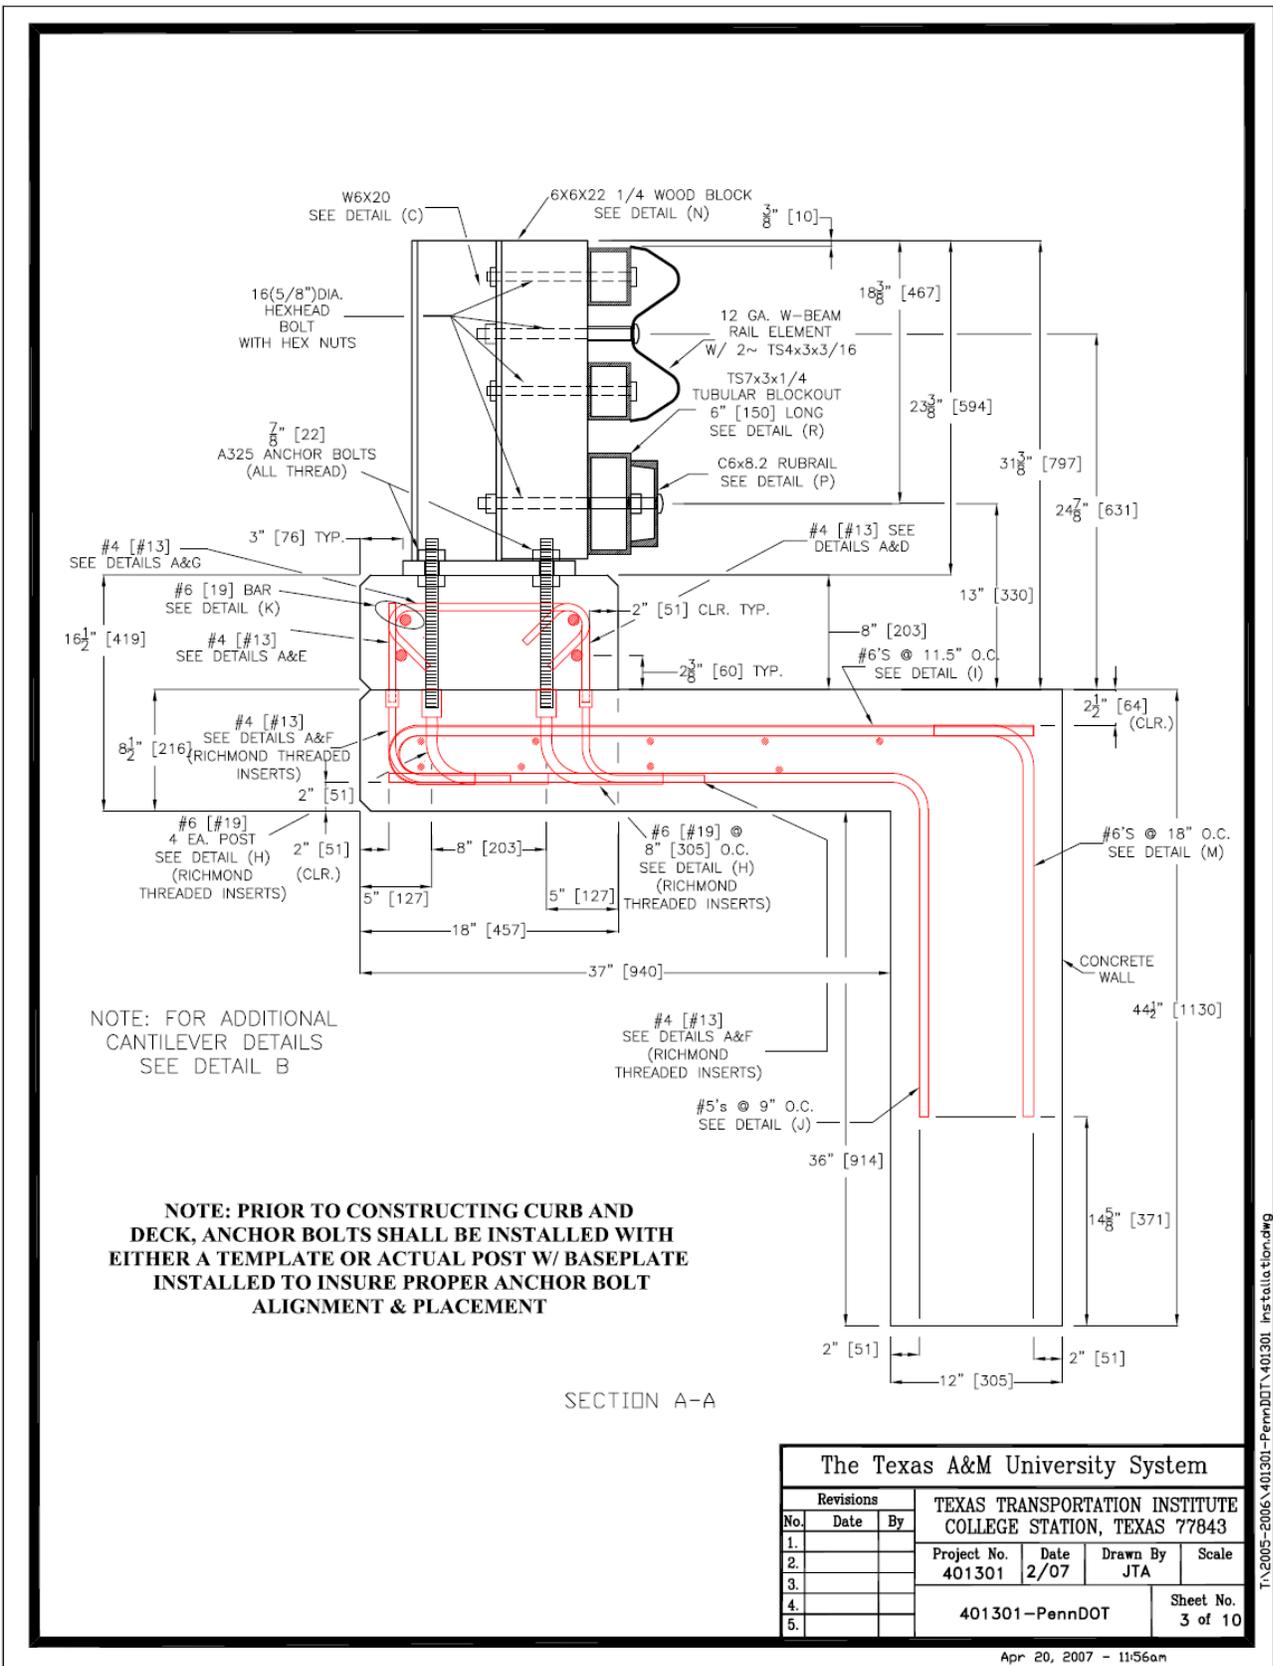
Figure 8. Cross section of the PENNDOT Structure Mounted Guide Rail Barrier.

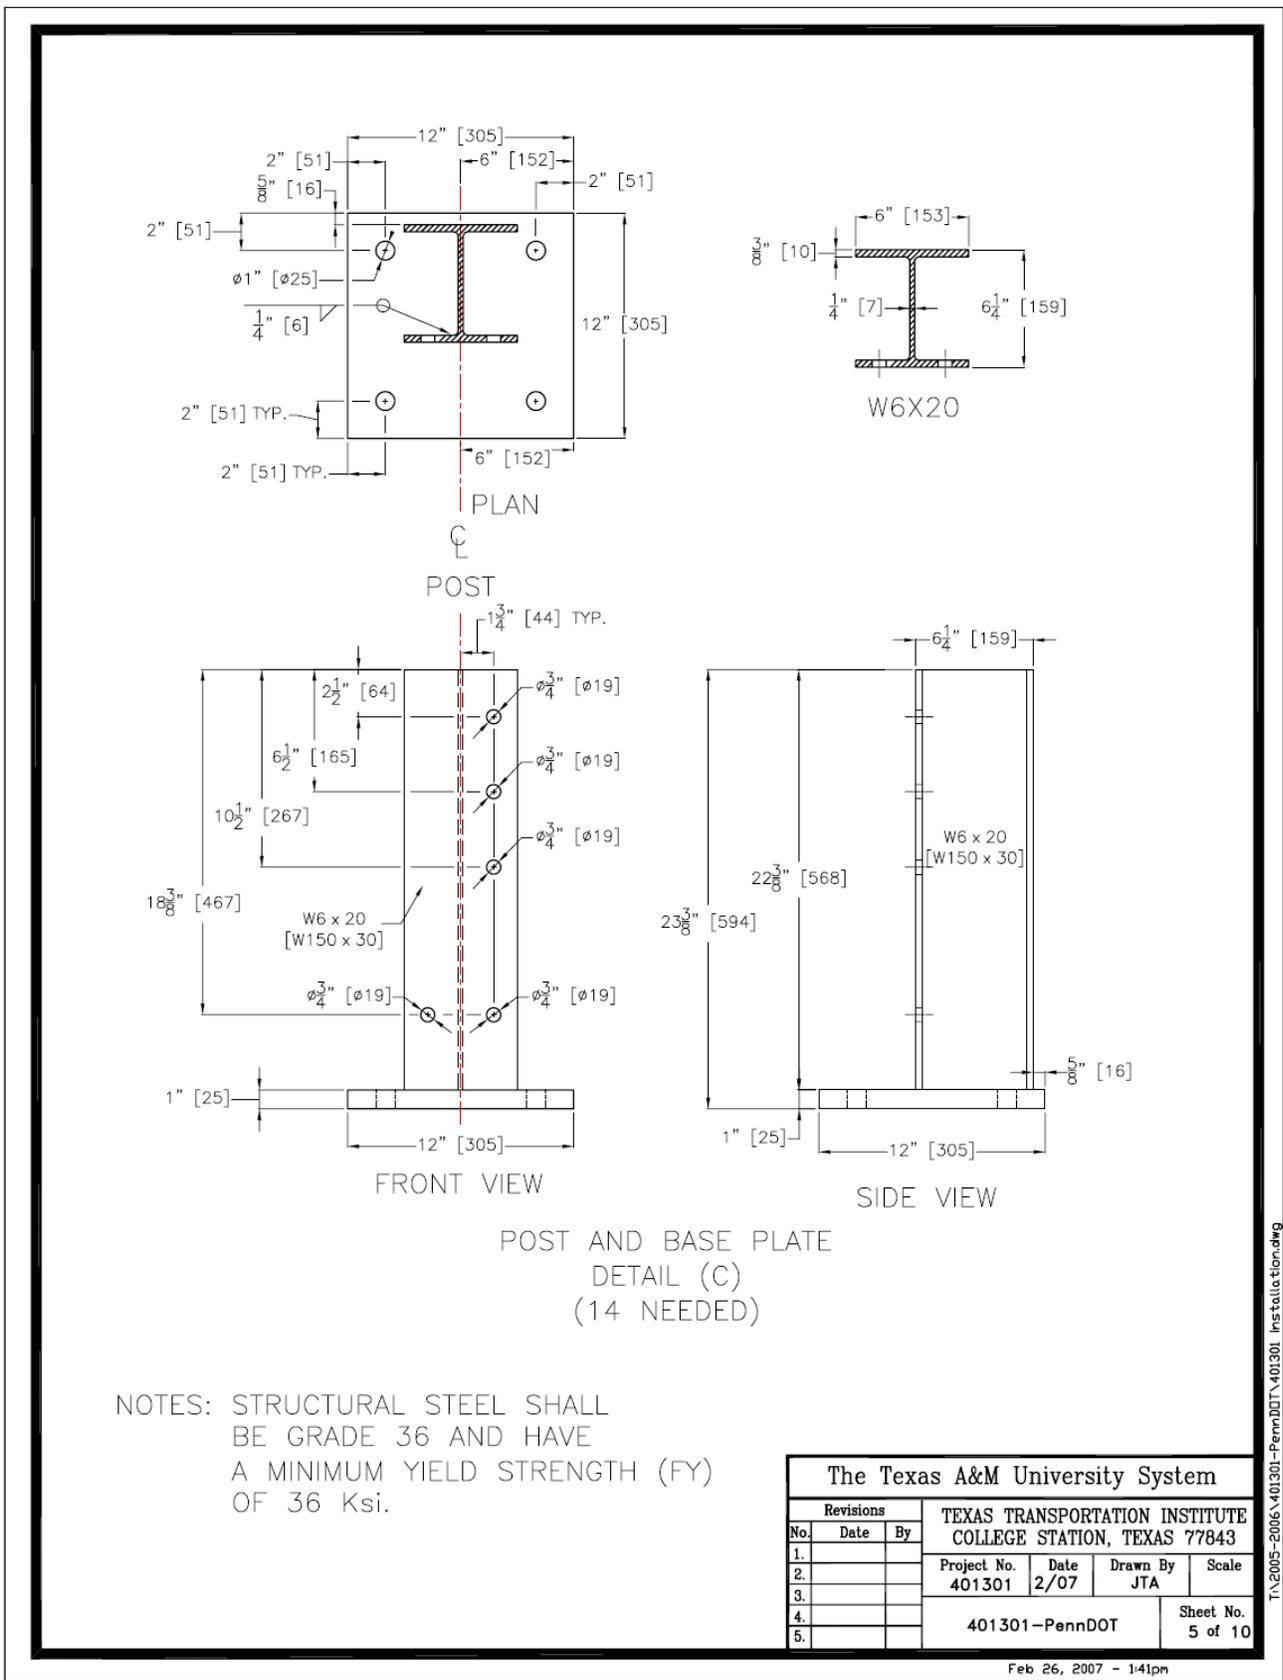
Figure 10. Details of the post and base plate.

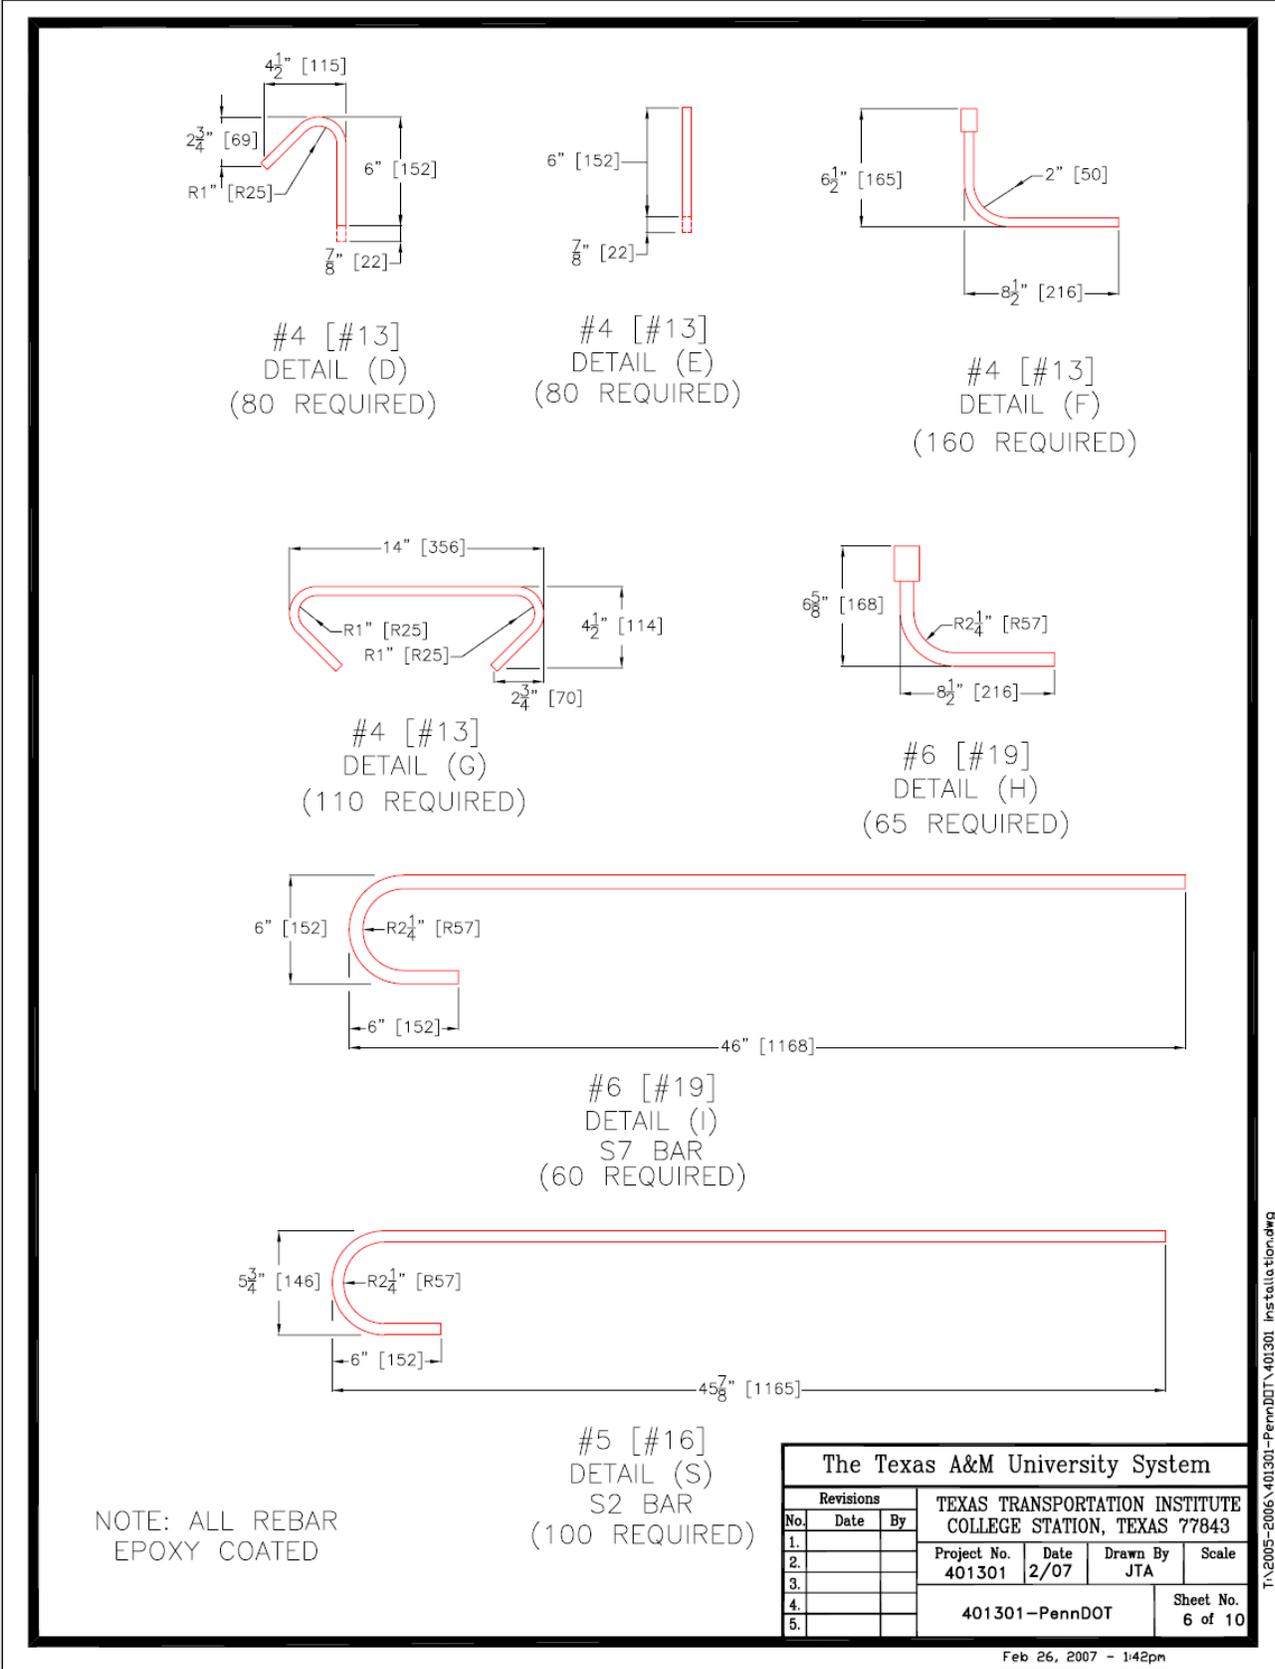
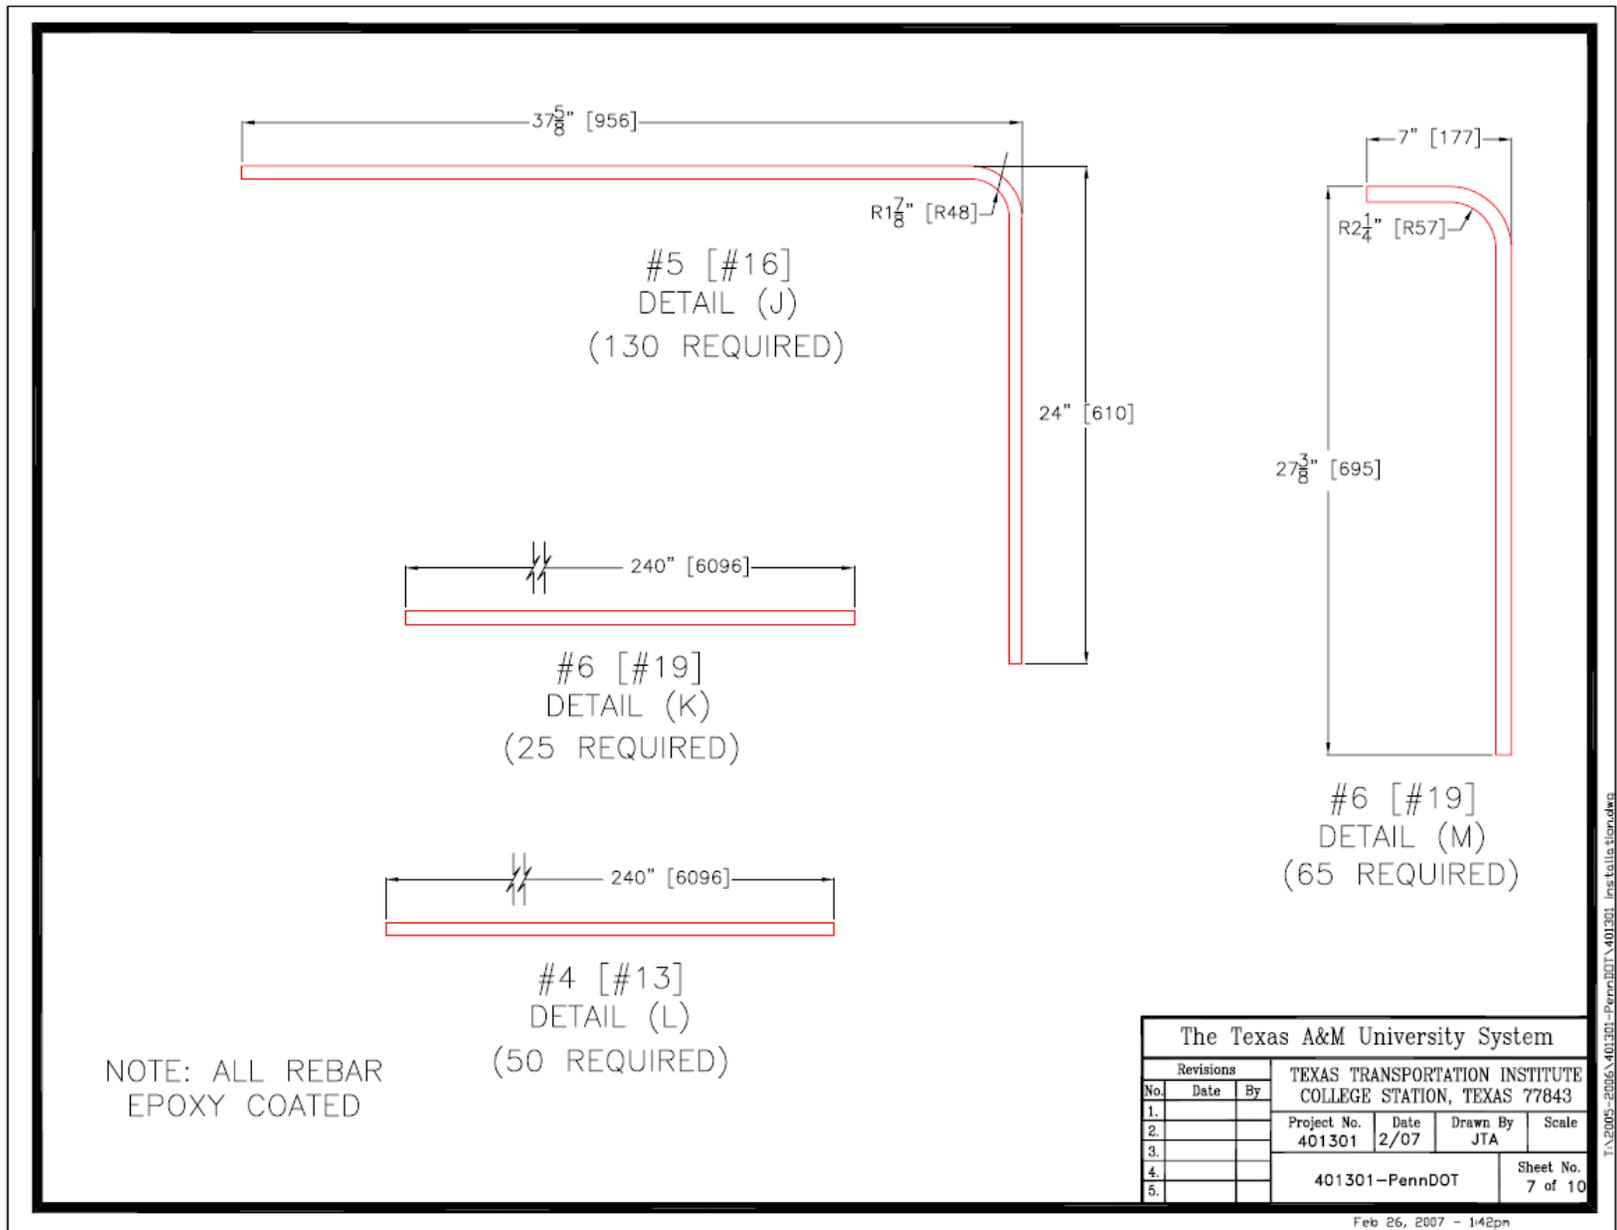
Figure 11. Rebar bend details.

Figure 11. Rebar bend details (continued).

Reinforcement in the deck consisted of two layers of reinforcement both in the transverse and longitudinal directions. The top and bottom layers of transverse reinforcement consisted of #5 (#16) transverse bars located 11-1/2 inches (292 mm) on center with additional #6 (#19 mm) bars added in the top transverse layer in the immediate area of the posts. Bottom transverse reinforcement consisted of #5 (#16) located on 9-1/2 inch centers. Longitudinal reinforcement in the top and bottom layers consisted of #4 (#12) spaced at 8 inches (203 mm) on center in the top mat and 9 inches (229 mm) on center in the bottom mat. Transverse reinforcement in the curb consisted of #4 (#12) hooked bars spaced at 8-1/2 inches (216 mm) on center around the posts. This curb reinforcement was anchored to the deck using Richmond threaded inserts. Longitudinal reinforcement in the curb consisted of four #6 (#19) bars located within the transverse curb reinforcement as shown in figures 3 and 4. All reinforcement used in the concrete deck and curb had a minimum specified yield strength of 414 MPa (60 ksi) and was epoxy coated. Standard concrete compressive strength cylinders were cast for both the concrete deck and curb. For the concrete deck, strength tests performed at 12 days age resulted in an average compressive strength of 5048 psi (34.8 MPa). For the concrete curb, strength tests performed at 10 days age resulted in an average compressive strength of 4380 psi (30.2 MPa). For additional information on the bridge railing test installation, please refer to figures 6 through 14. Photographs of the installation are shown in figure 15.

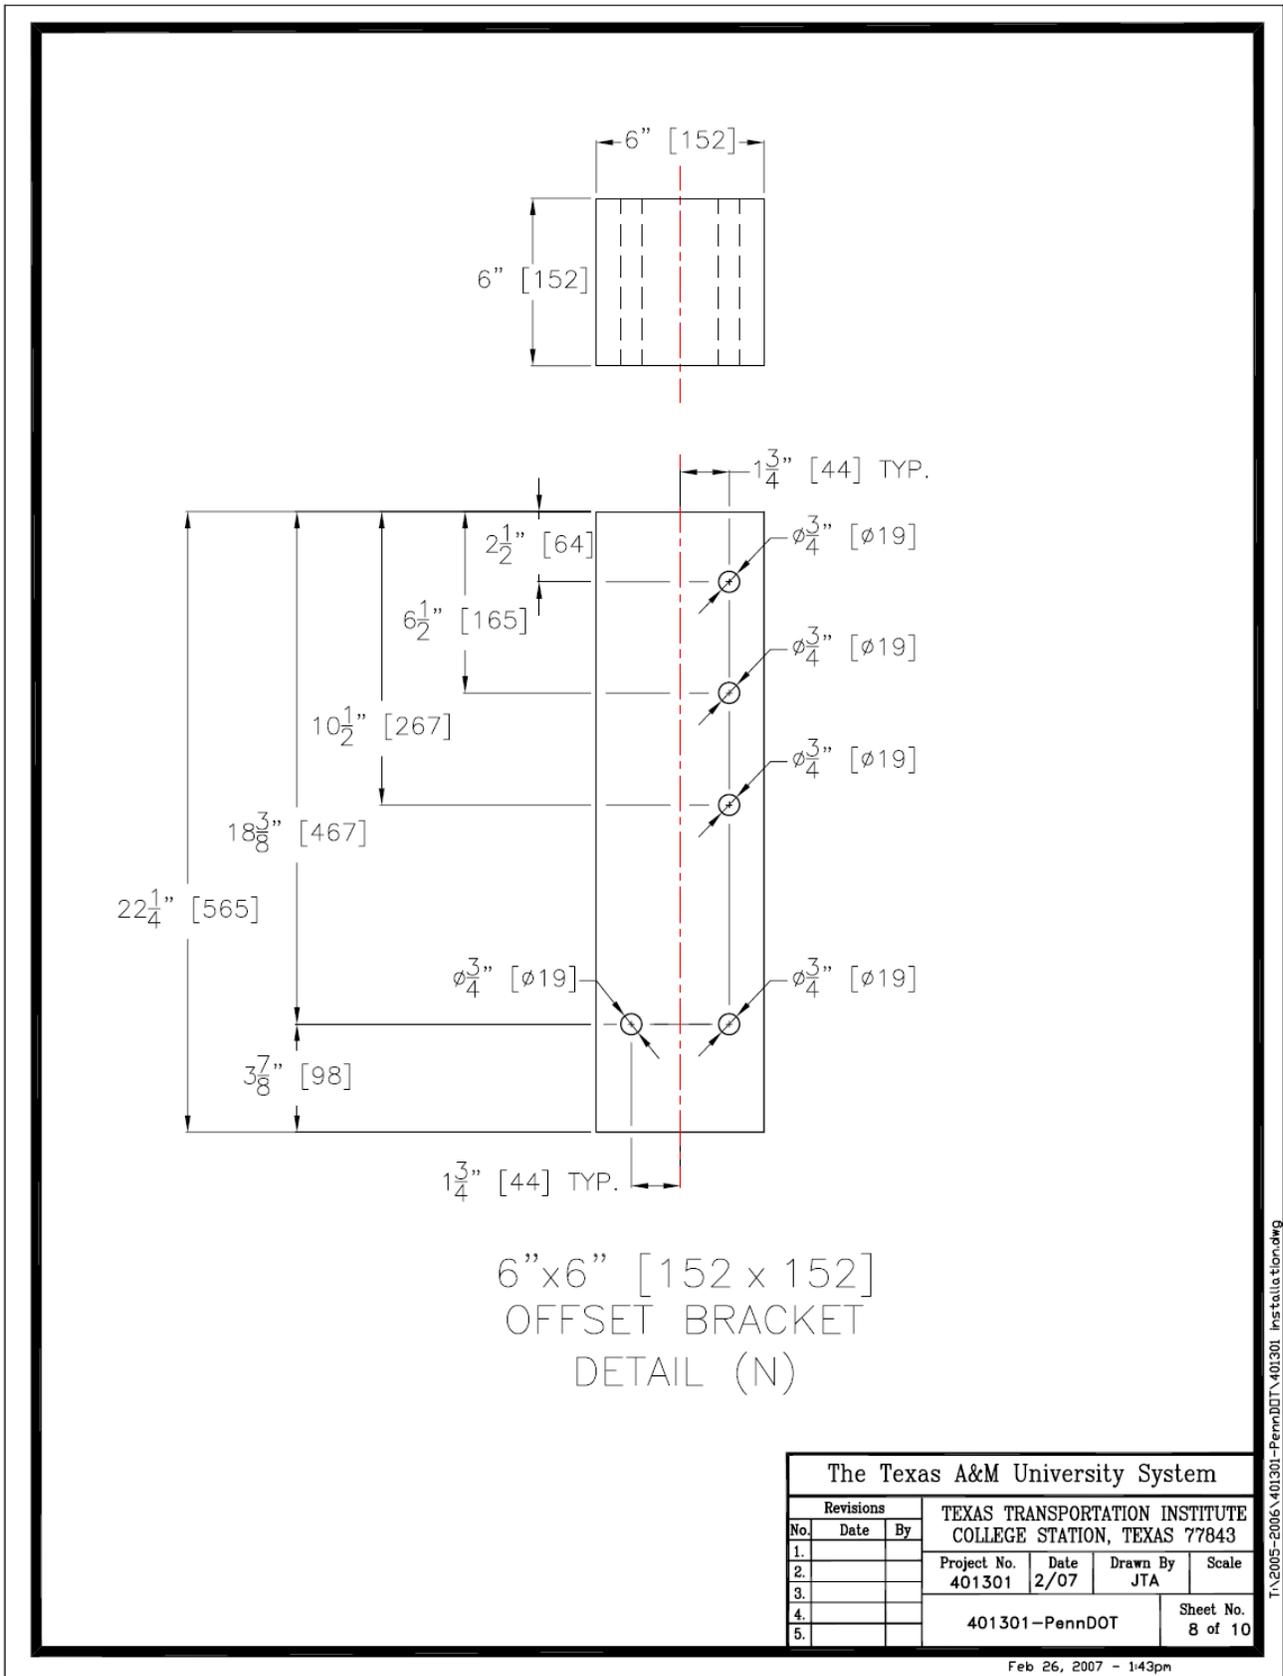
Figure 12. Details of the offset bracket.

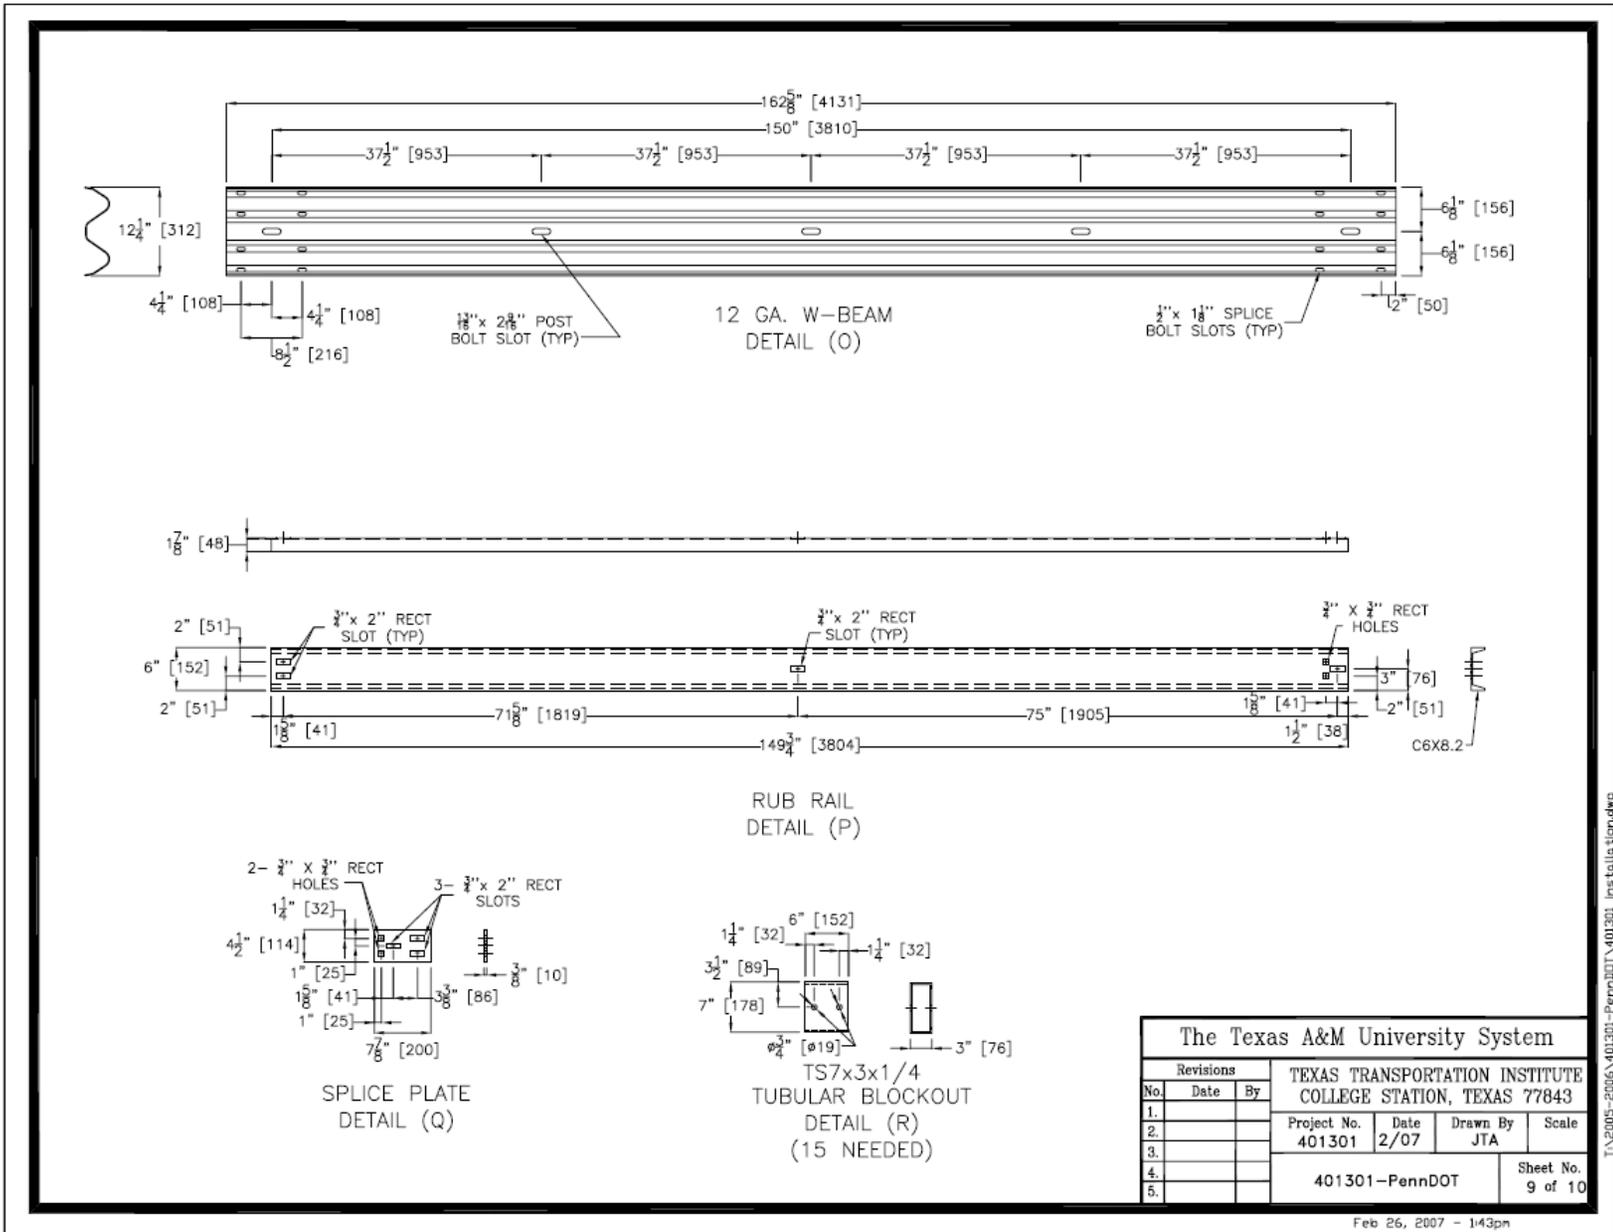
Figure 13. Details of the W-beam and rub rail.
