## **BRIDGE RAIL ANALYSIS AND CRASH TESTING**

Contract No. P2004010-PDOT (430137)  
Report/Test No. 401301-2  
Test Date: April 2, 2007

Sponsored by  
**Pennsylvania Department of Transportation**

**TEXAS TRANSPORTATION INSTITUTE  
THE TEXAS A&M UNIVERSITY SYSTEM  
COLLEGE STATION, TEXAS 77843**

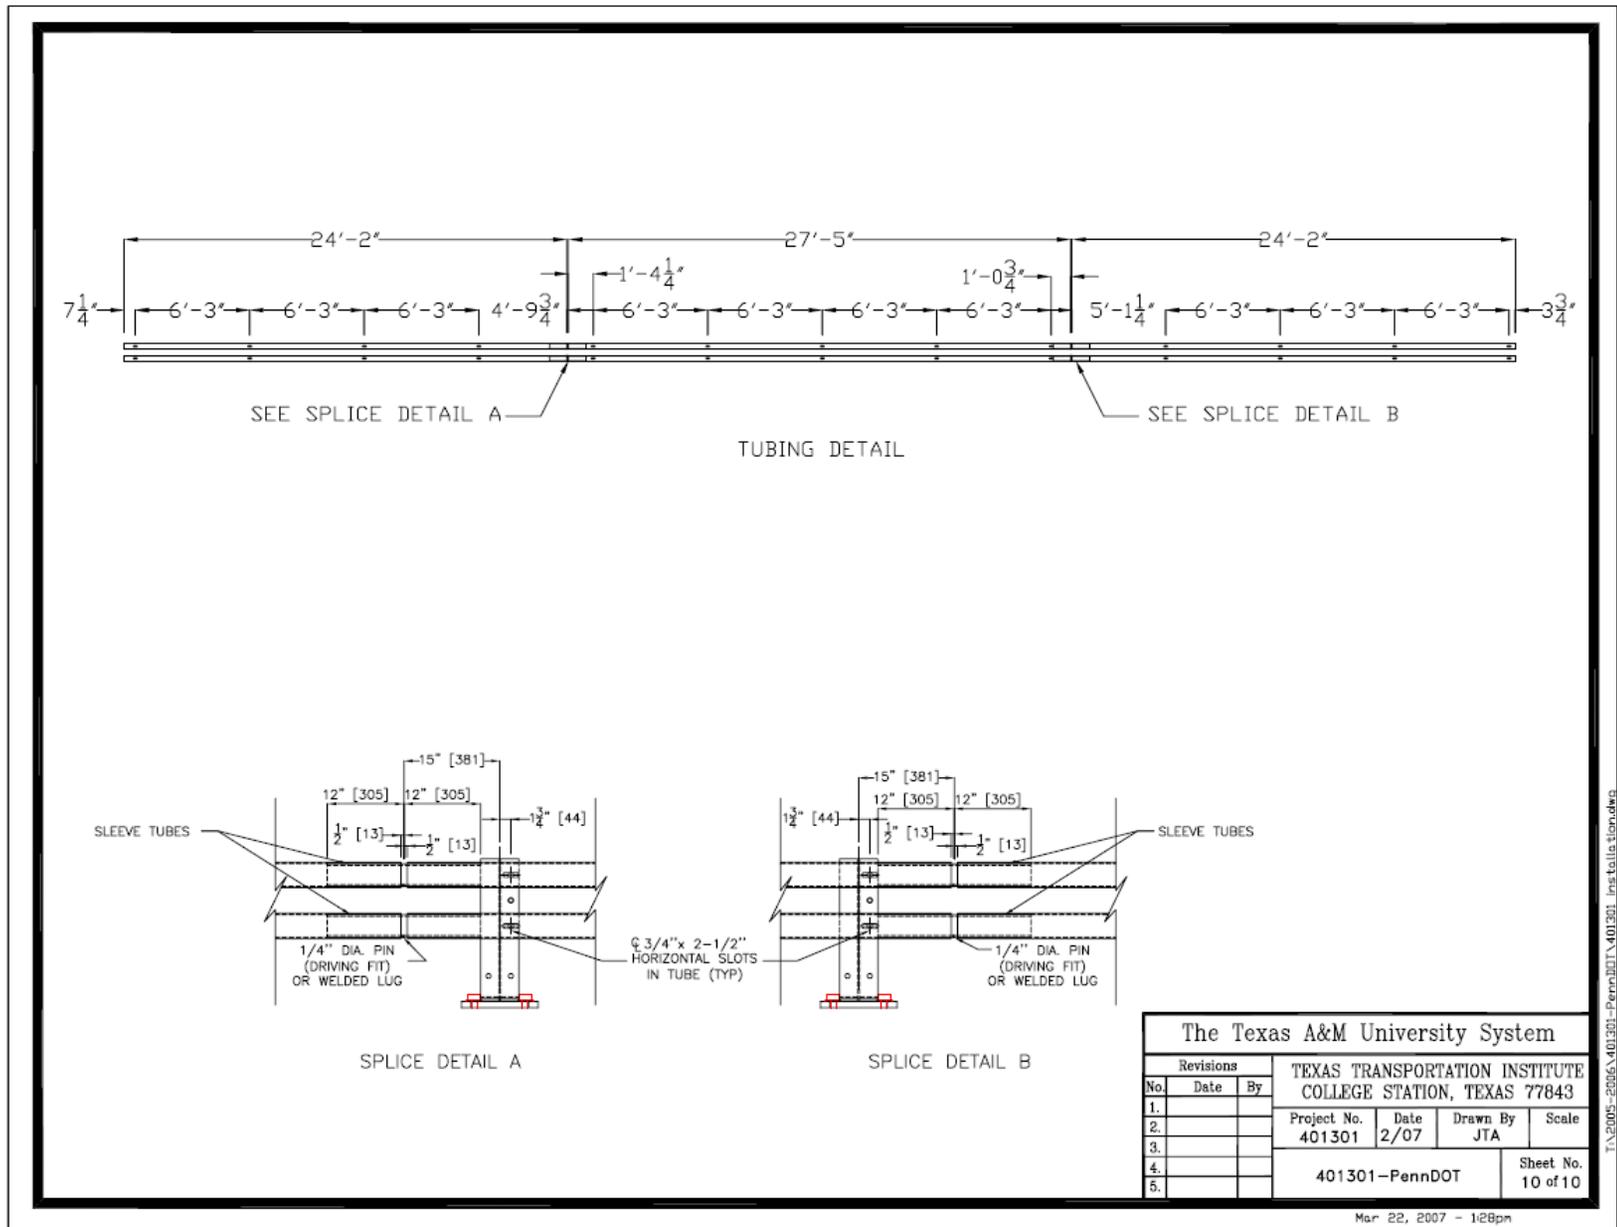
Figure 14. Splice details.

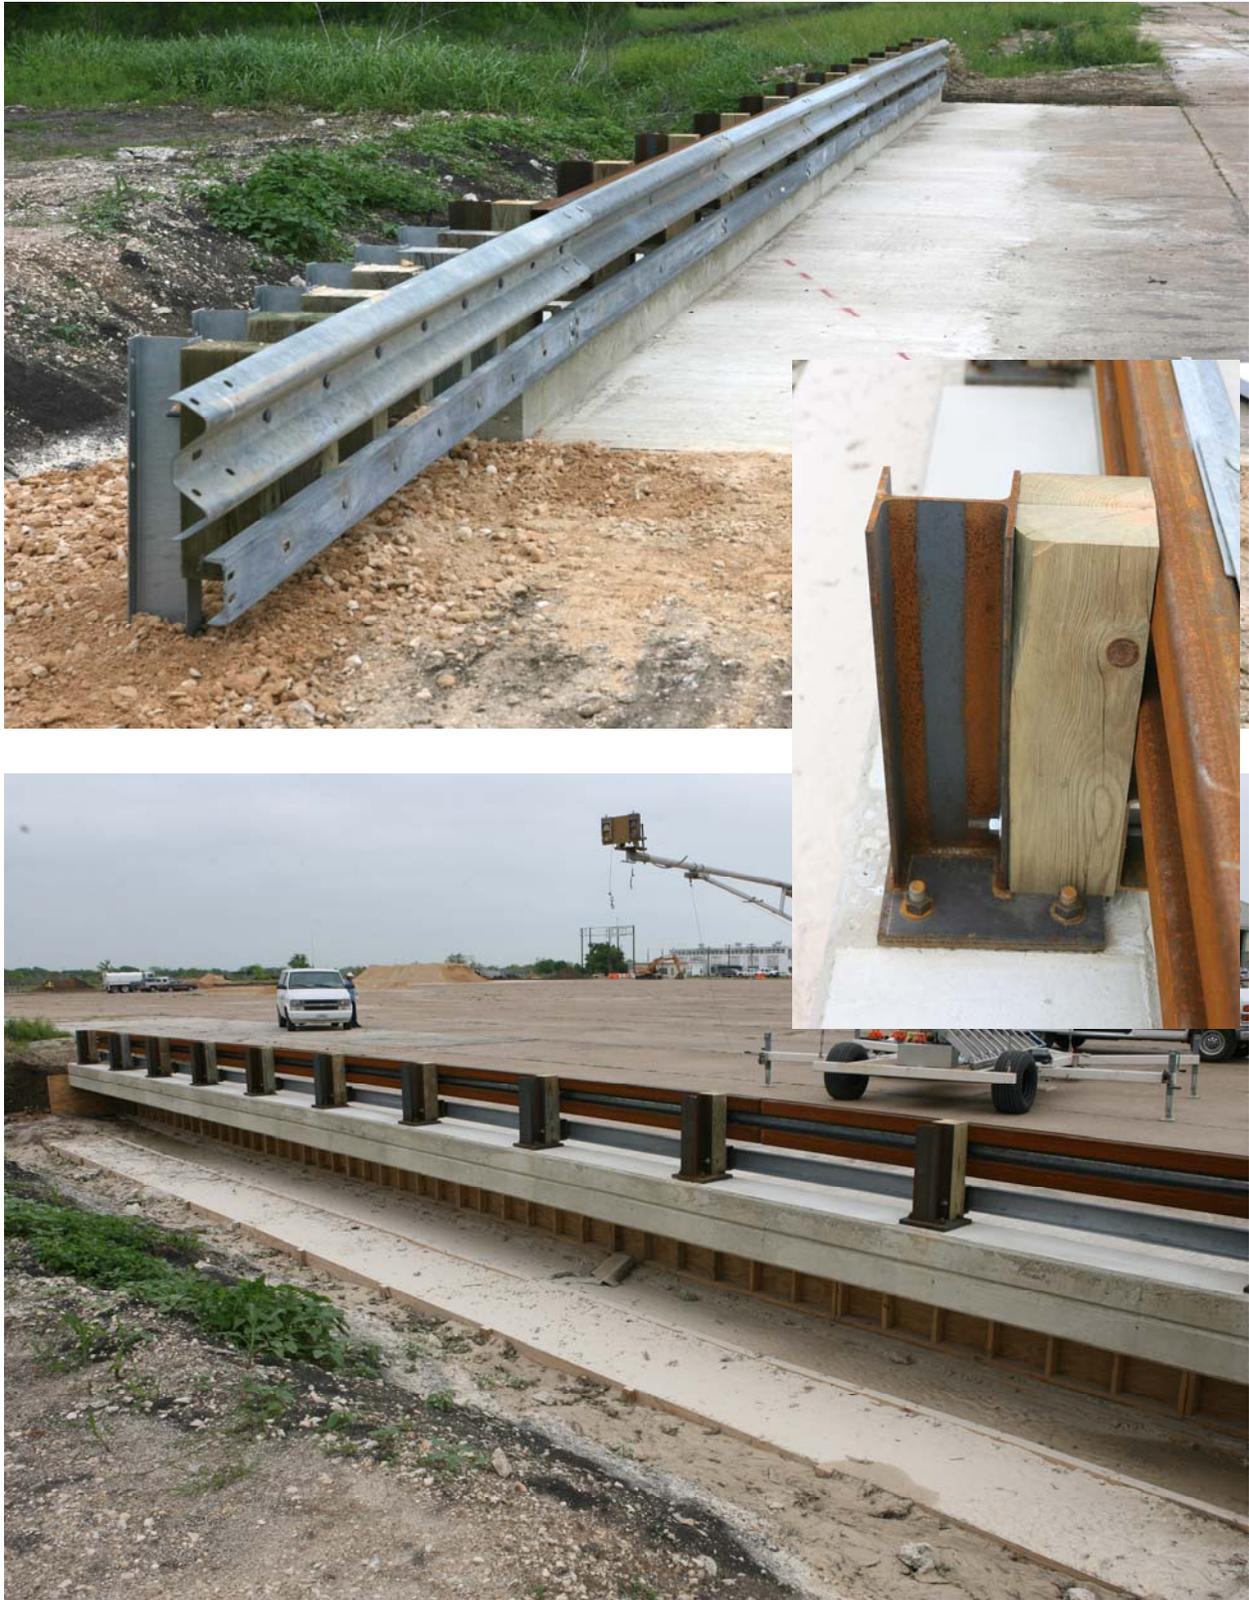
Figure 15. PENNDOT Structure Mounted Guide Rail Barrier prior to testing.

Reinforcement in the deck consisted of two layers of reinforcement both in the transverse and longitudinal directions. The top and bottom layers of transverse reinforcement consisted of #5 (#16) transverse bars located 11-1/2 inches (292 mm) on center with additional #6 (#19 mm) bars added in the top transverse layer in the immediate area of the posts. Bottom transverse reinforcement consisted of #5 (#16) located on 9-1/2 inch centers. Longitudinal reinforcement in the top and bottom layers consisted of #4 (#12) spaced at 8 inches (203 mm) on center in the top mat and 9 inches (229 mm) on center in the bottom mat. Transverse reinforcement in the curb consisted of #4 (#12) hooked bars spaced at 8-1/2 inches (216 mm) on center around the posts. This curb reinforcement was anchored to the deck using Richmond threaded inserts. Longitudinal reinforcement in the curb consisted of four #6 (#19) bars located within the transverse curb reinforcement as shown in figures 3 and 4. All reinforcement used in the concrete deck and curb had a minimum specified yield strength of 414 MPa (60 ksi) and was epoxy coated. Standard concrete compressive strength cylinders were cast for both the concrete deck and curb. For the concrete deck, strength tests performed at 12 days age resulted in an average compressive strength of 5048 psi (34.8 MPa). For the concrete curb, strength tests performed at 10 days age resulted in an average compressive strength of 4380 psi (30.2 MPa). For additional information on the bridge railing test installation, please refer to figures 6 through 14. Photographs of the installation are shown in figure 15.

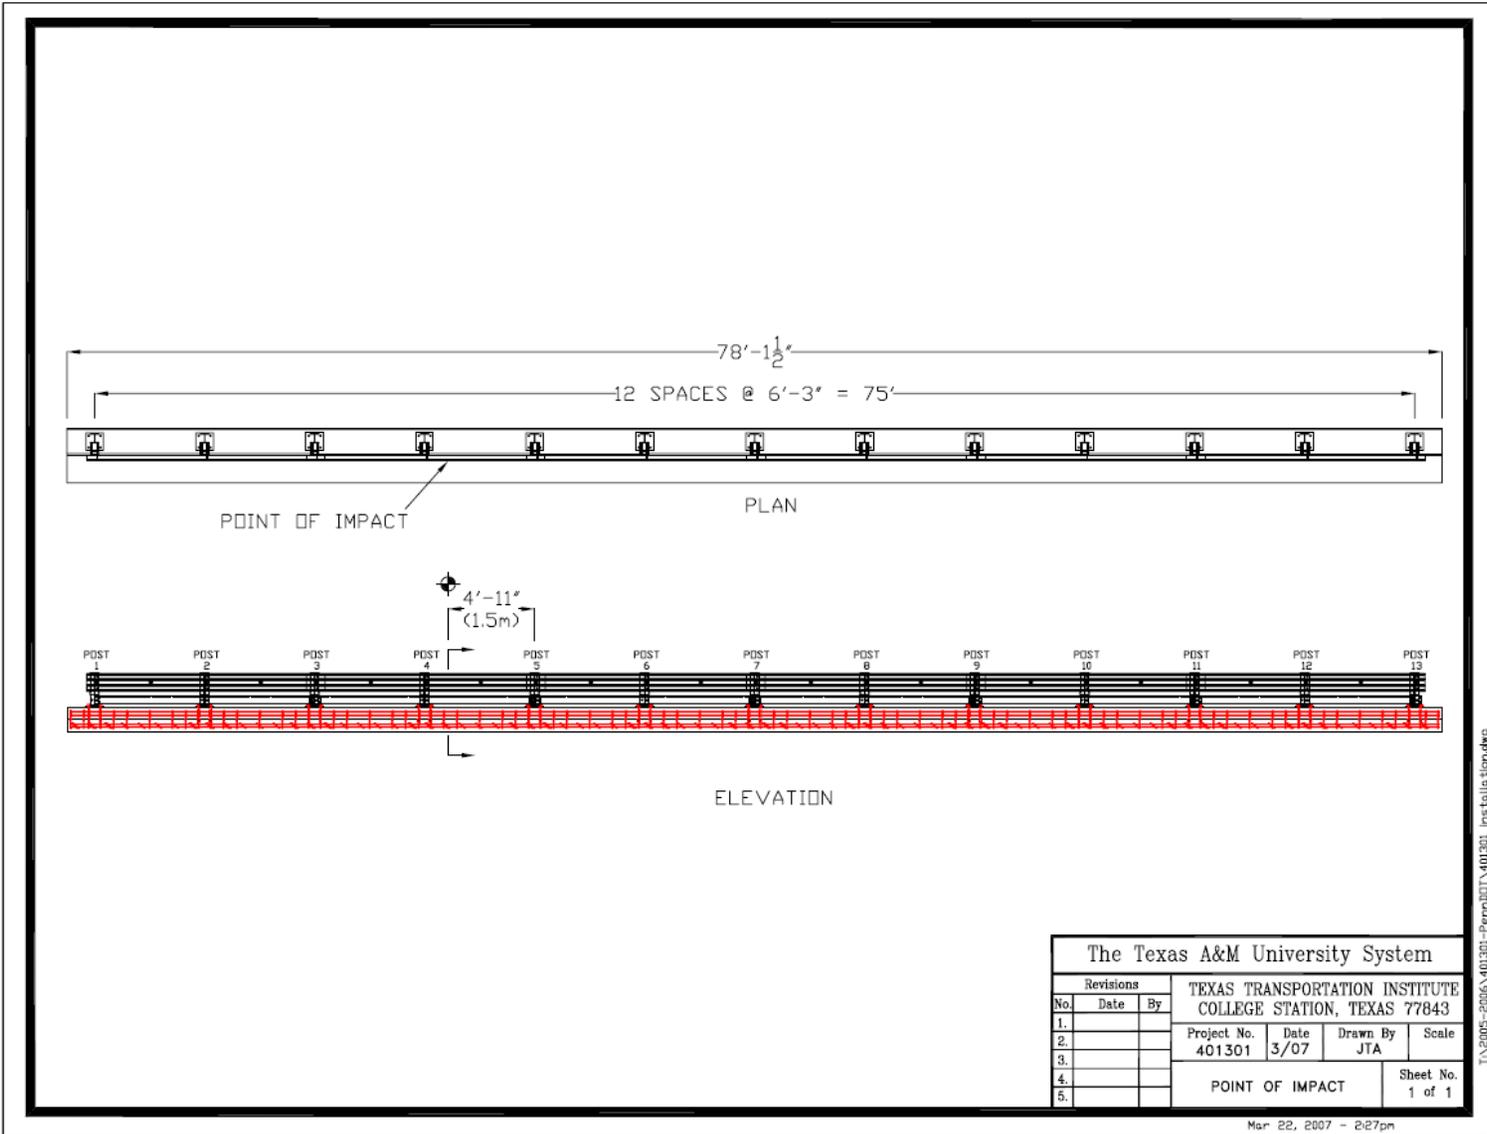
Figure 16. Location of impact point for the PENNDOT Structure Mounted Guide Rail Barrier.

Test 4-12 was performed in this study, and the target impact point was 1.5 m upstream of bridge rail post 5 (see figure 16).

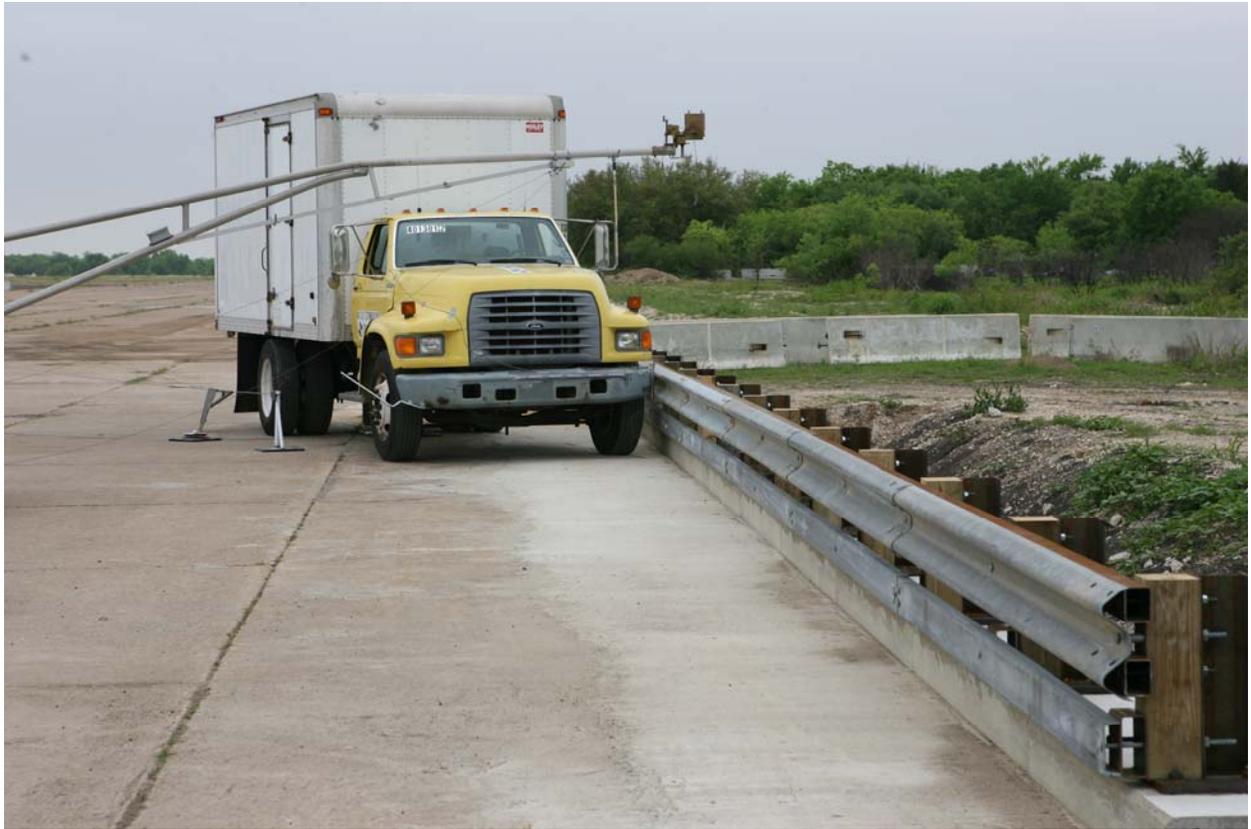
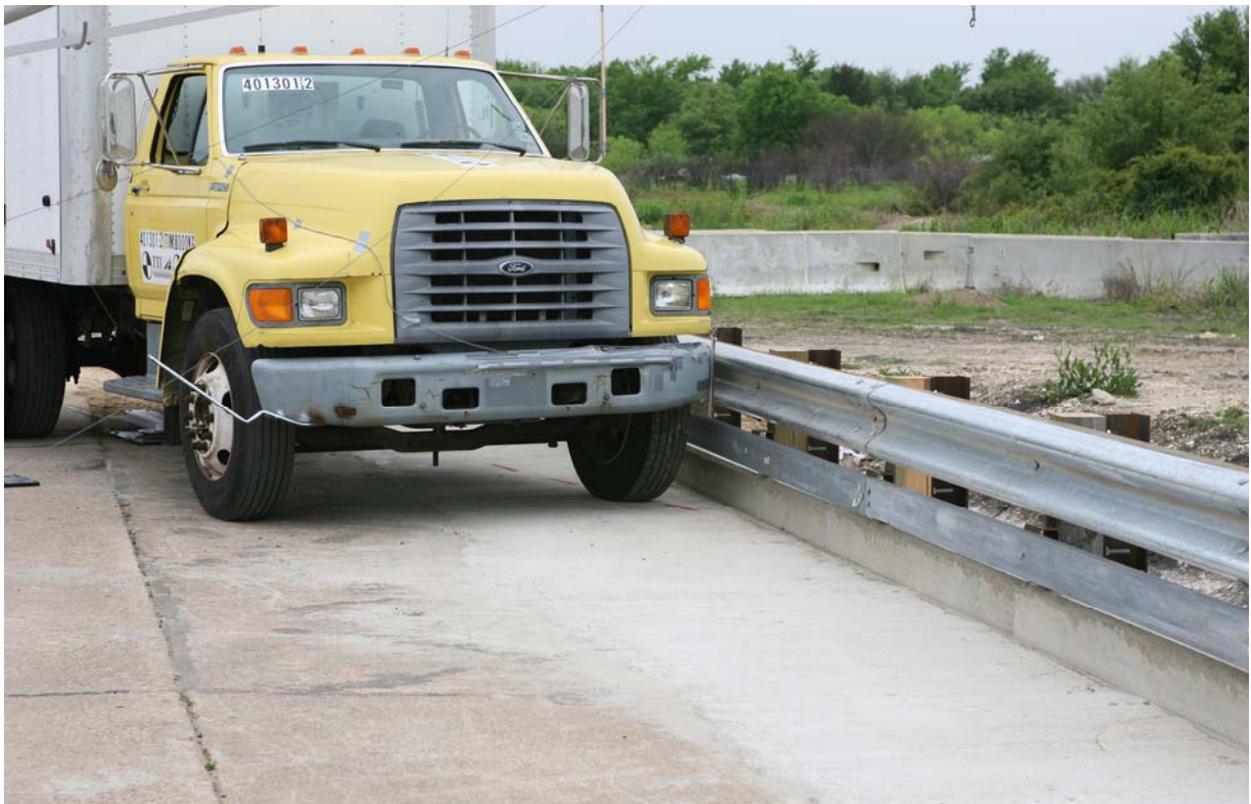
Figure 17. Vehicle/installation geometrics for test 401301-2.

A 1998 Ford F series single-unit truck, shown in figures 17 and 18, was used for the crash test. Test inertia weight of the vehicle was 7970 kg, and its gross static weight was 7970 kg. The height to the lower edge of the vehicle front bumper was 489 mm, and the height to the upper edge of the front bumper was 802 mm. Additional dimensions and information on the vehicle are given in appendix B, figure 23. The vehicle was directed into the installation using the cable reverse tow and guidance system, and was released to be free-wheeling and unrestrained just prior to impact.

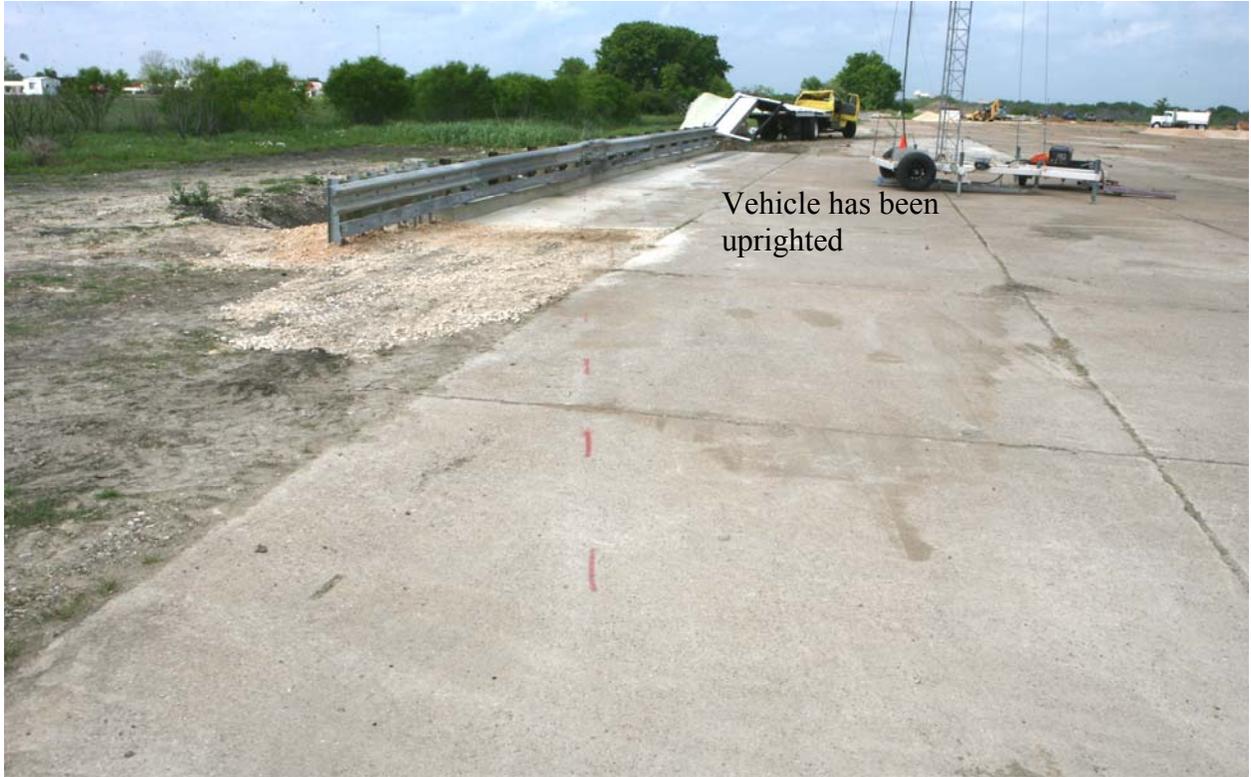
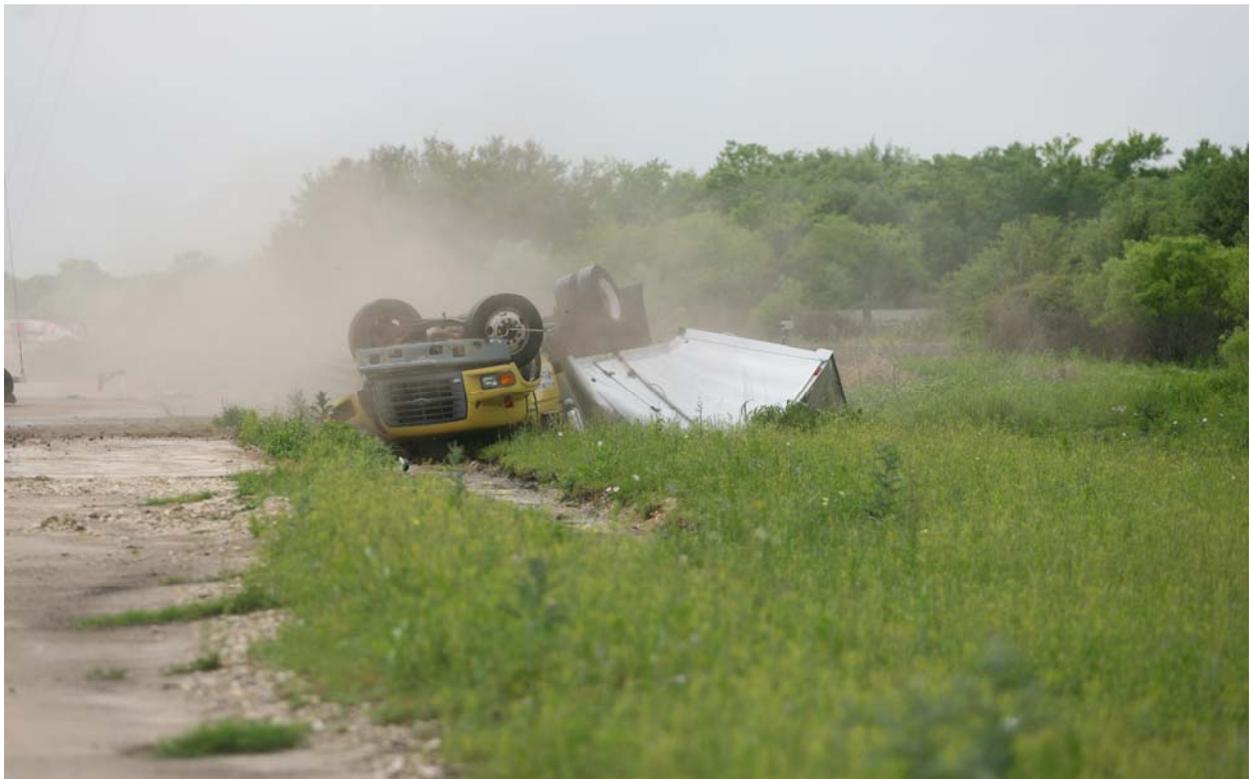
Figure 19. Vehicle trajectory path after test 401301-2.

Damage to the PENNDOT Structure Mounted Guide Rail Barrier is shown in figures 19 and 20. Actual impact occurred 3.4 ft (1.04 m) upstream of post 5. The right front corner of the blockout at post 5 was chipped, and the top of the blockout at post 4 was scraped. Cracks radiated from the left front anchor bolt at post 4 across the top of the curb only. At post 5, the top of the blockout and the traffic face of the post were marred. Cracks radiated from the front bolts on both sides across the top of the curb. A hairline crack on the downstream side radiated from the rear anchor bolt across and down the field side of the curb, with a very slight hairline crack into the upper part of the deck. The top of the blockout at post 6 was gouged, and the tops of the posts and blockouts at posts 7 and 8 were scraped. Length of contact of the vehicle with the rail was 29.5 ft (8.98 m), plus a second contact at 11.0 ft (3.34 m) from the end and off the end of the rail. Maximum dynamic deflection of the W-beam rail element was 2.6 inches (66 mm), as was the permanent deformation. Working width was 6.6 ft (2.015 m).

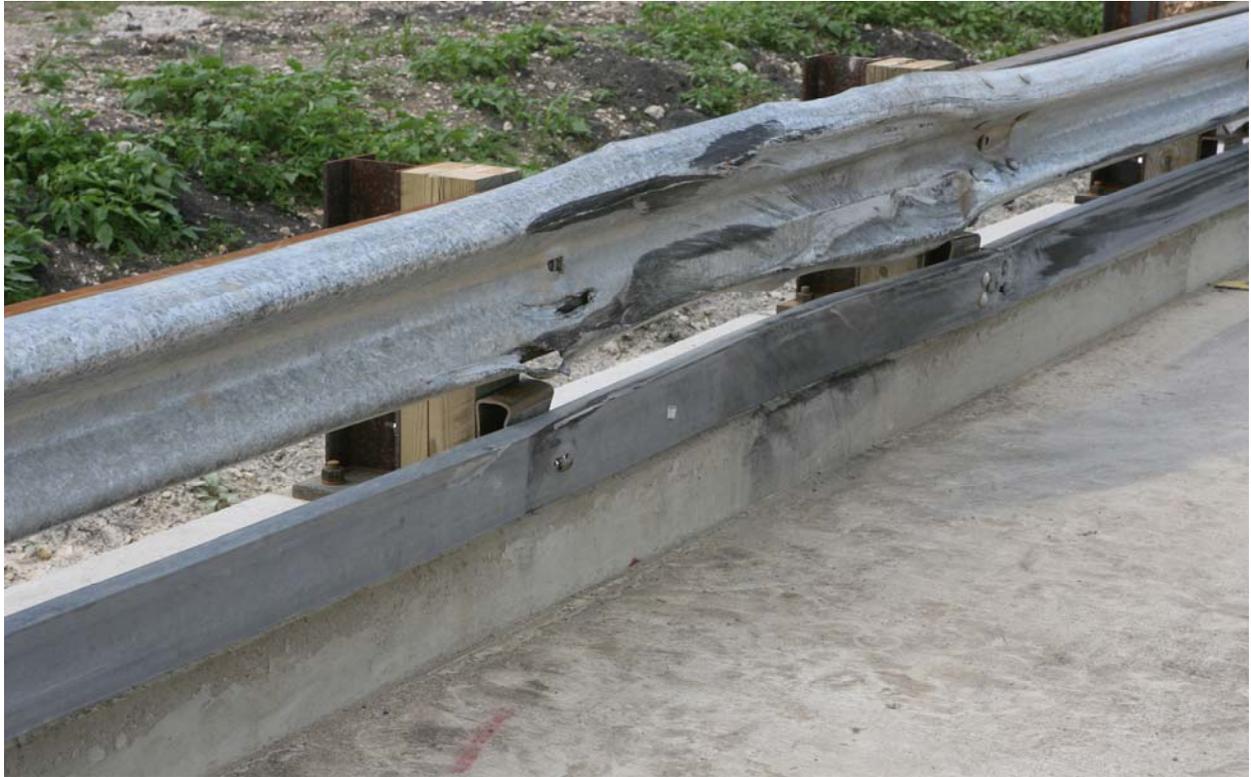
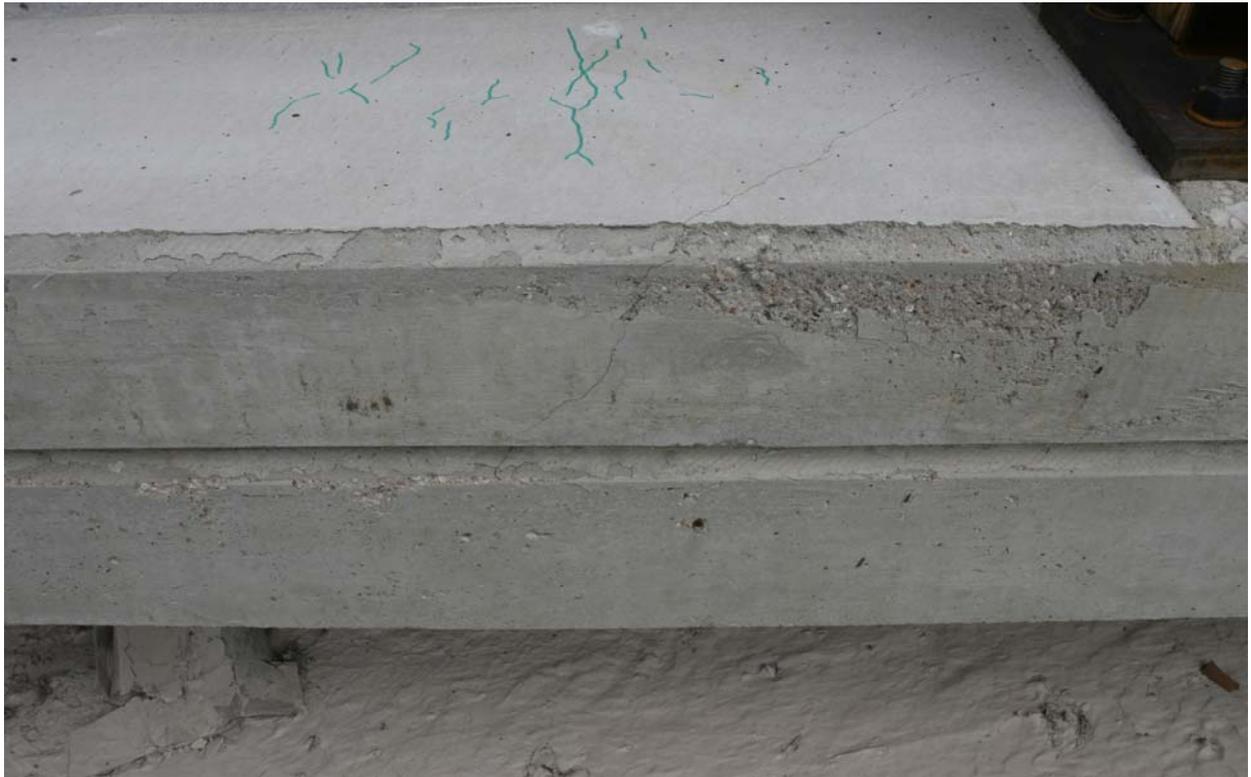
Figure 20. Installation after test 401301-2.

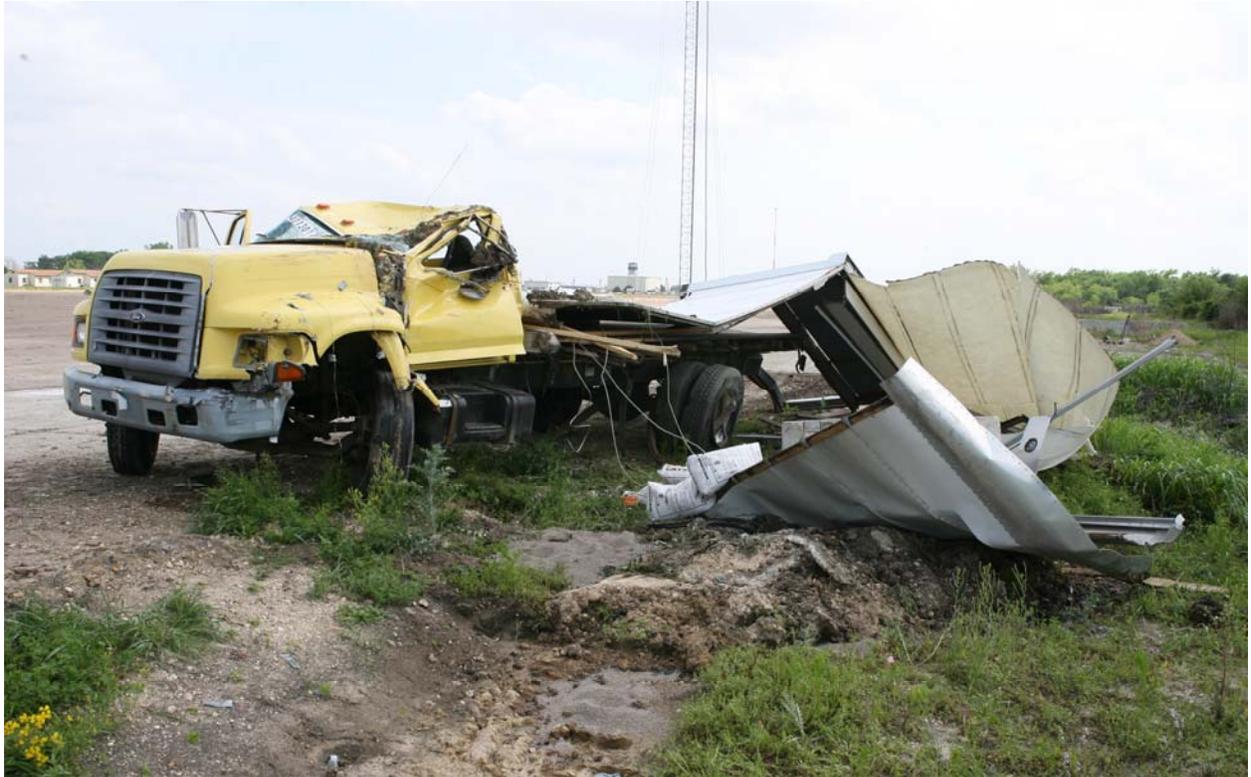
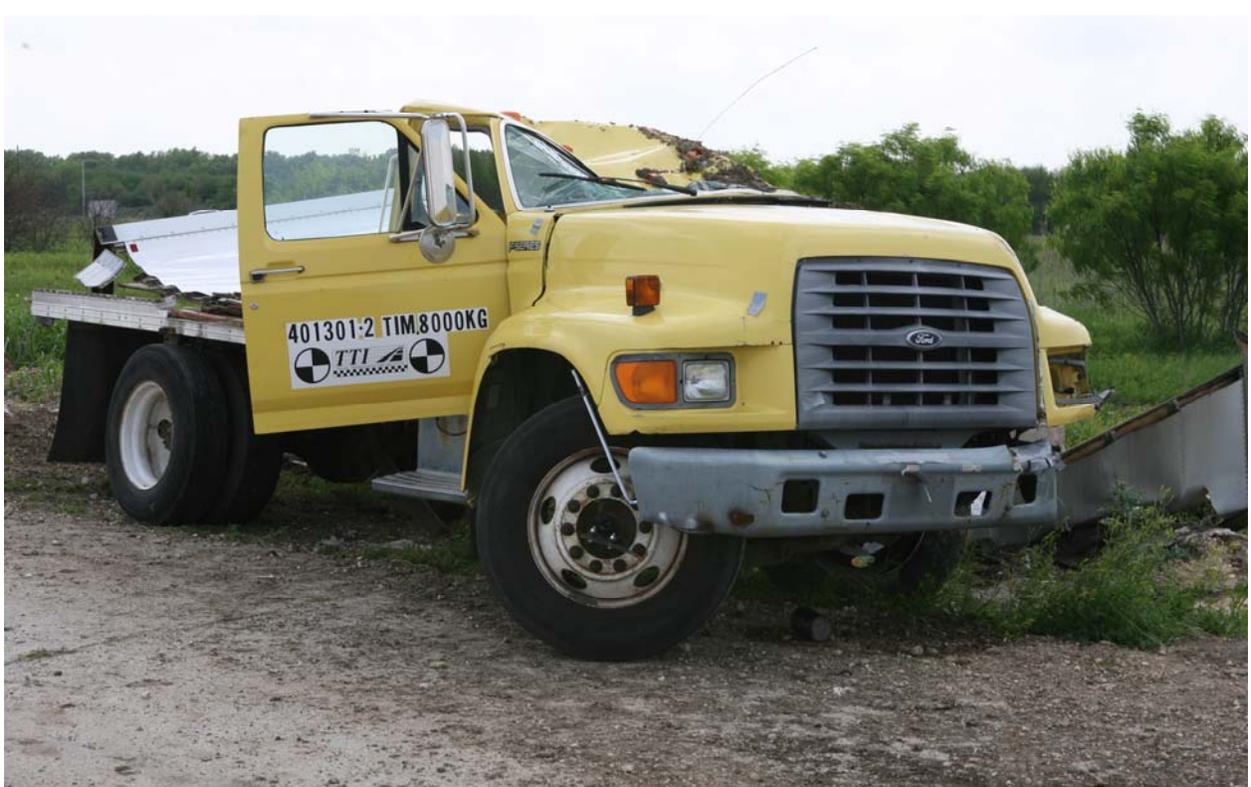
The single-unit truck was extensively damaged when it rolled over onto its top. However, as far as can be determined, damage from contact with the rail included the front bumper, hood, left door and glass, drive shaft, left rear leaf springs and rear U-bolts. Photographs of the vehicle are shown in figure 21.

Figure 21. Vehicle (uprighted) after test 401301-2.

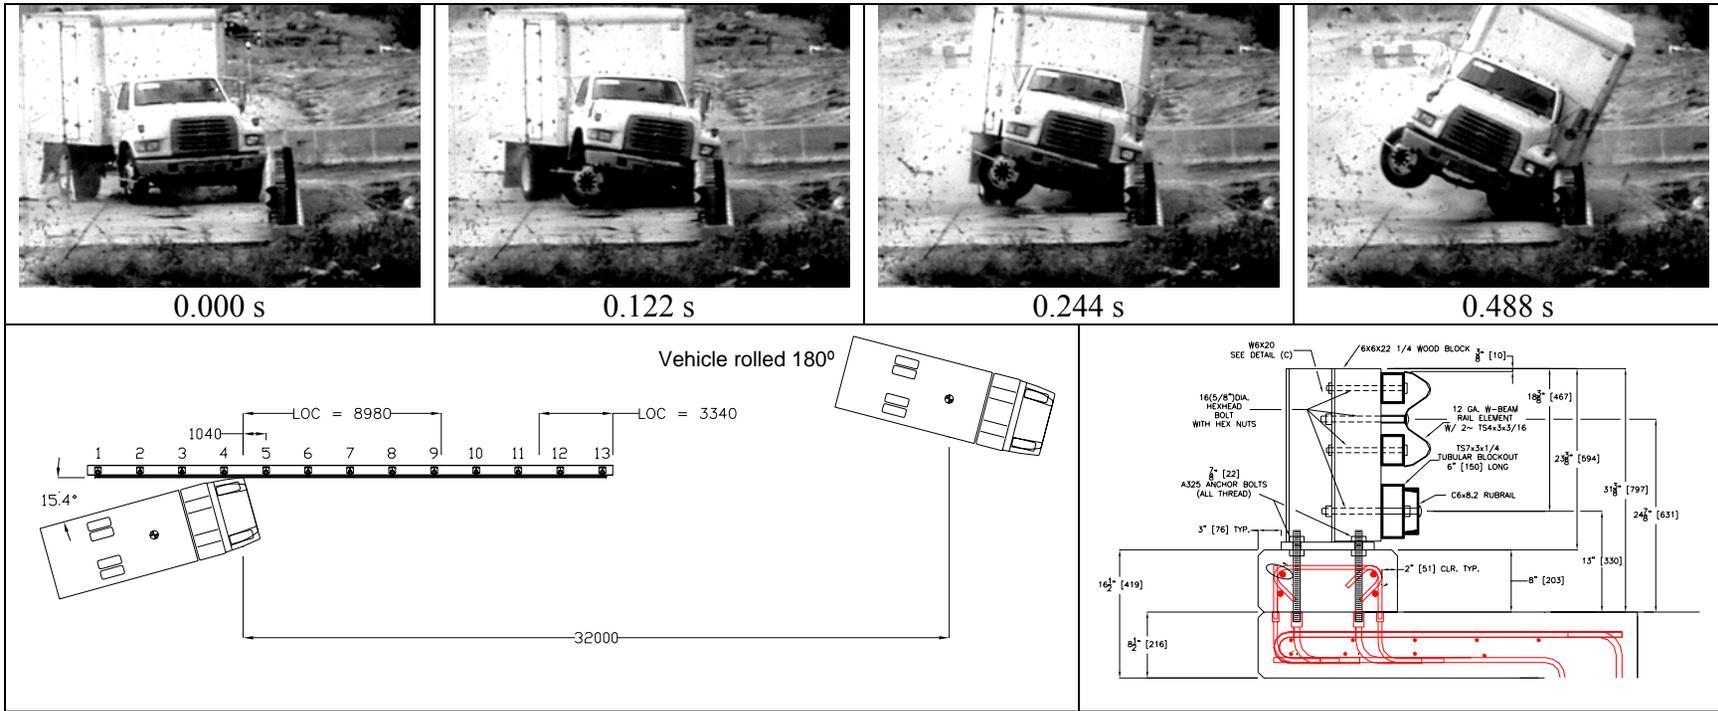
Figure 22. Summary of results for NCHRP Report 350 test 4-12 on the PENNDOT Structure Mounted Guide Rail Barrier.

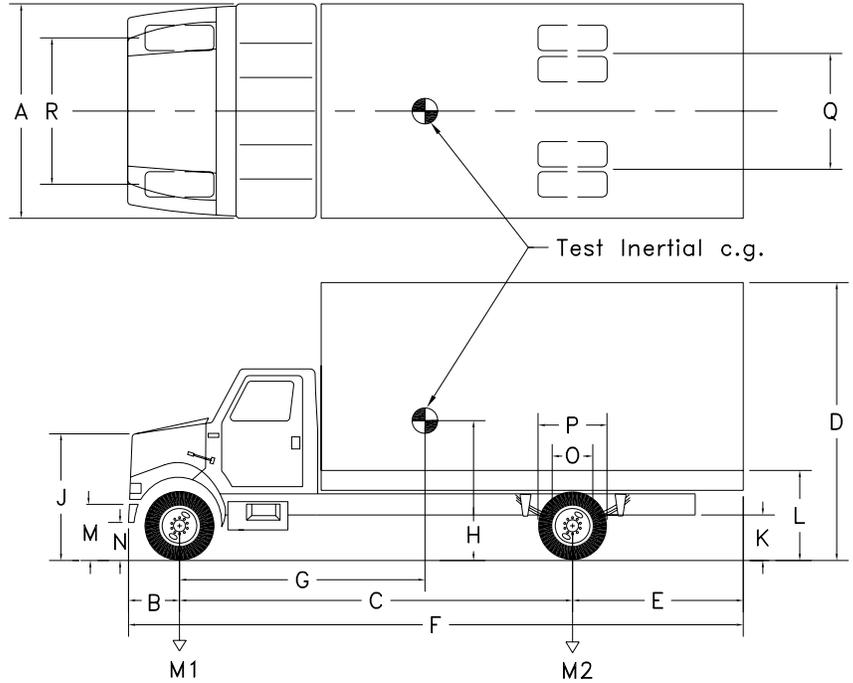
A	<u>2438</u>	E	<u>2553</u>	J	<u>1638</u>	N	<u>489</u>	R	<u>2019</u>
B	<u>864</u>	F	<u>7760</u>	K	<u>676</u>	O	<u>597</u>	S	_____
C	<u>4343</u>	G	<u>2620.38</u>	L	<u>1135</u>	P	<u>994</u>		
D	<u>3366</u>	H	_____	M	<u>802</u>	Q	<u>1880</u>

Figure 23. Vehicle properties for test 401301-2.

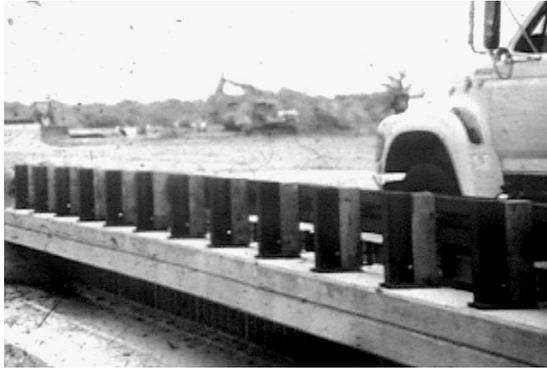
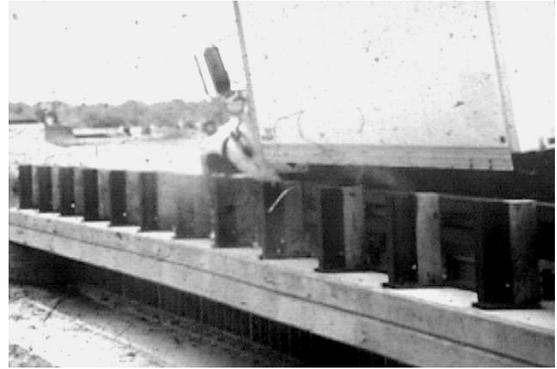
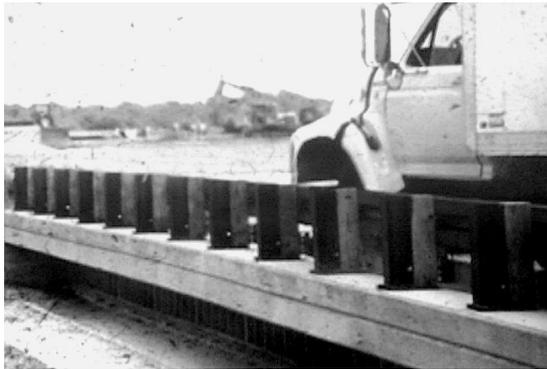
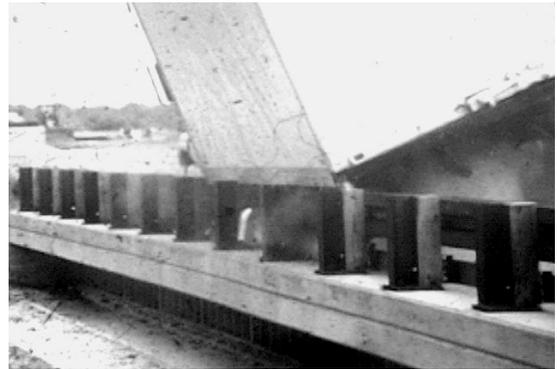
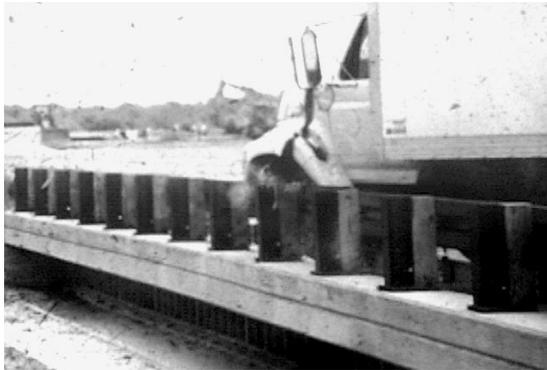
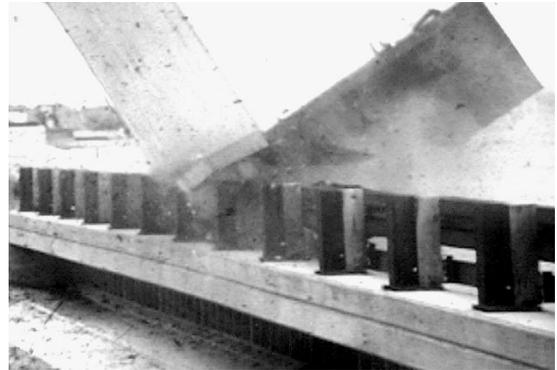
Figure 24. Sequential photographs for test 401301-2 (rear view).

The 1998 Ford F series single-unit truck, traveling at an impact speed of 50.0 mi/h (80.4 km/h), impacted the PENNDOT Structure Mounted Guide Rail Barrier 3.4 ft (1.04 m) upstream of post 5 at an impact angle of 15.4 degrees. Shortly after contact, the W-beam rail element and rub-rail began to deform at the point of impact. The cab of the vehicle began to redirect at 0.031 s, and the box-van began to redirect at 0.114 s. At 0.310 s, the vehicle was parallel with the rail and traveling at a speed of 46.2 mi/h (74.3 km/h). The lower front corner of the box-van contacted post 3 at 0.320 s, and the lower rear of the box-van contacted post 2 at 0.331 s. By 0.379 s, the lower front corner of the box-van contacted post 4. The vehicle rode down the rail and out of view of the overhead camera while traveling at a speed of 42.1 mi/h (67.7 km/h). As the vehicle rode off the rail, it rolled over onto its top, coming to rest 105 ft (32 m) downstream of impact and to the field side of the installation with the right front corner aligned with the traffic face of the bridge rail. Sequential photographs of the test period are shown in appendix C, figures 24 and 25.

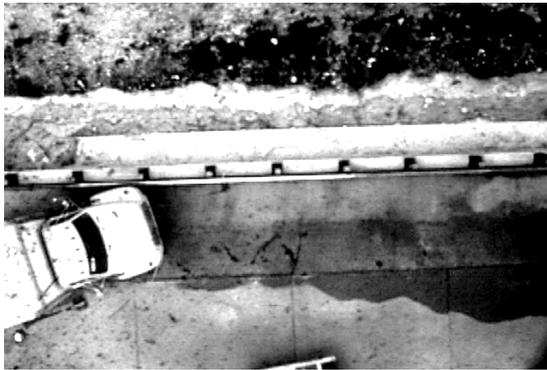
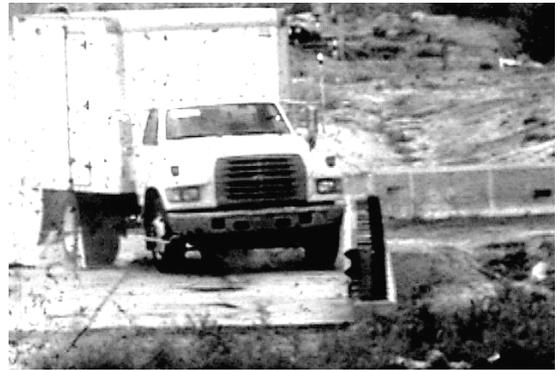
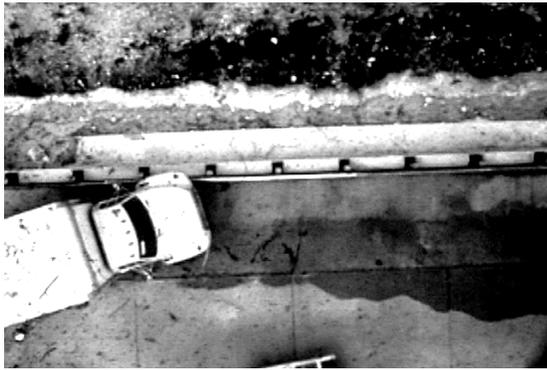
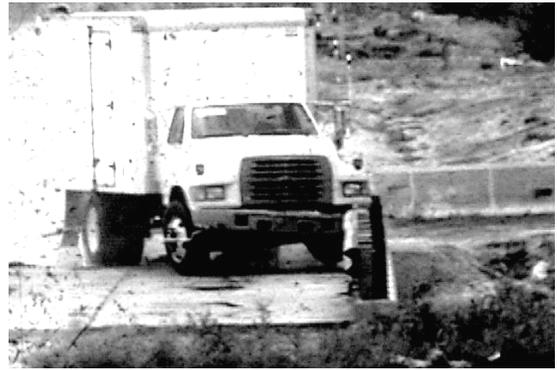
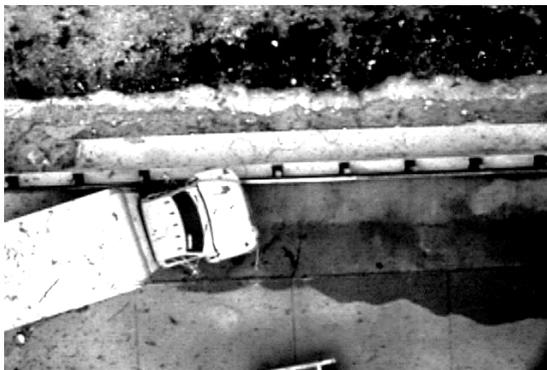
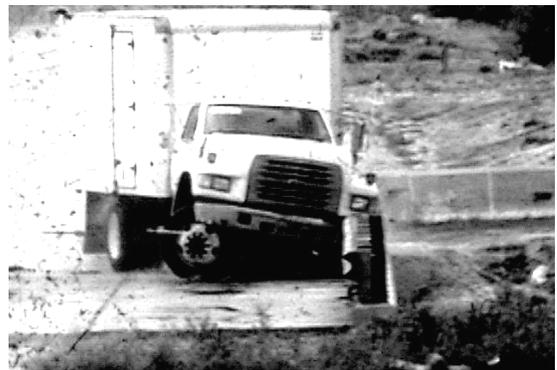
Figure 25. Sequential photographs for test 401301-2 (overhead and frontal views).

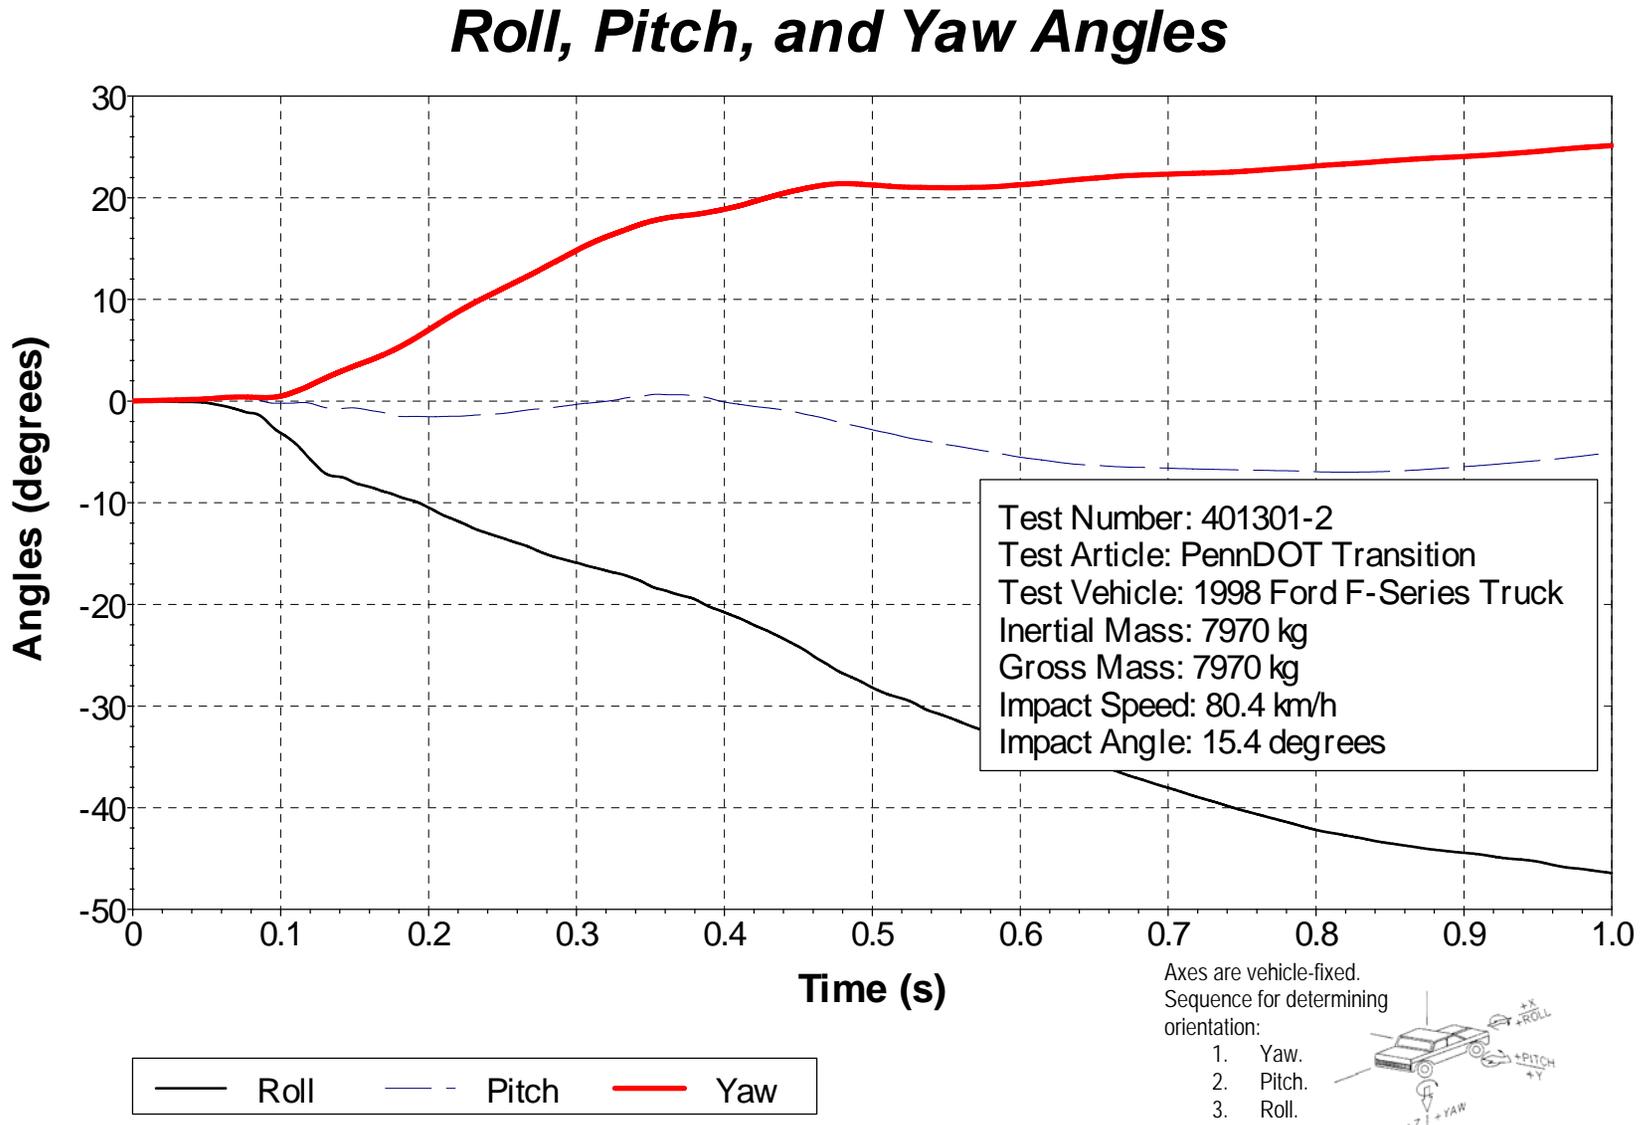
Figure 26. Vehicle angular displacements for test 401301-2.

Data from the accelerometer, located at the vehicle center of gravity, were digitized for evaluation of occupant risk. In the longitudinal direction, the occupant impact velocity was 8.5 ft/s (2.6 m/s) at 0.237 s, the highest 0.010-s occupant ridedown acceleration was -4.0 g's from 0.299 to 0.309 s, and the maximum 0.050-s average acceleration was -2.1 g's between 0.323 and 0.373 s. In the lateral direction, the occupant impact velocity was 11.2 ft/s (3.4 m/s) at 0.237 s, the highest 0.010-s occupant ridedown acceleration was 5.6 g's from 0.326 to 0.336 s, and the maximum 0.050-s average was 3.8 g's between 0.287 and 0.337 s. These data and other pertinent information from the test are summarized in figure 22. Vehicle angular displacements and accelerations versus time traces are presented in appendix D, figures 26 through 32.
