## **BRIDGE RAIL ANALYSIS AND CRASH TESTING**

Contract No. P2004010-PDOT (430137)  
Report/Test No. 401301-2  
Test Date: April 2, 2007

Sponsored by  
**Pennsylvania Department of Transportation**

**TEXAS TRANSPORTATION INSTITUTE  
THE TEXAS A&M UNIVERSITY SYSTEM  
COLLEGE STATION, TEXAS 77843**

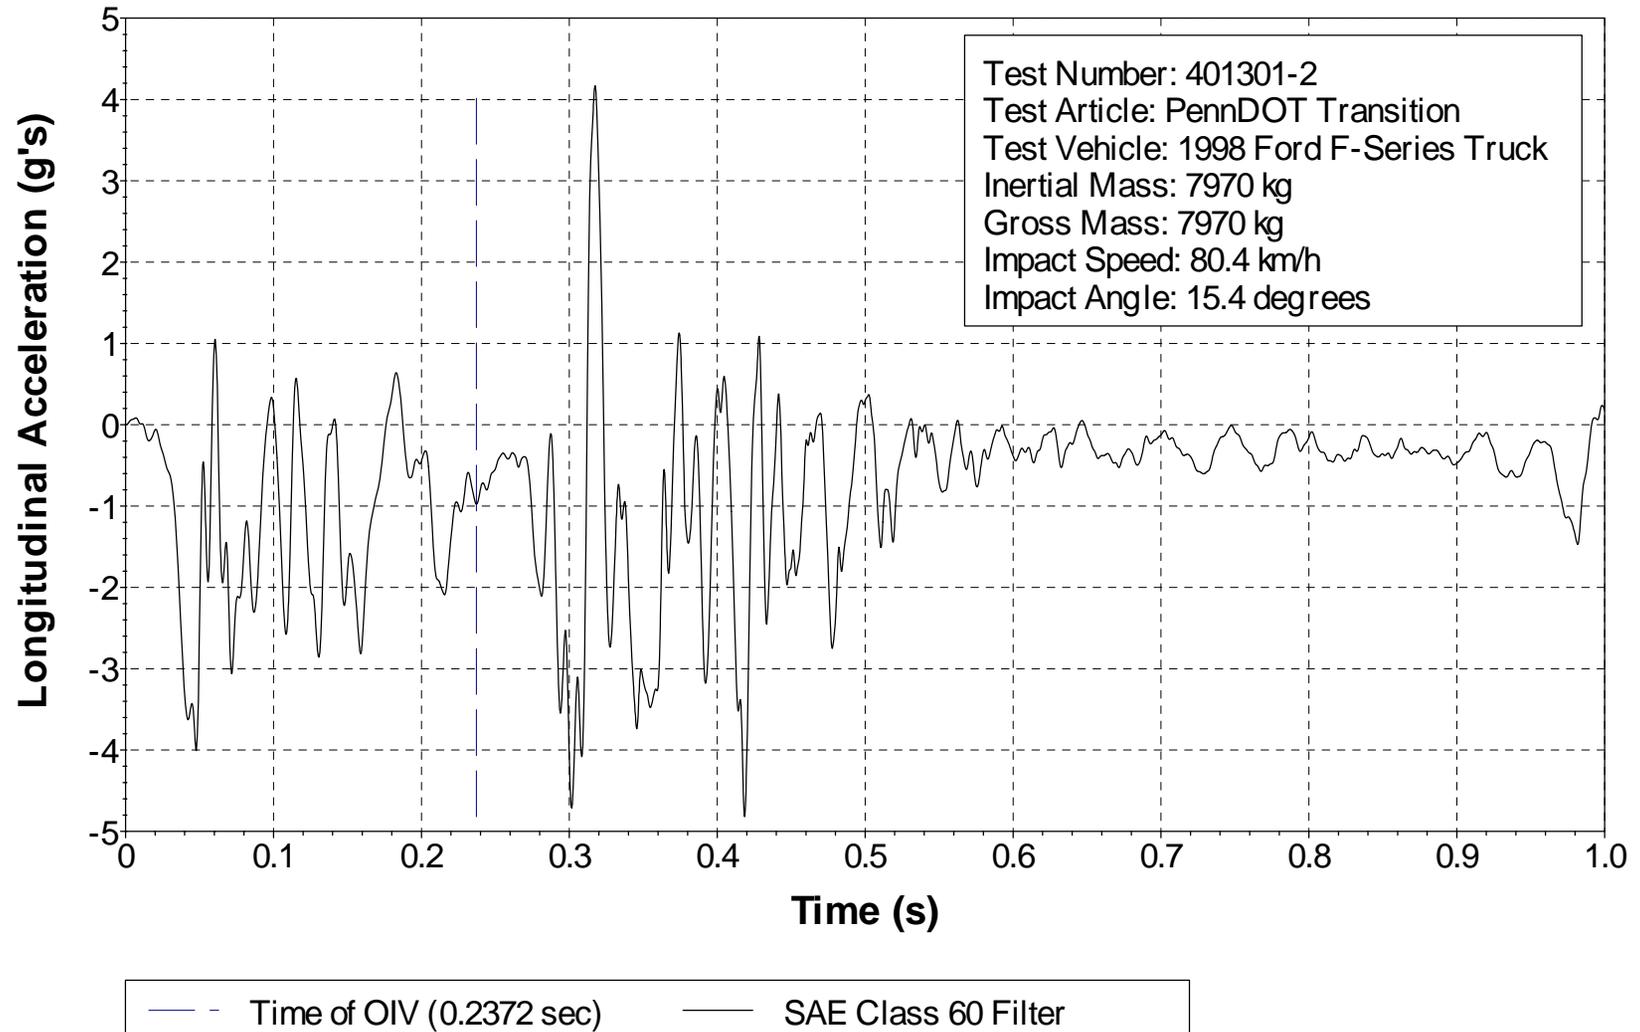
Figure 27. Vehicle longitudinal accelerometer trace for test 401301-2 (accelerometer located at center of gravity).

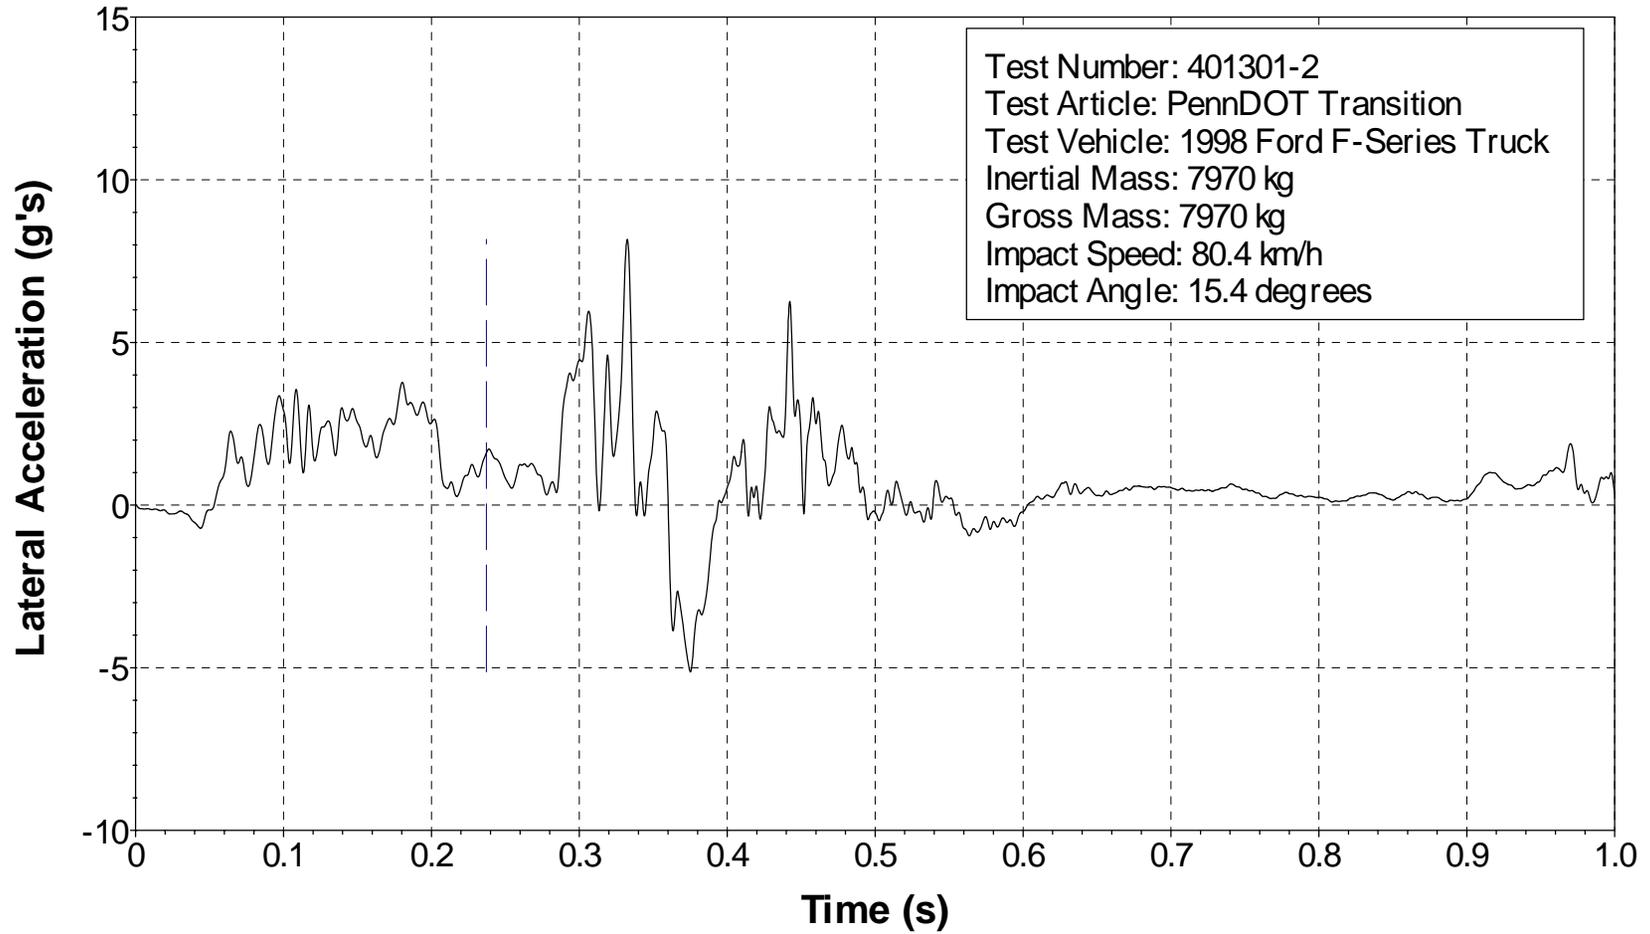
Figure 28. Vehicle lateral accelerometer trace for test 401301-2 (accelerometer located at center of gravity).

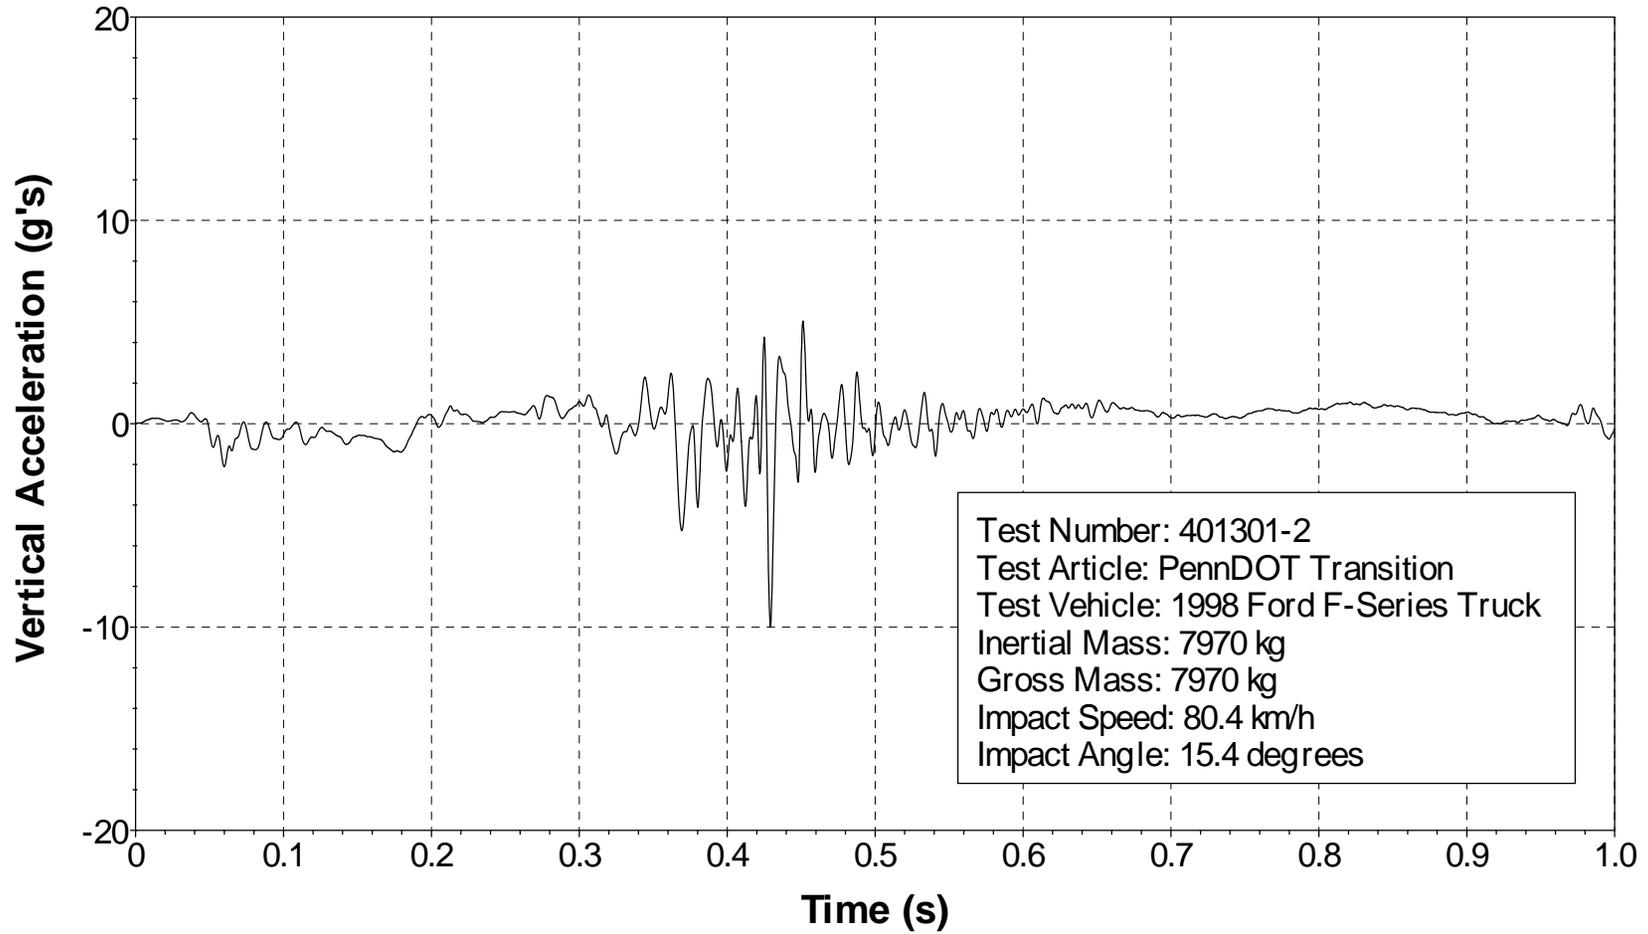
Figure 29. Vehicle vertical accelerometer trace for test 401301-2 (accelerometer located at center of gravity).

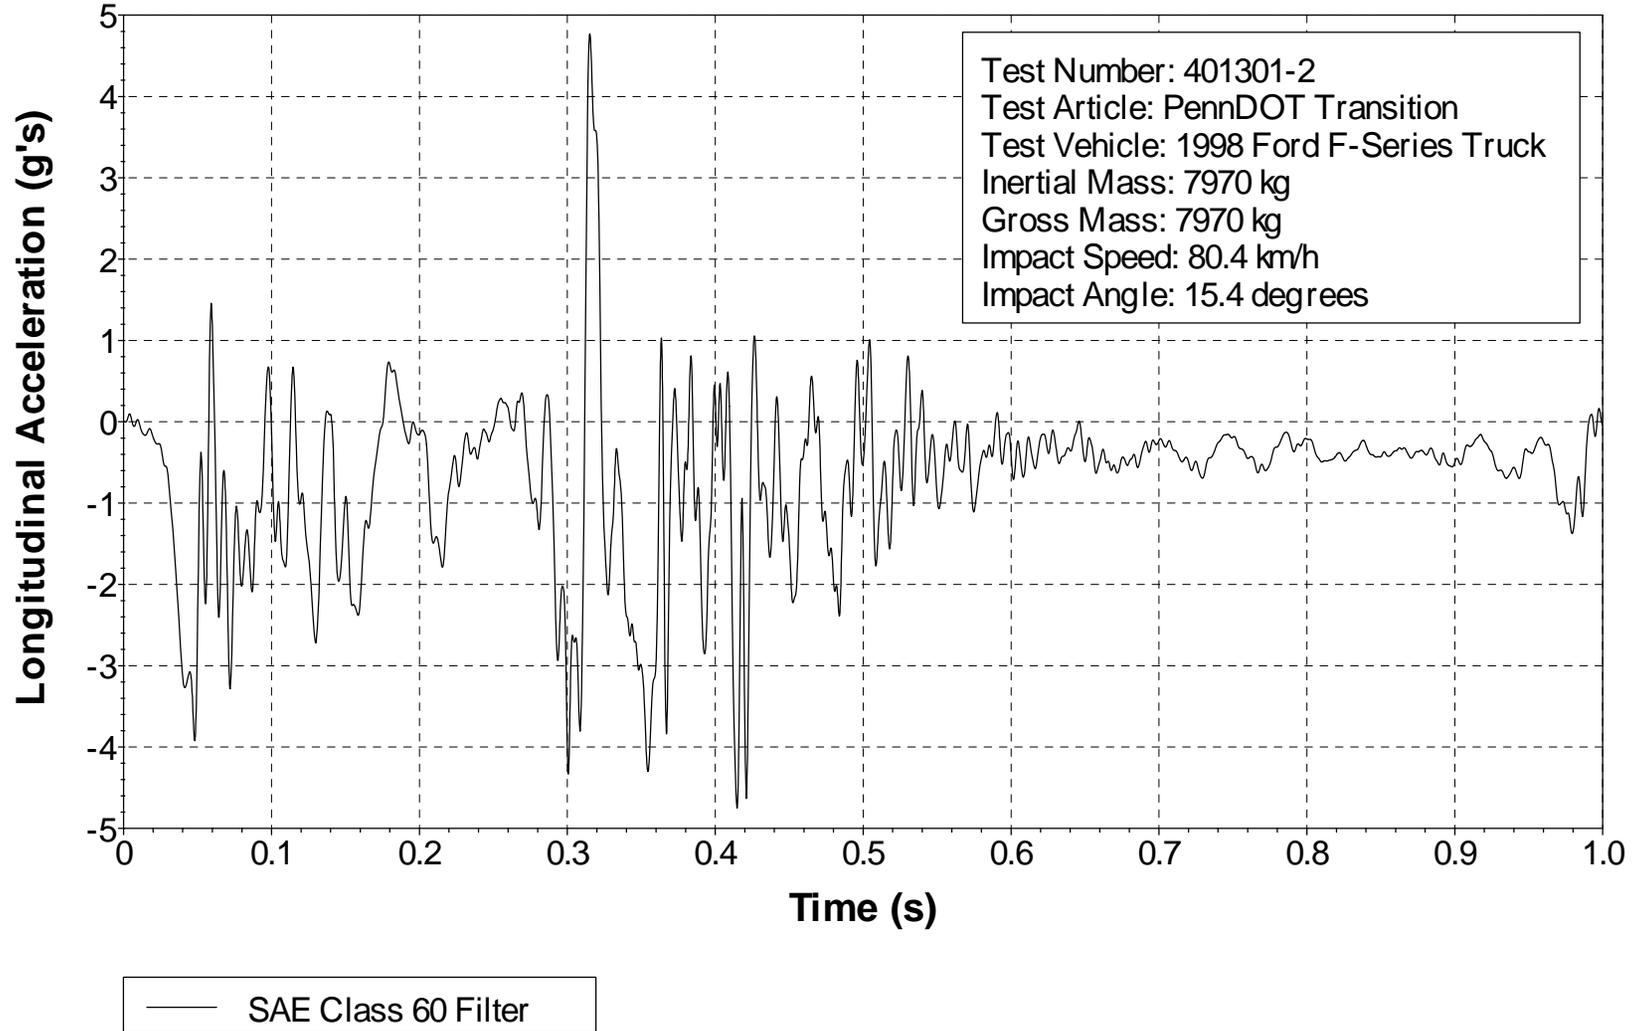
Figure 30. Vehicle longitudinal accelerometer trace for test 401301-2 (accelerometer located over rear axle).

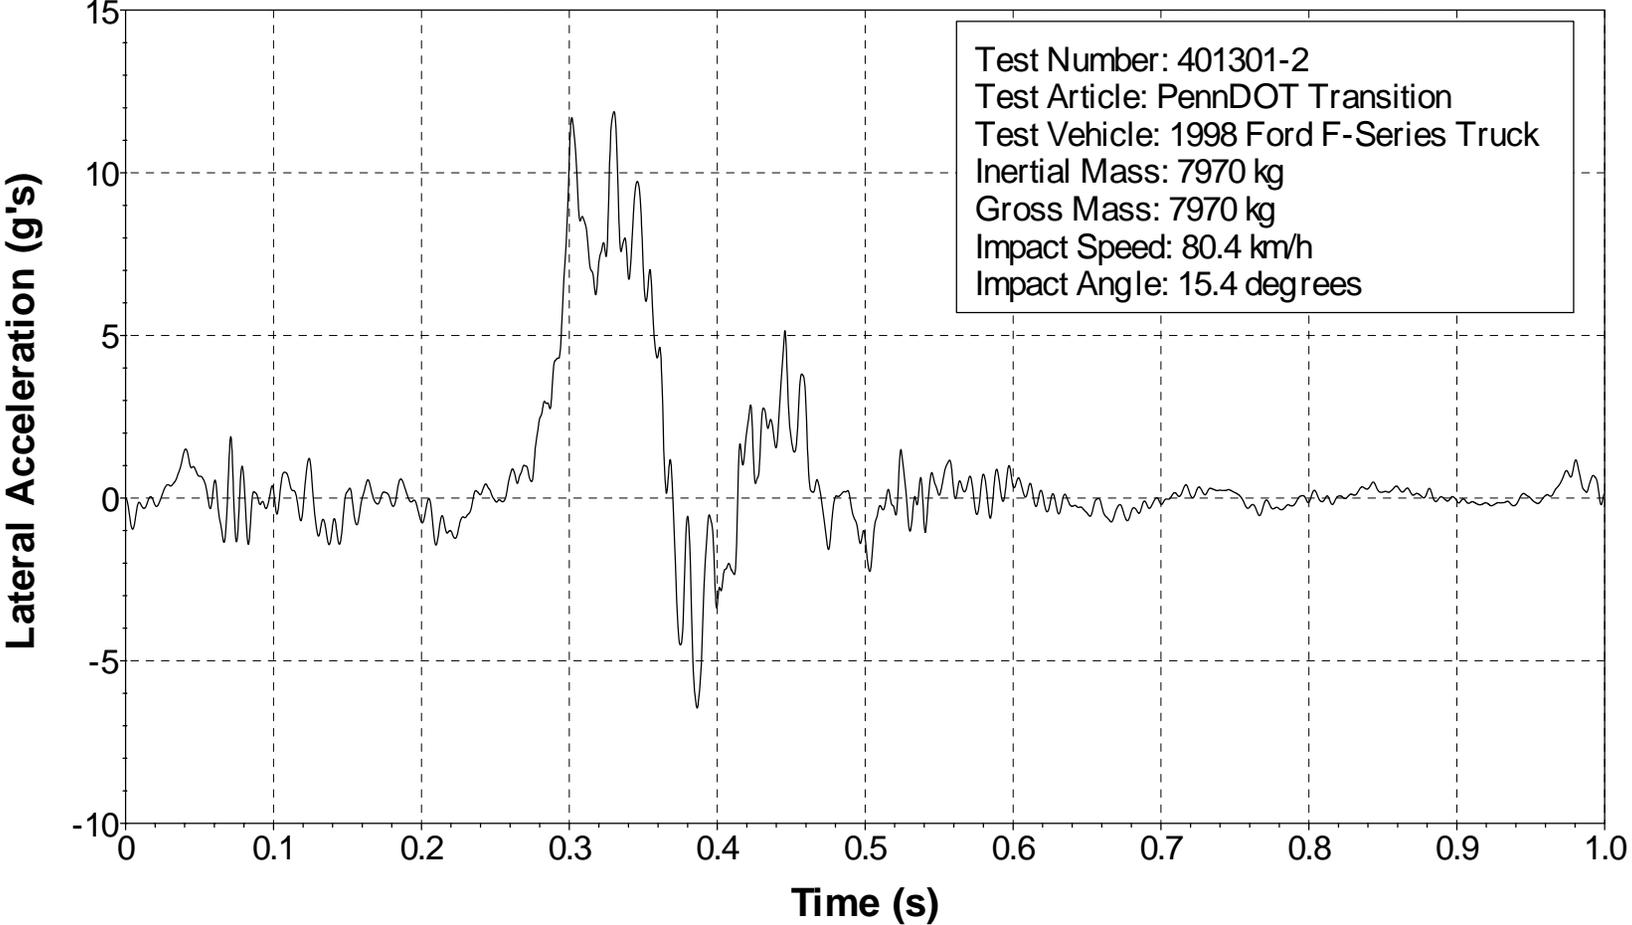
Figure 31. Vehicle lateral accelerometer trace for test 401301-2 (accelerometer located over rear axle).

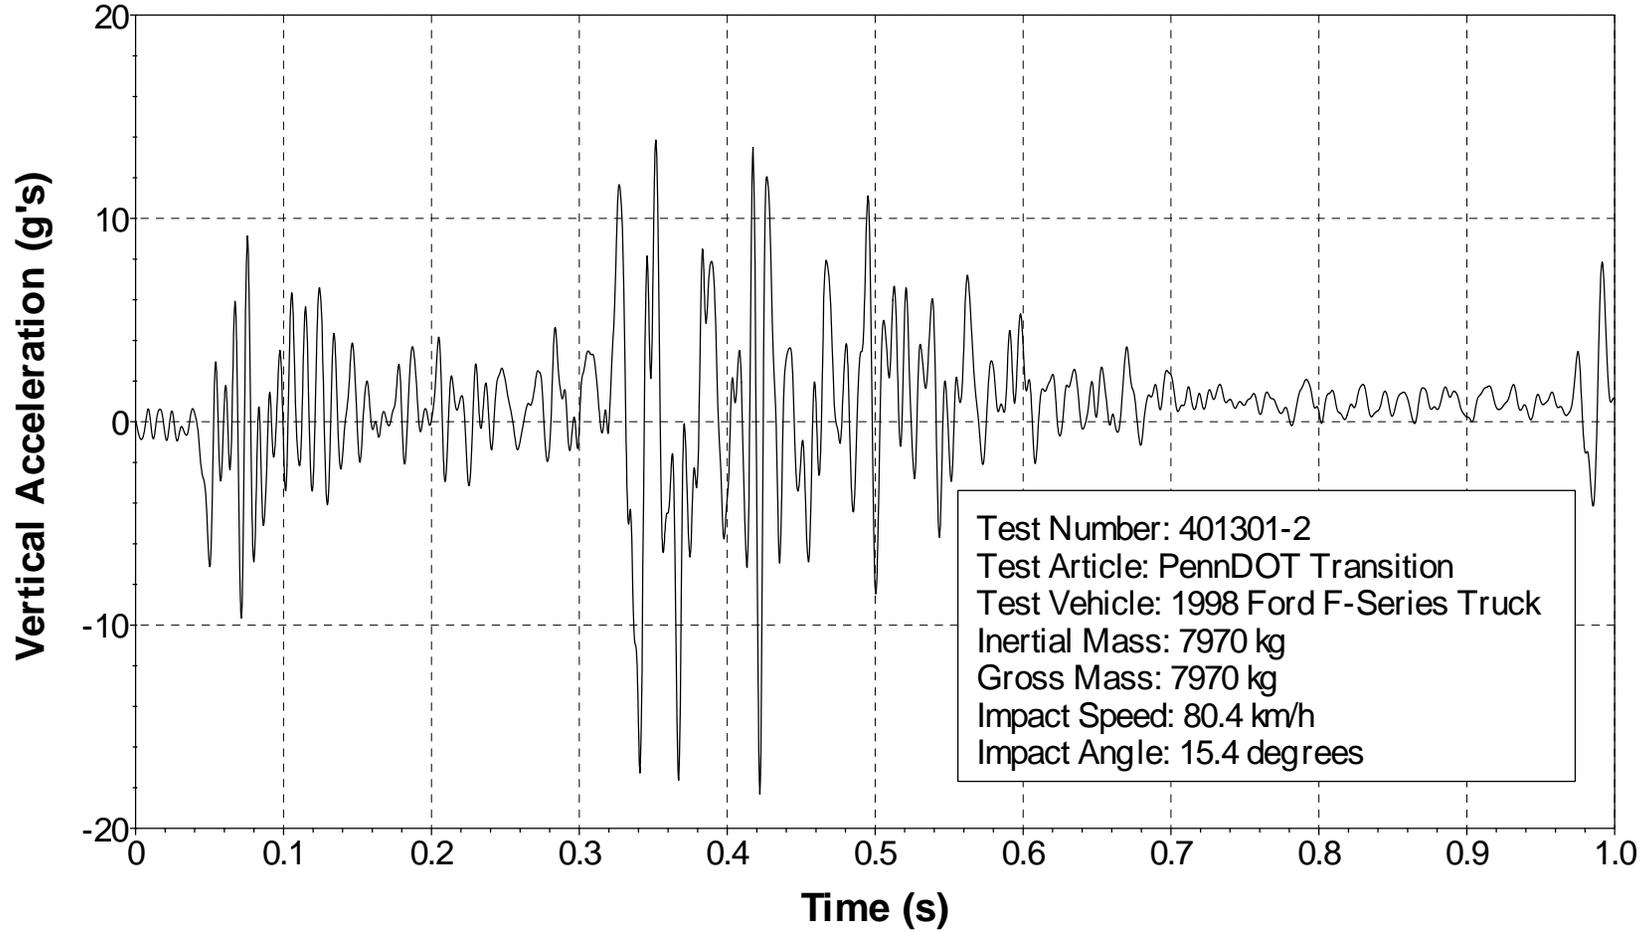
Figure 32. Vehicle vertical accelerometer trace for test 401301-2 (accelerometer located over rear axle).
