# **I-99 Environmental Research**

## **Final Report**

### **Executive Summaries**

**The University of Pittsburgh  
Civil & Environmental Engineering Department**

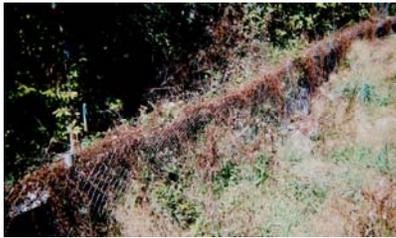
## Heavy Vegetation no fabric on fence

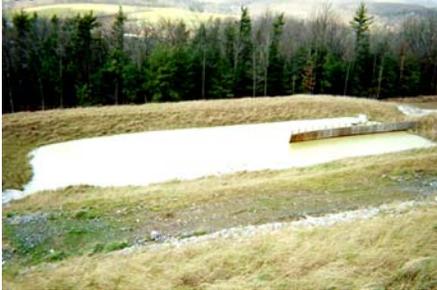
## Typical I-99 Sedimentation Basin

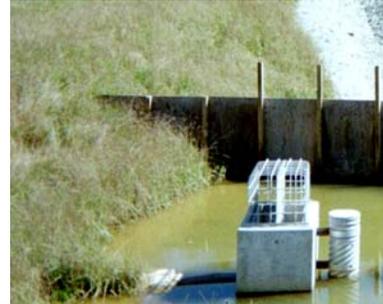
## I-99 Inlet Protection Structure

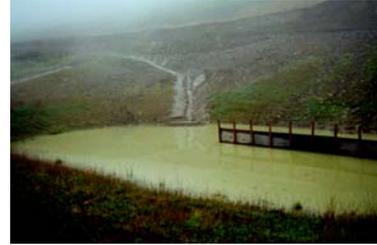
## Basins - Observations

SB-14 showing green algae growth as a possible consequence of nutrient runoff from erosion control mats

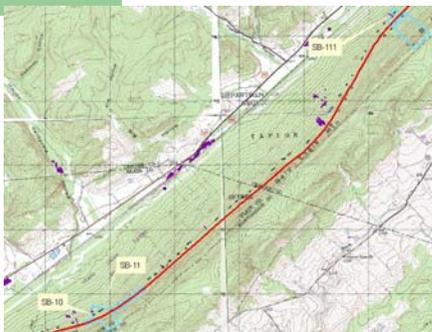
## Location of Test Watersheds

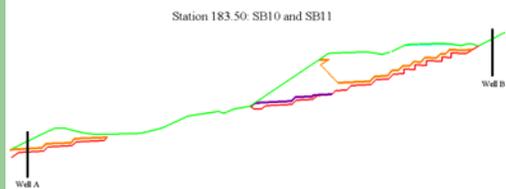
## Section at Station 183+50
