# Joint Deterioration Cause & Mitigation

51<sup>st</sup> Annual Mid-Atlantic Quality Assurance Workshop

National Concrete Pavement  
Technology Center

Steven L. Tritsch, P.E.  
stritsch@iastate.edu

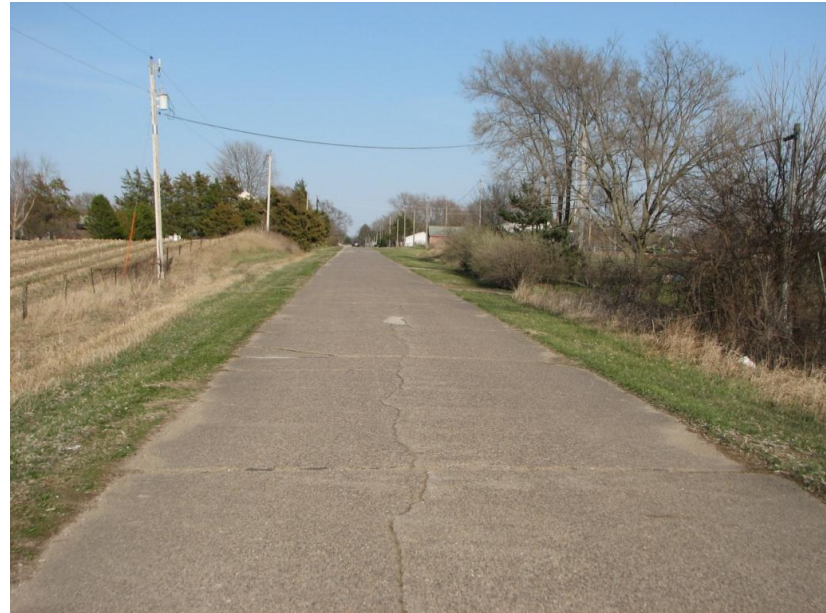
Built in 1914, 18' wide, no longitudinal joint, 25' formed transverse joints

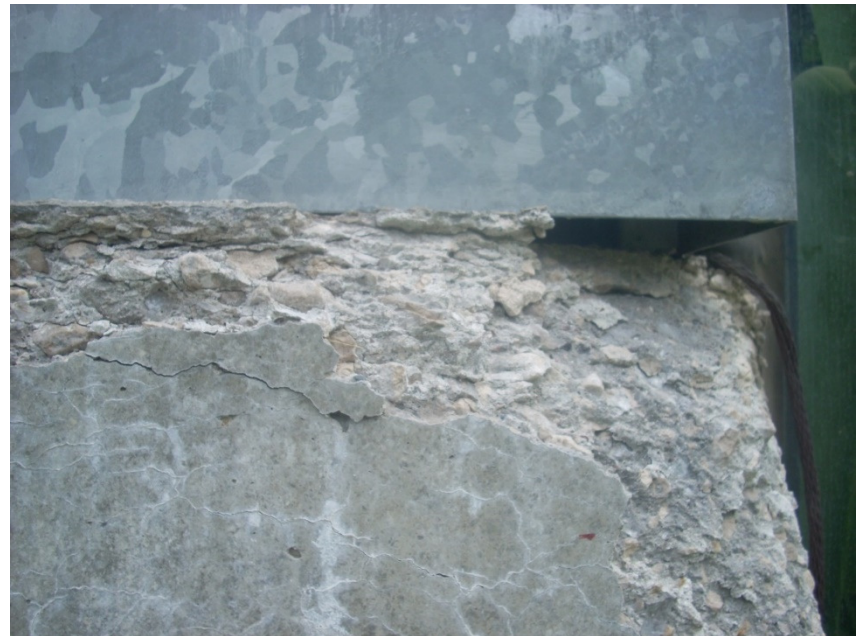
Marginal w/cm

Marginal air

Poor local drainage

Leads to rapid saturation

Shadowing

Thin flakes

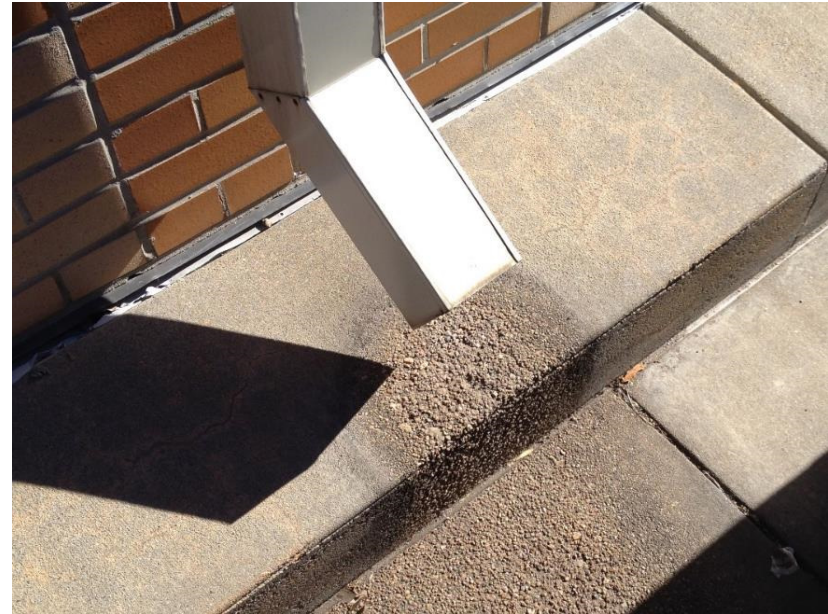
Damage occurs where the concrete does not dry out

Water needs space to expand into

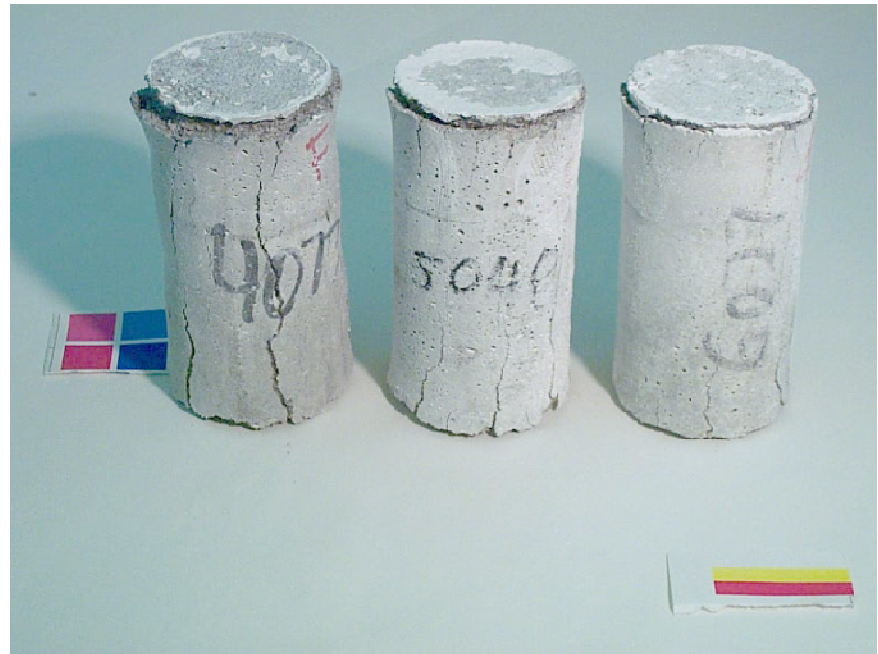
- Calcium hydroxide
- Chlorides from salts ( $\text{MgCl}_2$  and  $\text{CaCl}_2$ )
- Expands >30%
- At  $\sim 40^\circ\text{F}$

$\text{CaCl}_2$  @  $40^\circ\text{F}$

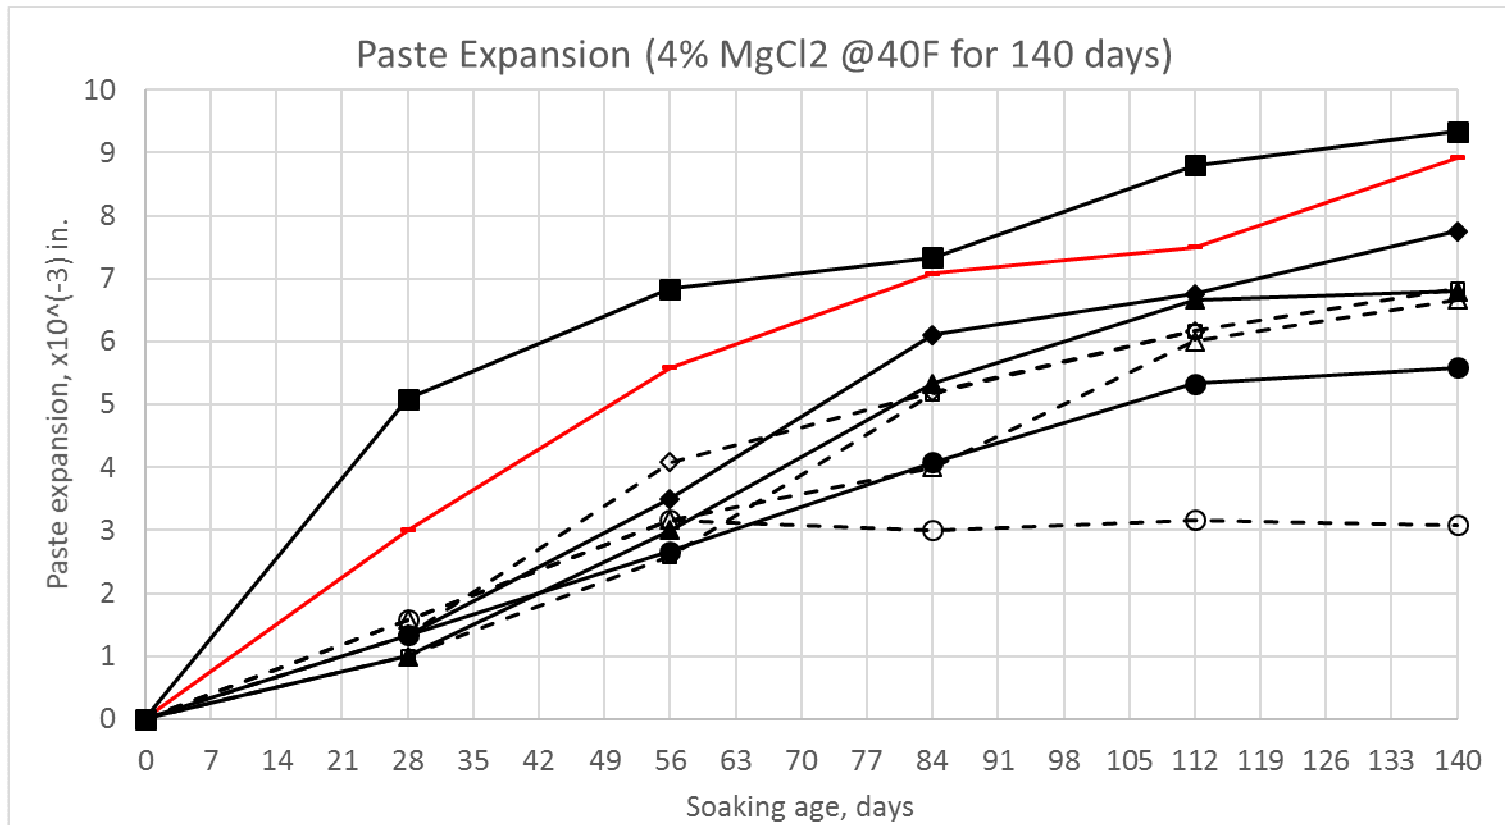
## Calcium oxychloride - Sealers can help

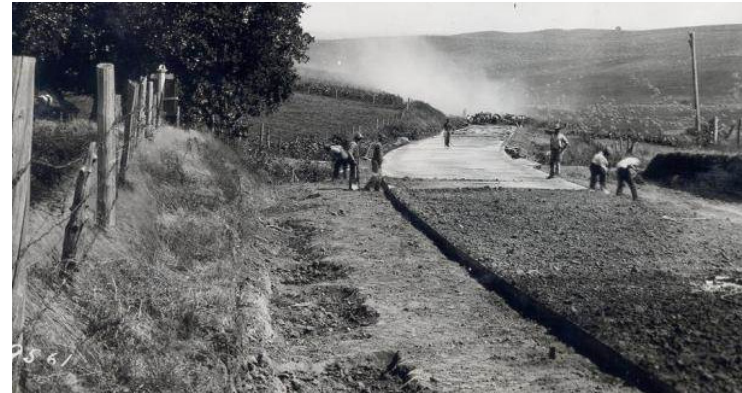
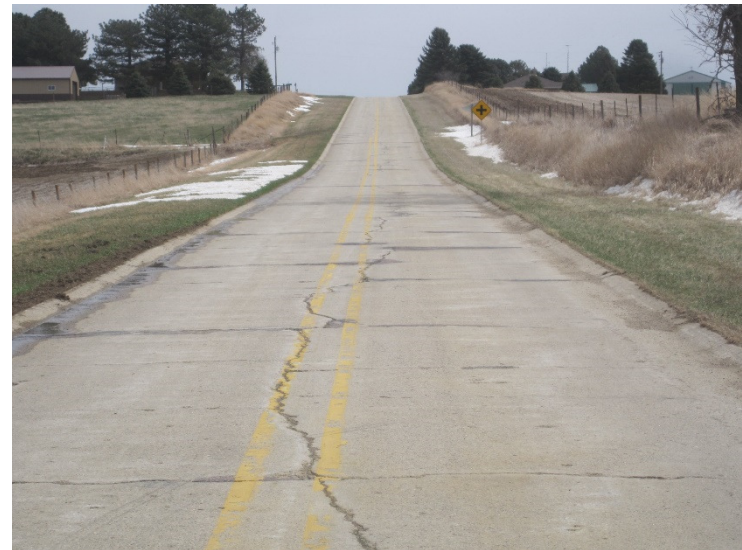
Old US 20, Woodbury County, 2014

Built in 1921, 18' wide, 7-8-7 slab, no jts
