*Innovative Infrared Nondestructive Evaluation
Technologies*

Infrared Ultra-Time Domain System IR-UTD

Infrared Coating Inspection System IR-CIS

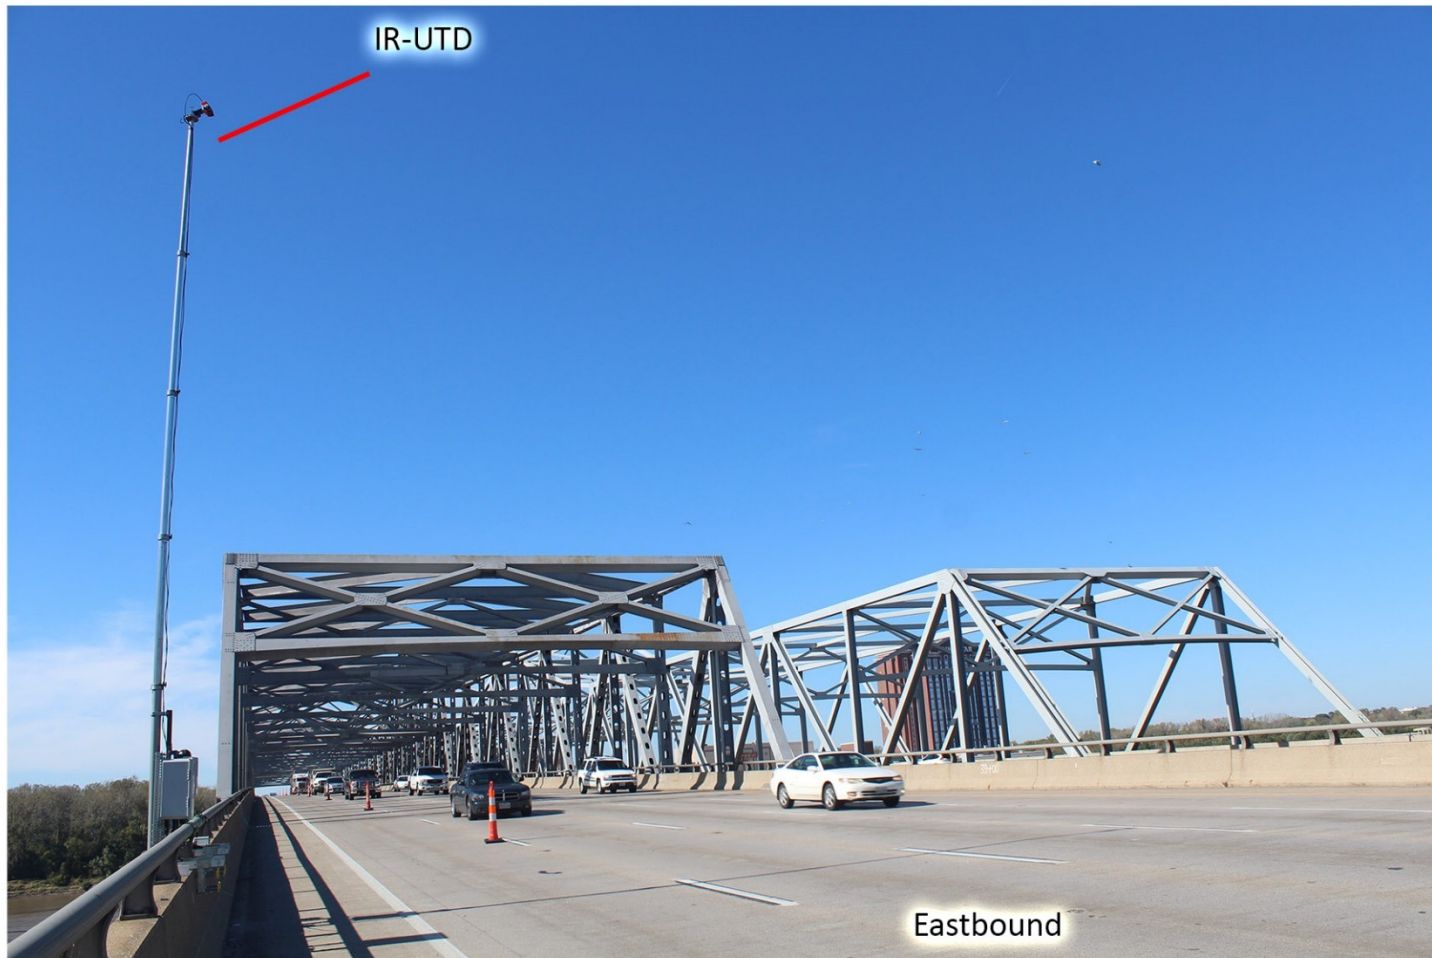
IR-UTD Concept

St. Louis, MO

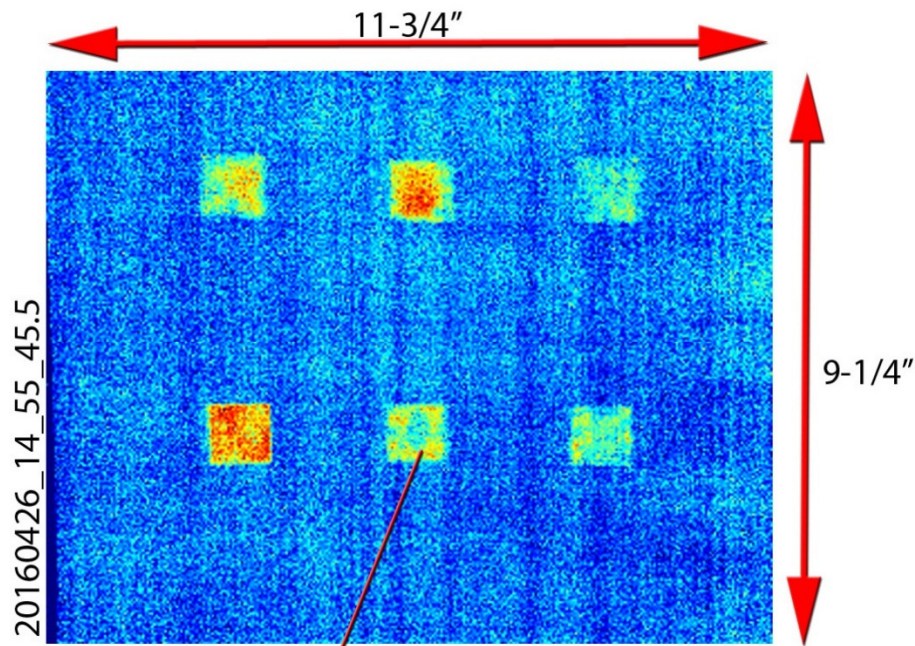
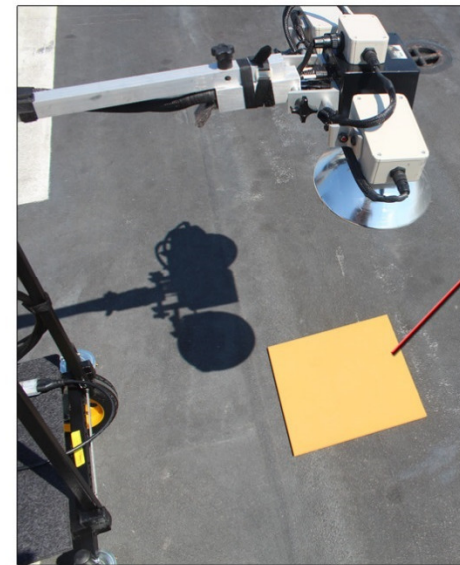
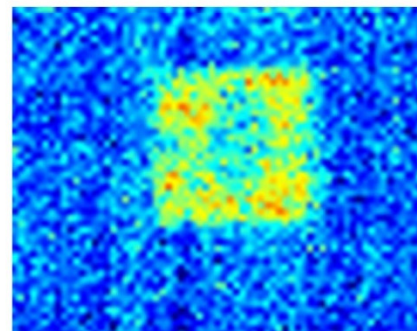
Image Details

12" x 12"
Plate

Distance = 29.5"

1" x 1"

0.036" resolution

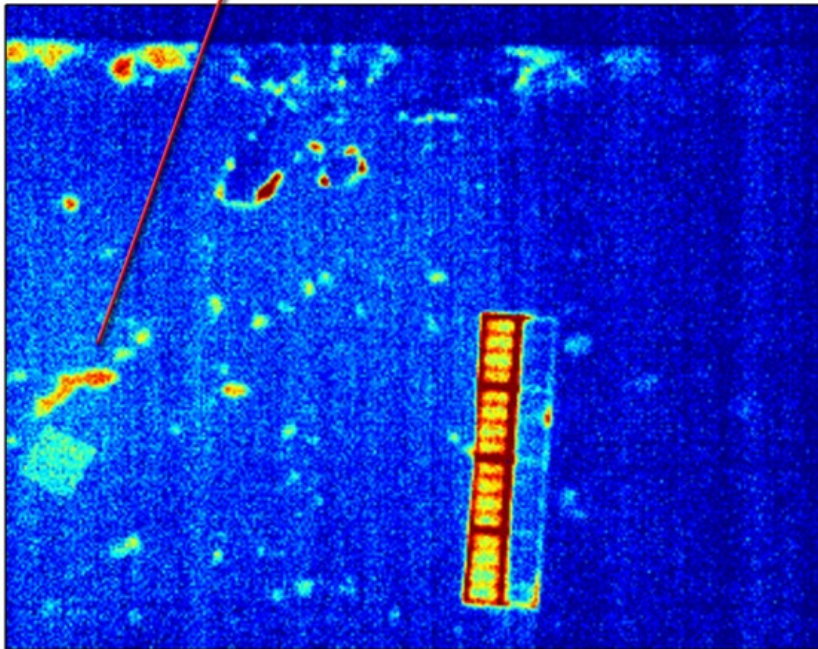
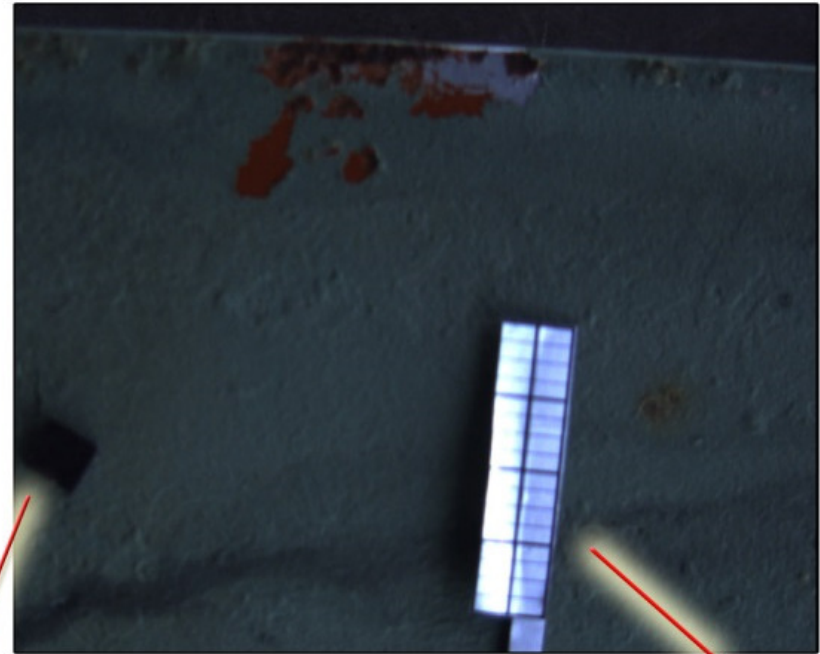
Example: Over-coating Defects

Defect of interest

Data Set: 20140721_16_01_39.7

Marker

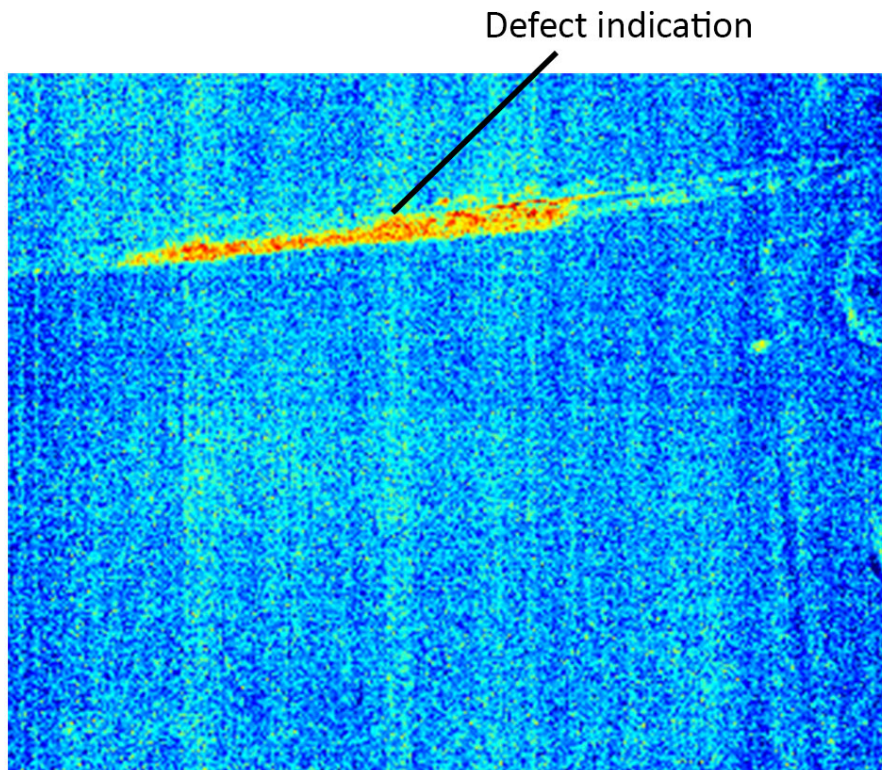
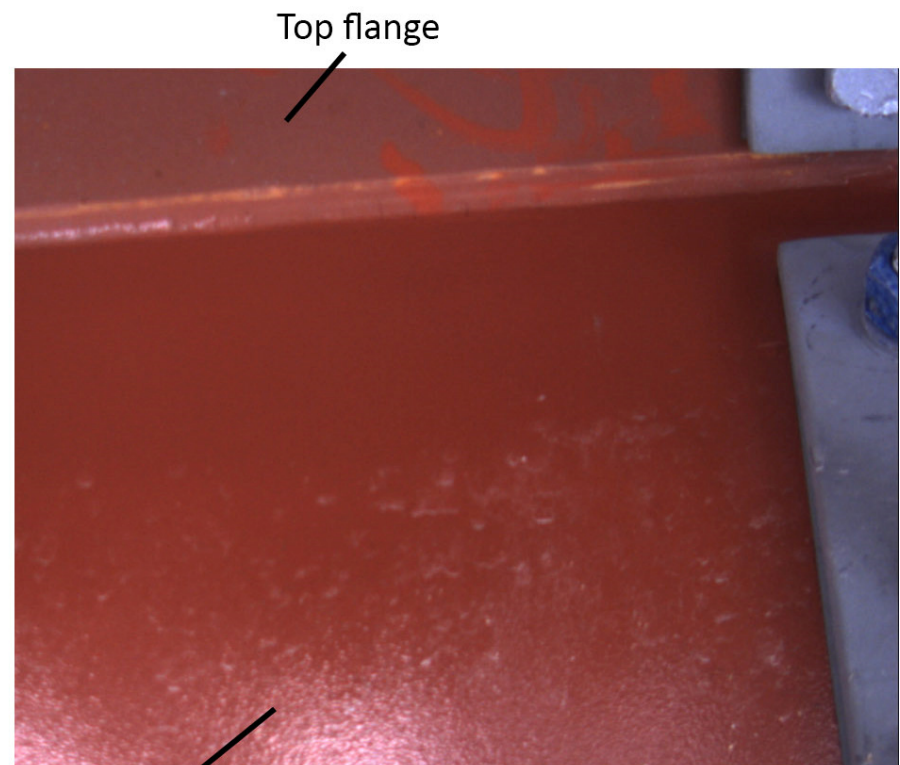
Example: Weld

20170721_10_18_50.9
