**Enhancing Pavement Quality and Longevity –  
Simple Solutions to Common Infrastructure Problems  
QAW 2020**

**Grover Allen, Ph.D., P.E.**

**BLACKLIDGE**

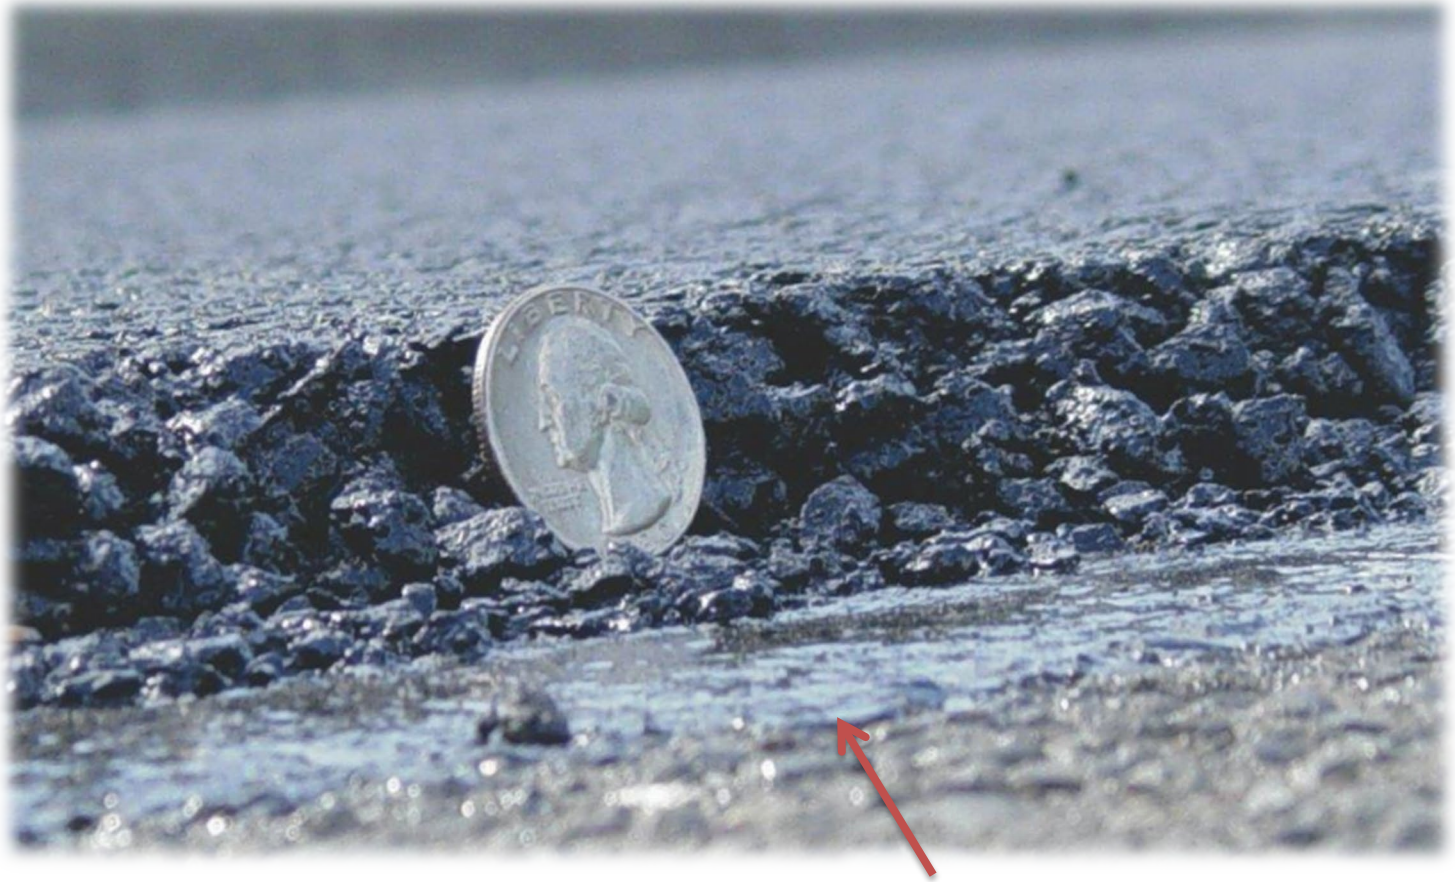
# Tack Coat

A light application of asphalt or asphalt emulsion  
Used to promote the bond between pavement layers  
Essential to overall pavement performance

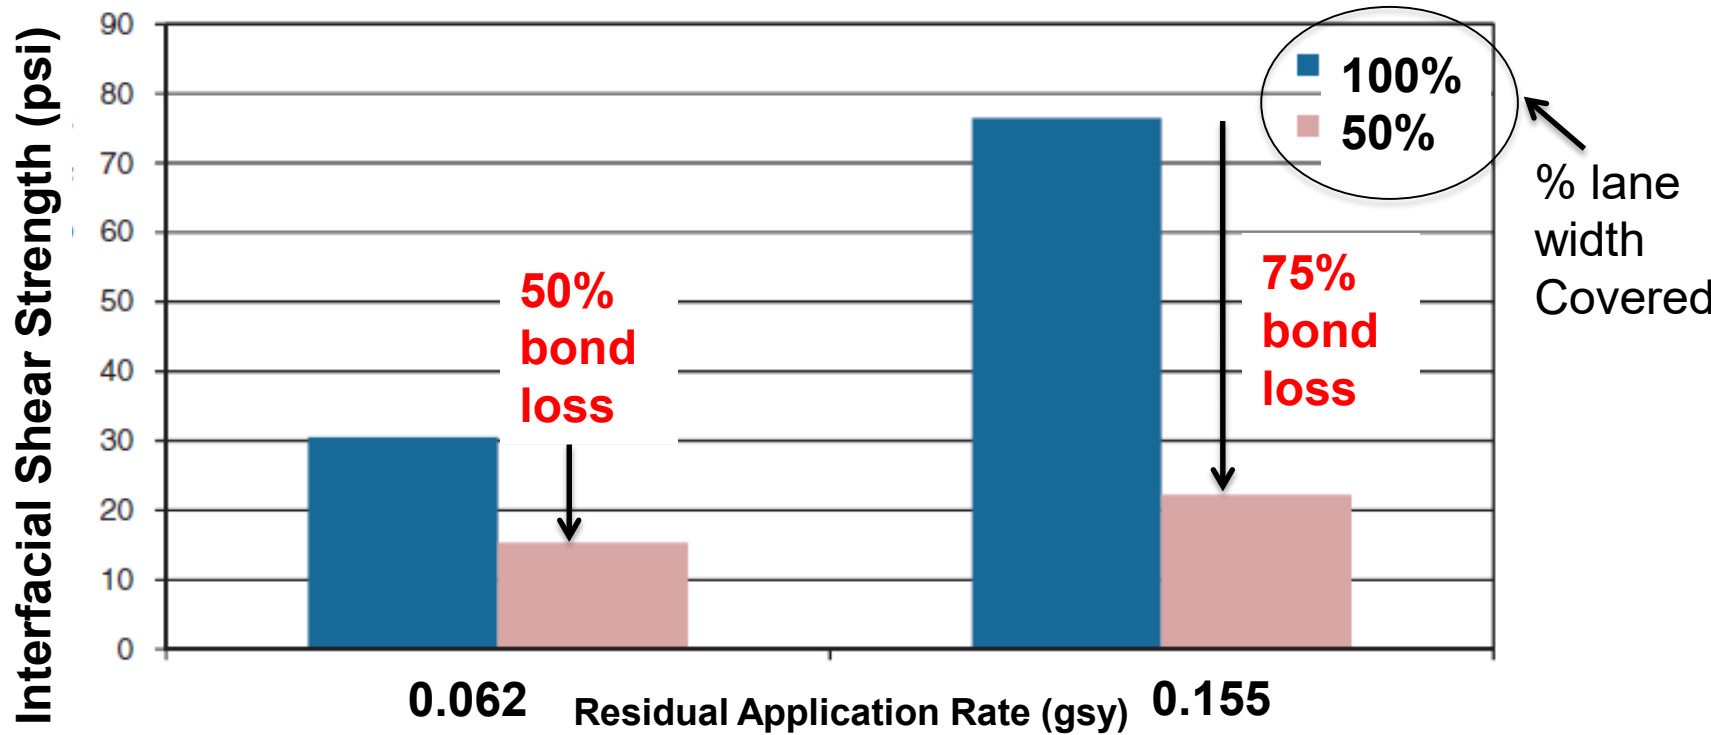
Figure 66. Effect of tack coat coverage on ISS.

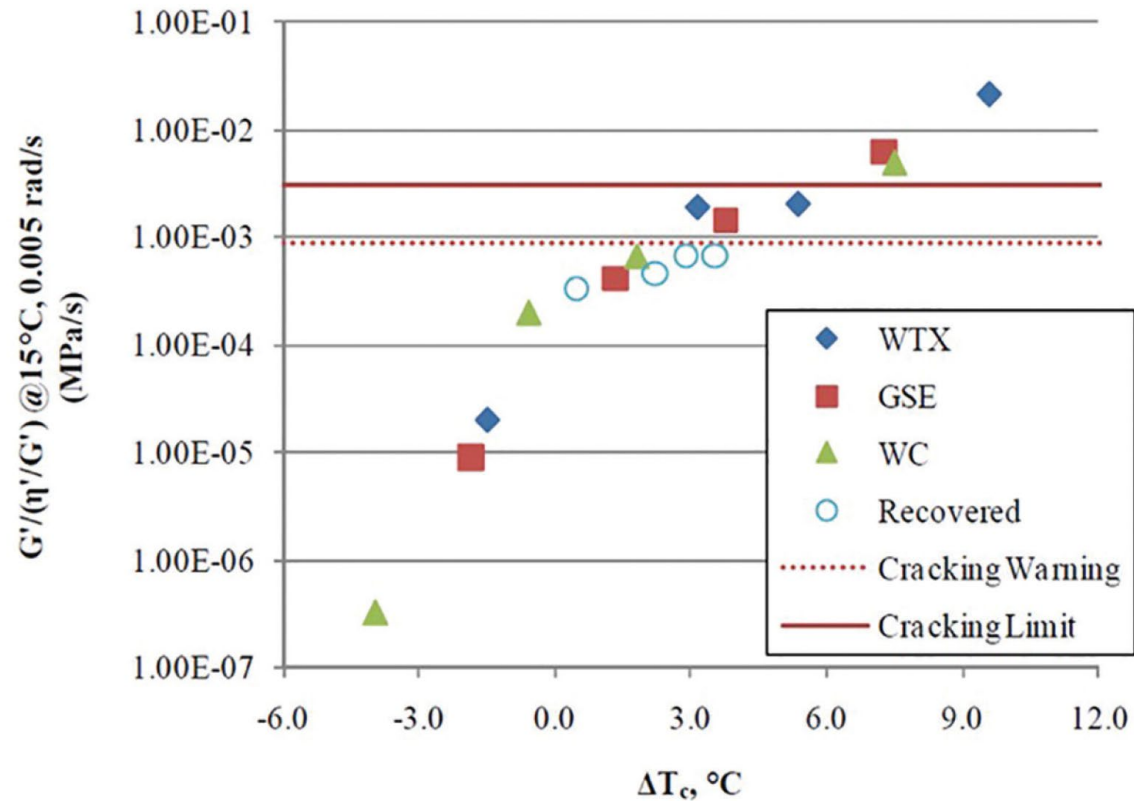
FIGURE 6. Relationship Between  $(G'/(\eta'/G'))$  and  $\Delta T_c$  Taken from (Anderson, 2011)

In research published in 2011 Anderson, et al (Anderson, 2011) investigated the rheological and ductility characteristics of PAV aged binders and binders recovered from aged air field cores to understand the relationship of those rheological properties to the level of non-load associated pavement distress. Key findings from that research suggested a cracking warning limit based on the difference between the BBR m-value critical temperature and the BBR S value critical temperature (defined as  $\Delta T_c$ ) at a  $\Delta T_c$  value of +2.5°C and a cracking limit at a  $\Delta T_c$  of +5°C. This concept is shown in FIGURE 6, taken from the Anderson, et. al paper. FIGURE 6 shows the relationship between the Glover parameter of  $(G'/(\eta'/G'))$  and  $\Delta T_c$ . Based on this work the authors concluded that a  $\Delta T_c$  value of 5°C corresponded to a value beyond which the binder ductility would have decreased to a point where durability had been lost.

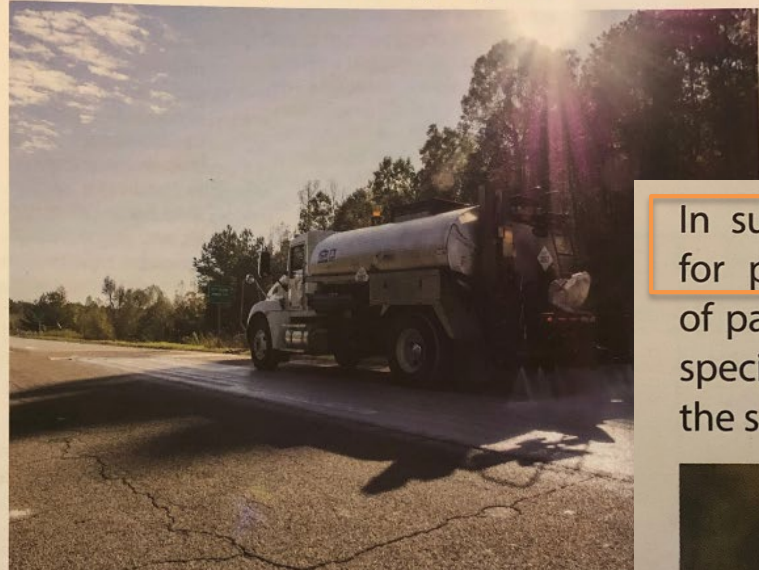
Delta Mist™ rejuvenator is applied to Section S3 of the NCAT Test Track.

A rejuvenating fog seal is a type of pavement preservation treatment applied to an existing asphalt pavement surface to preserve its functional and structural integrity and delay a more costly rehabilitation treatment in the near future.

A fog seal consists of a slow setting asphalt emulsion (e.g., SS-1, SS-1h, CSS-1 and CSS-1h) diluted with one to four equal parts of water and applied at rates between 0.06 - 0.13 gal/ yd<sup>2</sup> on an existing pavement surface without a cover aggregate. It is intended to penetrate into the surface pores of the pavement to seal very small cracks and surface voids as well as coat surface aggregate particles. Pavement surfaces with high void contents are more

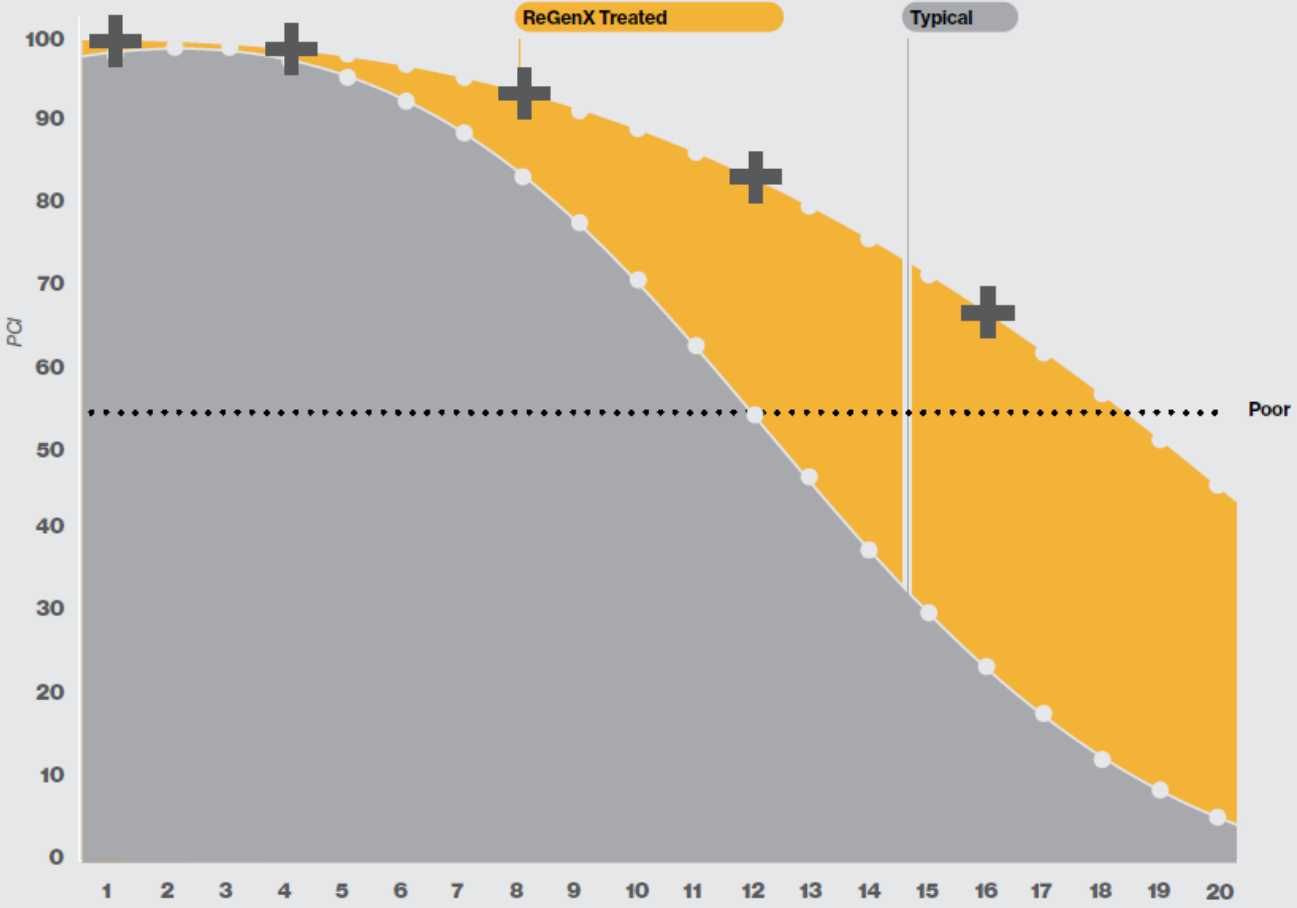
Applying ReGenX every 4-5 years in a routine maintenance program will extend the life of your pavement investment by many years.

Mixtures contained 20% RAP + antistrip
