PROJECT FACT SHEET

U.S. 1 ROOSEVELT BOULEVARD CROSSOVER LANES

CITY OF PHILADELPHIA, PHILADELPHIA COUNTY

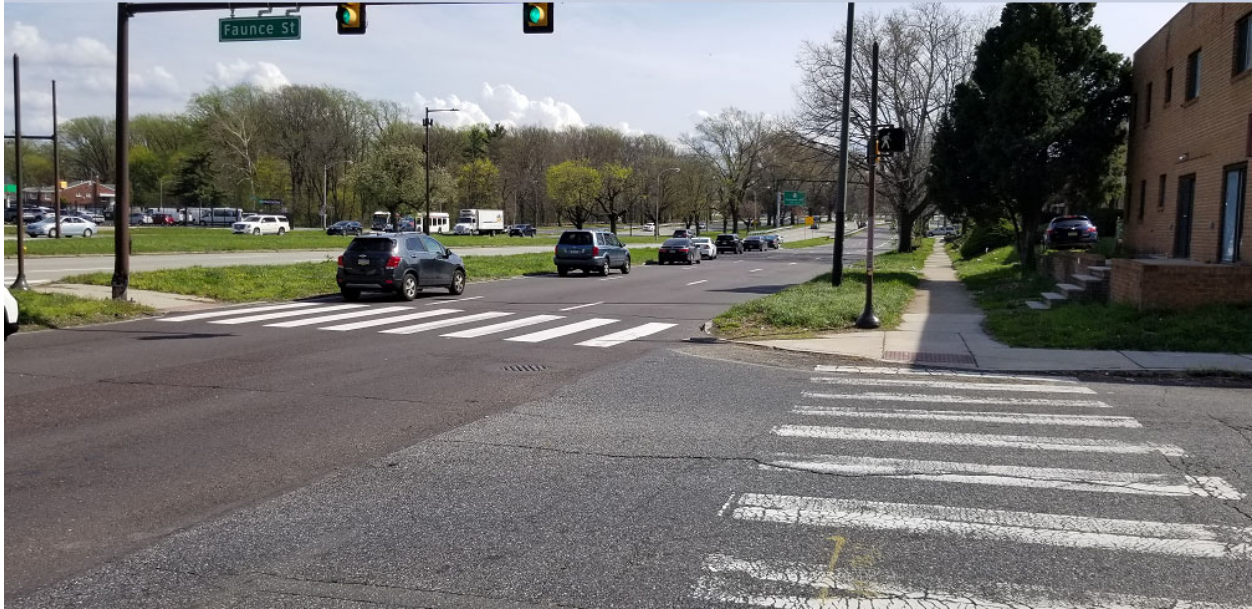
Photo 1: Southbound view of crossover congestion adjacent to U.S. 1 (Roosevelt Boulevard) and Faunce Street Intersection (Location #1)

- Existing ADA ramps, including refuge islands, are not compliant with PennDOT standards.
- Existing crossover length is inadequate for queuing and movement of vehicles between the outer and inner lanes.

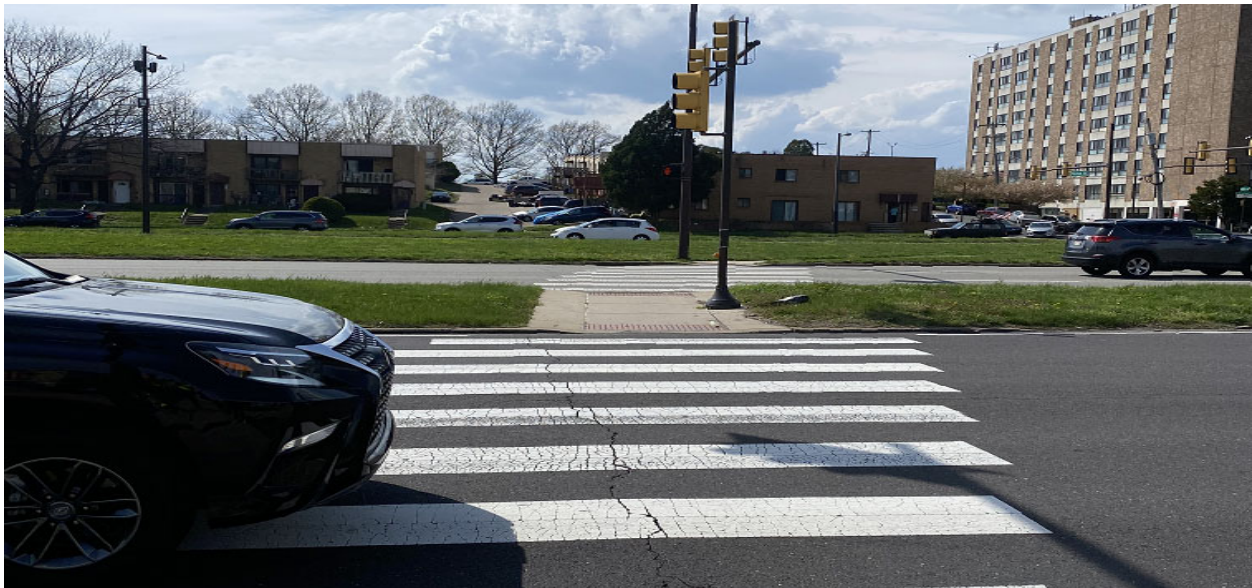
Photo 2: View of crosswalk alignment and pedestrian crossing refuge from East to West at the intersection of U.S. 1 (Roosevelt Boulevard) and Faunce Street (Location #1)

- Pedestrian crosswalk from the intersection of Revere Street and U.S. 1 (Roosevelt Boulevard) southbound to Faunce Street and U.S. 1 (Roosevelt Boulevard) northbound is unsafe; four fatal pedestrian crashes were documented in the past five years at this location.

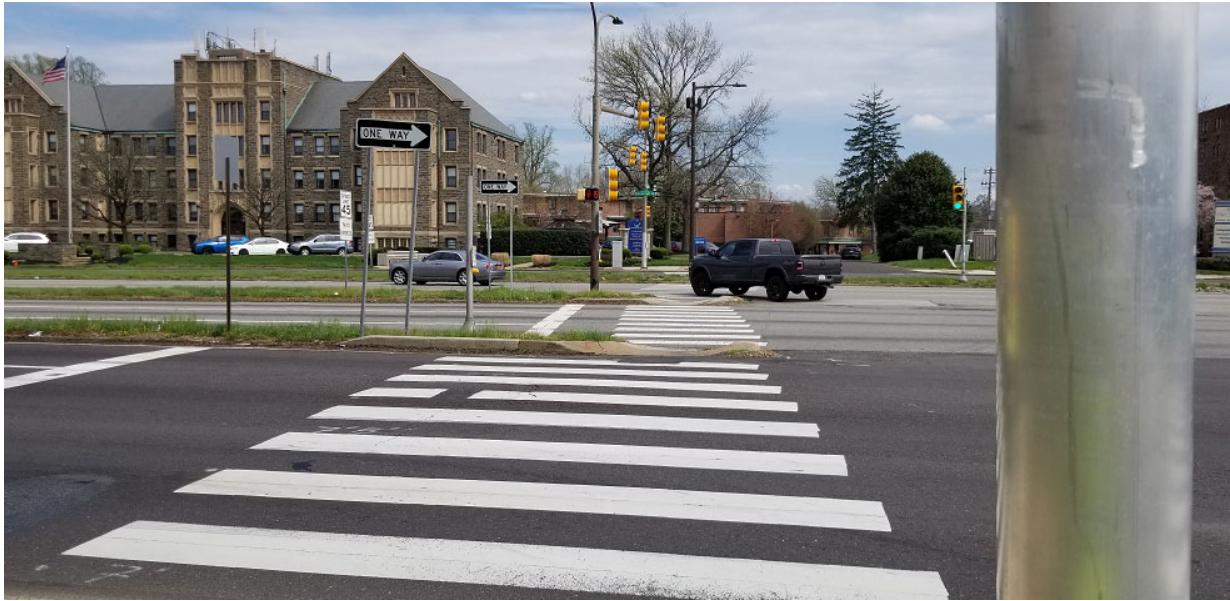
Photo 3: View of existing crosswalk alignment and pedestrian crossing refuge from West to East at the intersection of U.S. 1 (Roosevelt Boulevard) and Strahle Street (Location #2)

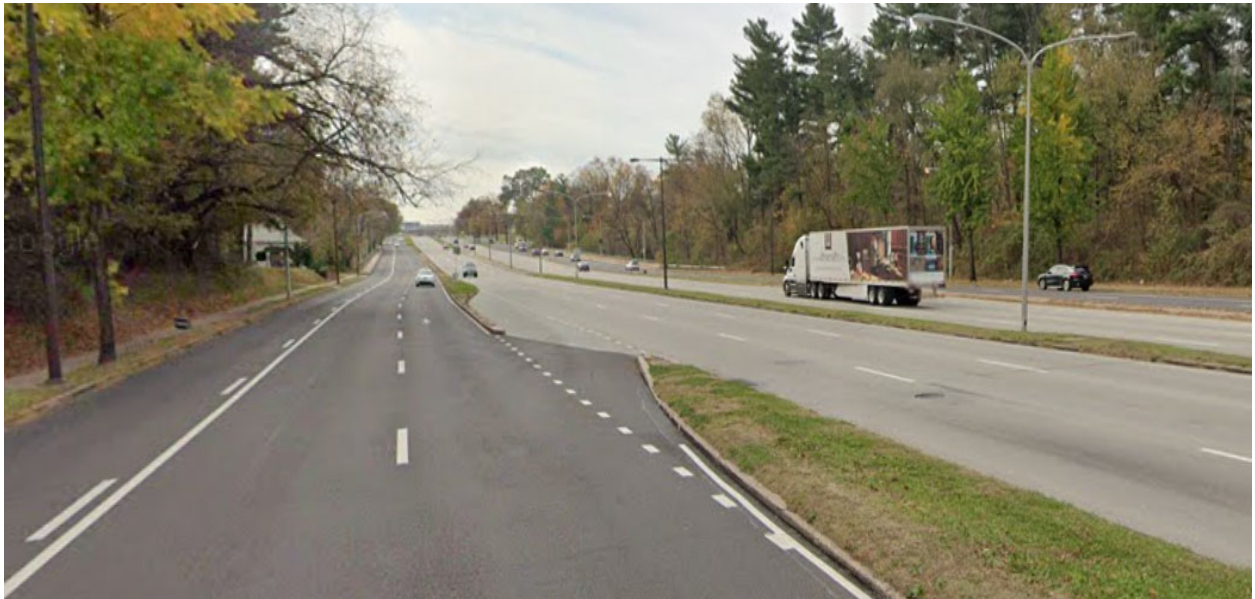
Photo 4: View of existing crossover at Winchester Avenue (Source: Google Earth) (Location #3)

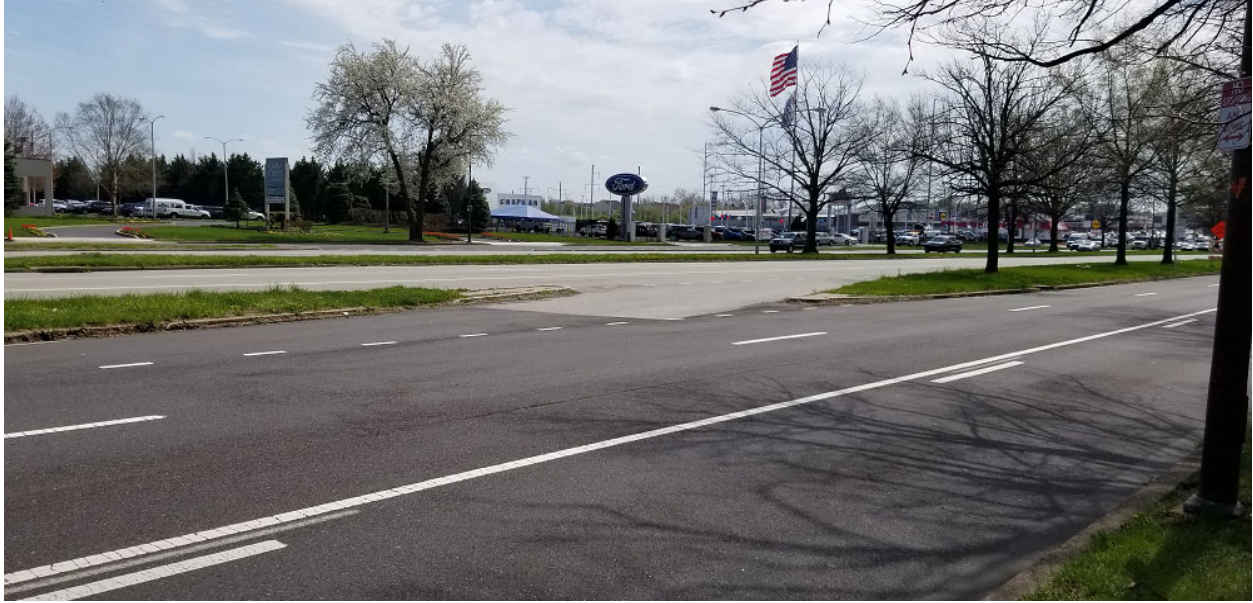
**Photo 5: View of existing southbound crossover adjacent to the intersection of U.S. 1 (Roosevelt Boulevard) and Michener Street.
(Location #4)**

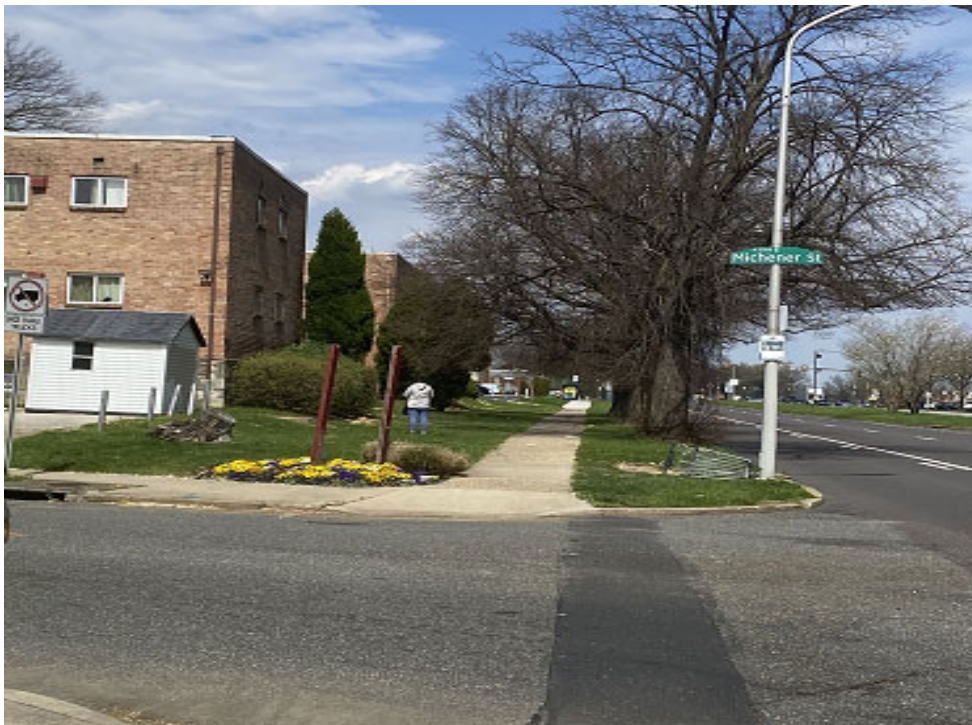
**Photo 6: View of existing vegetation and possible sight obstruction for vehicles conducting a right turning movement from Michener Street onto U.S. 1 (Roosevelt Boulevard).
(Location #4)**

- Inadequate sight distance at the intersection of Michener Street and U.S. 1 (Roosevelt Boulevard) due to existing vegetation (*see photo 6*).
- Signal equipment at multiple intersections is outdated and does not meet PennDOT standards.

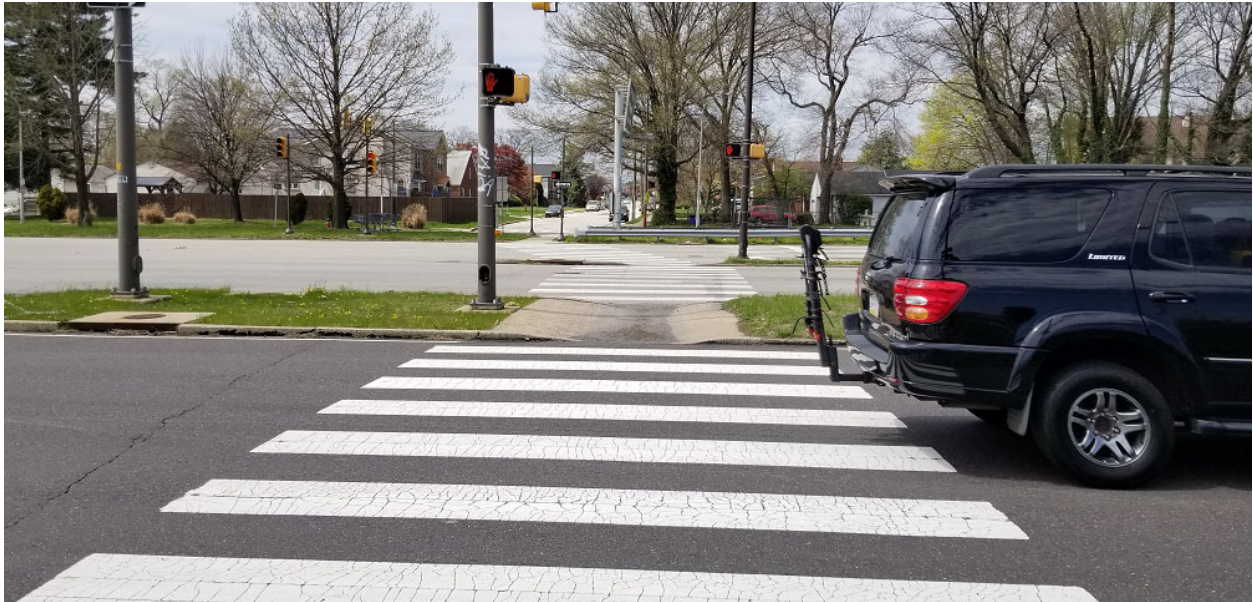
Photo 7: View of existing crosswalk alignment and pedestrian crossing refuge from East to West adjacent to the intersection of U.S. 1 (Roosevelt Boulevard) and Fulmer Street (Location #5)

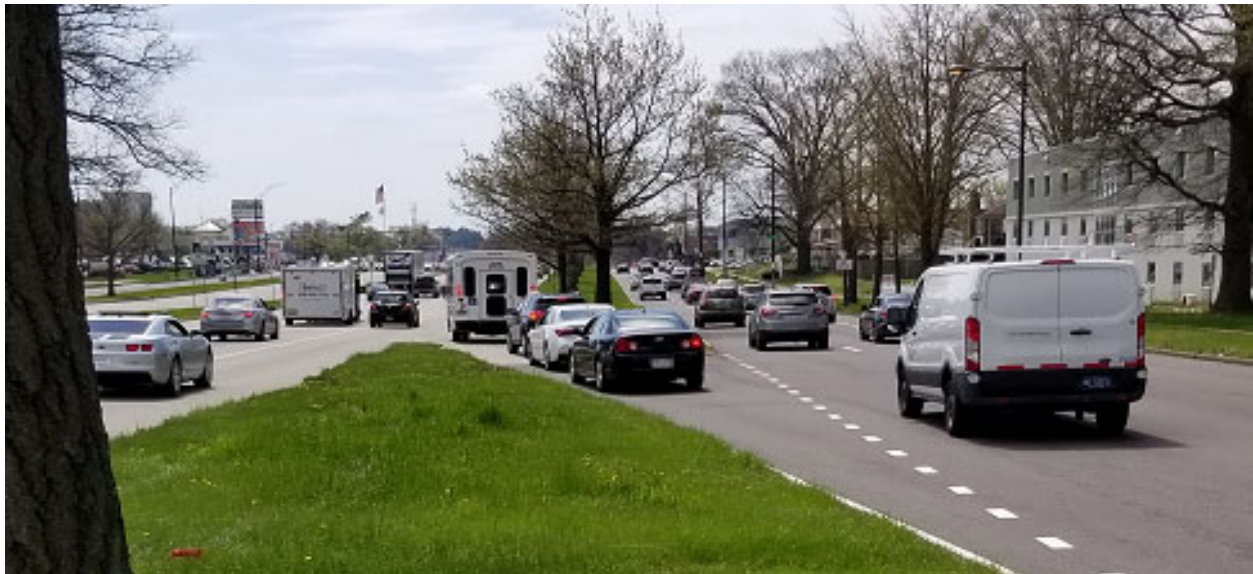
Photo 8: View of the southbound crossover adjacent to the intersection of U.S. 1 (Roosevelt Boulevard) and Fulmer Street (Location #5)
