2020 MID-ATLANTIC QUALITY ASSURANCE WORKSHOP – WILLIAMSBURG, VIRGINIA

Micropile Supported Slab for Sinkhole Mitigation on S.R. 422

Frank P. Namatka, P.E.
Chief Geotechnical Engineer

February 12, 2020

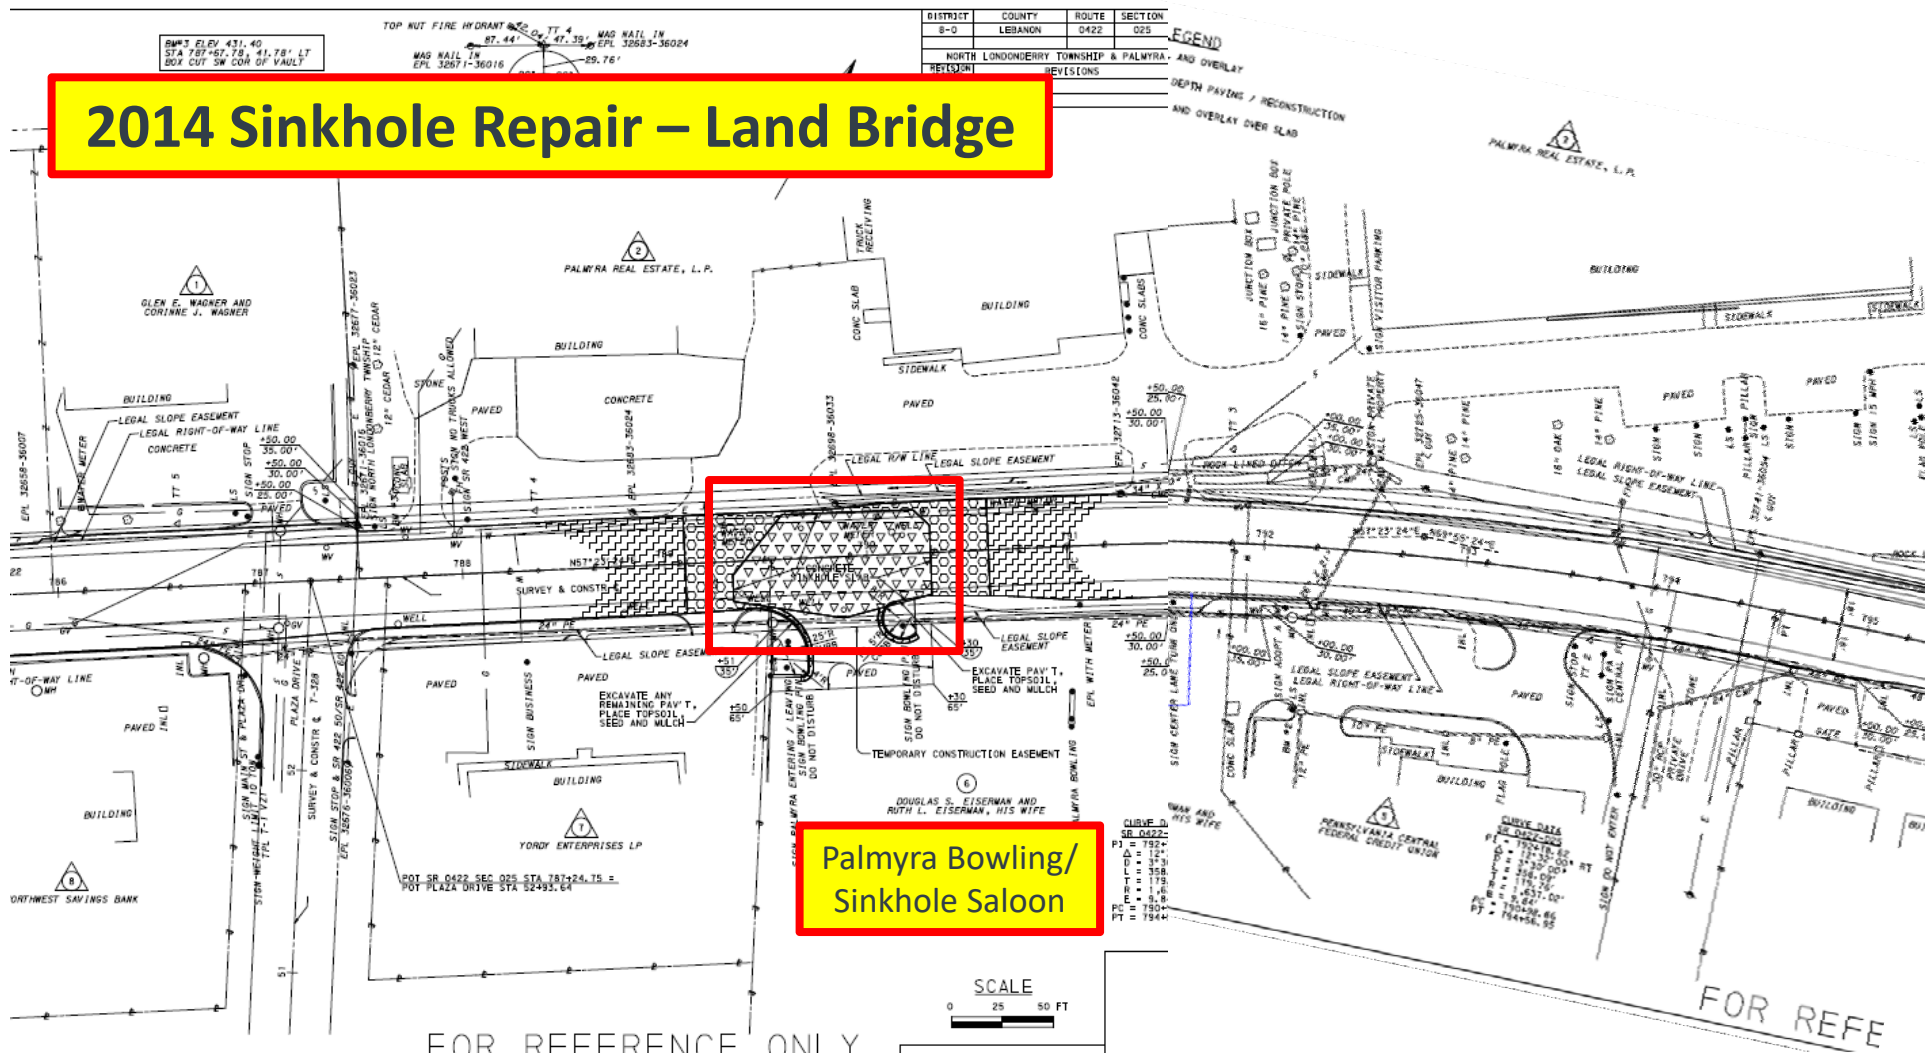
2014 Sinkhole Repair – Land Bridge

- Concrete Slab with Edge Beams

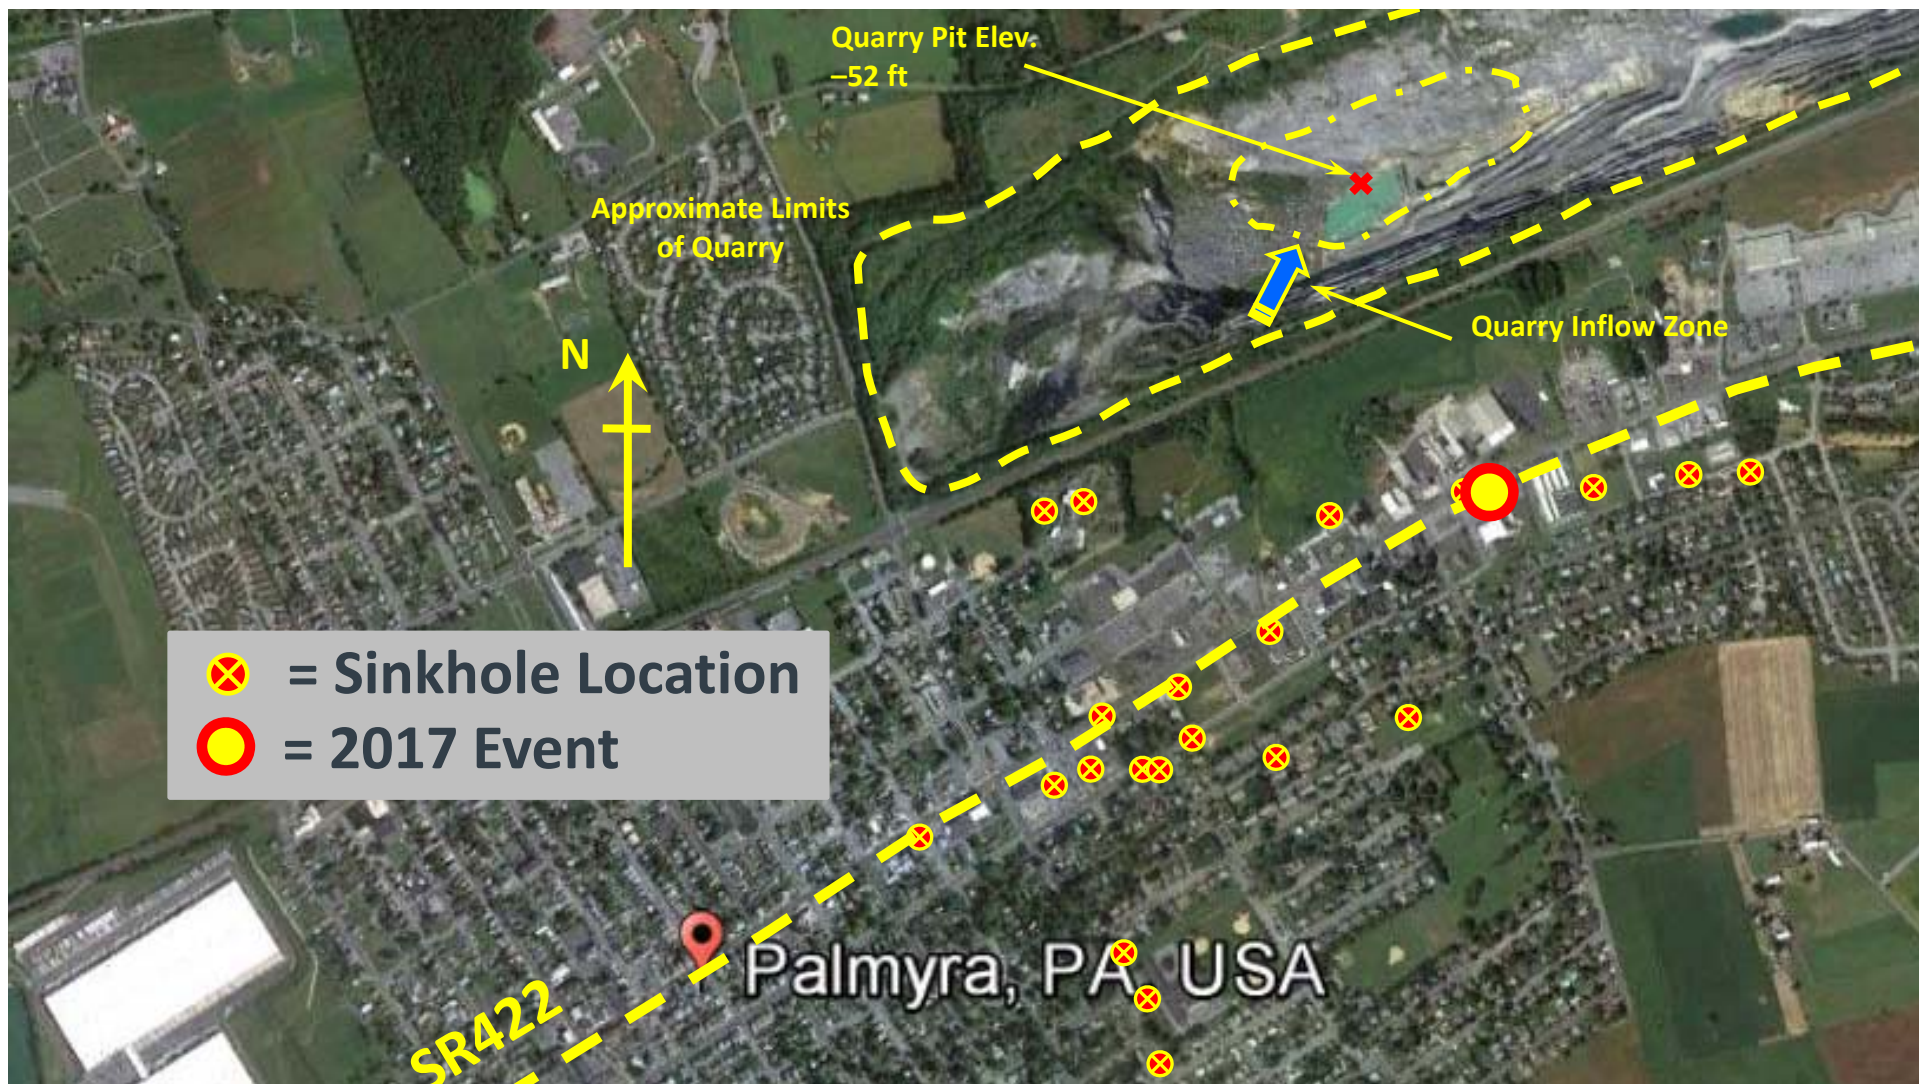
2017 Sinkhole Repair – Safety Net (i.e., layers of geosynthetics)

- PennDOT considered many conceptual designs:
 - “Buried Bridge”, similar to 2014 repair
 - Structural Concrete Slab
 - Unreinforced Concrete Slab
- PennDOT not comfortable with closing SR 422 for long duration. Developed Sinkhole Safety Net concept
- Intention is to mitigate and minimize the impact of future sinkholes
- **Not intended** to prevent future sinkhole events
- Provides means to better manage future events

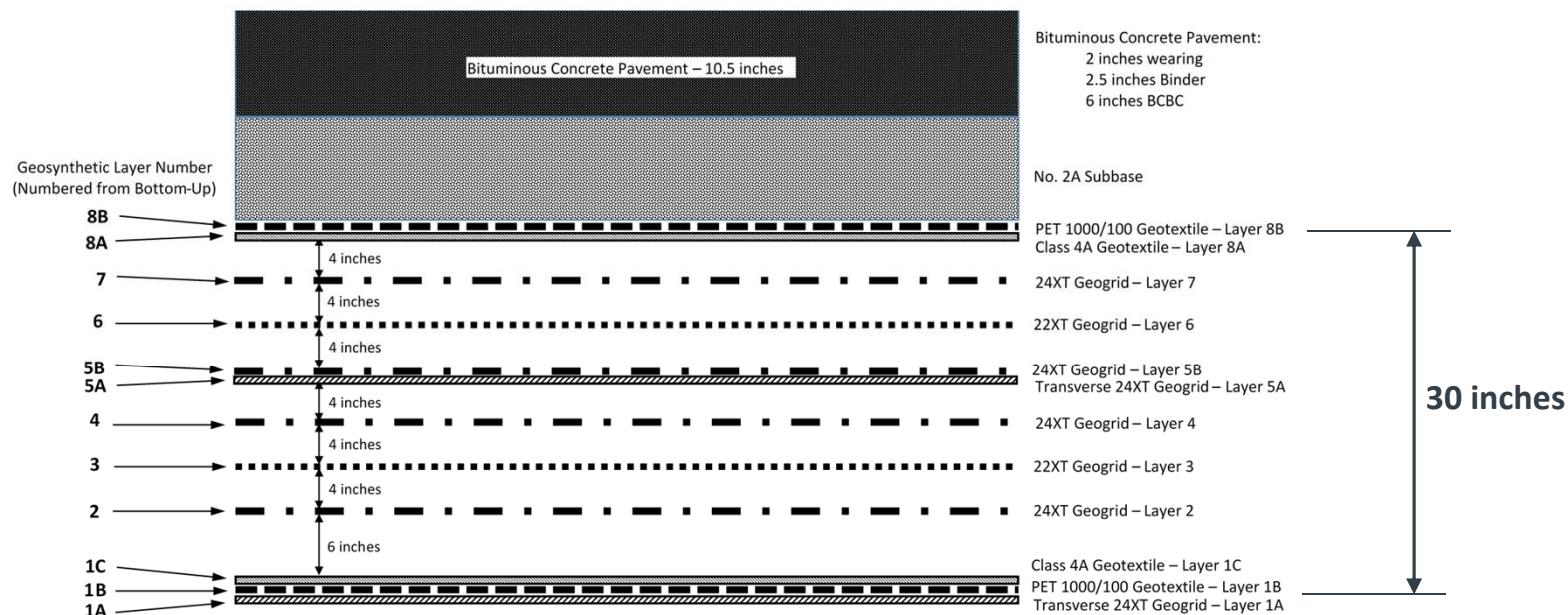
Typical Section – Flexible Sinkhole Safety Net – Roadway
(N.T.S.)

2017 Sinkhole Repair – Safety Net Typical Section

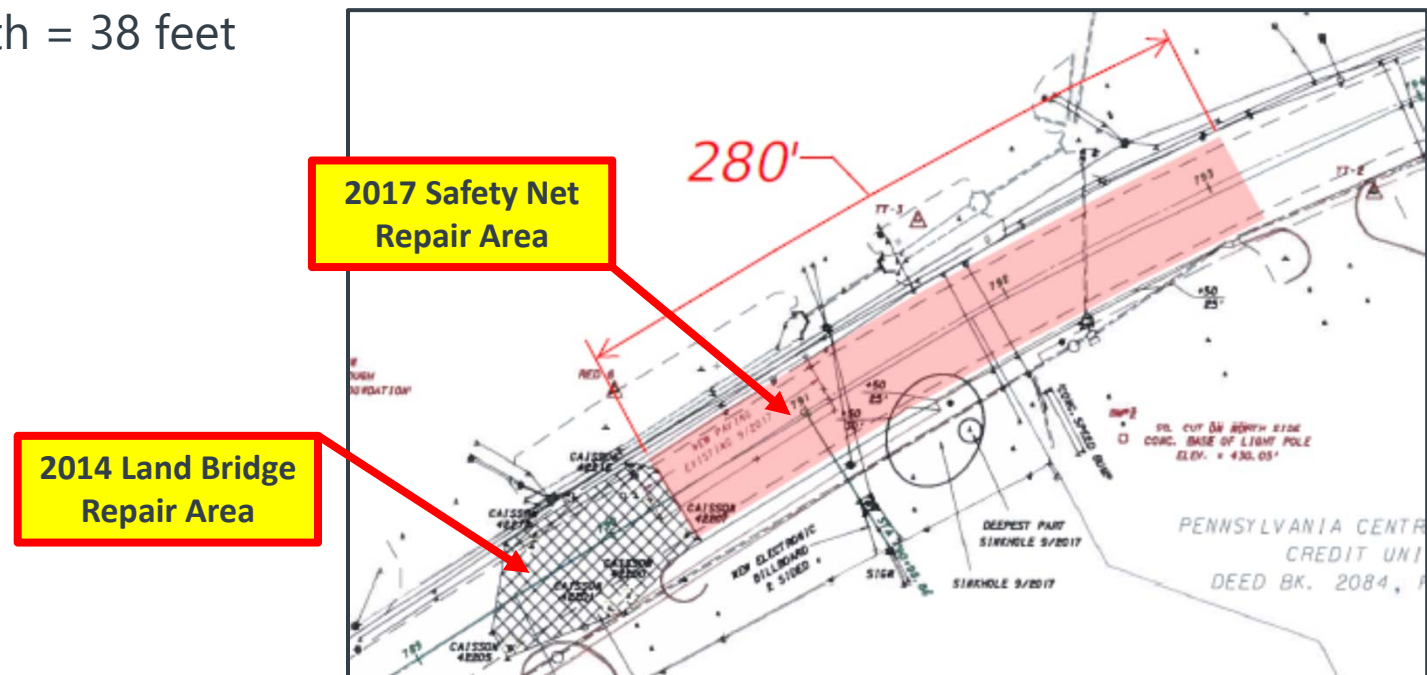
2019 Sinkhole Repair – Repair Area

- Micropile supported slab starts at 2014 land bridge
- Extend new slab 280 feet (i.e., limits of 2017 safety net repair)
- Total Width = 38 feet
