**RESEARCH PROJECT NO. RP 97-052 A & B  
EVALUATION OF MODULAR EXPANSION DAM  
FINAL REPORT**

**May 2008**

**PREPARED BY:  
ROBIN SUKLEY, P.E.**

**Engineering Technology and Information Division  
BUREAU OF CONSTRUCTION & MATERIALS  
PENNSYLVANIA DEPARTMENT OF TRANSPORTATION**

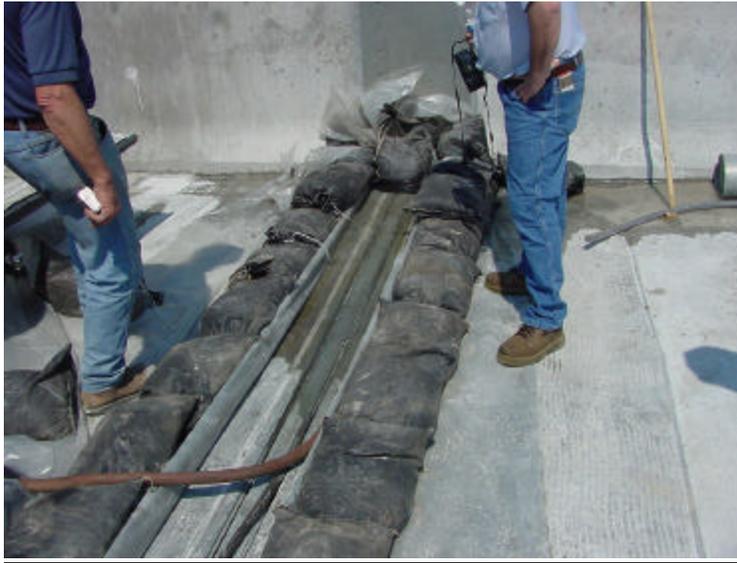
Site 'A' did not perform the water-tightness test and no good data on the water tightness of the joint is available. A water-tightness integrity test was performed by the contractor under the Department direction at site 'B' (see Figure 7,8, 9).

**FIGURE 7 WATER - TIGHTNESS INTEGRITY TEST SITE**

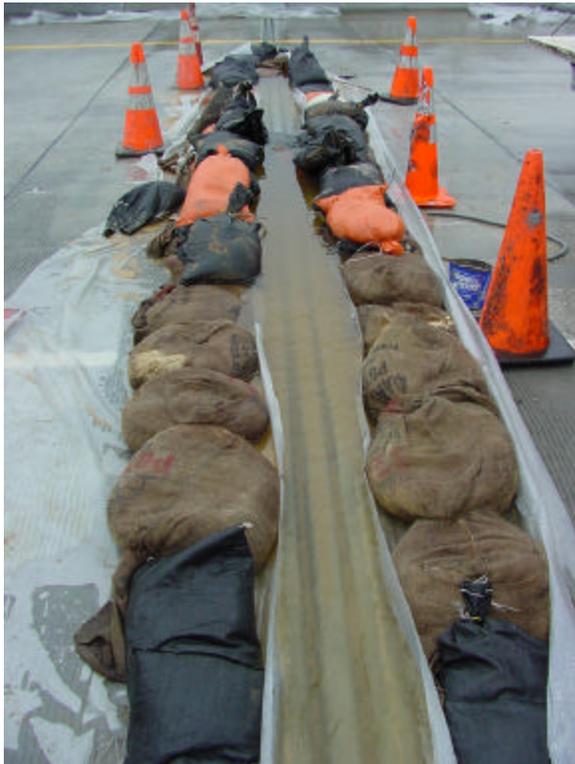
**FIGURE 8 SAND BAGGED ONE HALF OF MEJ AT A TIME**

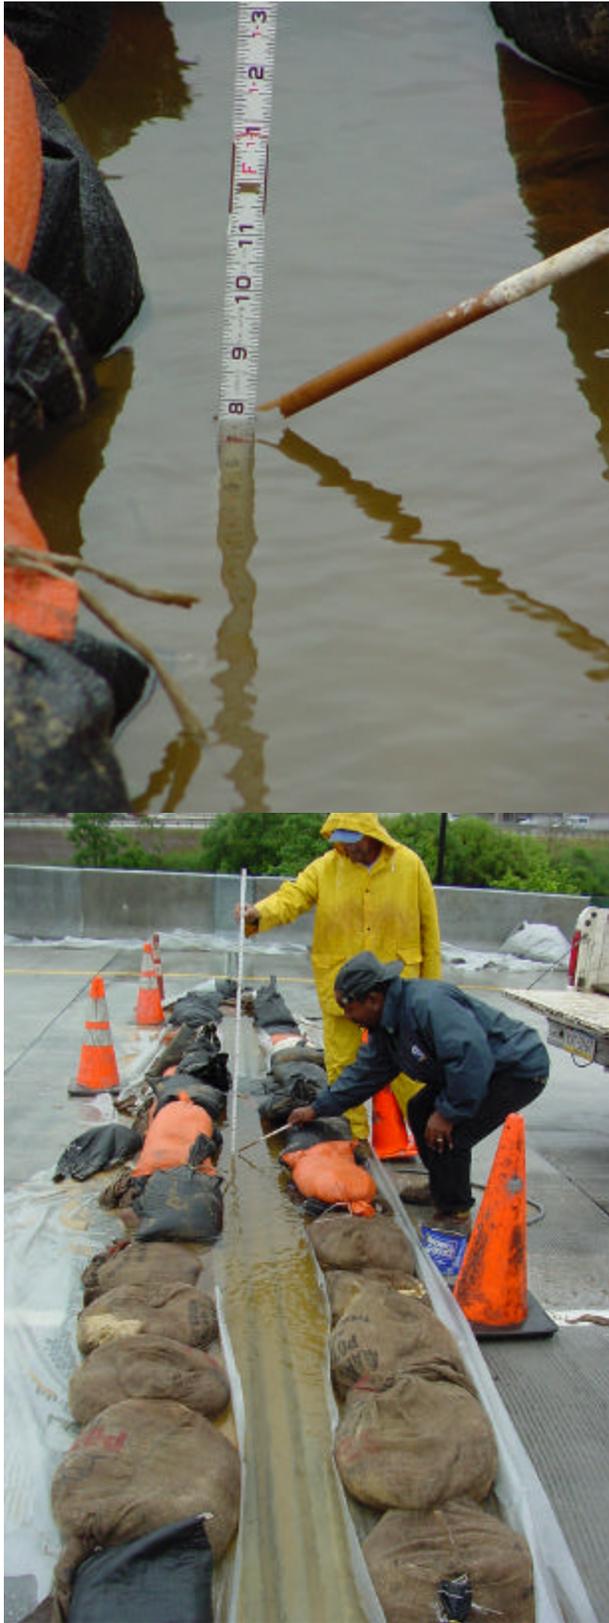
Sand bags were places on both sides of the expansion dam ( see figure 2) and a water truck placed water over dam until completely submerged by 1 inch of water for 1 hour . Minor leaking through the concrete was detected which was taken care of by a concrete sealer product. Only a high lift was available so the Pier 2 dam could be accessed for this test on this day. Inspection of the other Pier 2 dam would need a bridge inspection crane or appropriate alternate method. The sand bag ponded water method was again used for the 2<sup>nd</sup> joint and the results were accepted this time by the Department. Typically, the test is not performed in the rain but because it passed the test was determined successful.

**FIGURE 9 AT LEAST 1 INCH OF WATER MAINTAINED FOR 1 HOUR**

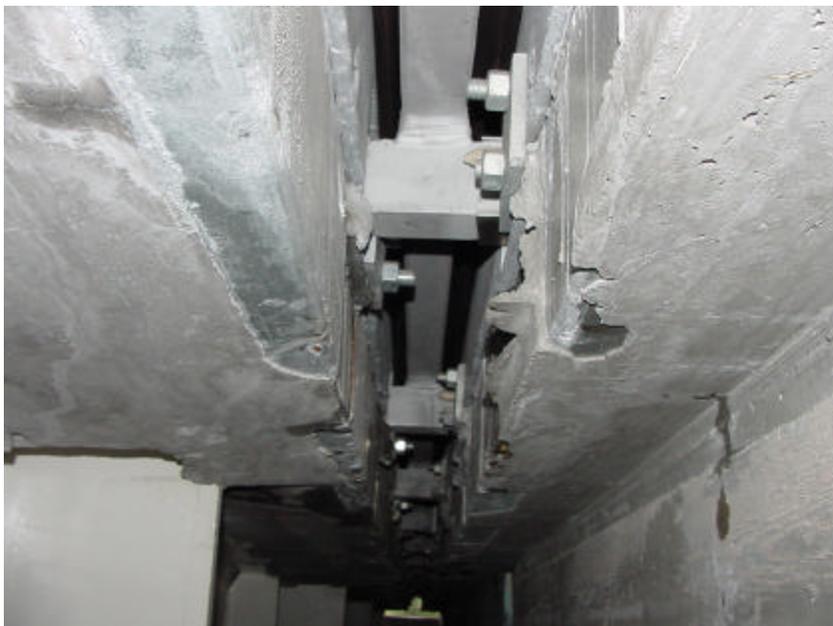
**FIGURE 11 MEJ UNDERVIEW DURING TEST**

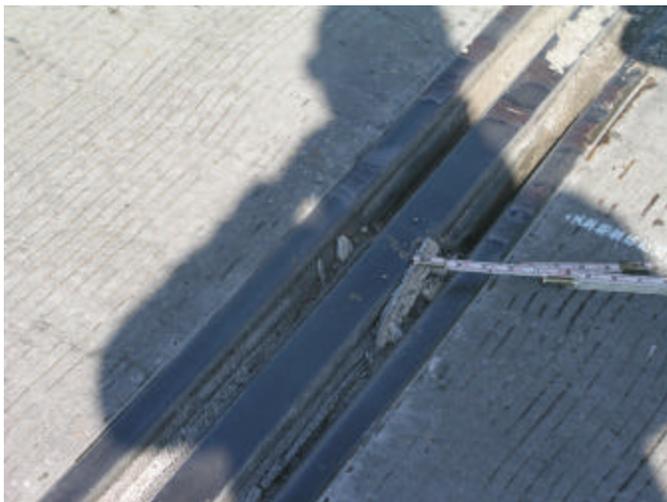
The joints were found to be in generally good condition. The only maintenance need is for flushing of both of the joints to remove debris that has collected in the neoprene glands with the largest concentration of debris in the shoulders.

**Photo 2 Pier 2 Debris removed for Joint Measurements**

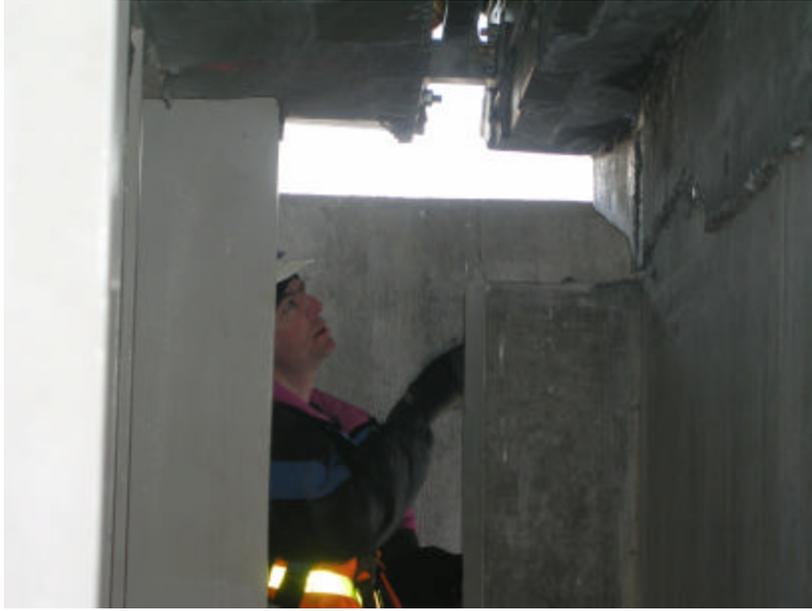
**Photo 11 Inspection 2/22/2006**
