Pennsylvania Department of Transportation
Bureau of Planning and Research Project
Contract No. 355I01 / Project No. 070202

Inspection Methods & Techniques to Determine Non Visible Corrosion of
Prestressing Strands in Concrete Bridge Components

Task 2 - Assessment of Candidate NDT Methods

ATLSS REPORT NO. 09-09

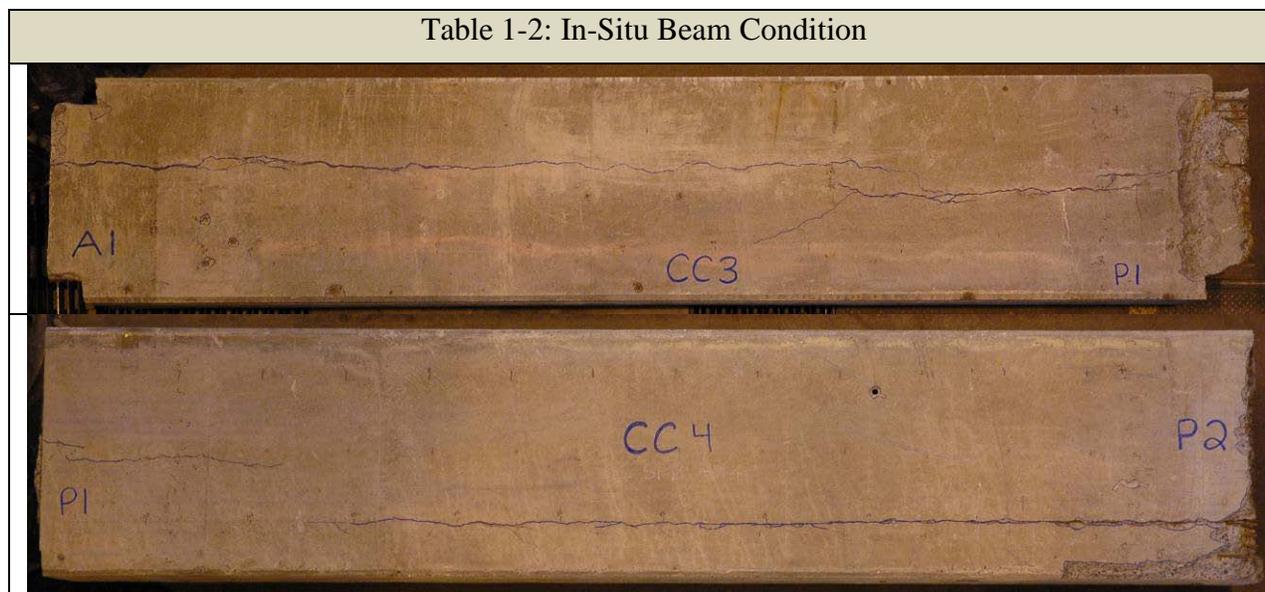
Table 1-2: In-Situ Beam Condition

As noted in Table 1-1, the condition of the selected beams varied so as to represent the spectrum of conditions that may be encountered in the field. Table 1-2 provides images of the beam bottom flange (soffit). As shown, the various beam conditions can be ranked as average – minimal cracking and exterior damage in CC3 and CC4, through poor – concrete spalling, large cracks, and rust staining in LV7.

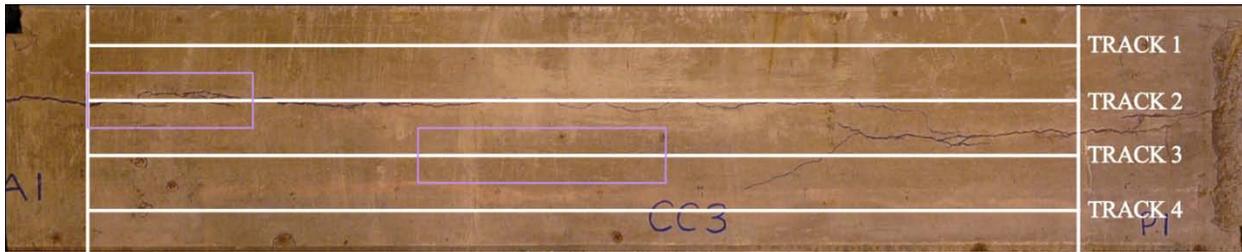
Figure 2-4: MFL Scan Results for Beam CC3

For Beam CC3, major findings were limited to a location along track 3 – which is called out as a concentration of local steel – and a location along track 4 – which is described as “corrosion or bumps”. A plot of the findings on the beams surface is shown below in Figure 2-4.

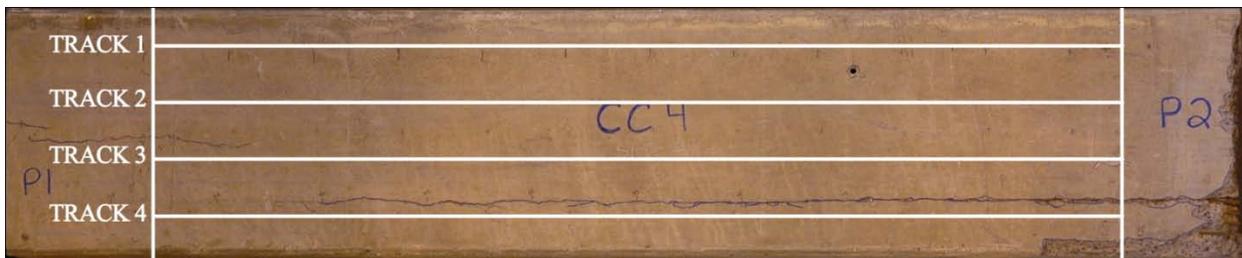
Figure 2-5: MFL Scan Results for Beam CC4

Beam CC4 had no major findings, as shown in Figure 2-5, indicating that no serious cases of corrosion within that particular specimen were found.

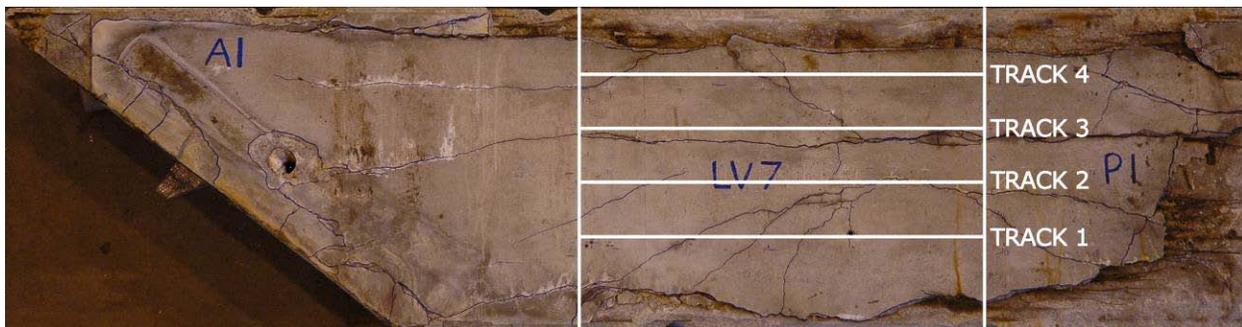
Figure 2-6: MFL Scan Results for Beam LV7

No regions of corrosion were found on Beam LV 7 as shown in Figure 2-6. The locations of transverse reinforcement were accurately identified as illustrated in Figure 2-7.

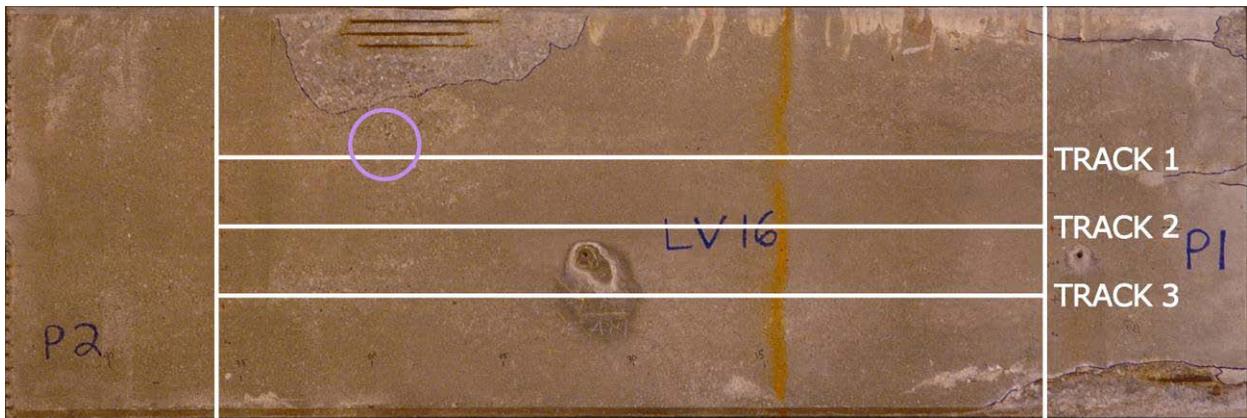
Figure 2-8: MFL Scan Results for Beam LVD16

In Beam LV16, an anomaly was detected in track 1 near a spalled area of concrete by the MFL scans. This can be seen in Figure 2-8. It was noted that the contractor was uncertain what may lie beneath the concrete in this area.

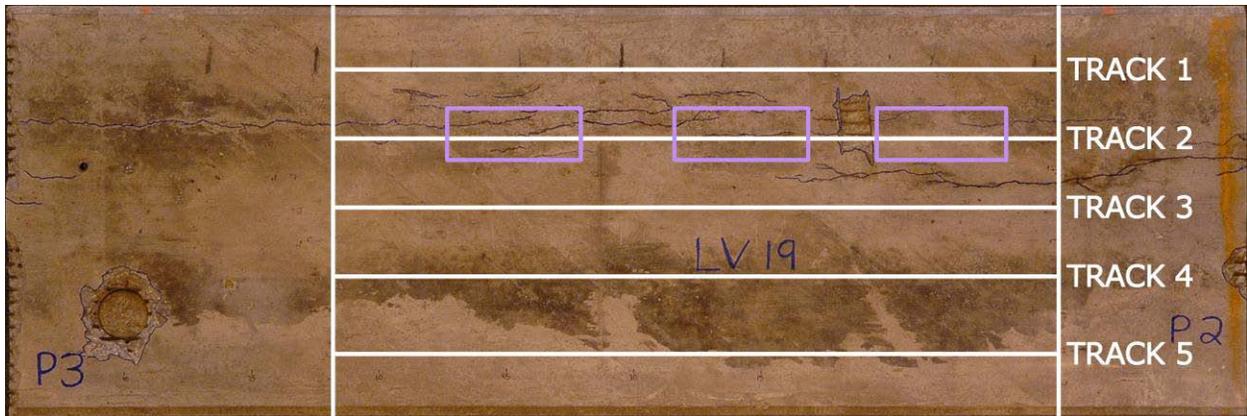
Figure 2-9: MFL Scan Results for Beam LVD19

Beam LV19 has several possible corrosion locations, all of which lie along track 2. Coincidentally, track 2 lies almost directly under the longitudinally cracked region of the beam. This can be seen in Figure 2-9.

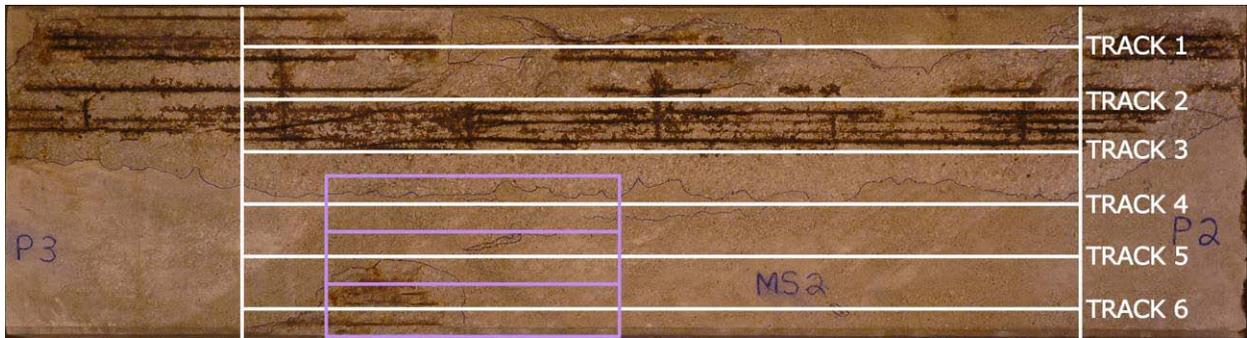
Figure 2-10: MFL Scan Results for Beam MS2

Beam MS2 has several possible corrosion locations, one each on tracks 4, 5, and 6. This can be seen in Figure 2-10. The spalled top half of the beam was inspected, despite the apparatus' ineffectiveness on uneven surfaces. A smooth surface was created by filling in the uneven spalled area with wood chips. The area was then covered with plastic tape. It is of importance to note that this method detected the corrosion in the prestressing strands underneath the added material.

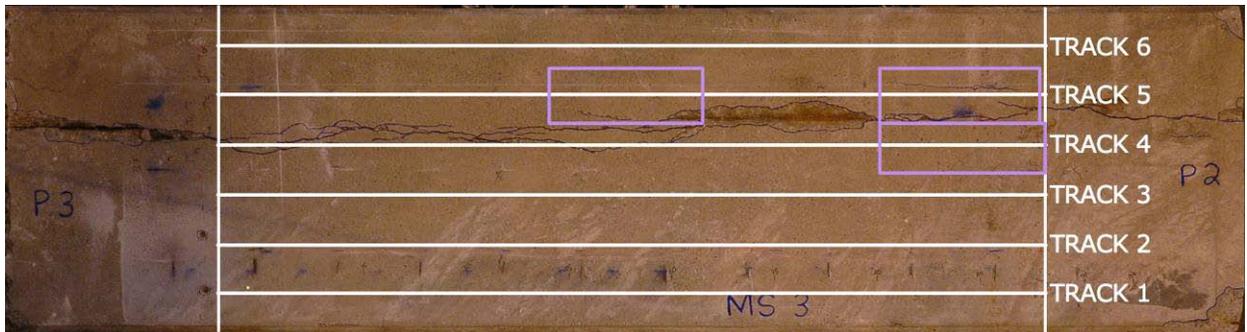
Figure 2-11: MFL Scan Results for Beam MS3

Beam MS3 has several potential corrosion locations, two on track 5 and one on track 4. This can be seen in Figure 2-11. The detected corrosion locations lie along the longitudinal crack on the beam surface.

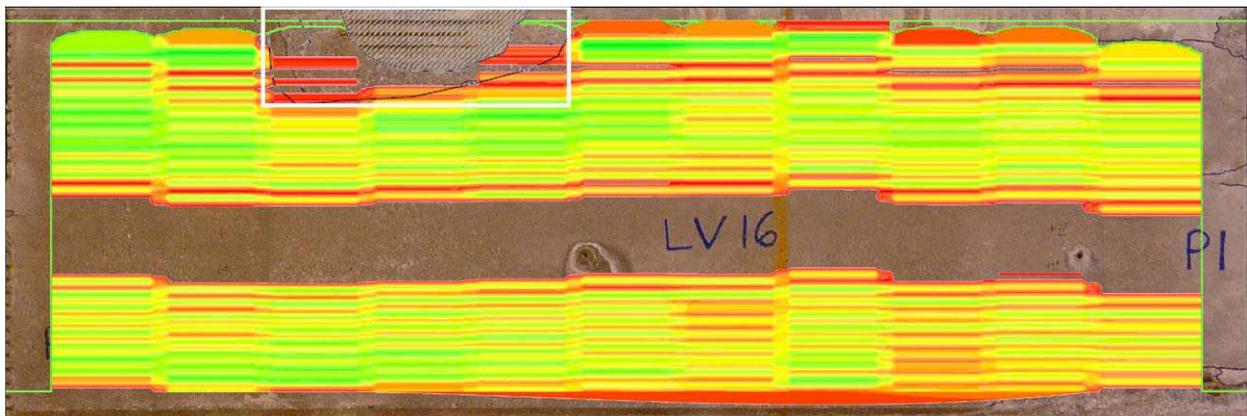
Figure 2-18: GPR Contour Plot Superimposed on Surface for Beam LV16

The strand reflection amplitude contour plot for LV16, Figure 2-17, shows diminished amplitude around the area of the spall indicating that this is a possible area of corrosion. Along the North edge of the beam, east of the spall, low reflection amplitudes exist. Regions of low reflection amplitude also exist along the south edge of the beam, from approximately five to ten feet.

The GPR contour plot was superimposed over the beams surface. The corrosion locations are surrounded with a white box (see Figure 2-18).

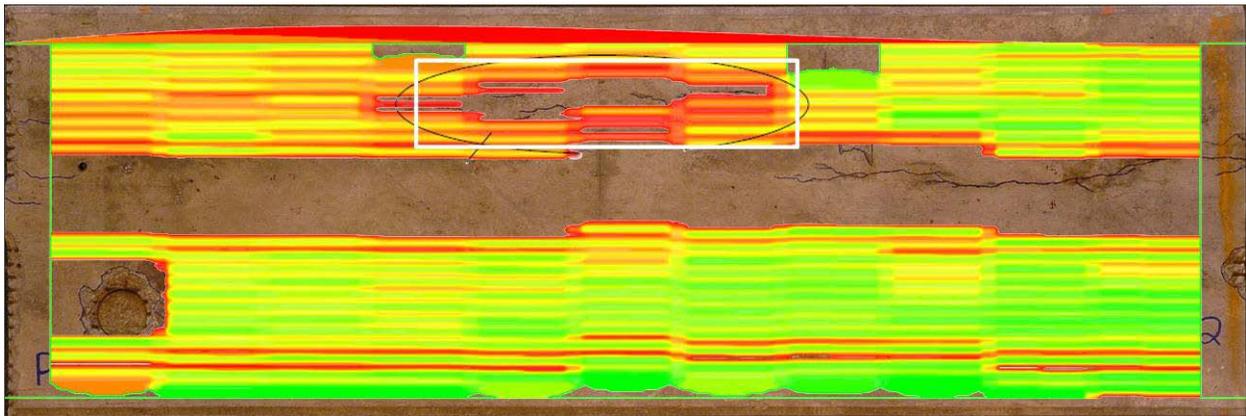
Figure 2-20: GPR Contour Plot Superimposed on Surface for Beam LV19

The strand reflection amplitude contour plot for LV19 (see Figure 2-19) indicates a large possible area of corrosion on the bottom half of the beam. Some of the areas appear white, indicating that no strands were found. Isolated strands can be found in the top half of the beam indicating low reflection amplitude.

The GPR contour plot was then superimposed over an image of the beam surface. Potential corrosion locations were surrounded with a white box (see Figure 2-20).

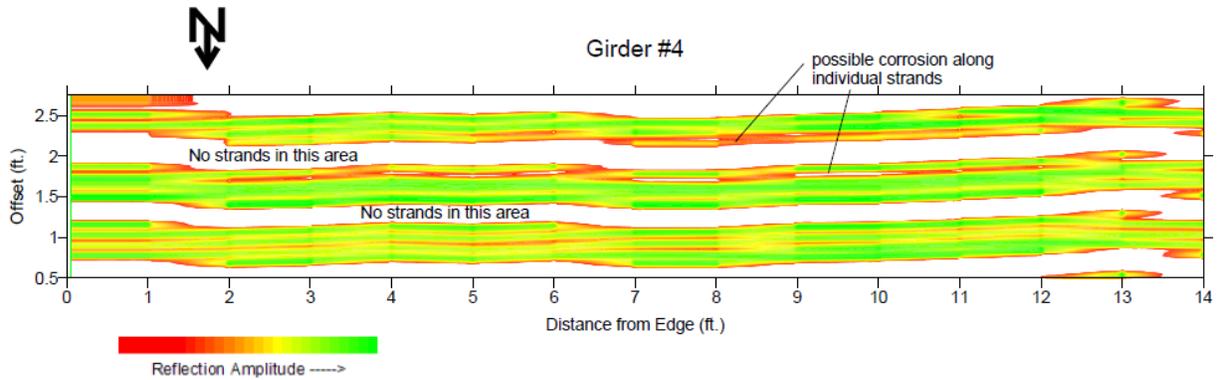
Figure 2-21: Strand Reflection Amplitude Contour Plot for CC4

The strand reflection amplitude contour plot for CC4, Figure 2-21, shows minimal areas of low reflection amplitude. Two areas are called out as having possible corrosion along individual strands.

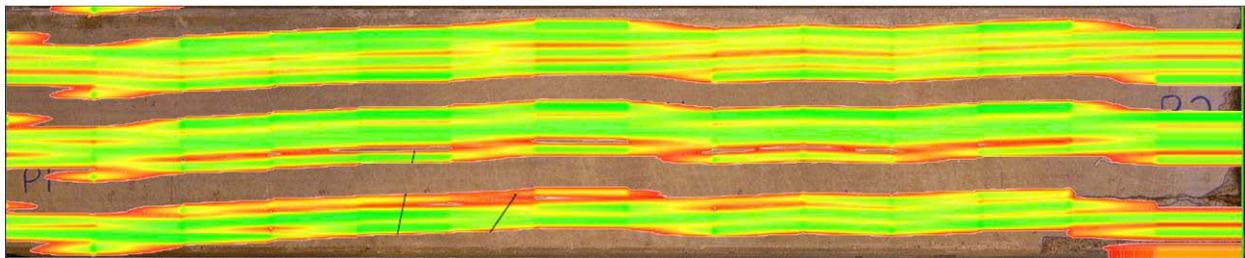
Figure 2-22: Contour Plot Superimposed on Surface for Beam CC4

The GPR contour plot was superimposed over an image of the beam surface. No areas of corrosion were identified. It is indicated, however, that corrosion may lie along the strand under the crack (see Figure 2-22).

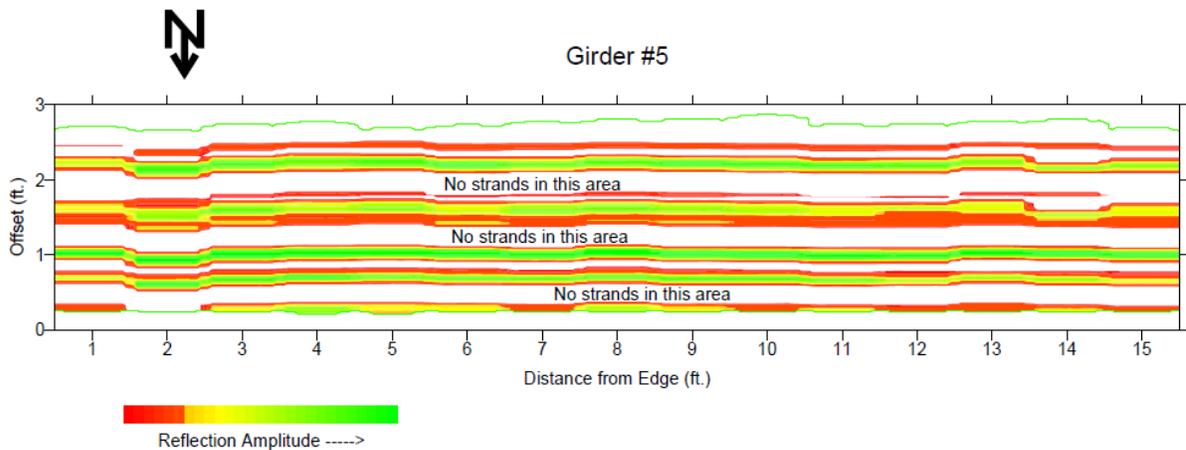
Figure 2-23: Strand Reflection Amplitude Contour Plot for CC3

The strand reflection amplitude contour plot for CC3, Figure 2-23, indicates erratic strand placement and several strands that indicate low reflection amplitude along the entire length. However, no areas of potential corrosion are explicitly identified by the Infrasense, Inc. team.

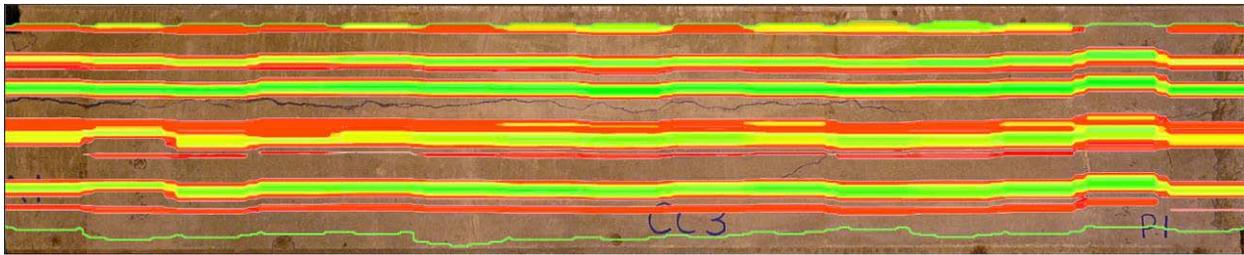
Figure 2-24: Contour Plot Superimposed on Surface for Beam CC3

The GPR contour plot was superimposed over an image of the beam surface. Again, no areas of potential corrosion were identified (see Figure 2-24).

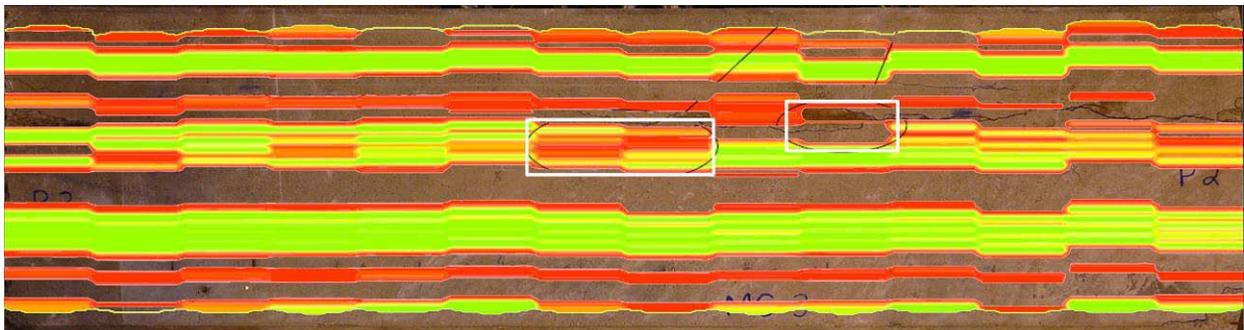
Figure 2-26: Contour Plot Superimposed on Surface for Beam CC3

The strand reflection amplitude contour plot for MS3, Figure 2-25, indicates two possible areas of corrosion on the beam, both on the top half of the beam. There are many strands within this beam that indicate low reflection amplitudes along their length.

The GPR contour plot was superimposed over an image of the beam surface. Two potential areas of corrosion were identified by reduced GPR readings (see Figure 2-26).

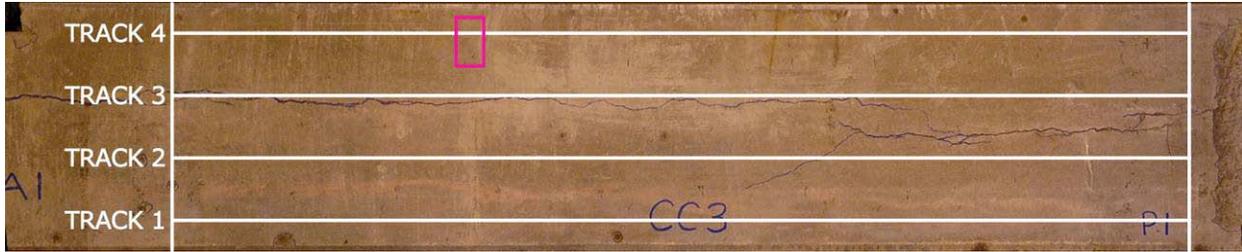
Figure 2-32: RM Scan Results for Beam CC3

The RM scan results for beam CC3, shown in Figure 2-32, indicate one suspected area of wire fracture along track 4. No surface indicators of corrosion are present at this location.

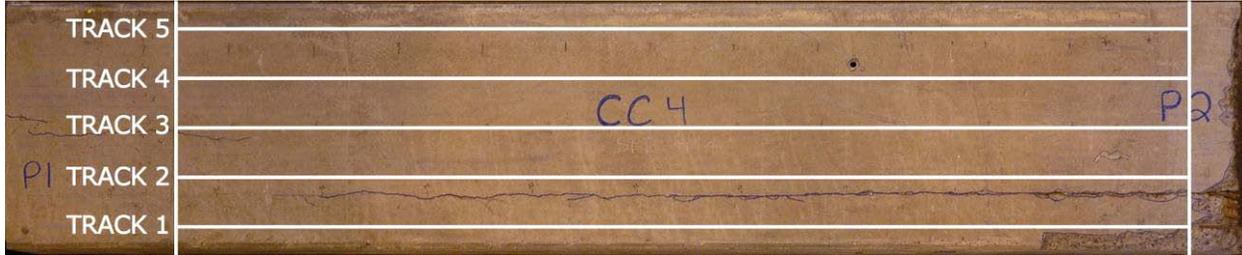
Figure 2-33: RM Scan Results for Beam CC4

The RM scan results for beam CC4, shown in Figure 2-33, indicate no suspected areas of wire fracture throughout this member despite the large longitudinal crack present along nearly the entire length of the beam.

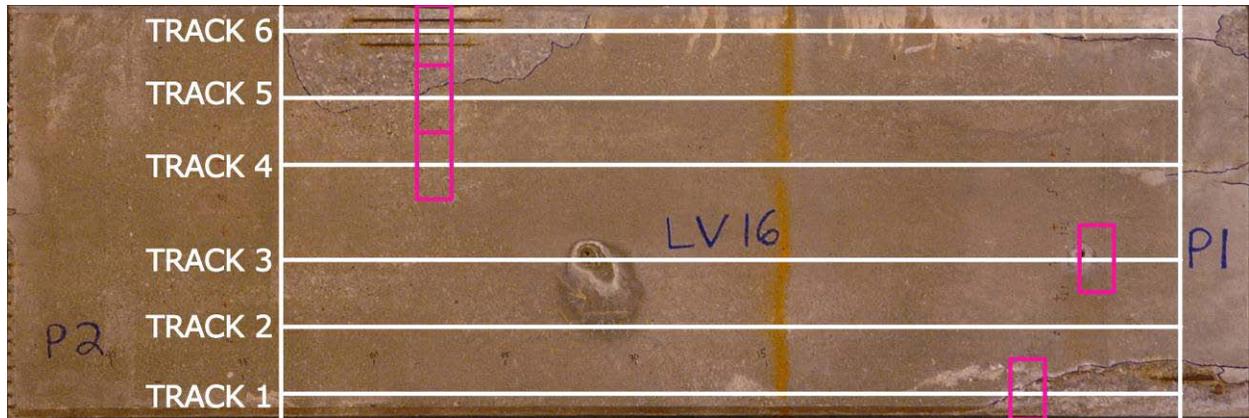
Figure 2-34: RM Scan Results for Beam LV16

The RM scan results for beam LV16, shown in Figure 2-34, indicate five suspected areas of wire fracture throughout this member. It is important to note that the scans along tracks 4 and 5 picked up the same anomaly: a fracture in a particular strand. The suspected corrosion location

along track 6 can be identified as visually correct since it is located over a spalled section of concrete where heavily corroded steel reinforcement is exposed. The region identified along track 3 is located above a drainage hole and the region identified along track 1 is near a spalled section of concrete with cracking.

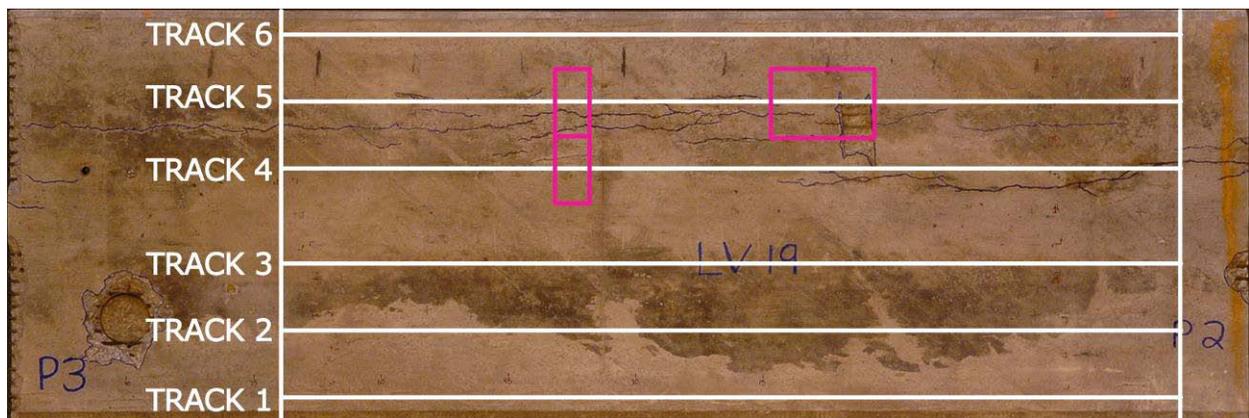
Figure 2-35: RM Scan Results for Beam LV19

The RM scan results for beam LV19, shown in Figure 2-35, indicate three suspected areas of wire fracture throughout this member all of which are near the various longitudinal cracks just north of the beam centerline.

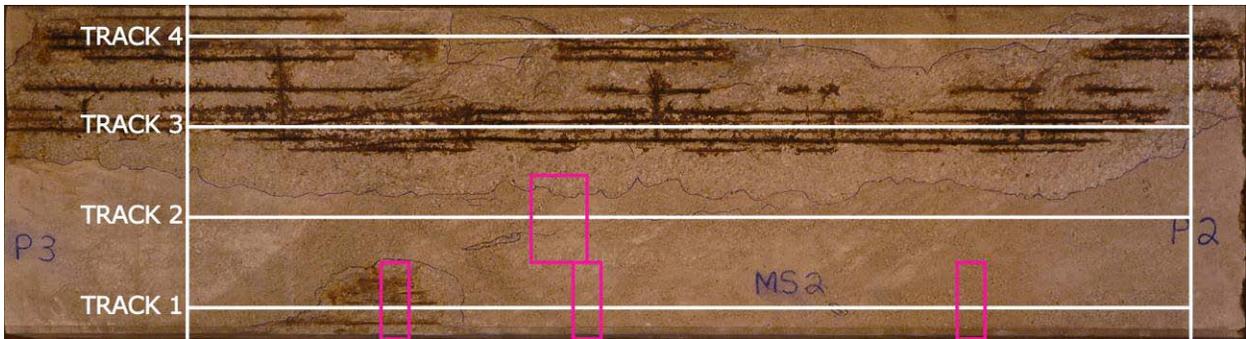
Figure 2-36: RM Scan Results for Beam MS2

The RM scan results for beam MS2, shown in Figure 2-36, indicate four suspected areas of wire fracture throughout this member. The first suspected area from the P3 side of track 1 is visually identifiable. It is located over a spalled section of concrete where the reinforcing steel is exposed and clearly corroded. The other three suspected fracture locations show no visible signs of strand damage on the concrete surface.

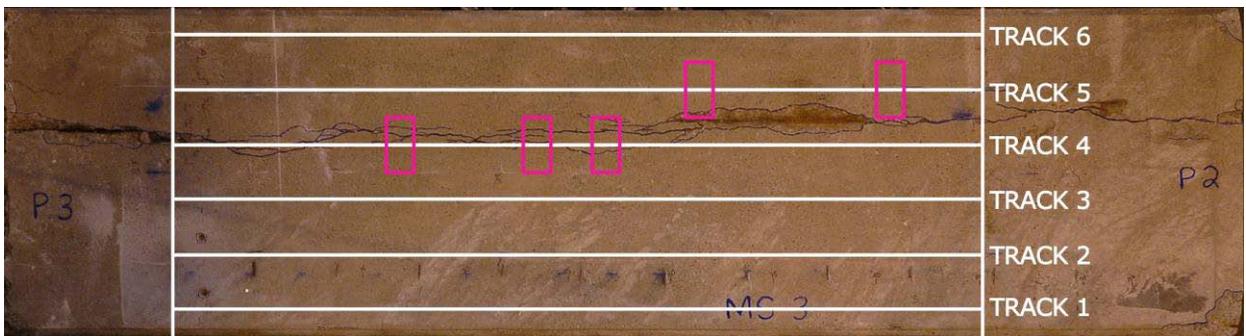
Figure 2-37: RM Scan Results for Beam MS3

The RM scan results for beam MS3, shown in Figure 2-37, indicate five suspected areas of wire fracture throughout this member all of which lie along the longitudinal crack detected during the visual inspection.

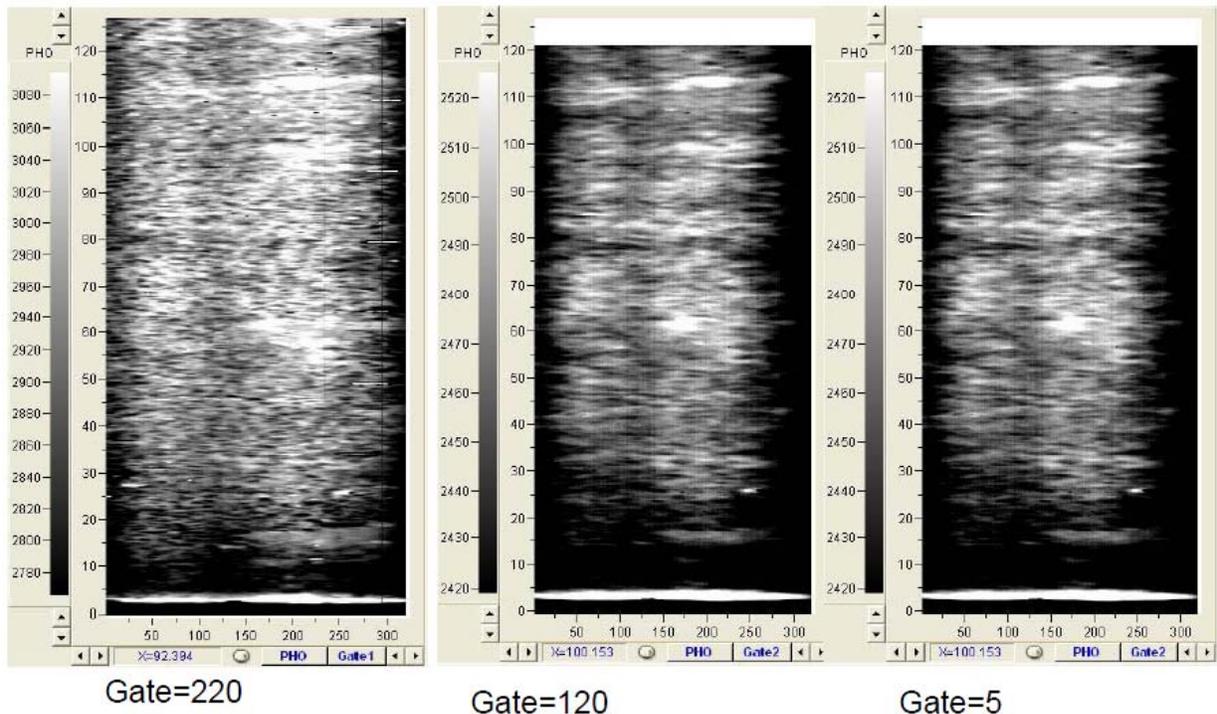
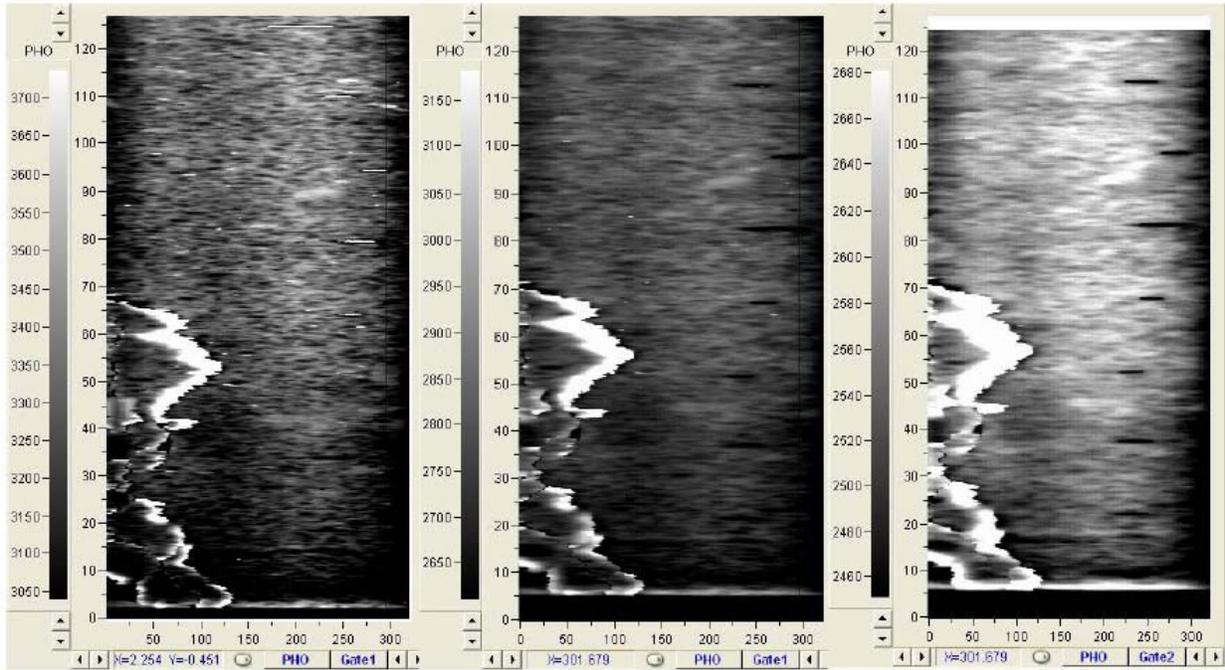
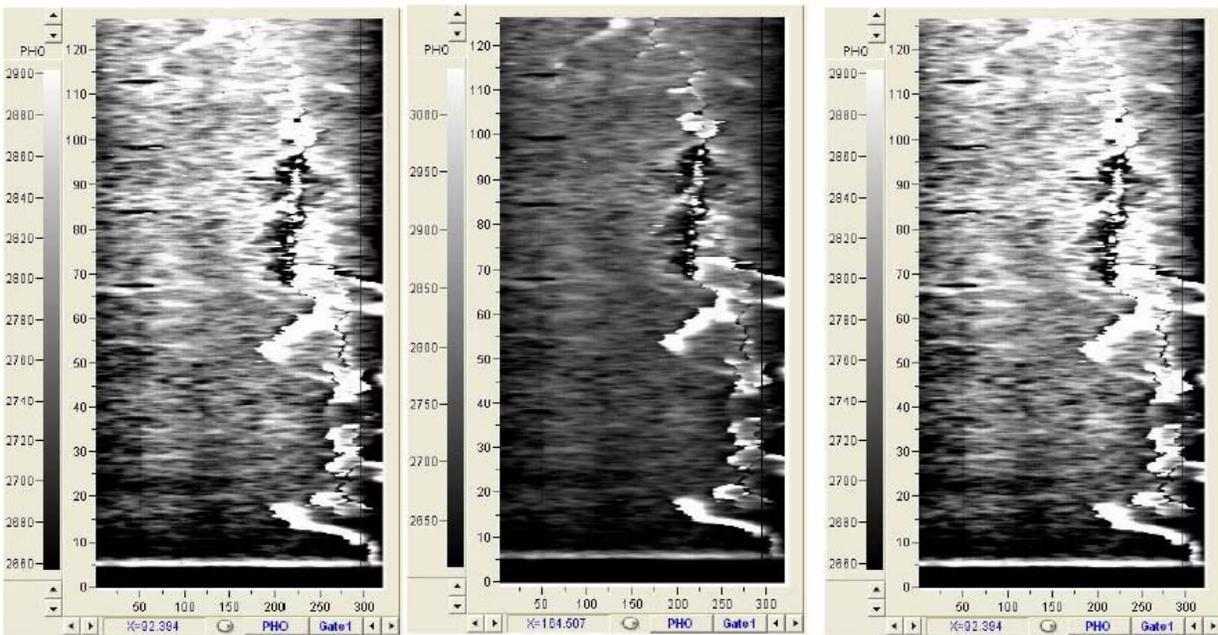
Beam MS3 was scanned in three strips, starting from the P3 end. The first scan represents the bottom third of the beam as shown in the picture of MS3 in Table 1-2. Accordingly, scan two represents the middle third of the beam and scan three represents the top third of the beam in that table. Scan 1, Scan 2, and Scan 3 for beam MS3 can be seen in Figure 2-40, Figure 2-41, and Figure 2-42, respectively. Scans 2 and 3 show the longitudinal crack on the surface of the beam detected during the visual inspection. The strands are not identifiable in the following figures. Consequently, it appears that identification of corrosion is not feasible with this method.

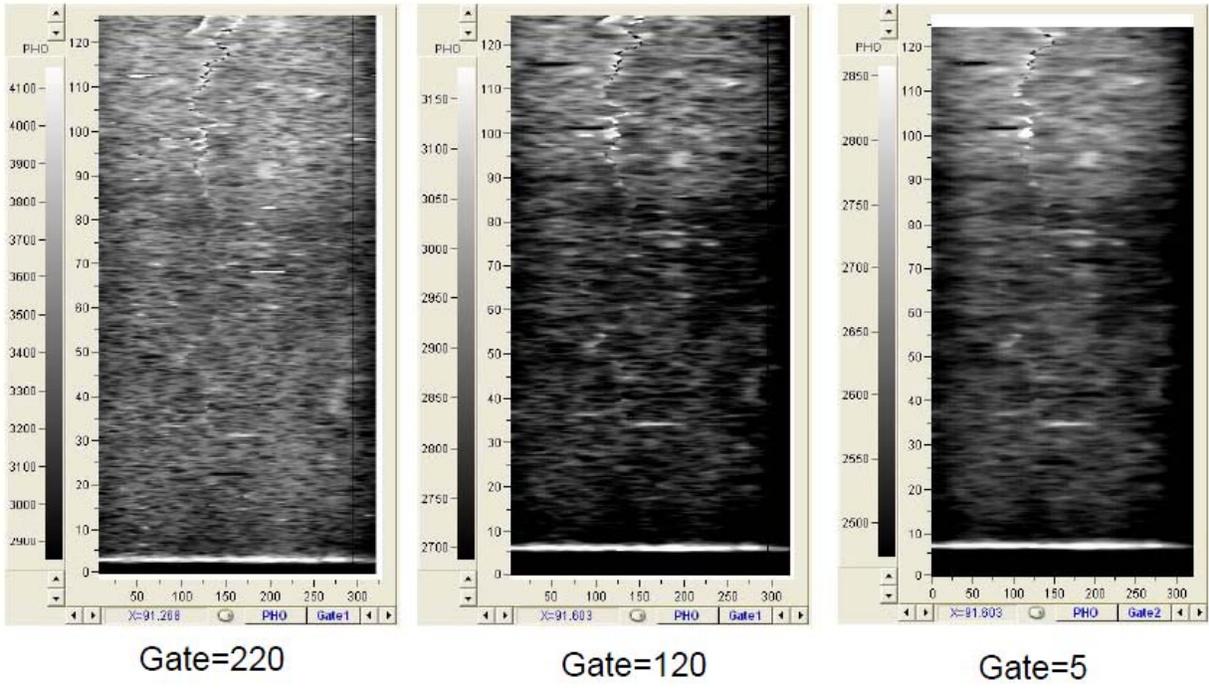
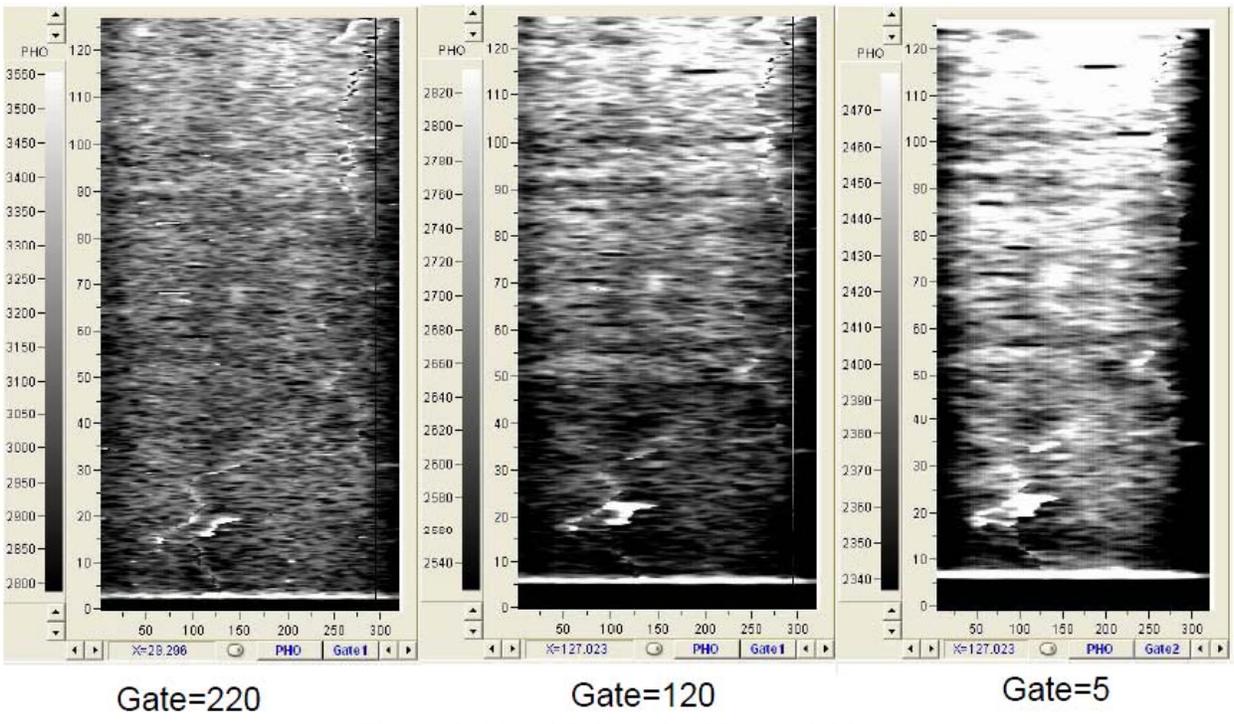
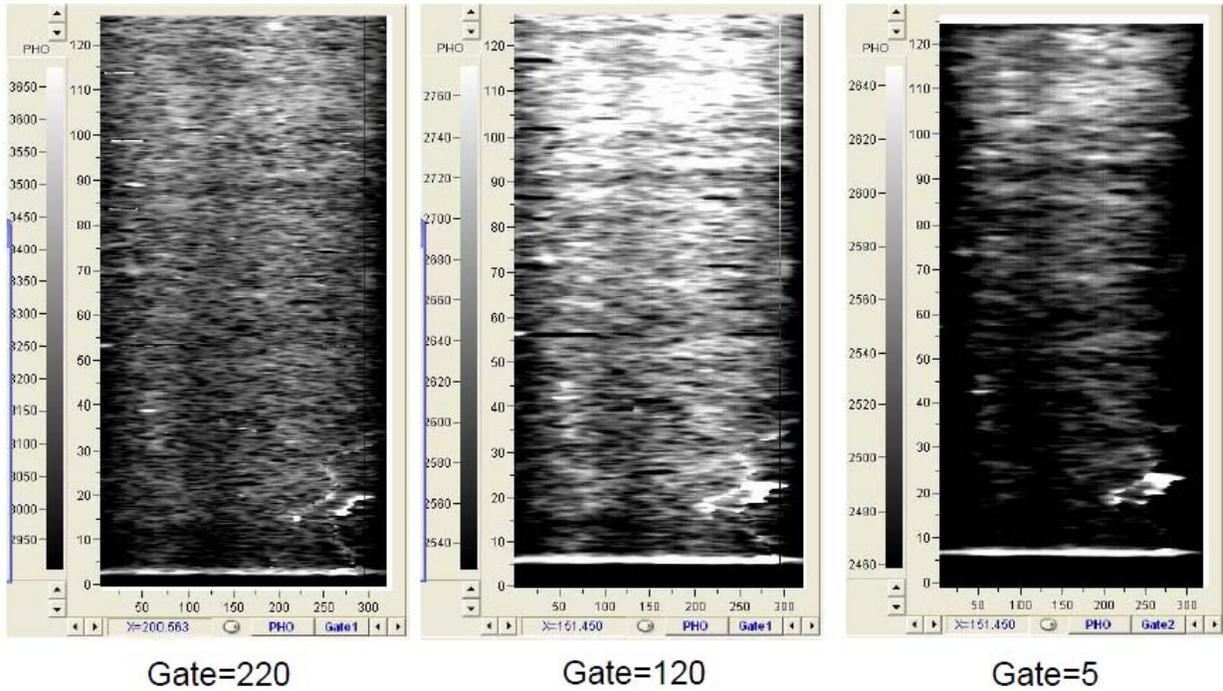
Beam CC3 was scanned in three strips starting from the P1 end. Scan 1, Scan 2, and Scan 3 for beam CC3 can be seen in Figure 2-43, Figure 2-44, and Figure 2-45, respectively. In the three scans, the longitudinal cracks along the center of the beam appear to be identified. The strands however are not discernable. Consequently, corrosion locations cannot be identified.

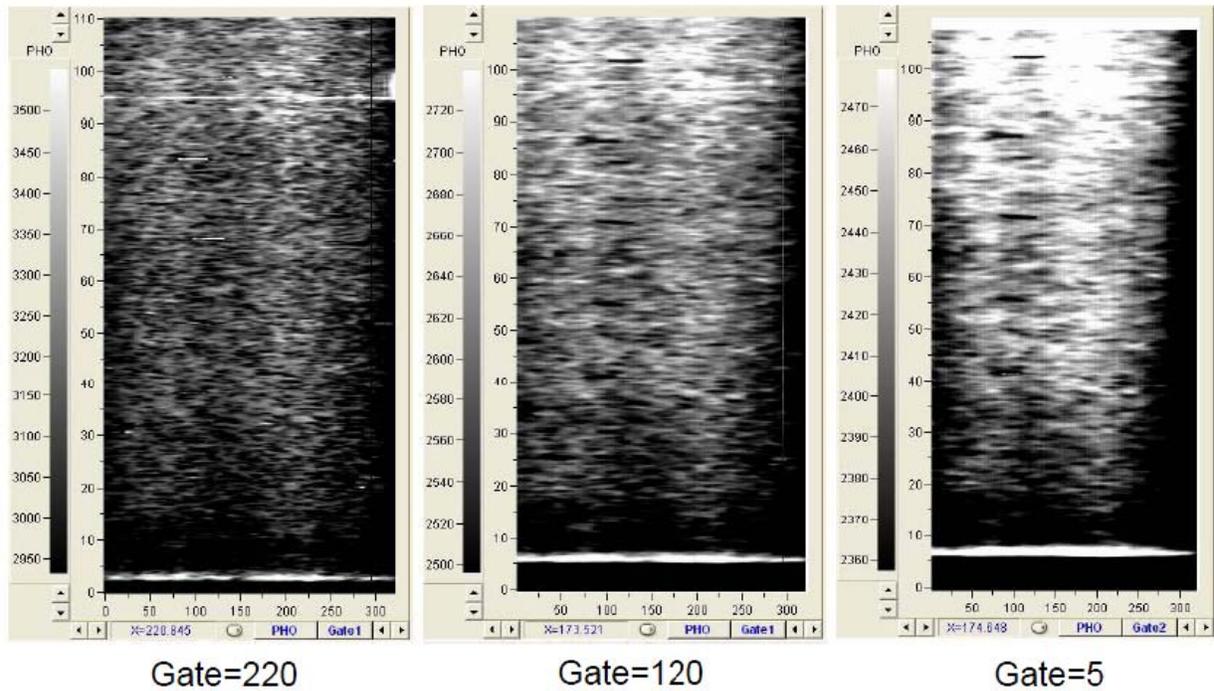
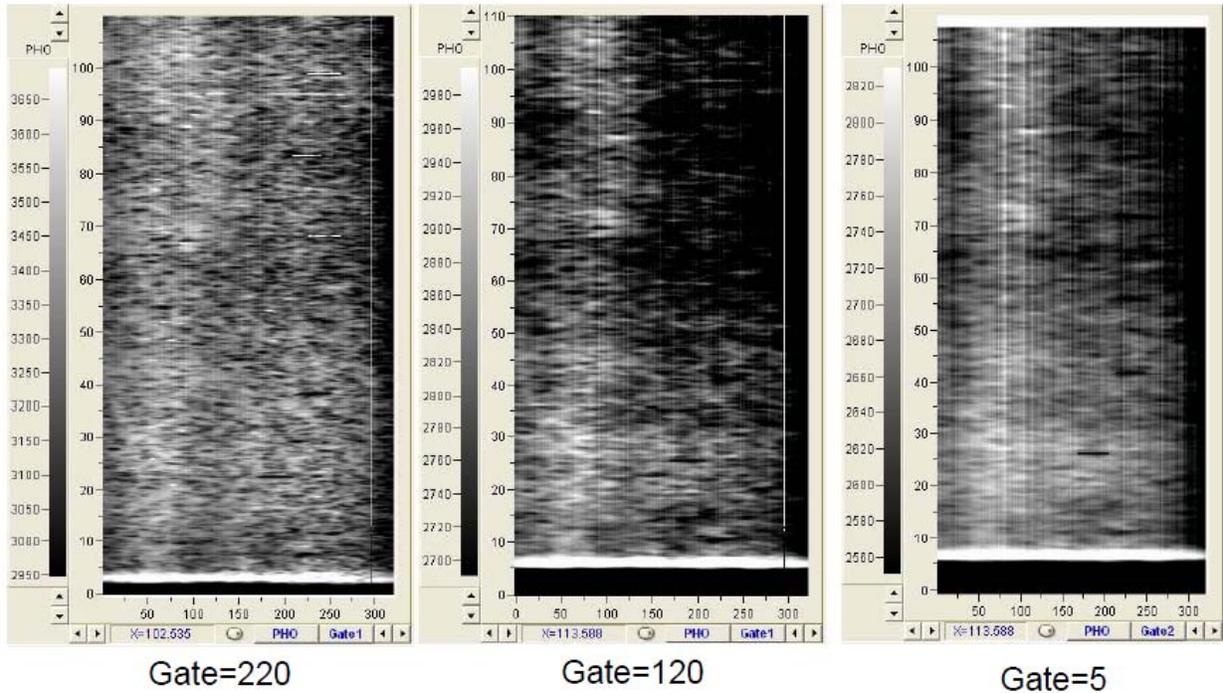
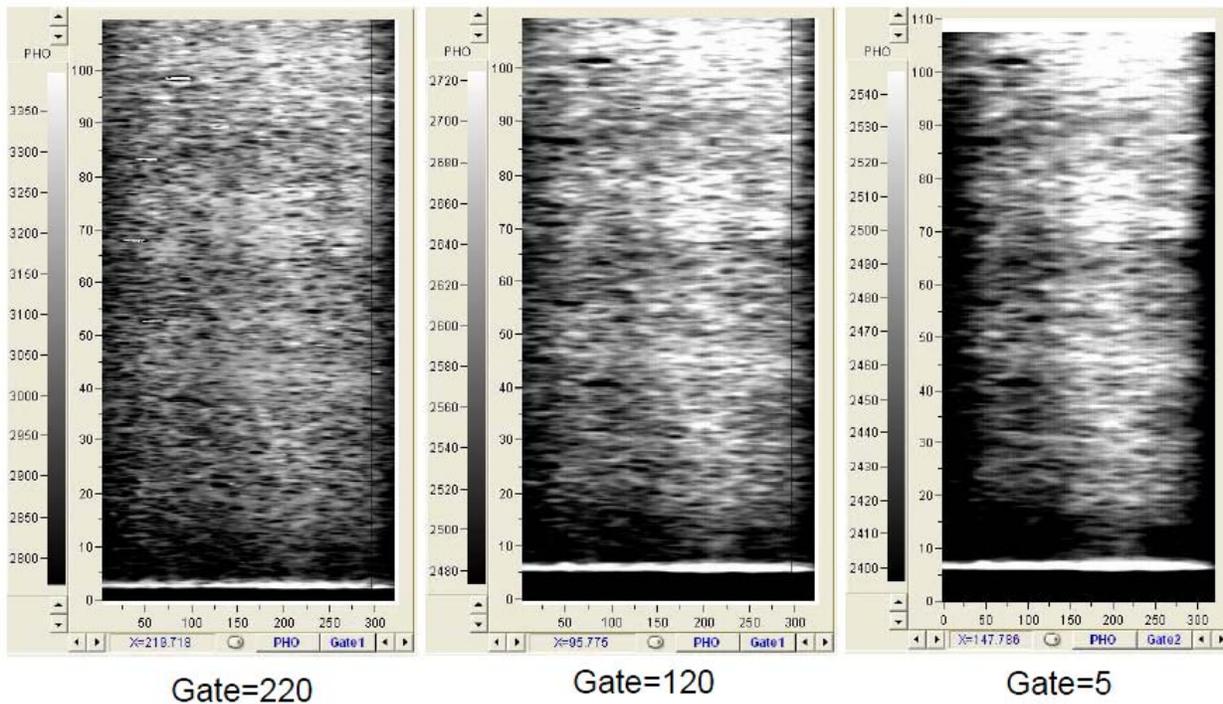
Beam CC4 was scanned in three strips, starting from the P2 end. Scan 1, Scan 2, and Scan 3 for beam CC4 can be seen in Figure 2-46, Figure 2-47, and Figure 2-48, respectively. Throughout the three scans, the longitudinal crack detected during the visual inspection cannot be located. The strands cannot be located in the following figures. Consequently, corrosion locations cannot be identified.

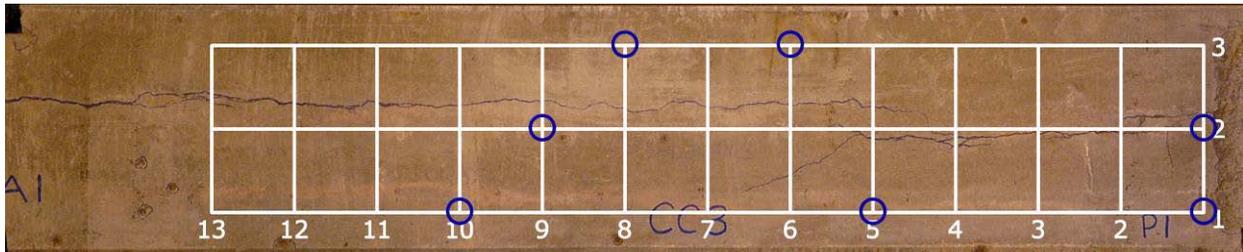
Figure 2-53: EMCD Results for Beam CC3

The findings for beam CC3 indicate corrosion at seven different grid intersection points; as shown in Figure 2-53.

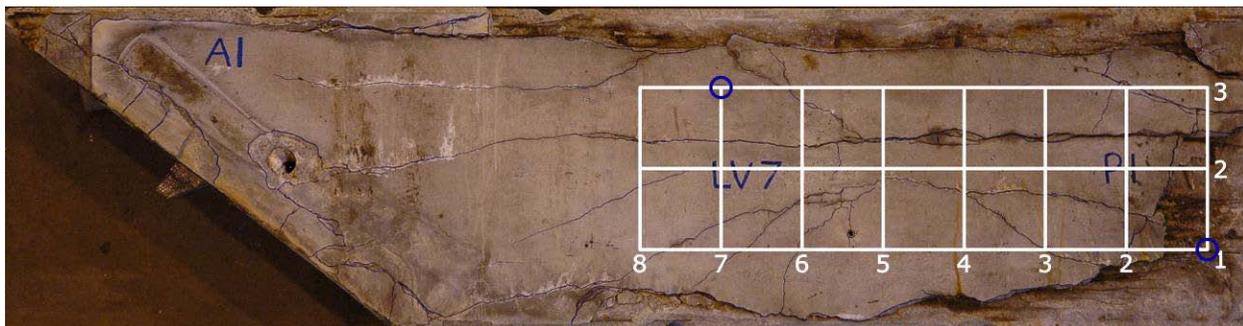
Figure 2-54: EMCD Results for Beam LV7

The findings for beam LVD7 indicate corrosion at two different grid intersection points; as shown in Figure 2-54.

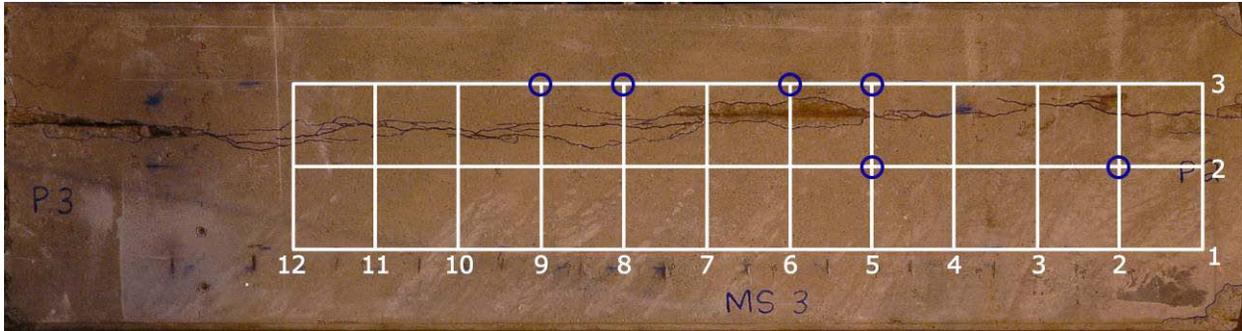
Figure 2-56: EMCD Results for Beam MS3

The findings for beam MS3 indicate corrosion at six different grid intersection points as shown in Figure 2-56. The four points located along the longitudinal line 3 are located near the longitudinal crack detected during the visual inspection.

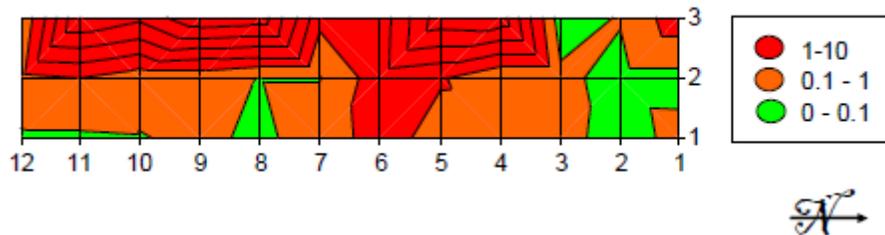
Figure 2-57: Corrosion Rate Potential (i_{corr}) for Top Mat of MS3

Figure 2-57 shows the corrosion rate potential for the bottom strand layer of MS3. It indicates that along the top half of the beam, i_{corr} readings show a likelihood of a high corrosion rate. The bottom half of the beam has i_{corr} readings that indicate a moderate to low corrosion rate.

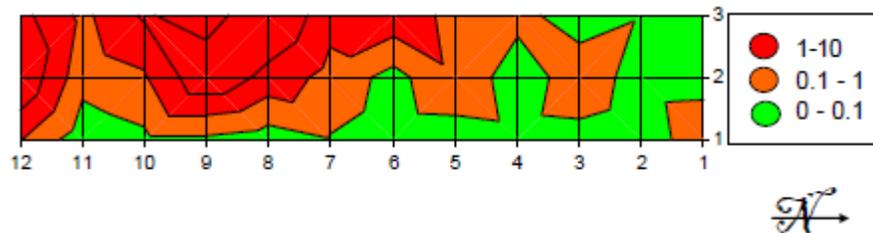
Figure 2-58: Corrosion Rate Potential (i_{corr}) for Bottom Mat of MS3

Figure 2-58 shows the corrosion rate potential for the bottom strand layer of MS3. It shows that the bottom mat has less corrosion rate potential than the top mat. There is an i_{corr} indication for high corrosion rate potential along the top half of the beam from approximately grid lines 6 through 12.

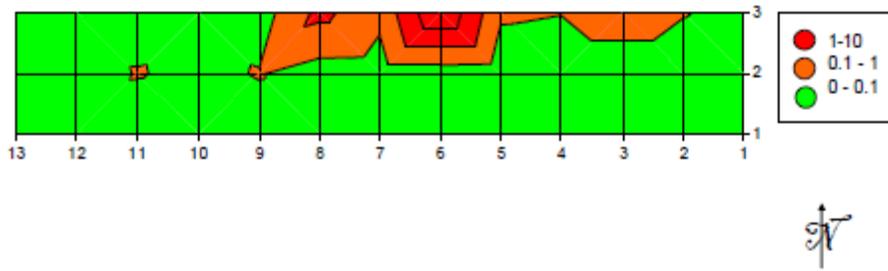
Figure 2-59: Corrosion Rate Potential (i_{corr}) for Top Mat of CC3

Figure 2-59 shows the corrosion rate potential for the top mat reinforcement of CC3. The vast majority of the beam has i_{corr} readings in the negligible range. High i_{corr} readings can be found at the grid intersections of 8-3 and 6-3.

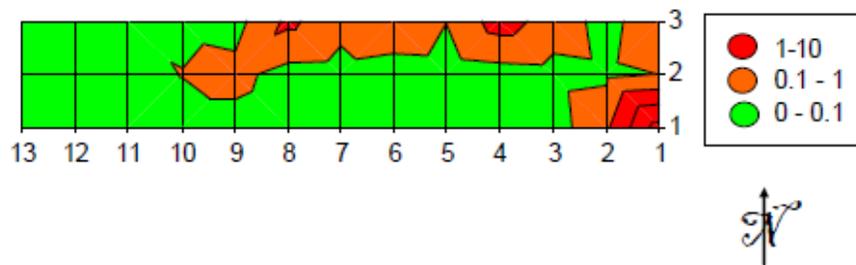
Figure 2-60: Corrosion Rate Potential for Bottom Mat of CC3

Figure 2-60 shows the corrosion rate potential for the bottom mat reinforcement of CC3. Again, the majority of the beam has i_{corr} readings in the negligible range. Locations of high corrosion rate potential can be found at grid intersections 1-1, 4-3, and 8-3.

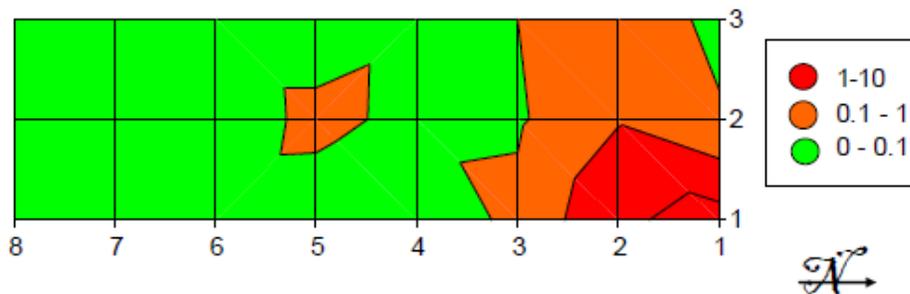
Figure 2-61: Corrosion Rate Potential for Top Mat of LV7

Figure 2-61 shows the corrosion rate potential for the top mat reinforcement of LV7. The i_{corr} readings in the lower-right quadrant of the beam indicate the likelihood of a high corrosion rate.

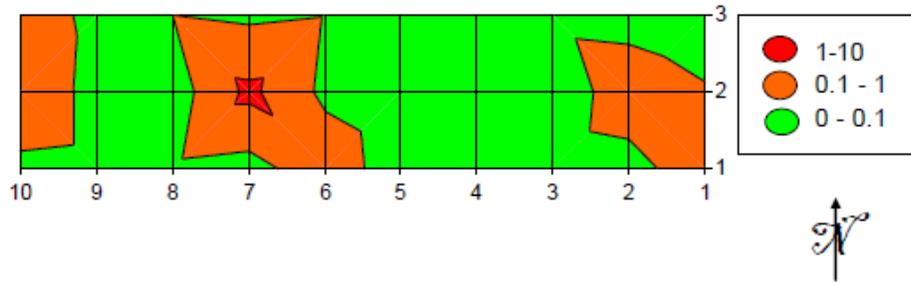
Figure 2-62: Corrosion Rate Potential for Top Mat of LV19

Figure 2-62 shows the corrosion rate potential for the top mat reinforcement of LV19. All areas except grid intersection 7-2 show i_{corr} in the range of low to moderate and negligible corrosion rate potential. Grid intersection 7-2 indicates a high corrosion rate potential.
