Pennsylvania Department of Transportation
Bureau of Planning and Research Project
Contract No. 355I01 / Project No. 070202

Inspection Methods & Techniques to Determine Non Visible Corrosion of
Prestressing Strands in Concrete Bridge Components

Task 2 - Assessment of Candidate NDT Methods

ATLSS REPORT NO. 09-09

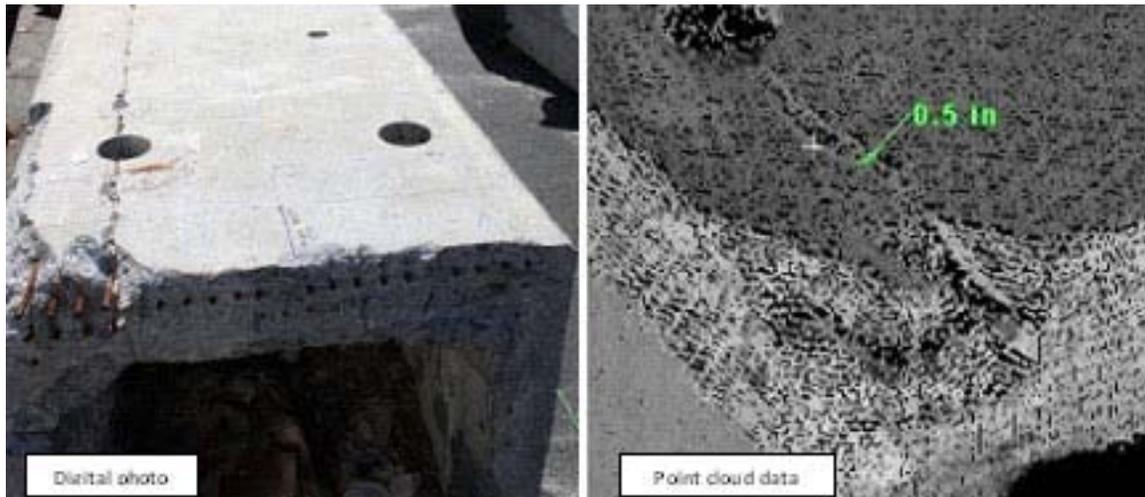
Figure 2-72: 3D Laser Scanning used to Detect and Identify Crack-Width

Shown below, in Figure 2-72 and Figure 2-73, is a comparison of the physical state of a box-girder compared to the 3D Laser Scanning representation.

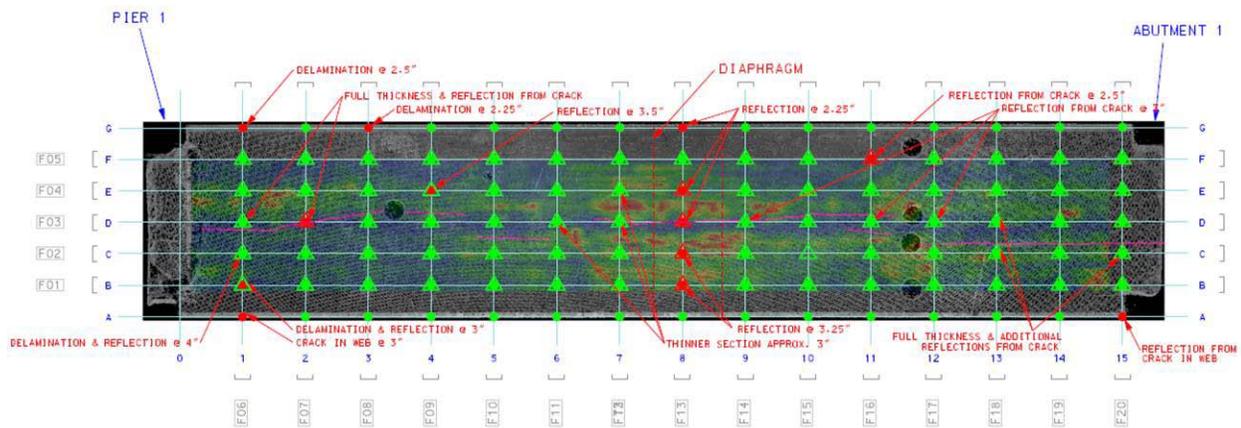
Figure 2-75: Combined NDT Results Superimposed on Beam Surface for CC3

Beam CC3 was subjected to a combination of NDT procedures. The results are shown in Figure 2-75. Of the 75 locations tested by the Monolith device, 6 were identified as having potential anomalies. Of the 105 locations tested by the IE method, 13 were identified as having potential anomalies. GPR technology was applied to this beam, but no diminished reflections were identified. The polygon UST results indicate diminished reflections towards the midspan of the beam. Some of the anomalies have been listed as: “Delamination,” “Crack in Web,” and “Reflection from Crack.” It is important to note that the methods also picked up the diaphragm located within the void of the beam.

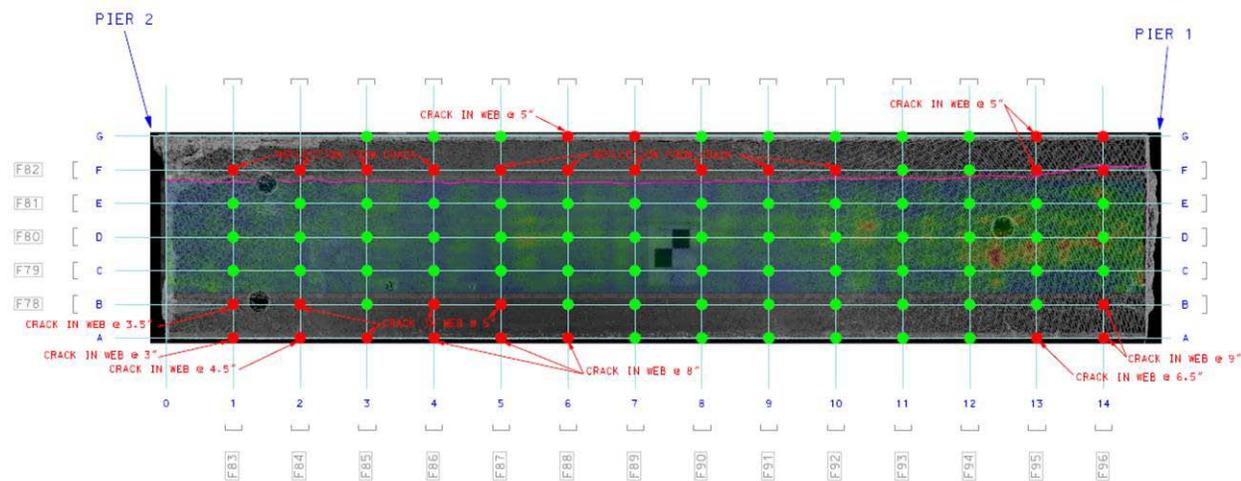
Figure 2-76: Combined NDT Results Superimposed on Beam Surface for CC4

Beam CC4 was subjected to a combination of NDT procedures. The results are shown in Figure 2-76. Of the 96 locations tested by the IE method, 29 were identified as having potential anomalies. GPR technology was applied to this beam, but no diminished reflections were identified. The polygon UST results indicate diminished reflections towards the pier 1 end of the beam. Some of the anomalies have been listed as: “Crack in Web” and “Reflection from Crack.”

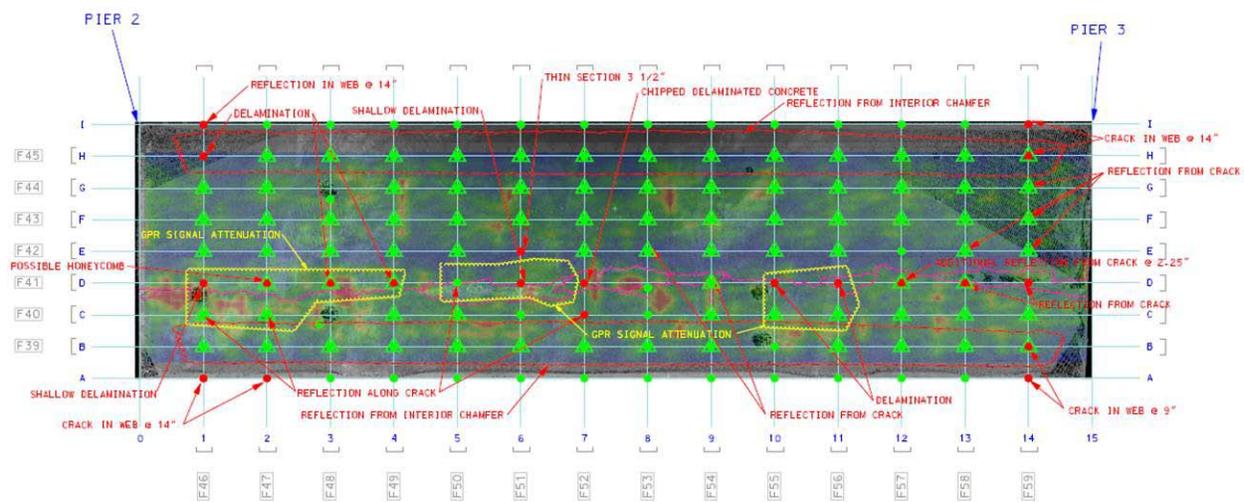
Figure 2-80: Combined NDT Results Superimposed on Beam Surface for MS3

Beam MS3 was subjected to a combination of NDT procedures. The results are shown in Figure 2-80. Of the 68 locations tested by the monolith device (UST), none were identified as having potential anomalies. Of the 126 locations tested by the IE method, 22 were identified as having potential anomalies. GPR technology was applied to this beam, and three areas with diminished reflection are identified, all of which lie above the longitudinal crack present on the beam surface. The polygon UST results indicate diminished reflections around the longitudinal crack. Some of the anomalies have been listed as: “Crack in Web,” “Crack,” “Shallow Delamination,” “Possible Honeycomb,” “Reflection in Web,” “Delamination,” and “Reflection from Crack.”

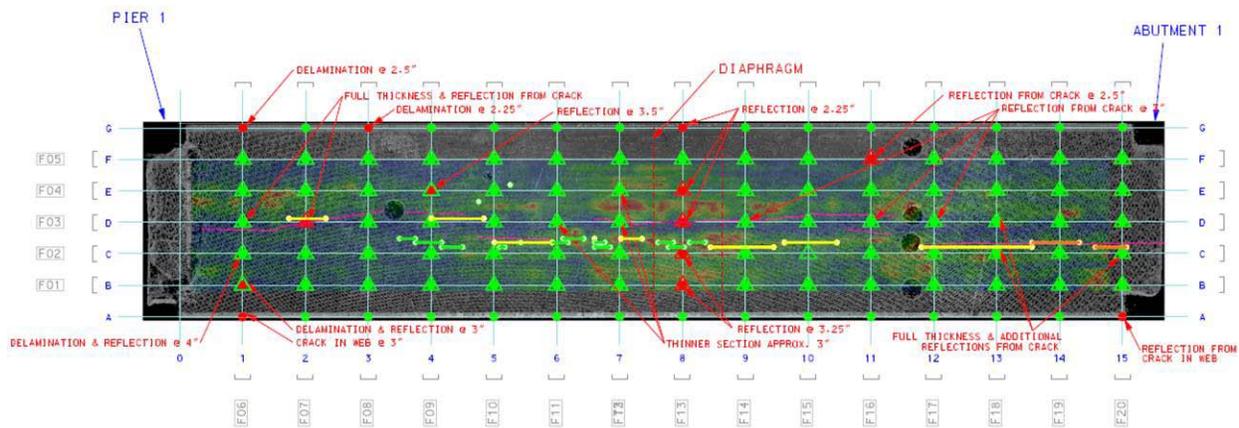
Figure 3-3: Summary of NDT Findings on Beam CC3

Beam CC3 was scanned using the aforementioned NDT procedures and Figure 3-3 was produced. The combination of NDT technologies did not identify the severe cases of wire loss and heavy pitting present in the structure. Two regions were correctly identified as being corroded: a case of pitting at grid intersection 8-C and a case of heavy pitting at grid intersection at 2-D. Of the 19 overall anomalies identified through IE and Monolith UST, corrosion was found at only 4 of them; a 21% success rate. Further, the GPR technology did not detect any instances of deterioration within this beam. The Polygon UST had moderate correlation with strand damage in some locations, and no correlation in other locations.

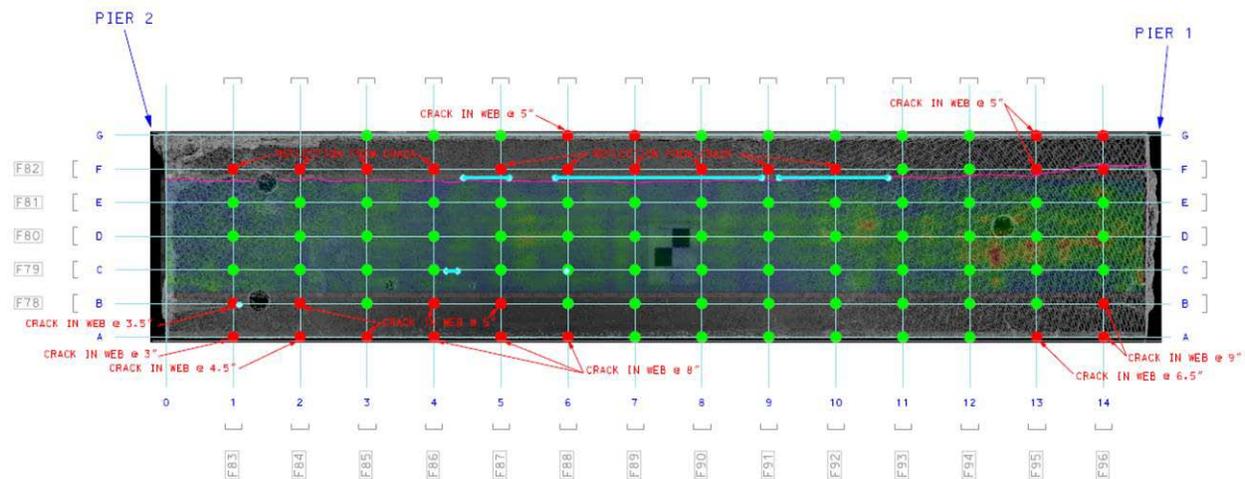
Figure 3-4: Summary of NDT Findings on Beam CC4

Beam CC4 was scanned using the aforementioned NDT procedures and Figure 3-4 was produced. Of the 29 overall anomalies identified through IE, corrosion was found at only 6 of them; a 21% success rate. The GPR accurately showed no signal attenuation. No severe damage (HP and WL) was detected in the strands of this member. The Polygon UST showed no correlation with strand damage.

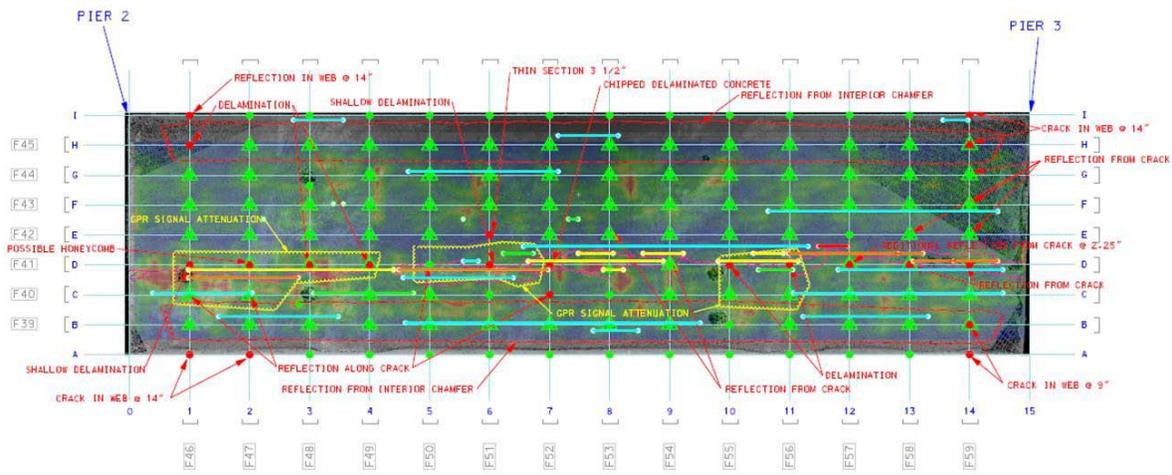
Figure 3-7: Summary of NDT Findings on Beam MS3

Beam MS2 was scanned using the aforementioned NDT procedures. The results of the scan are summarized in Figure 3-7. The combination of NDT technologies picked up cases of wire loss and heavy pitting in some areas, and missed them in other areas. Of the 21 overall anomalies identified through IE and Monolith UST, corrosion was found at 11 locations; a 52% identification success rate. The GPR technology had signal attenuations in three areas on the beam surface, all of which were confirmed to have corrosion in the form of Heavy Pitting and Wire Loss. However, the areas identified as having GPR signal attenuation were very large. The technology was not able to identify corrosion in a more localized area such as a particular strand. The Polygon UST had moderate correlation with strand damage in some locations, and no correlation in other locations.

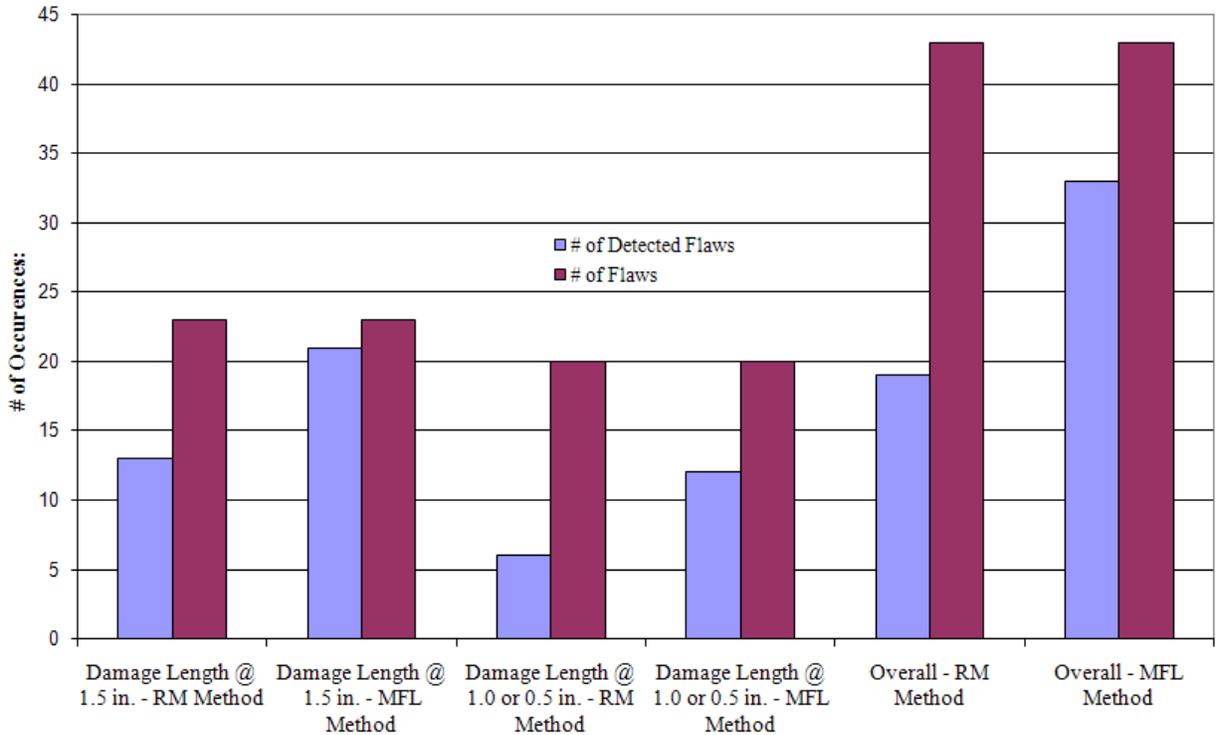
Figure 5-8: Identification of Small Flaws by Non-Destructive Magnetic Methods

Due to the fact that both methods had an almost perfect detection rate for medium flaws, large flaws, and fractures, the sensitivity of the equipment to clear cover and damage length is assessed by comparison of the of the small flaws. The effect of varying the damage length at 1.5 in., 1 in., or 0.5 in. can be seen in Figure 5-8. Both methods were better at locating small section flaws with a damage length of 1.5 in. over those that were shorter in length, i.e., 0.5 or 1 in. The MFL method correctly identified the presence of 91.3% of all small flaws with a large damage length of 1.5 in., compared to only 60% correctly identified for those with damage lengths of 1 inch or ½ in. The RM method correctly identified the presence of 56.5% of all small flaws with a damage length of 1.5 in., compared to only 30% correctly identified for those with damage lengths of 1 in. or ½ in.

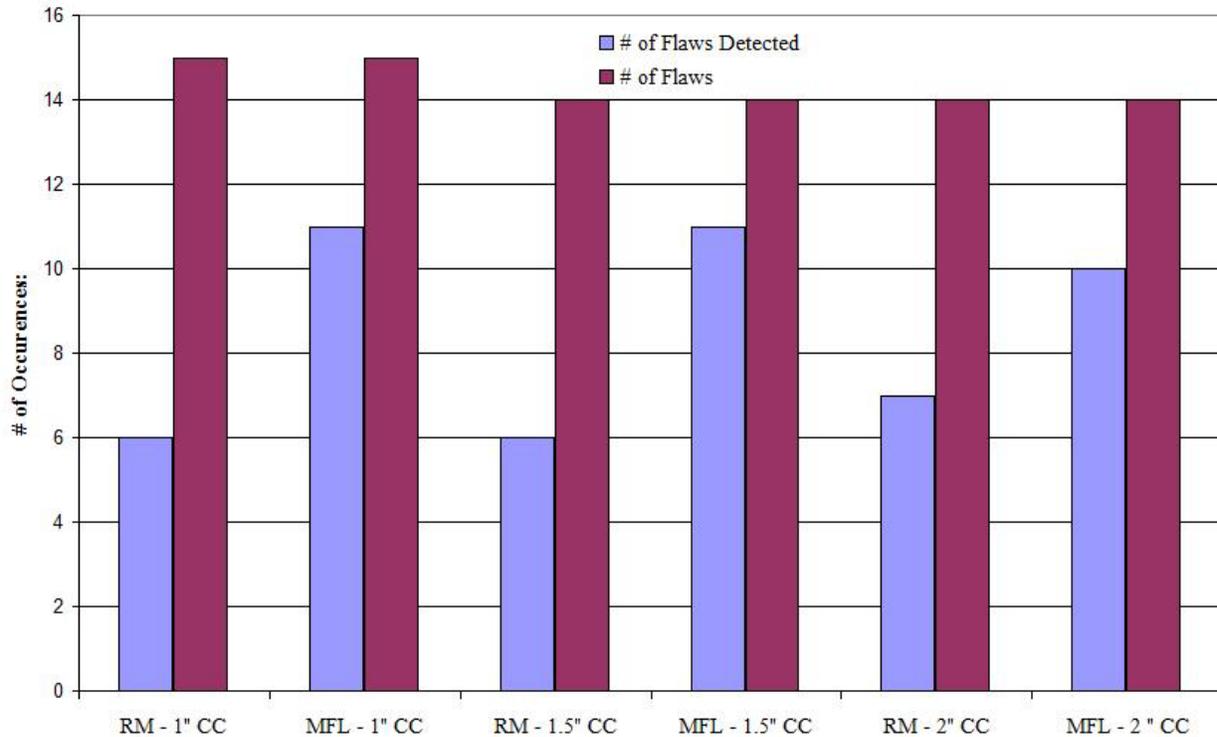
Figure 5-9: Identification of Small Flaws with Respect to Clear Cover

The effect of varying the clear cover at 2.0 in., 1.5 in., or 1 in. is illustrated in Figure 5-9. As the clear cover varied, both magnetic methods had a somewhat consistent flaw identification rate with respect to small flaws. The MFL method successfully detected 73.3% of small flaws with 1 inch of clear cover, 78.6% of small flaws with 1.5 in. of clear cover, and 71.4% of small flaws with 2 in. of clear cover. The RM method successfully detected 40% of small flaws with 1 in. of clear cover, 42.9% of small flaws with 1.5 in. of clear cover, and 50% of small flaws with 2 in. of clear cover.

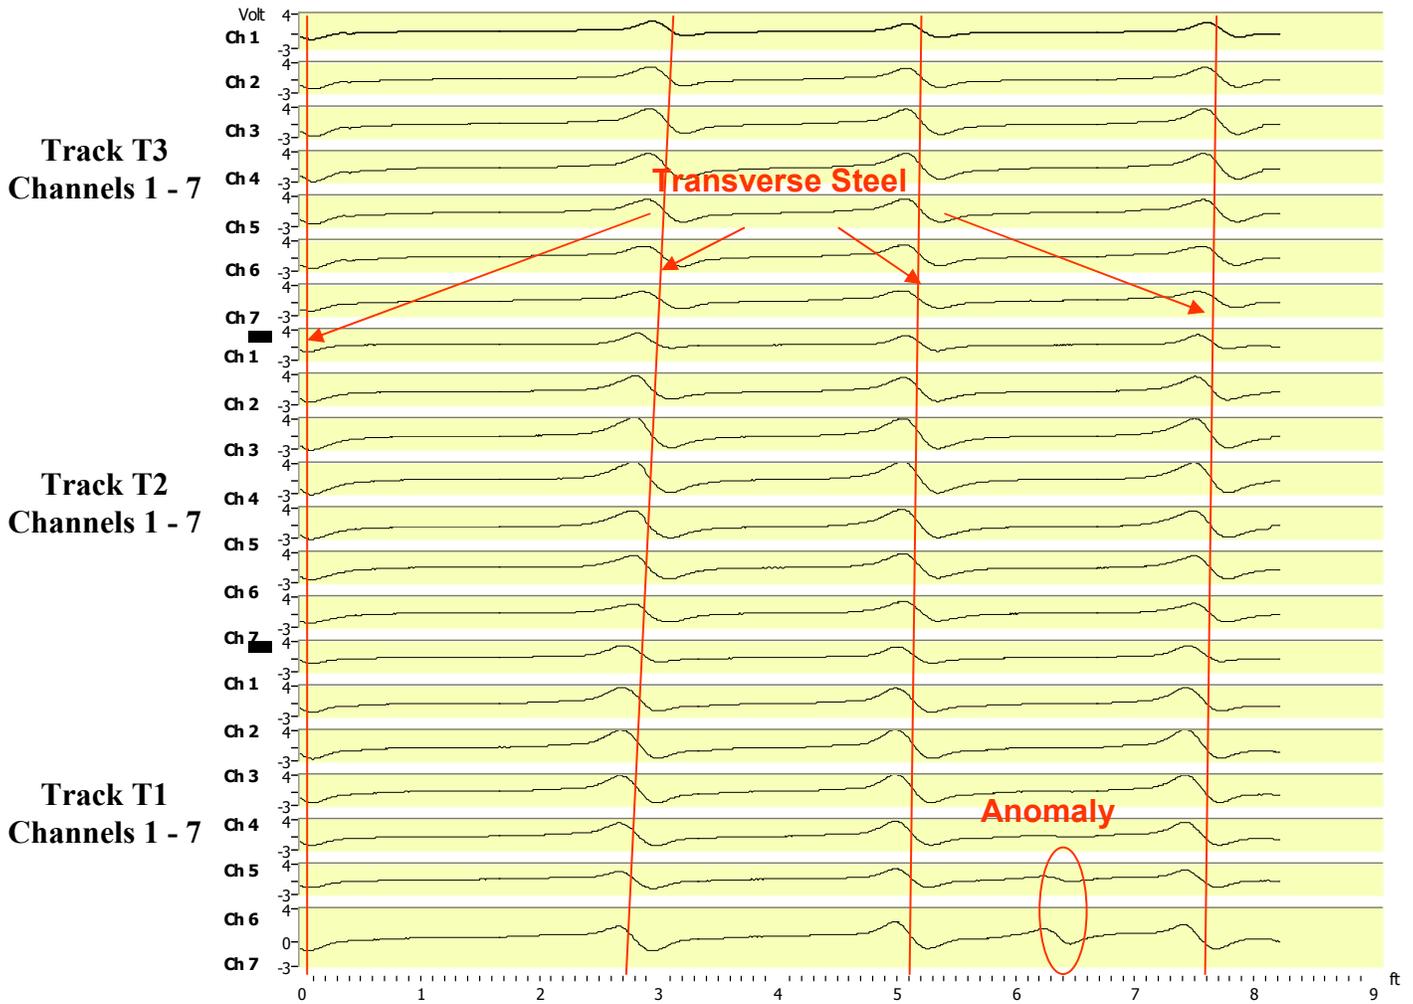
Figure 5 – Side-by-side longitudinal MFL scans shown for 3 Tracks in Beam 2

Beam 2 was located immediately to the south side of Beam 1 but it was oriented in the east to west direction. Three MFL tests were performed (tracks T1 to T3) for this beam and each test was along the east to west direction. A local concrete damaged area was present along the north edge and closer to the west end of the beam. As such, the first scan was performed at a clear distance of 13.5 inches from the north edge of the beam. Each scan length was approximately 8 feet. Each scan was started at a distance of 23.5 inches from the east end of the beam. The MFL test results indicated no prestressing steel wire breaks or significant corrosion in the area of the beam that was scanned. The MFL scan for track T1, however, indicated the presence of a local anomaly (i.e., additional steel, or a ferromagnetic material) at 6.3 feet from the start of the scan or 8.25 feet from the east end of the beam. The anomaly is estimated to be located within a circular area with a diameter of 8 inches located at 8.25 feet from the east end and 16 inches from the north edge of the beam. Figure 5 shows the MFL scans from tracks, T1, T2, and T3 laid out side-by-side and with the beam's transverse reinforcing steels and the local anomaly marked on the figure.

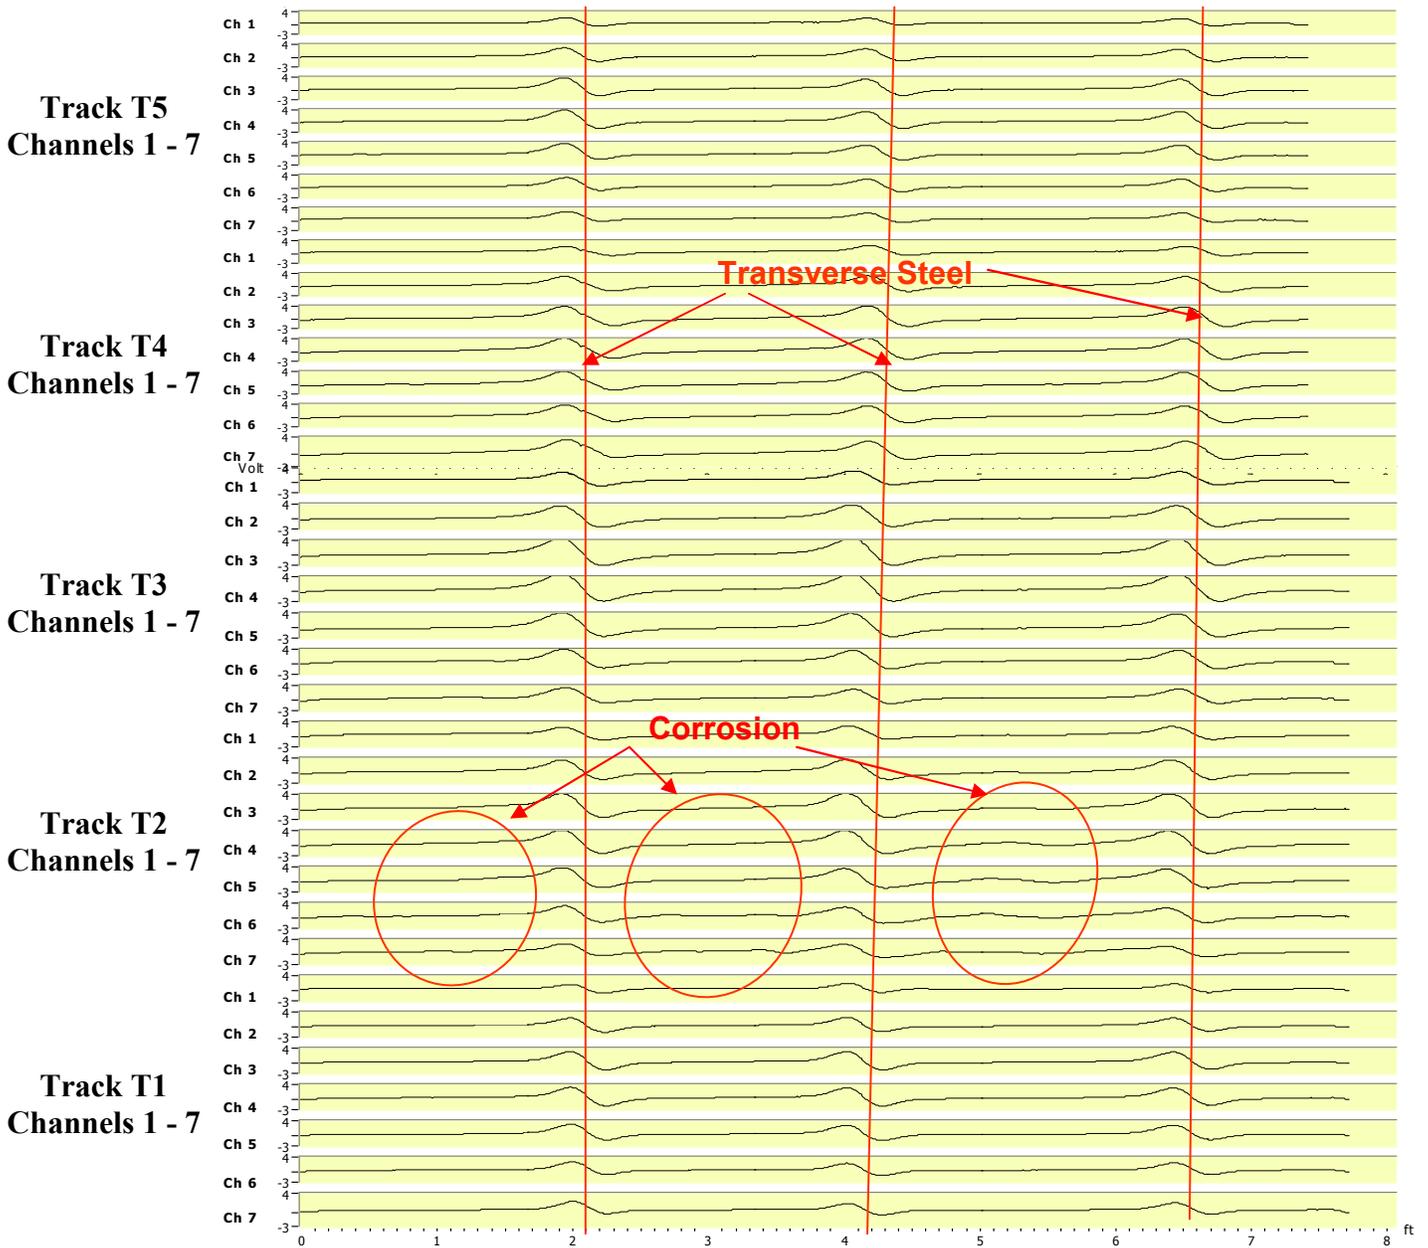
Beam 3 was located immediately to the south side of Beam 2 also oriented in the east to west direction. No significant evidence of corrosion (i.e, corrosion stain or concrete spall) was observed on the surface of the concrete that was scanned by the MFL system. Five MFL tests were performed (tracks T1 to T5) for this beam and each test was along the east to west direction. Because of the edge chamfers, MFL scans were made with 3.5 inches clear of each edge of the beam. Each scan length was approximately 7 feet. Each scan was started at a distance of about 22 inches from the east end of the beam. The MFL results indicated no prestressing steel wire breaks or significant corrosion in most of the area of the beam that was scanned except in an area under track T2. Indications of corrosion of prestressing steel were observed along the length of the scan for the northern one half of the width of the MFL system (Channels 4, 5, 6, and 7) for track T2. The area of the corroded prestressing steel is bound by a band width between 12 to 18 inches from the north edge of the beam. Figure 6 shows MFL scans from Tracks, T1 to T5 laid out side-by-side and with the beam's transverse reinforcing steels and the corroded prestressing steel region marked on the figure. Figure 7 shows close up MFL test graphs for tracks T1 and T2. Evidence of corrosion can be seen easily in the data from track T2 in comparison with the graph from track T1 that showed no corrosion indications.

Figure 6 – Side-by-side longitudinal MFL scans shown for 5 Tracks in Beam 3

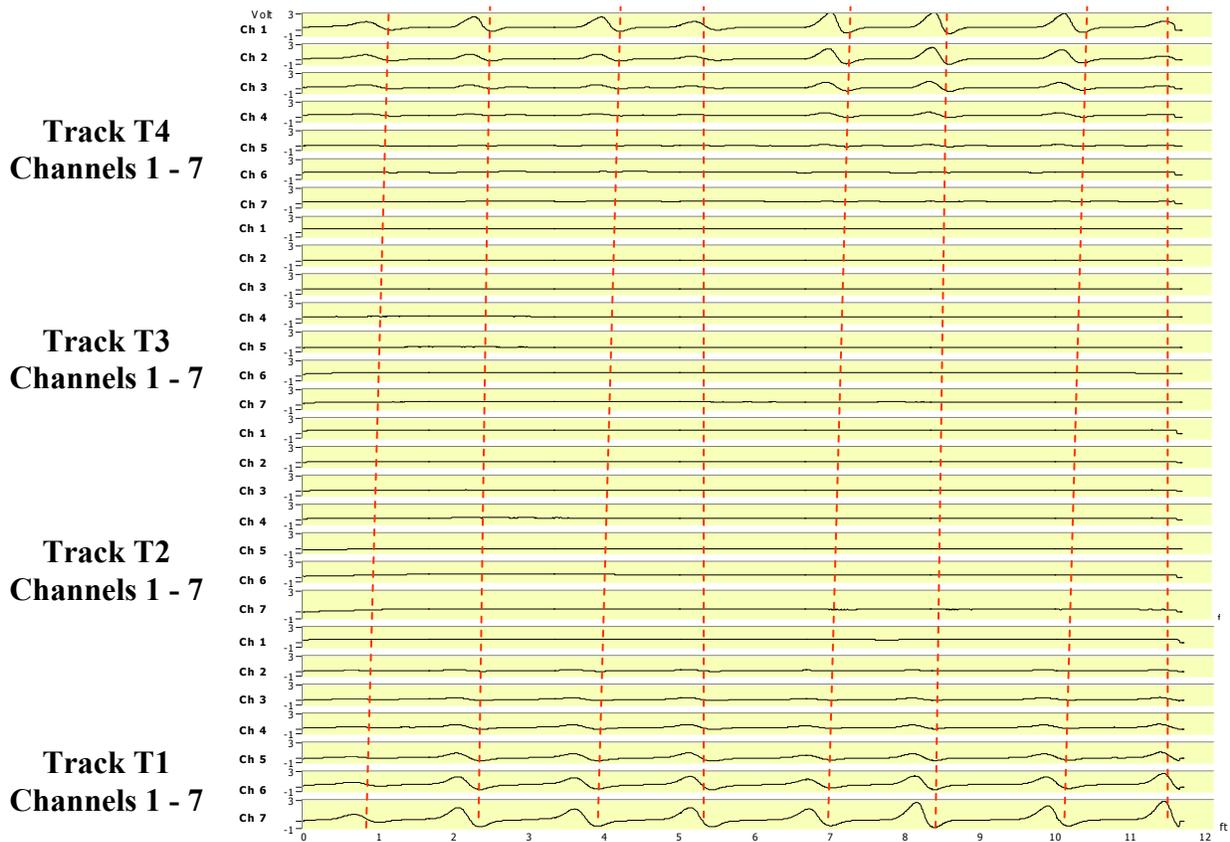
Beam 4 was located immediately to the south side of Beam 3 also oriented in the east to west direction. No significant evidence of corrosion (i.e, corrosion stain or concrete spall) was observed on the surface of the concrete that was scanned by the MFL system. Four MFL tests were performed (tracks T1 to T4) for this beam and each test was along the east to west direction. Because of the edge chamfers, MFL scans were made with 1.5 inches clear of the north edge and 2.5 inches clear of the south edge of the beam. Each track scan was about 11.5 feet long and started at 17.5 inches from the east end of the beam. Based on the results of the MFL tests, there were no indications of prestressing steel wire breaks or major corrosion in the bottom flange of the beam. Figure 8 shows side-by-side MFL longitudinal scans for 4 tracks, T1 to T4, for Beam 4. As shown in the figure, there are no transverse reinforcing steel bars in the bottom flange of the beam. Please note the MFL signals from the near side sensors indicating the presence of tips of vertical bars in the webs (stirrups) on both sides of the beam.

Figure 8 - Side-by-side MFL longitudinal scans for 4 tracks in Beam 4

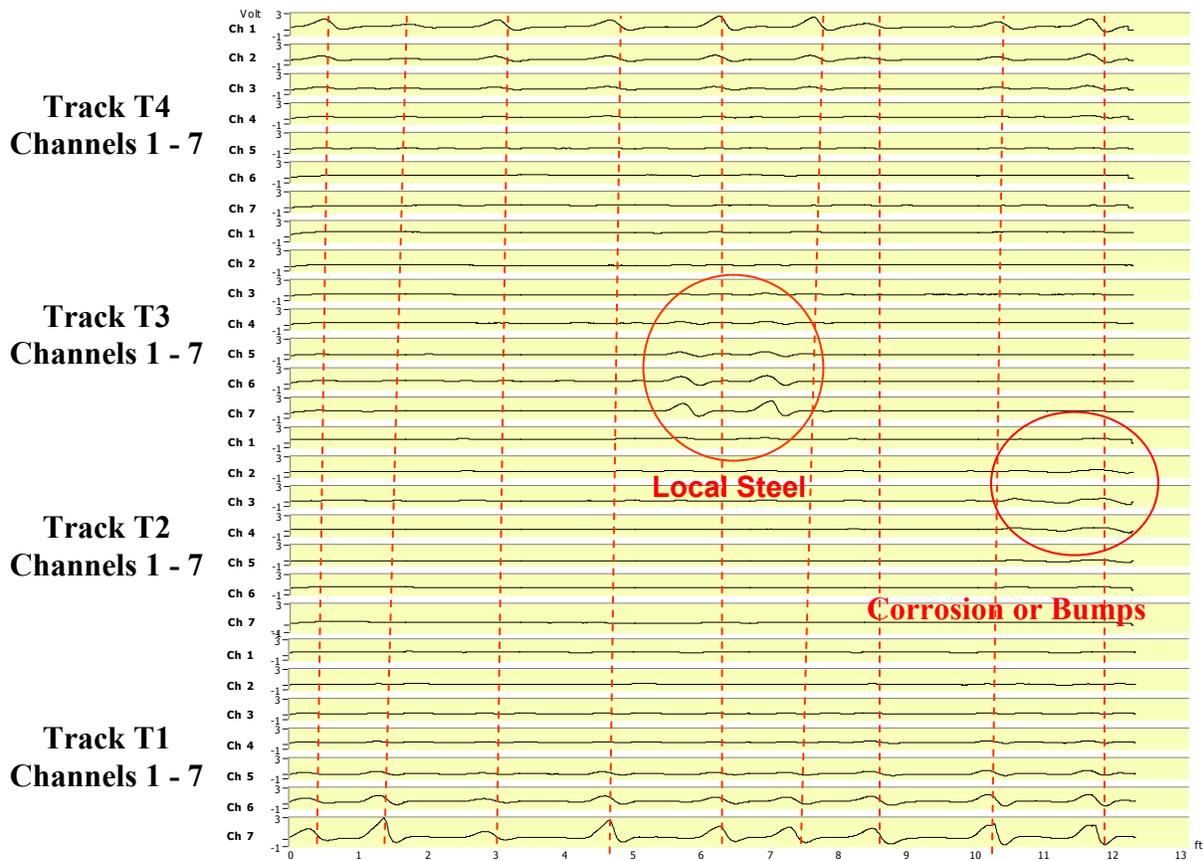
Beam B5 was located immediately to the south side of beam B4 also oriented in the east to west direction. No significant evidence of corrosion (i.e, corrosion stain or concrete spall) was observed on the surface of the concrete that was scanned by the MFL system. Four MFL tests were performed (Tracks T1 to T4) for this beam and each test was along the east to west direction. Because of the edge chamfers, MFL scans were made with 2.0 inches clear of the north and south edges of the beam. Each track scan was about 12 feet long and it started at 24.0 inches from the east end of the beam. Based on the results of the MFL tests, there were no indications of prestressing steel wire breaks or major corrosion in the bottom flange of the beam. Figure 9 shows side-by-side MFL longitudinal scans for 4 tracks for the beam. As shown in the figure, there are no transverse reinforcing steel bars in the bottom flange of the beam. Please note the MFL signals from the near side sensors indicating the presence of tips of vertical bars in the webs (stirrups) on both sides of the beam. Also, please note the MFL data indications from track T3 at locations between 5 ft to 8 ft from the start of the test (7 ft to 10 ft from the east end of the beam). The MFL amplitude variations in this region are related to the presence of local steel elements such as chairs, couplers, etc. They do not indicate the presence of prestressing steel wire breaks or major corrosion.

Figure 9 - Side-by-side MFL longitudinal scans for 4 tracks in Beam 5

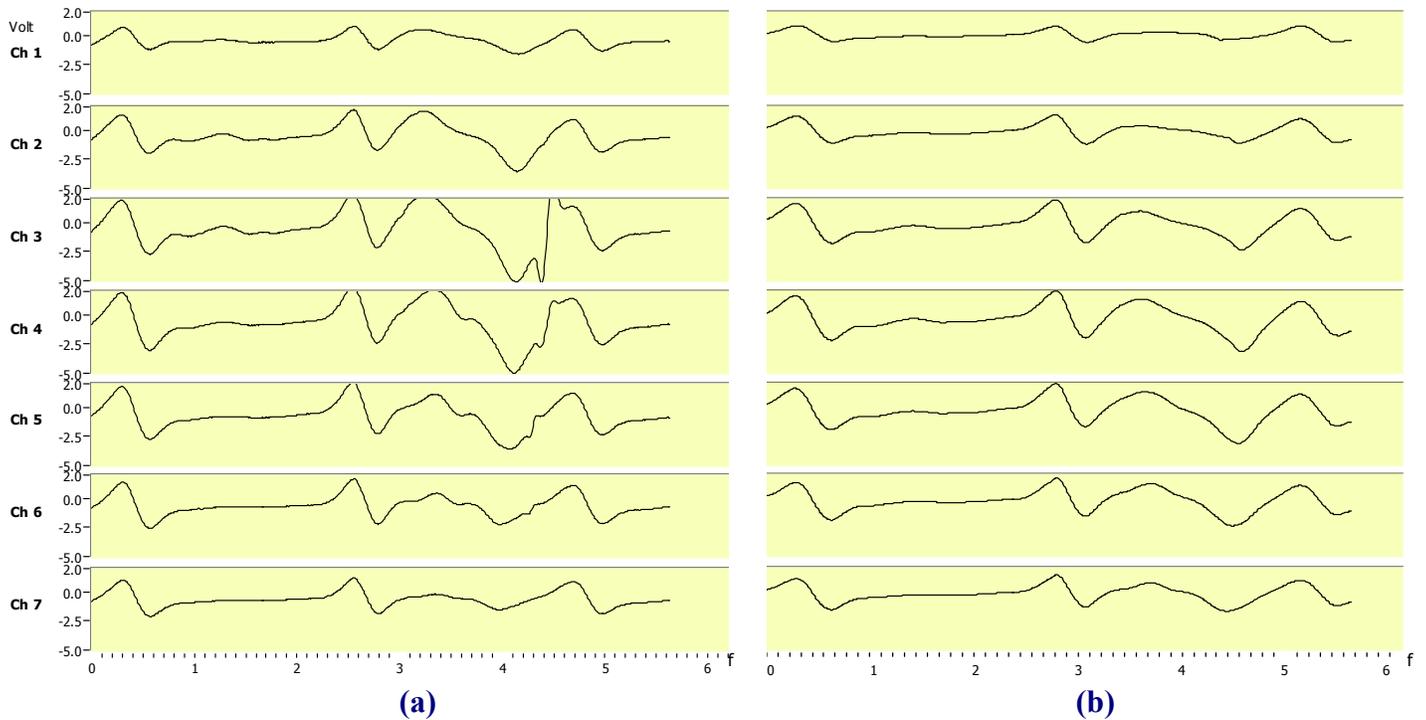
Figure 11 shows the MFL test results for track T7 in Beam 6. As shown in the figure, test track T7 was conducted for a scan length of about 5.5 feet and it was taken in the east to west direction. The figure on the left side (a) shows the test results when the MFL system was placed directly on the concrete and the plastic-tape-covered surfaces. The figure on the right side (b) shows the MFL results from the same test except with a ½-in. wood board that was placed on the lower flange surface. In both figures (a) and (b), indications of transverse steel and prestressing corrosion can be seen. While corrosion indications can be seen clearly from both figures, it should be noted that the placement of the ½-in. wood board on the concrete surface caused a reduction in the MFL signal amplitudes and a diminishing of some of the MFL signal details related to the steel corrosion.

Figure 11 – MFL test results for track T7 in Beam 6
 (a) MFL scan without the ½-in. wood board, (b) MFL scan with the ½-in. wood board

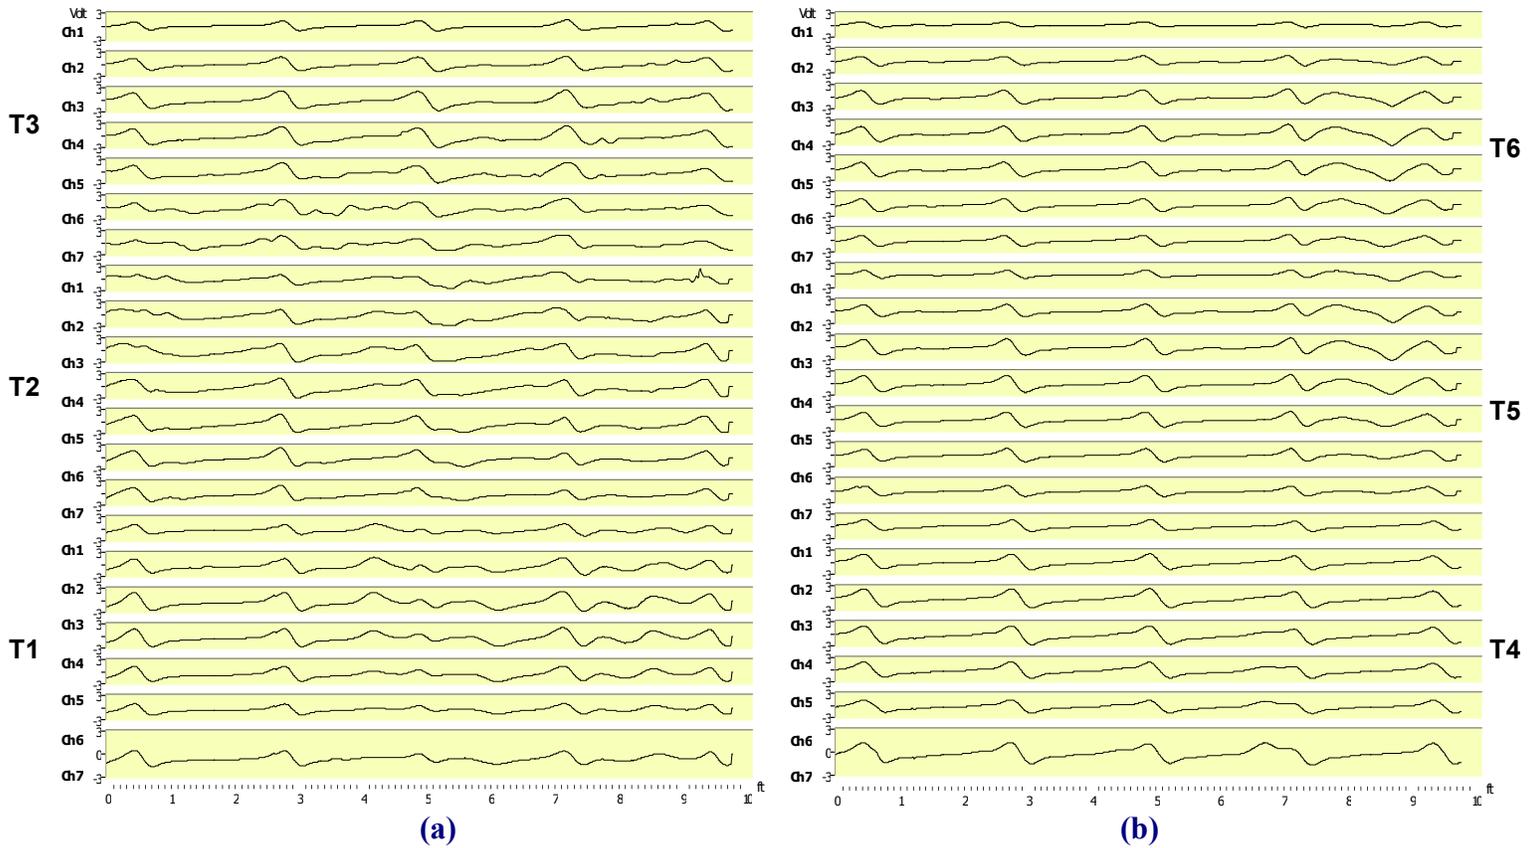
After the ½-in. thick wood board was placed on the surface of the lower flange of Beam 6, a total of six MFL tests (scans) were performed, Figure 10. Each test was performed along the east to west direction. Each test scan was about 10 feet long and it started at about 24 inches from the east end of the beam. Because of the edge chamfers, the MFL scans for tracks T1 and T6 were made at a distance of about 2.0 inches and 0.5 inches clear from the north and south edges of the beam, respectively. Based on the results of the MFL tests, indications of significant corrosion and wire breaks in prestressing steel were noted. Figure 12 shows side-by-side MFL longitudinal scans for 6 tracks in Beam 6. Figure 12(a) shows the MFL data for tracks T1, T2, and T3 and Figure 12(b) shows the data for tracks T4, T5, and T6. Scan tracks T1, T2, and T3 indicated the presence of corrosion throughout the scan lengths. For tracks T4, T5, and T6 corrosion was detected primarily at locations closer to the end of each scan (7.5 to 11 feet from the east end of the beam). The magnetic field variations due to the presence of steel corrosion in Beam 6 can be seen easier if the MFL scans are shown separately for each track as presented in Figure 13. For comparison, the MFL data without any indications of steel corrosion from the test scan for track T5 is also shown in Figure 14.

Figure 12 - Side-by-side MFL longitudinal scans for 6 tracks in Beam 6 (w/ 1/2" thick plank)
 (a) Tracks T1 to T3, (b) Tracks T4 to T6

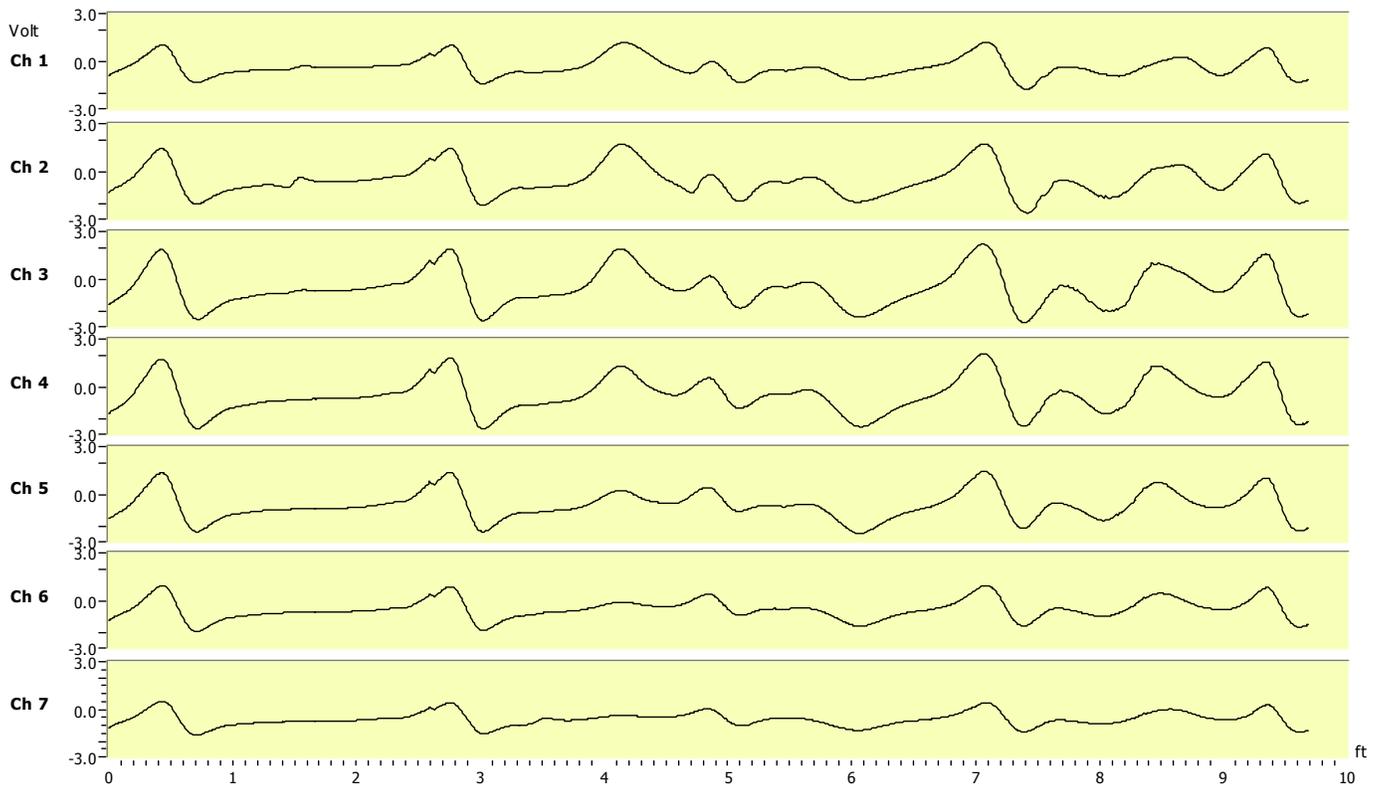
Figure 13 - MFL scan data for track T1 in Beam 6 (w/ 1/2" thick plank)

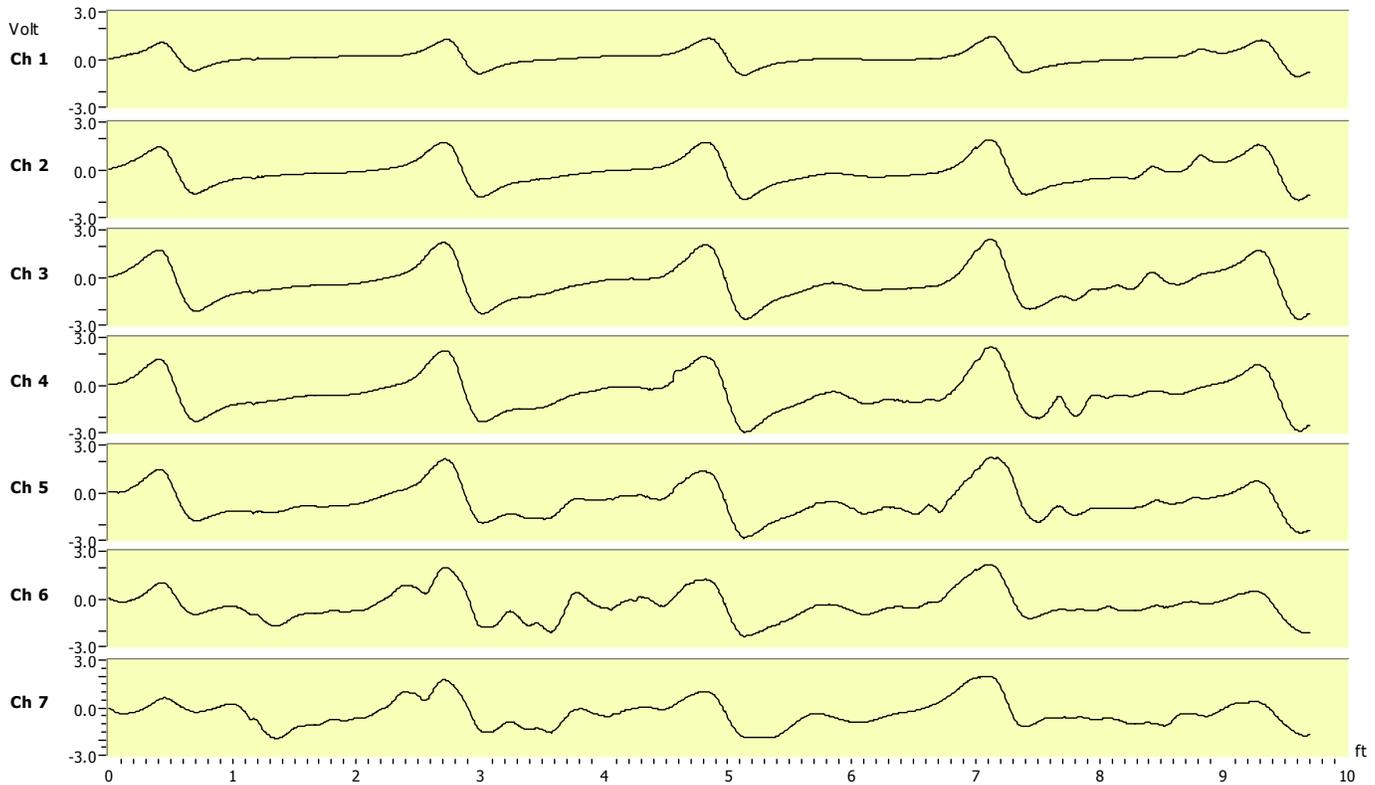
Figure 14 - MFL scan data for track T3 in Beam 6 (w/ 1/2" thick plank)

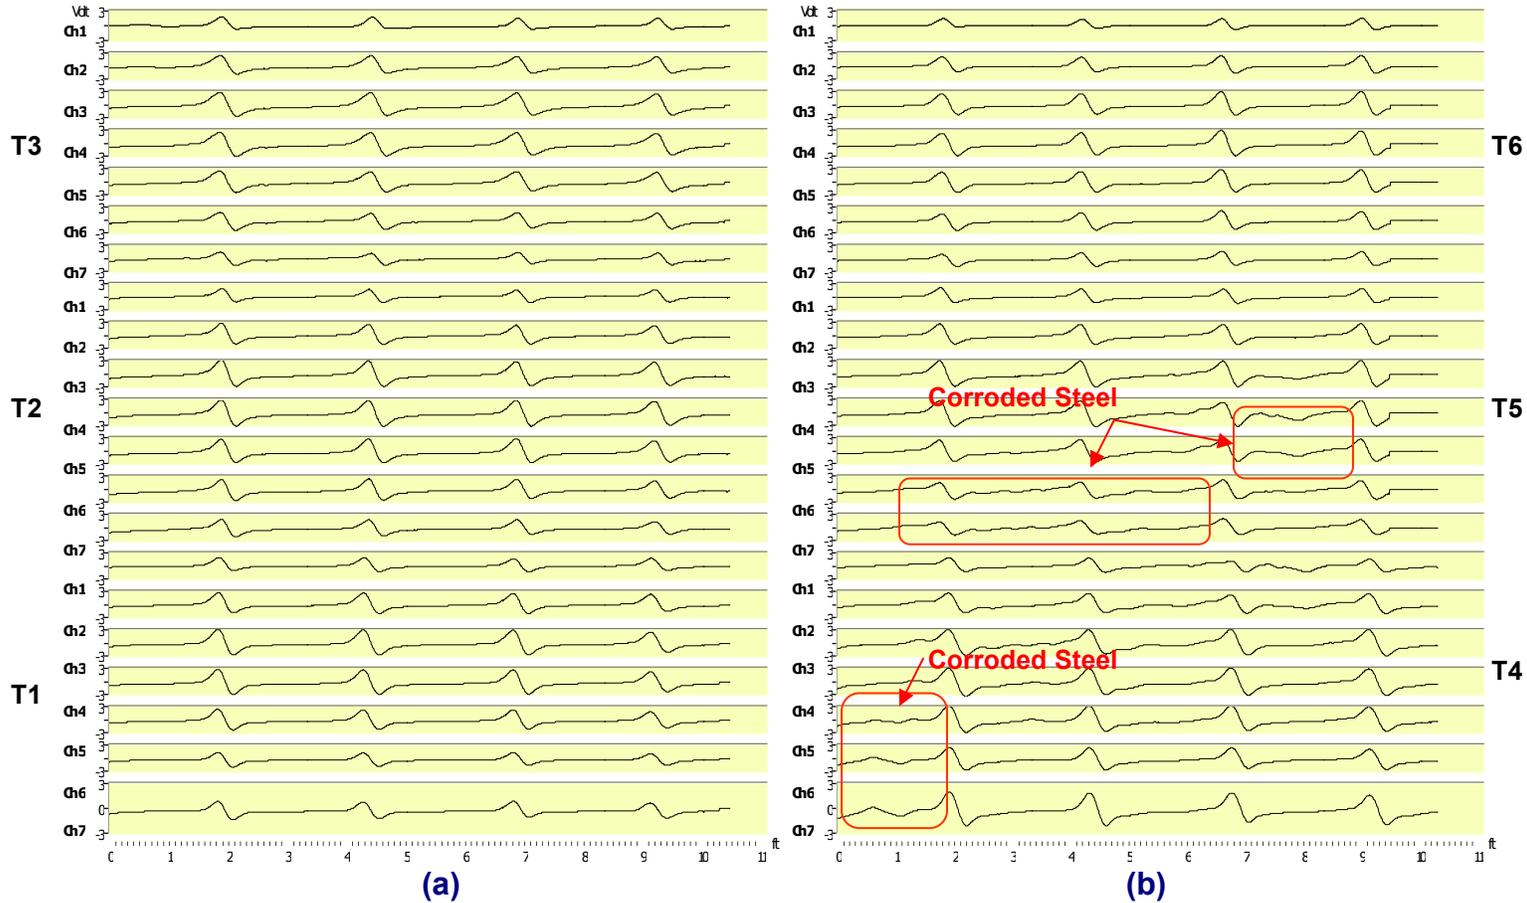
Beam 7 was located at the far south side of the area where the test beams were placed in the laboratory. This beam was oriented in the south to north direction. The beam's lower flange contained isolated longitudinal cracks, concrete splitting, and exposed corroded strands. Figure 15 is a photograph showing the surface condition for the lower flange of Beam 7 and the locations of the centerlines of all the MFL scans (tracks T1 to T6) taken for the beam. A total of six MFL tests (scans) were performed for this beam. Each test was performed along the south to north direction. Each test scan was about 10 feet long and it started at about 29 inches from the south end of the beam. Because of the edge chamfers, the MFL scans for tracks T1 and T6 were made at a distance of 2.0 inches clear from the east and west edges of the beam. Due to the location of concrete splitting on the flange surface, the MFL test scans for tracks T4 and T5 had an overlap of about 4 inches. As such, the data from channels 1, 2, and 3 of track T4 are duplicates of those from channels 5, 6, and 7 of track T5. Based on the results of the MFL tests, no evidence of prestressing wire breaks or major corrosion was noted for tests performed along tracks T1, T2, T3, and T6. Test results performed along tracks T4 and T5 showed indications of corrosion of prestressing steel along the longitudinal cracked area and where there was concrete splitting and exposed corroded prestressing steel. Figure 16 shows side-by-side MFL longitudinal scans for 6 tracks in Beam 7. Figure 16(a) shows the MFL data for tracks T1, T2, and T3 and Figure 16(b) shows the data for tracks T4, T5, and T6. Evidence of steel corrosion can be seen in the test scans for tracks T4 and T5 as marked on the figure. Steel corrosion is detected along the beginning part of the scan for track T4 and along most part of the scan for track T5. The magnetic field variations due to the presence of steel corrosion in Beam 7 can be seen easier if the MFL test graphs are shown separately for tracks T4 and T5 as presented in Figure 17. For comparison, the MFL graph for a test scan with no indications of steel corrosion (for track T2) is also shown in Figure 18.

Figure 16 - Side-by-side MFL longitudinal scans for 6 tracks in beam B7
 (a) Tracks T1 to T3, (b) Tracks T4 to T6 (5" overlap of T4 & T5)
