Pennsylvania Department of Transportation
Bureau of Planning and Research Project
Contract No. 355I01 / Project No. 070202

Inspection Methods & Techniques to Determine Non Visible Corrosion of
Prestressing Strands in Concrete Bridge Components

Task 2 - Assessment of Candidate NDT Methods

ATLSS REPORT NO. 09-09

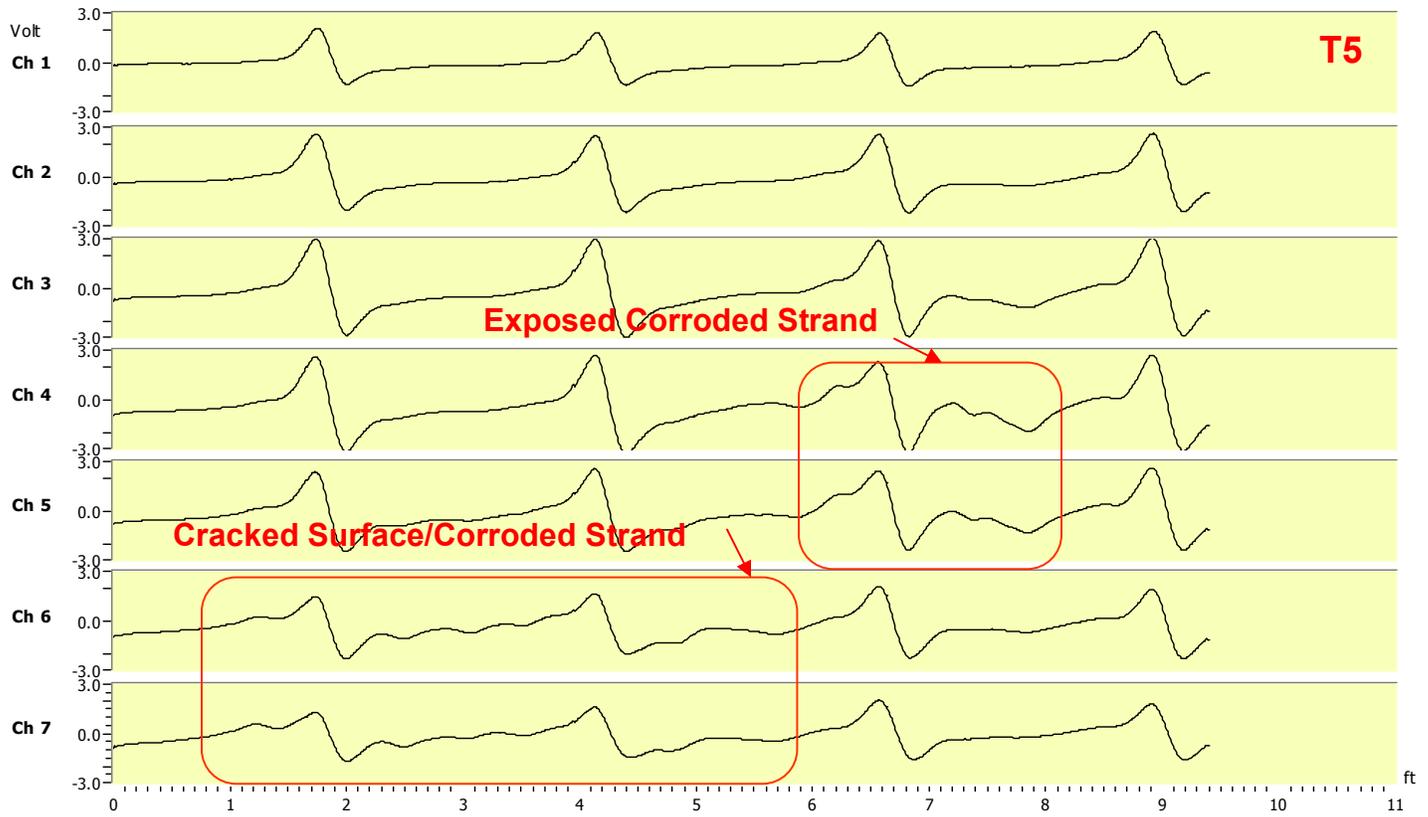
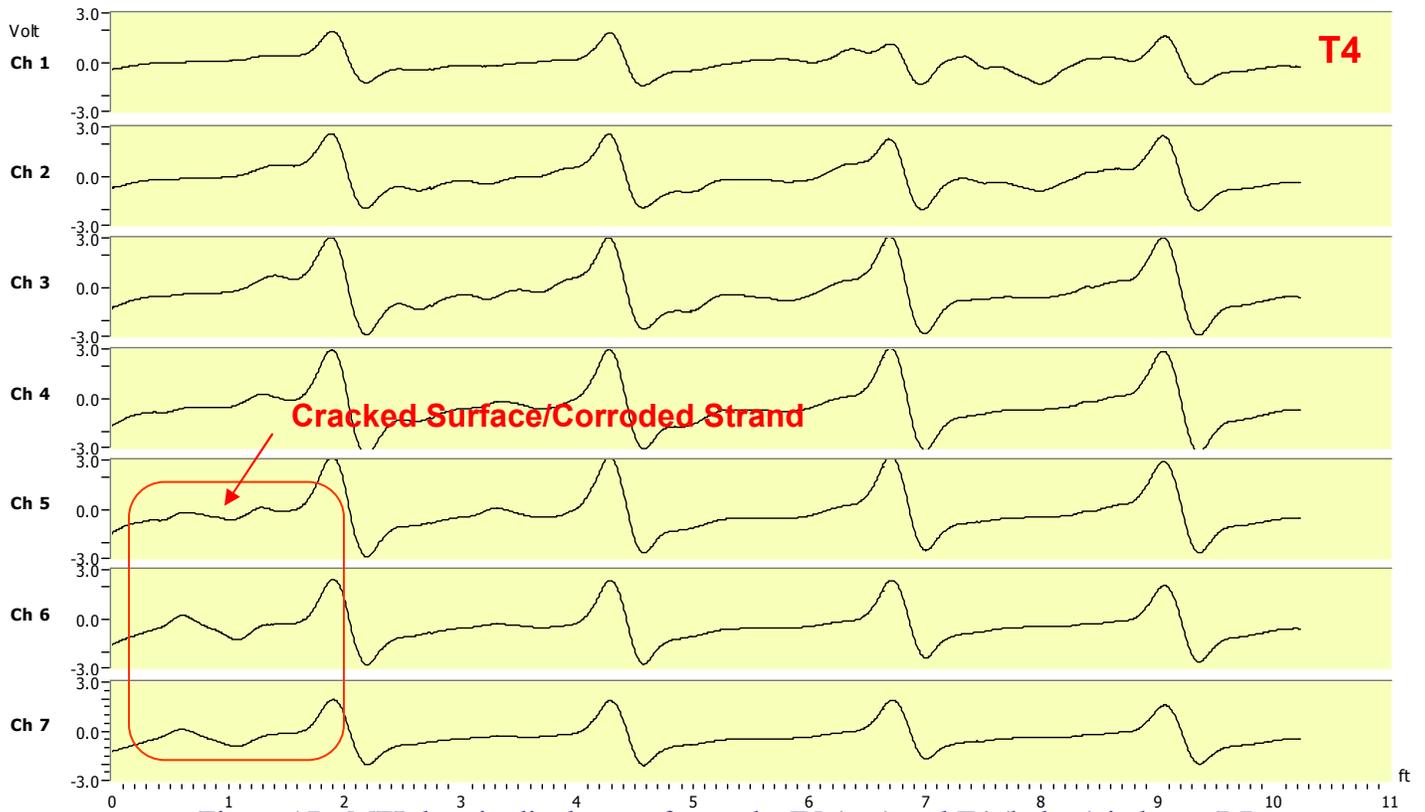
Figure 17 - MFL longitudinal scans for tracks T5 (top) and T4 (below) in beam B7
 (Note: Scan overlap resulting duplicate data in Ch. 5, 6, and 7 of track T5 and Ch. 1, 2, and 3 of track T4)

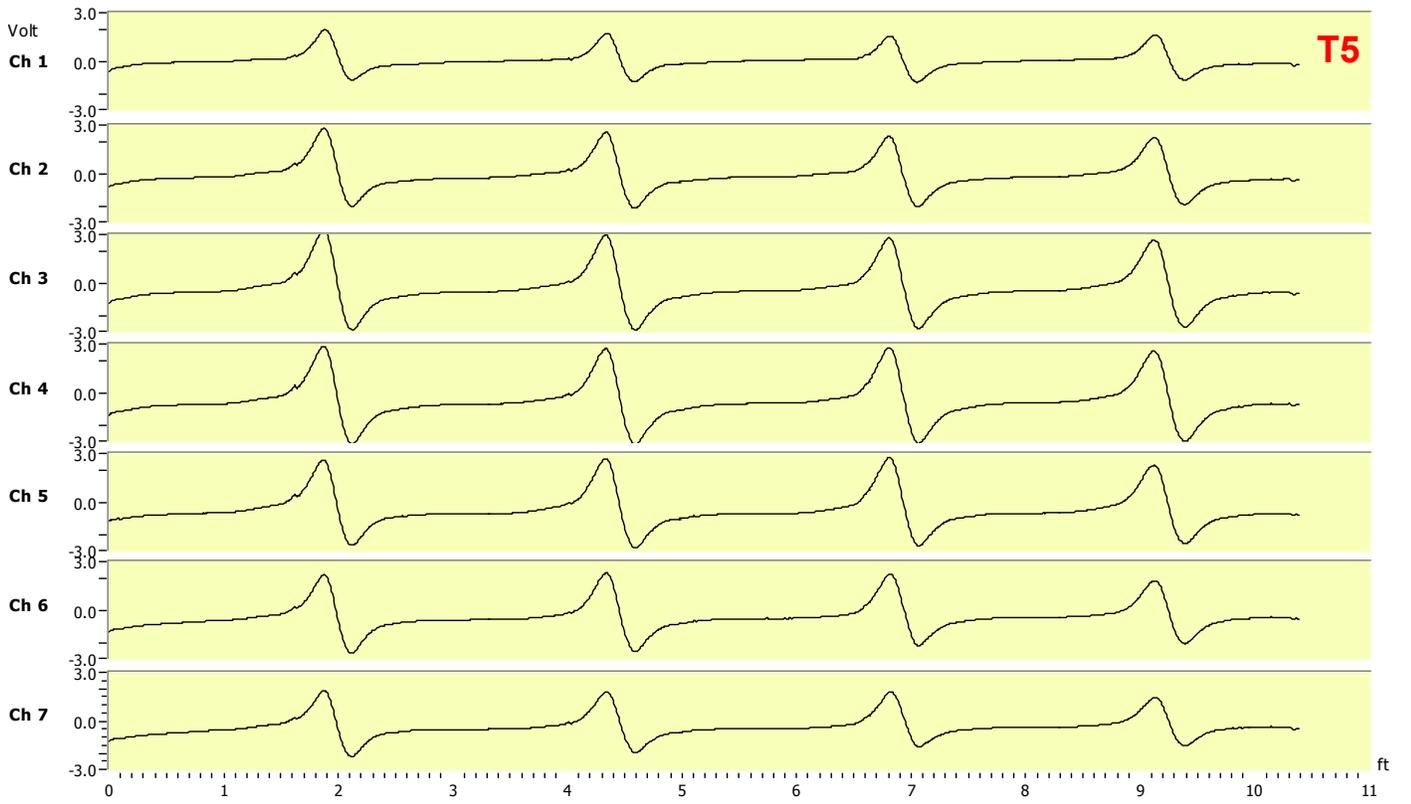
Figure 18 - MFL data for track T2 where there are no indications of steel corrosion in Beam B7

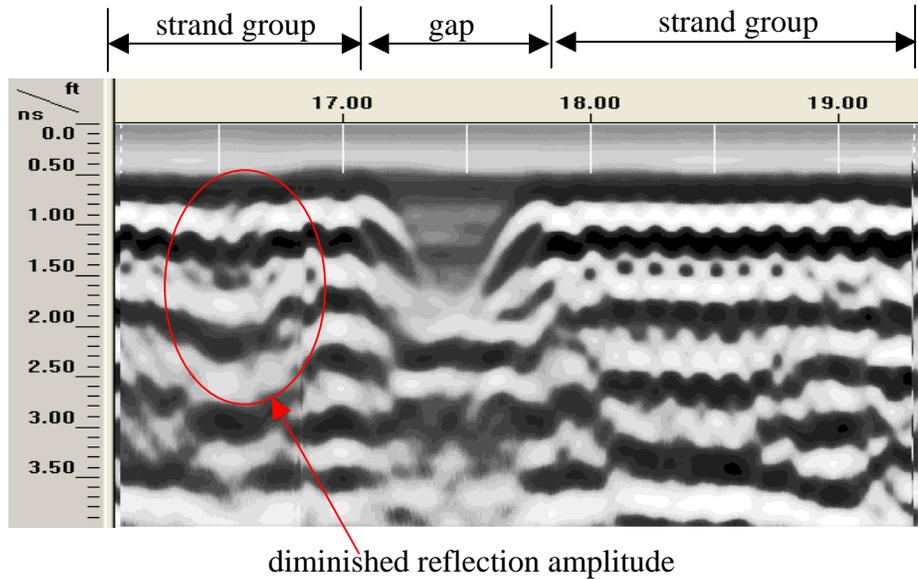
The fundamental principle applied in this work is that the reflections from corroded strands will be less than that from intact scans due to the loss of section and the presence of moisture, chloride, and corrosion products in the concrete surrounding the corroded scans. The effect of the latter is diminished in the laboratory due to the dry environment, but the loss of section should still be present and possibly detectable. This analysis principle can be observed visually in Figure 9. This figure shows a transverse scan at offset 5 feet on girder #3. The reflection amplitude is proportional to the intensity of the color in the display. Note that the reflection amplitudes in the strand group on the right side of the figure is diminished compared to the group on the left side of the figure. This reduction in amplitude could be due to corrosion.

Figure 9 – Transverse Scan, Girder #3, at 5 Feet from E end, Scanning N-S

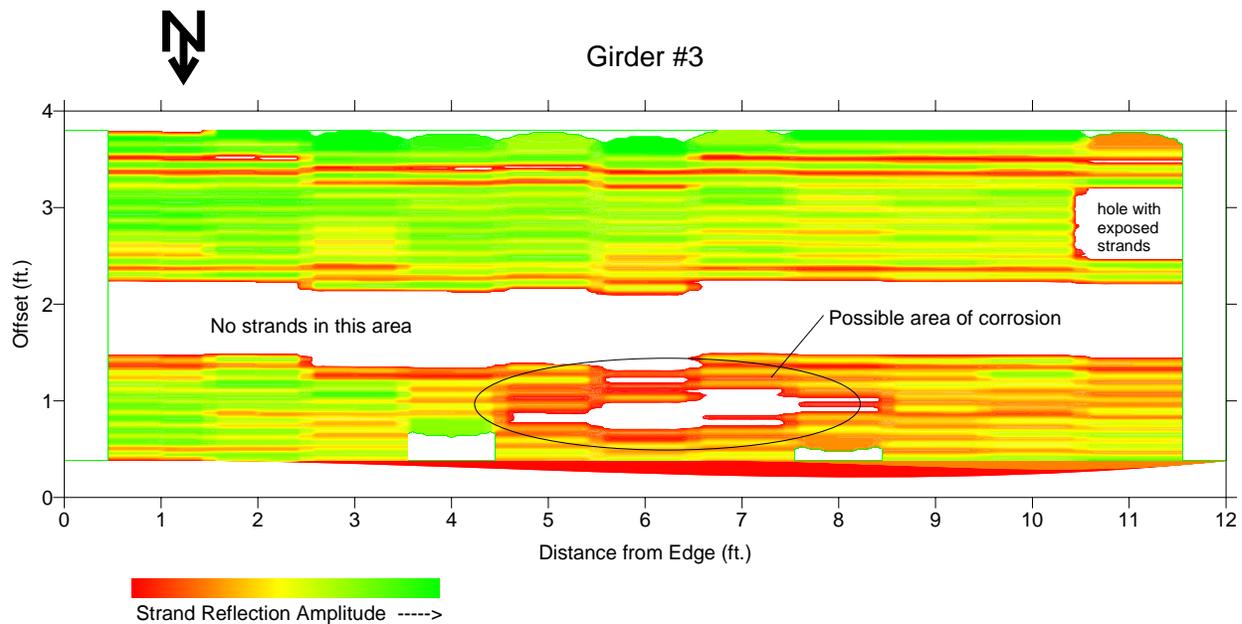
The qualitative observation described above was converted into a quantitative analysis using Infrasense's automated GPR analysis software, *winDecar*. The software was used to track the reflection amplitude from the prestressing strands as they appeared in the transverse scans. These amplitudes were then contour plotted to graphically display areas with diminished reflection amplitude. These areas are identified as areas of potential corrosion. A sample contour map is shown in Figure 10.

Figure 10 – Sample Contour Plot of Strand Reflection Amplitude, Girder #3

In order to generate the contour plot of Figure 10, a color scale was established ranging from red for low amplitude reflections to green for high amplitude reflections. Below a certain threshold, the color was set to white. This was done to distinguish the areas where there are no strands from the areas where the strands exist. The horizontal striations in the contour map represent the alignment of the individual strands. These are not perfectly horizontal, due to slight discrepancies in the start location of each transverse scan.

The contoured data for girders 2 and 3 show a similar prestressing pattern, which is expected since both girders come from the same bridge. In each case, there is an area that shows diminished reflection amplitude. In girder 2, this area surrounds an existing spall, and is very likely showing the expansion of the corrosion that created the spall. In girder 3, the area identified in the contour map does not coincide with any surface distress.

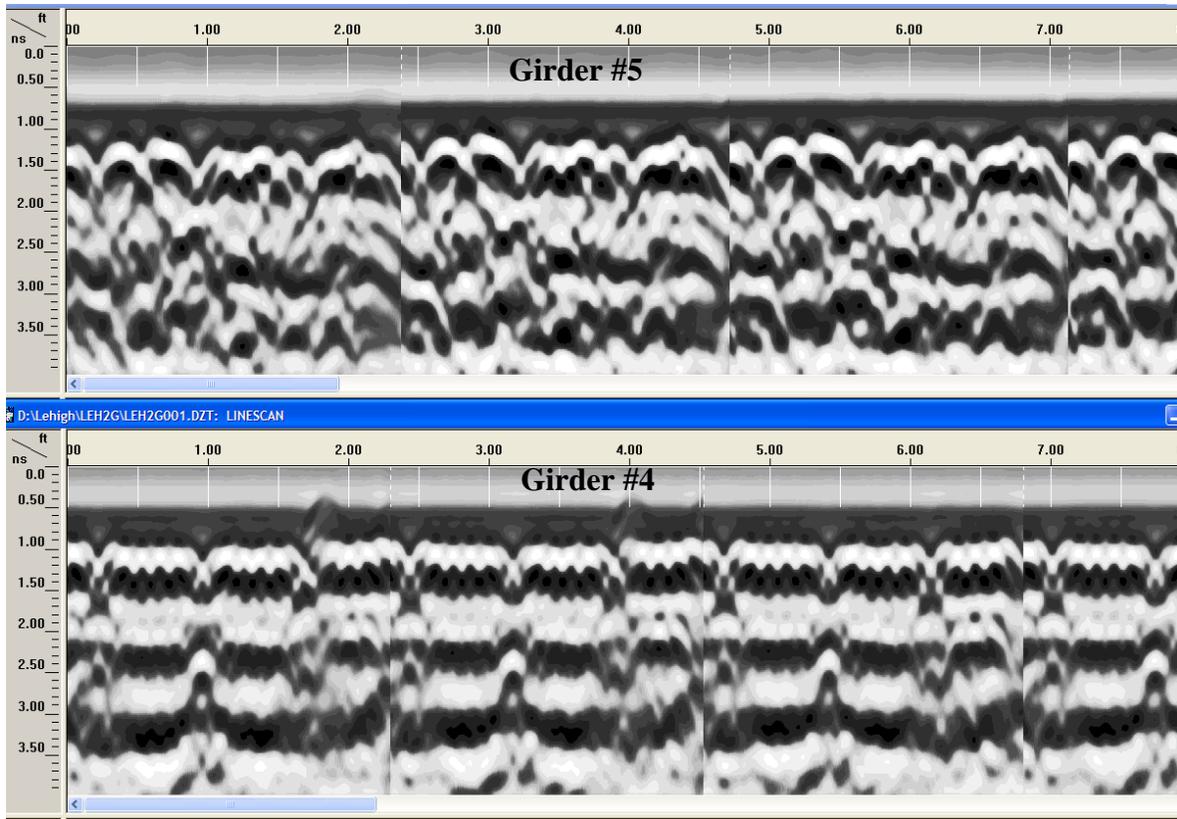
The contoured data for girder 4 also shows a regular prestressing pattern, but one that is different than girders 2 and 3. This is to be expected, since girder 4 comes from a different bridge. There are no large areas of diminished reflection amplitude, but there appear to be individual strands that show low amplitude, and these individual strands may be corroded. While girder 4 is from the center span of the Clearfield bridge, girder 5 is from the end span, and shows an entirely different, and somewhat irregular pattern of prestressing. Figure 11 shows the raw GPR data for these two girders, and the difference is readily apparent. Reference to the design drawings does not explain the irregular pattern observed in girder 5. The irregular pattern makes it difficult to identify possible areas of corrosion with this type of contour plot.

Figure 11 – GPR Data Showing Prestressing Patterns of Girders #5 and #4

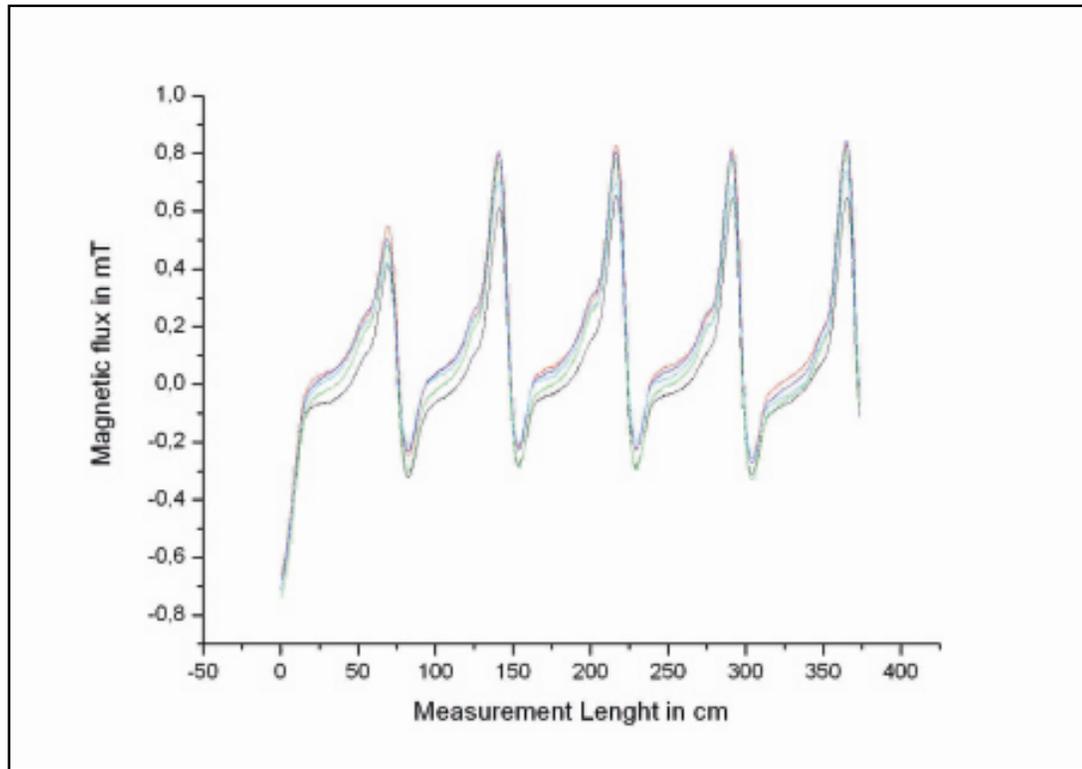
Figure 6: Measured signal along the course of the tension wire of box girder MS 3 with typical signals from stirrups

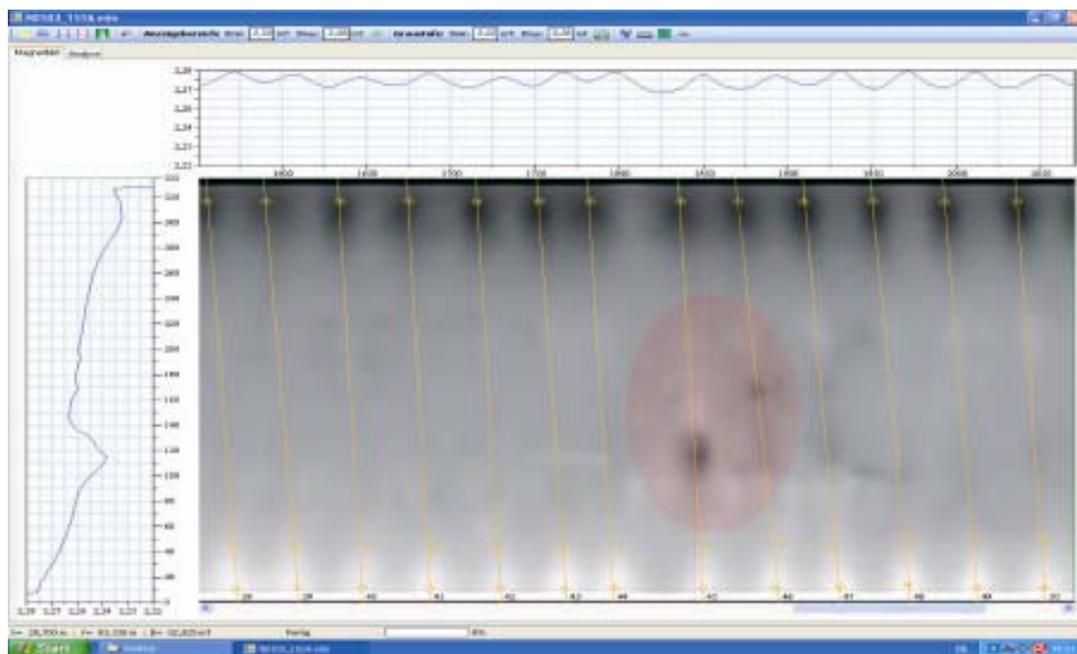
Figure 14: Screenshot of the stray magnetic field as a grayscale image of a road section with the marked range of a fracture

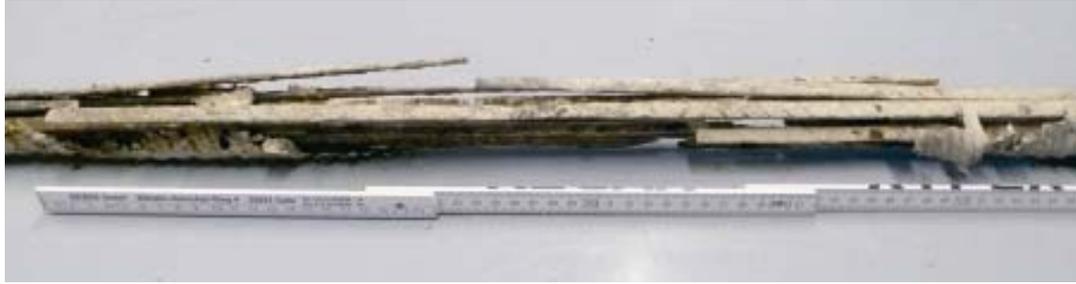
Figure 14.1: Located shear tendon break in the bridge deck

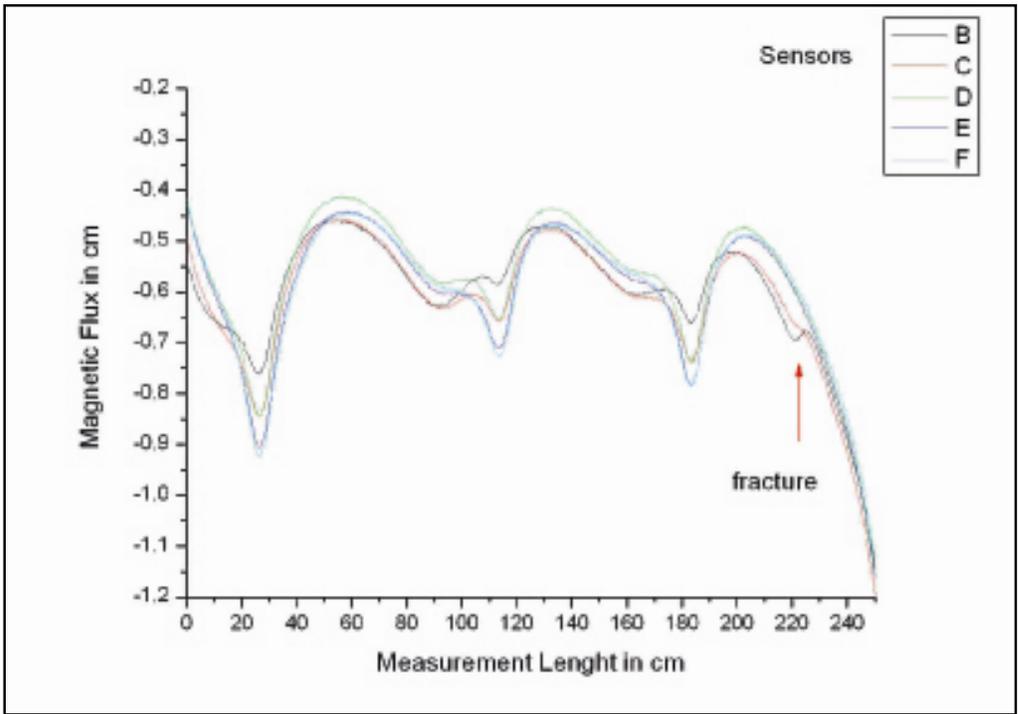
While scanning track line 4, sensor one (the sensor arranged on the far right of the measuring unit) detected the clear evidence of a fracture (Figure 19). This break shows itself in the active field as shown in Figure 20.

Figure 19: Box girder LV16, line 4; fracture signal by measuring the stray magnetic field of the tension wires

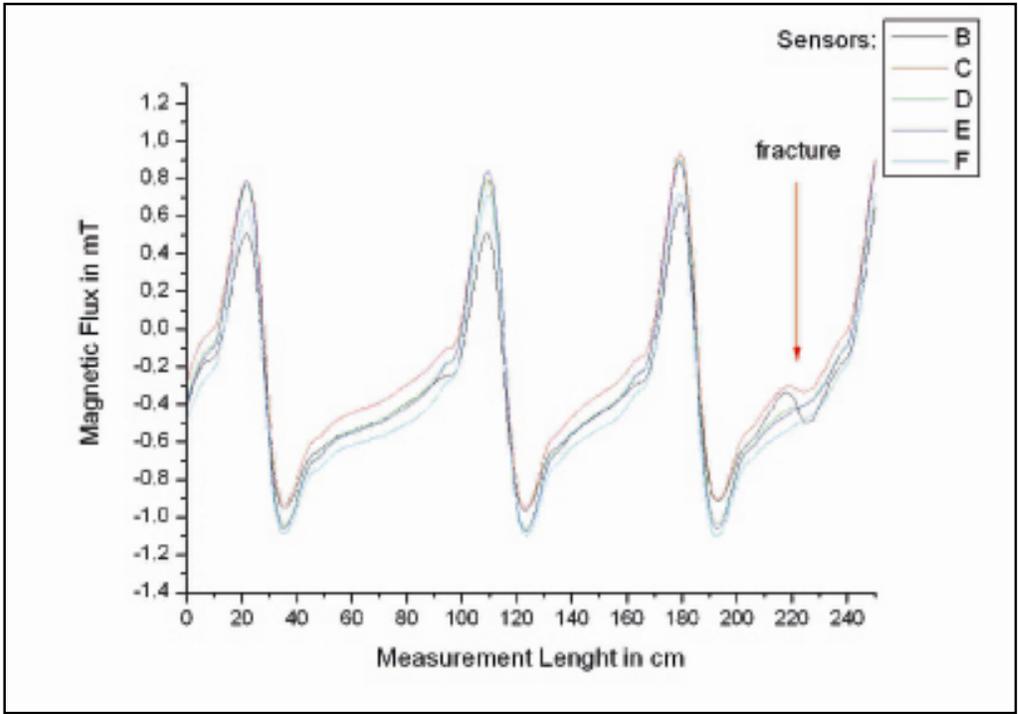
Figure 20: Box girder LV16, line 4; fracture signal measured in the active magnetic field

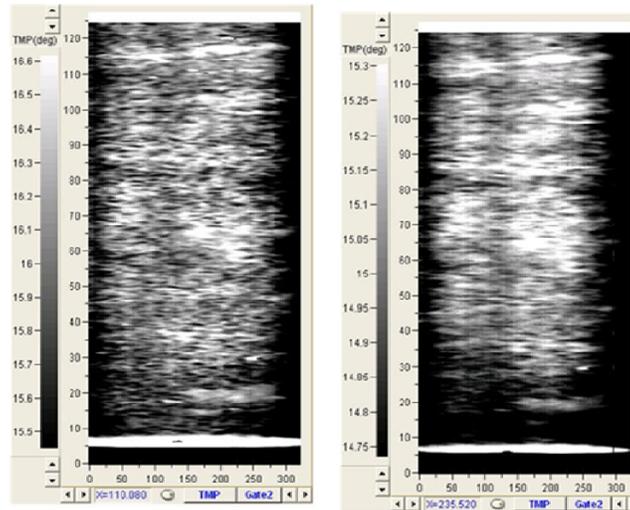
Figure 4. Thermal images of Beam 3. The scans cover 128in in length and the external edge of the prototype wheels were placed 4.5in from the edge of the structure. Direction of scanning in indicated in Fig. 3.

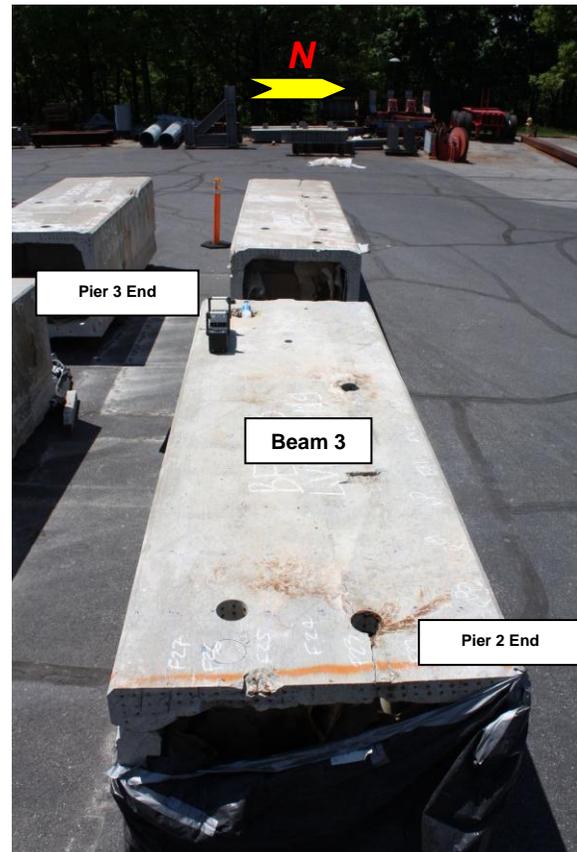
Figure 3 - Beam 3

Similarly, Beam 3 showed a longitudinal crack with some corrosion staining spanning almost the full length of the bottom flange. In addition, a large concrete opening was also noted near one of the corners of the beam (see Figure 3). A total of four 4-in. diameter cores had been extracted from the bottom flange. Cracks in the webs were noted at the ends of the beam. Figures 2 and 3 are views of the Beams 2 and 3, respectively. Also, the documented visual deterioration for beams 2 and 3 is shown in the appendix section of this report (See Figures 2V and 3V).

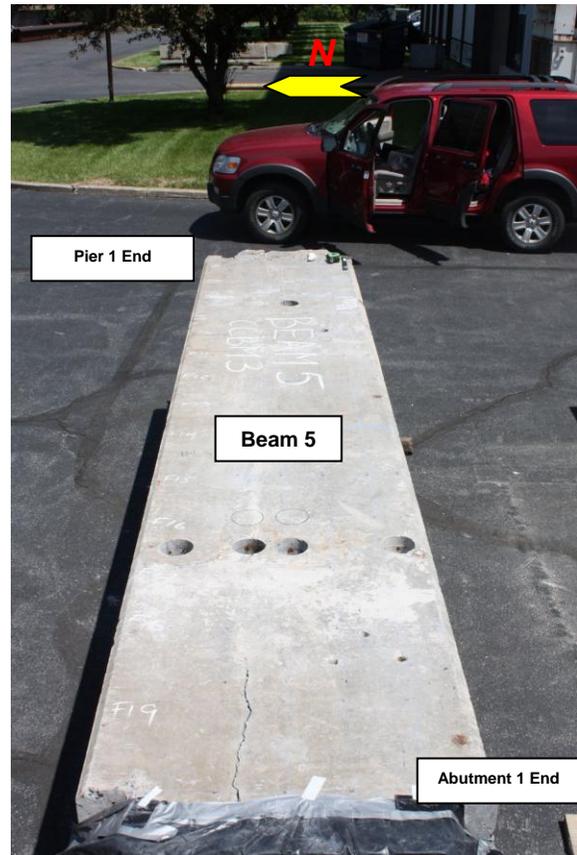
Figure 5 - Beam 5

Beam 5 showed a longitudinal crack with some corrosion staining spanning the full length of the beam. A total of five 4-in. diameter cores had been extracted from the bottom flange (see Figure 5). Figures 4 and 5 are views of the Beams 4 and 5, respectively. Cracks in the webs were noted at the ends of the beam. Also, the documented visual deterioration for Beams 4 and 5 is shown in the appendix section of this report (See Figures 4V and 5V).

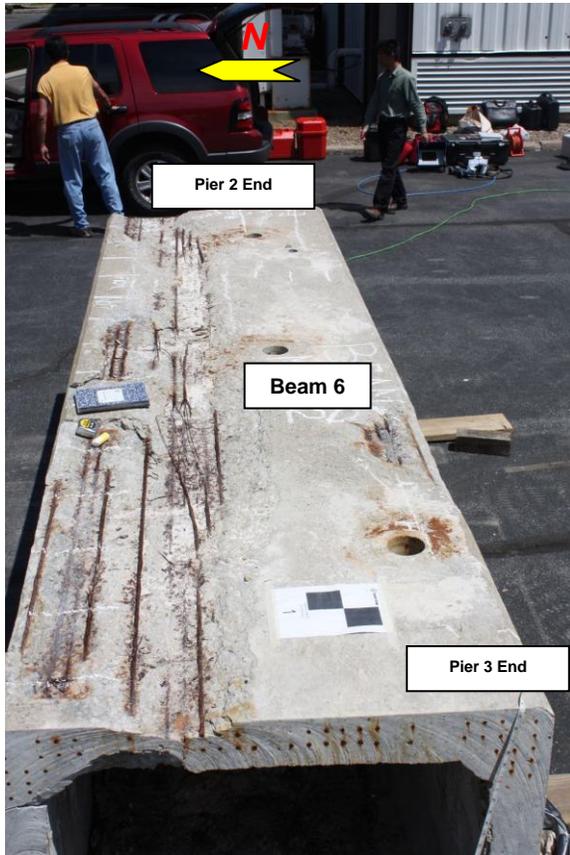
Figure 6 - Beam 6

The visual inspection of Beam 6 showed a severe deterioration on at least half of the bottom flange surface, where the concrete had spalled, exposing the prestressing strands. A total of three 4-in. diameter cores and a 2-in. diameter core had been extracted from the bottom flange. Web cracks at the ends of the beams were also noted (see Figure 6).

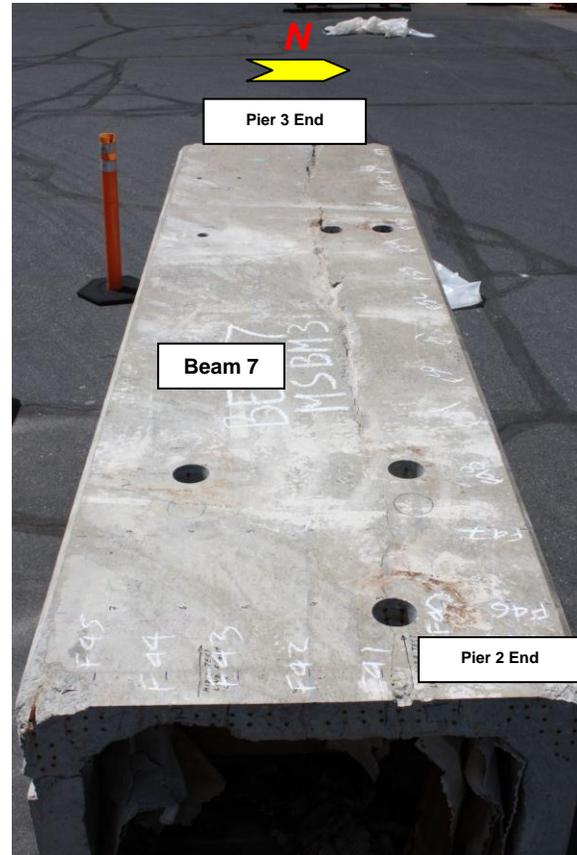
Figure 7 - Beam 7

Beam 7 showed a wide longitudinal crack with some corrosion staining spanning the full length of the beam segment. Some of the concrete had spalled around the edges of the cracks. A total of five 4-in. diameter cores and a 2-in. diameter core had been extracted from the bottom flange (see Figure 7). Figures 6 and 7 below are views of the Beams 6 and 7, respectively. Also, the

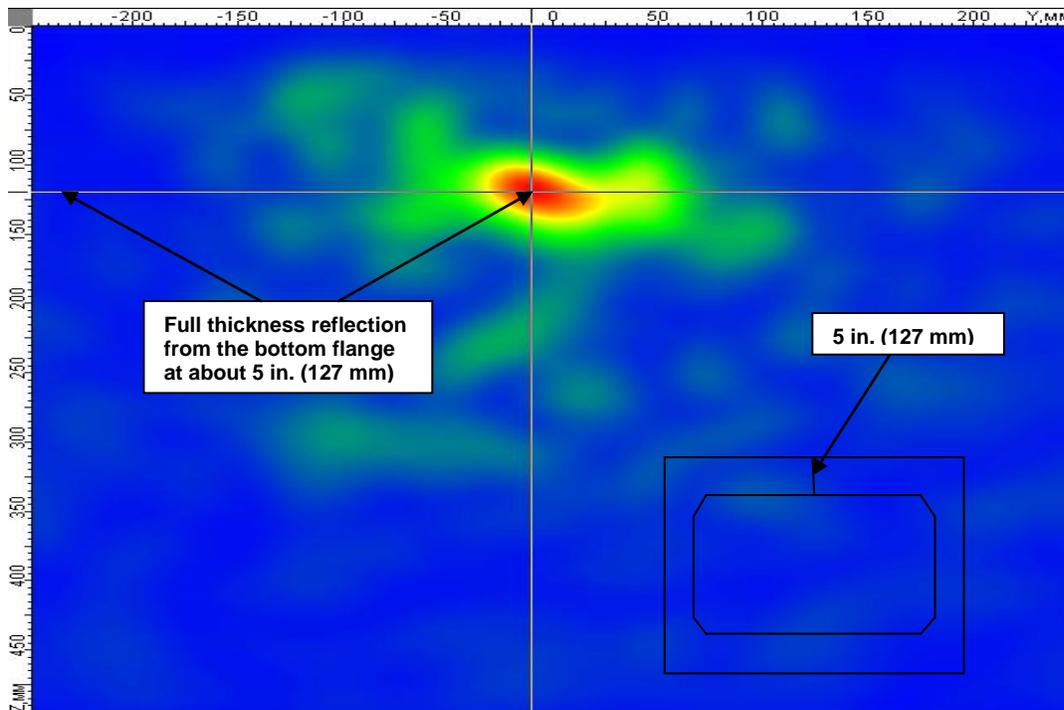
Figure 10- Polygon test result showing a bottom flange thickness of about 5 in.

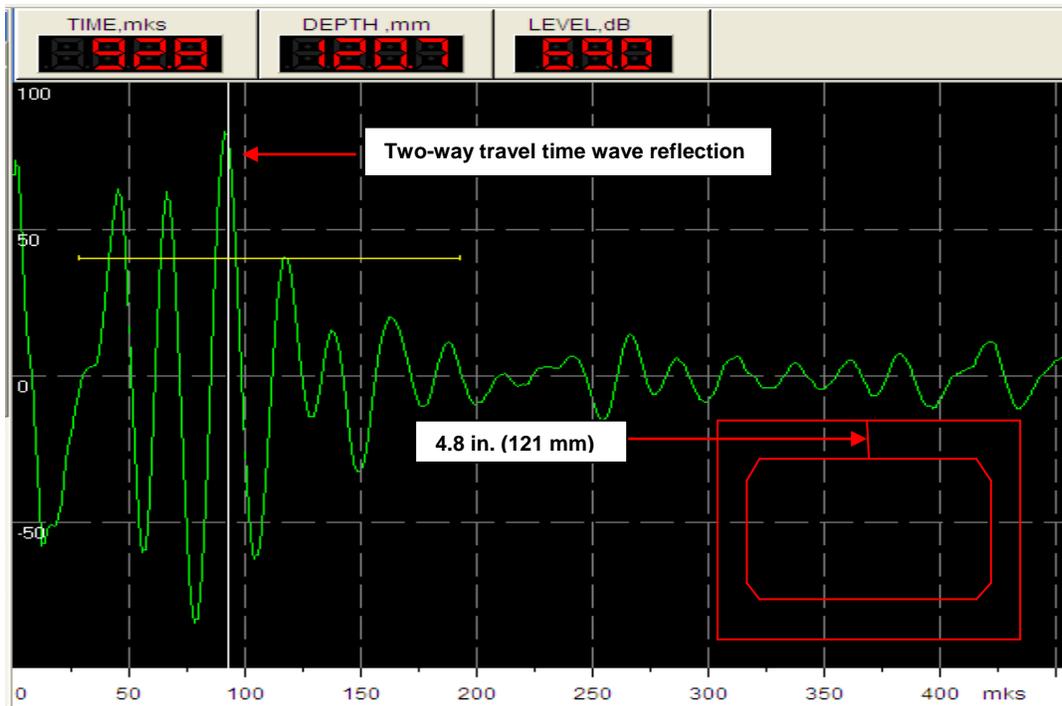
Figure 12- Monolith test result showing a nominal bottom flange thickness of 4.8 in thick.

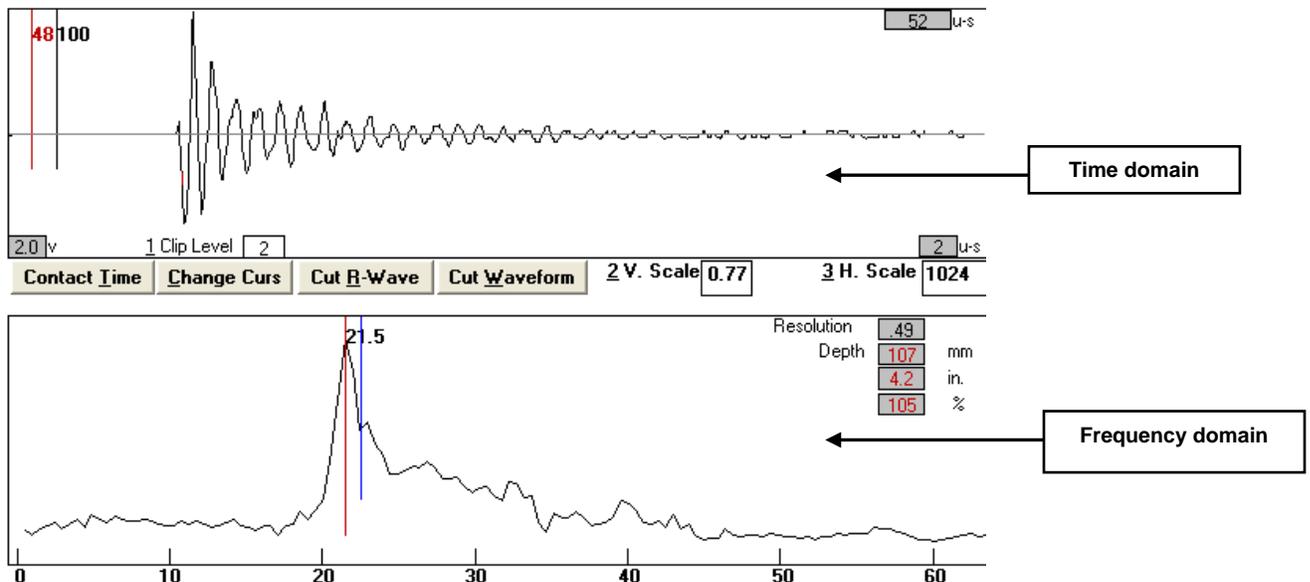
Figure 18- IE test result showing a full thickness reflection at Beam 3, Grid Point D5

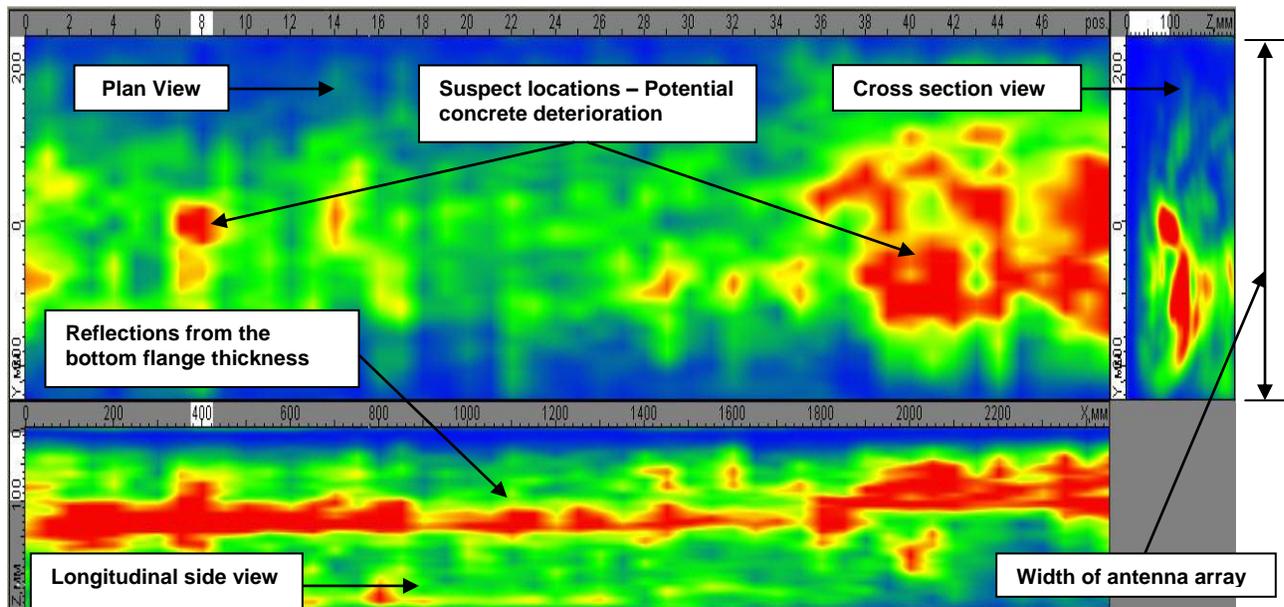
Figure 22- Typical view of a Polygon test result showing a tomographic view of potential concrete deterioration locations (Partial section of Beam 5).

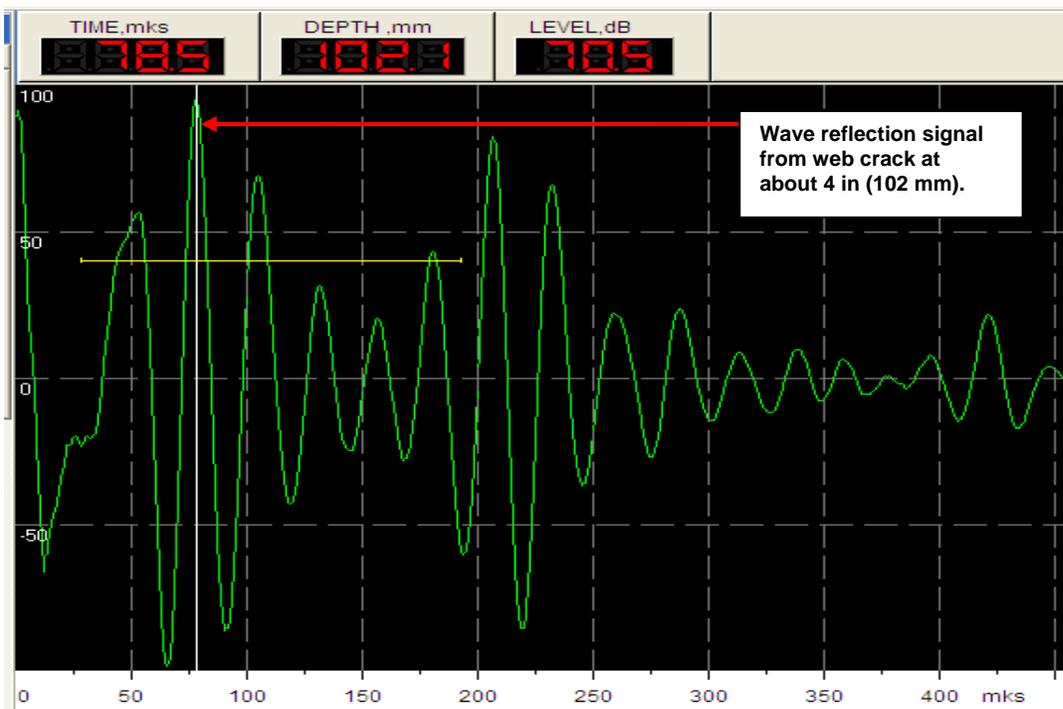
The Monolith instrument was also used to check the crack depth in the concrete webs at the edges of the bottom flange. Figure 23 shows a view of Monolith test at a web crack location showing a nominal crack depth of 4 in. Figure 24 shows the corresponding Monolith time domain plot indicating a concrete reflection at a depth of 4 in (102 mm). Similar to the IE and Polygon test results, the results of the Monolith tests have been integrated into the superimposed combined plots included in the Appendix section of the report (see Sheets 2S through 7S). The time domain spectra plots for each of the monolith test results can interactively be seen on the accompanying CD by clicking on each of the test grid points.

Figure 24 - Monolith test results showing a reflection from a web crack at about 4 in. deep.

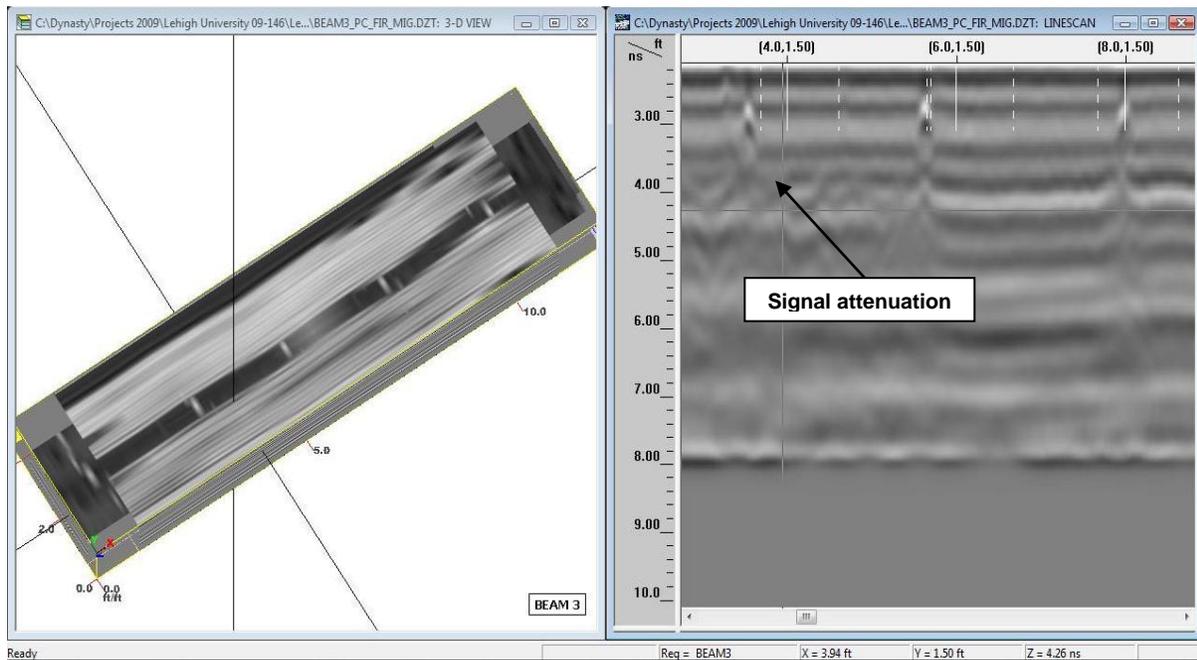
Figure 27 shows a GPR 3-D view of Beam 3 and a linescan showing some signal attenuation, which may be indicative of delaminations or corrosion of the reinforcing steel.

Figure 27 - GPR 3-D view and a linescan view of Beam 3 showing some signal attenuation.

Finally, the results of the GPR testing on Beam 3 show several locations where signal attenuations were found. These locations may be indicative of potential corrosion of the embedded reinforcement, which have not cause the concrete cover to delaminate yet. These suspect areas will be correlated by the Lehigh researches with results from the destructive testing. Locations of potential corrosion activity were found between Grid Lines B through G and 0 through 4 and Grid Lines A through E and 4 through 8.

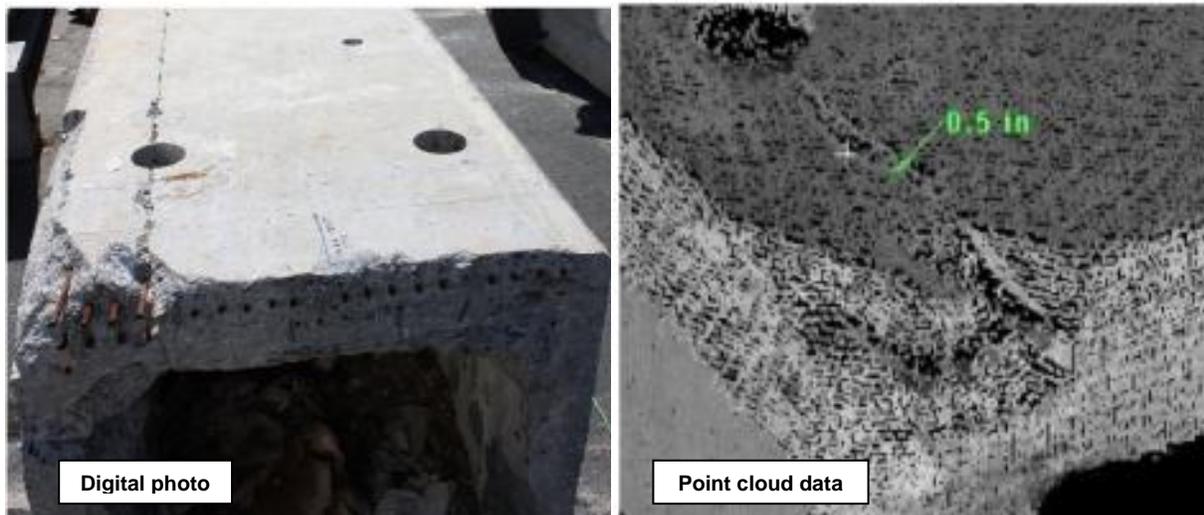
Figure 32 – View of a crack measured with a tape measure and the point cloud data.

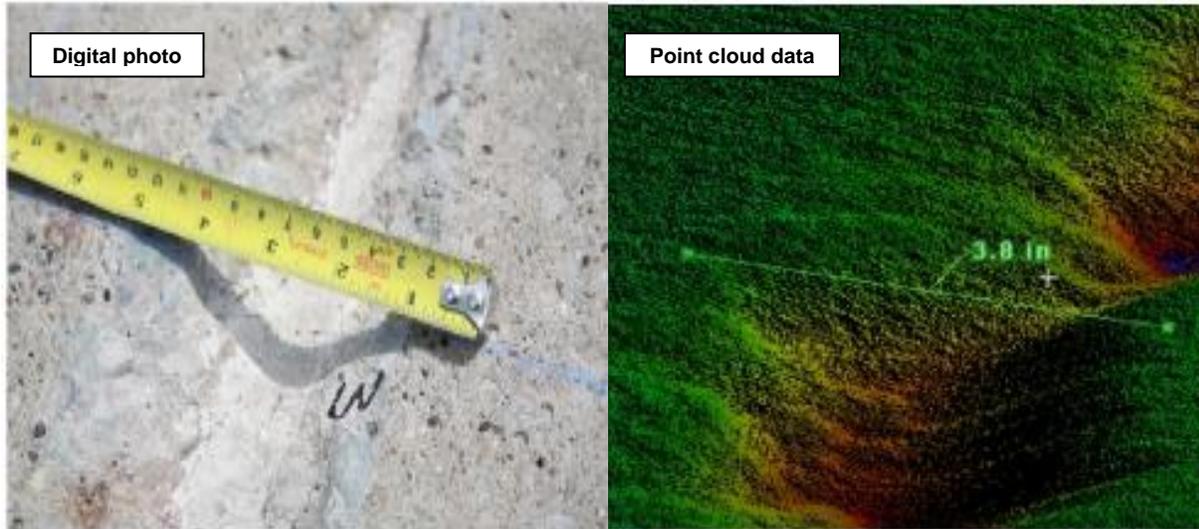
In addition, at selected locations, the point cloud data was used to map and measure the width of the longitudinal cracks. Figure 33 is comparison of a crack width measured using a conventional tape measure and the point cloud data. The actual width of the cracks that can be measured using the laser scanner instrument depends on the amount of points registered in the point cloud data; the greater the amount of points, the finer the crack width that may be measured. Similarly, Figure 34 is a view of longitudinal crack observed in Beam 4 and the corresponding width measurement made using the point cloud data.

Figure 33 – View of a crack in Beam 4
