## Premature Deterioration of Jointed Plain Concrete Pavements

FINAL REPORT

Date April 2011

By (PI) Dr. J. M. Vandenbossche, P.E.  
University of Pittsburgh

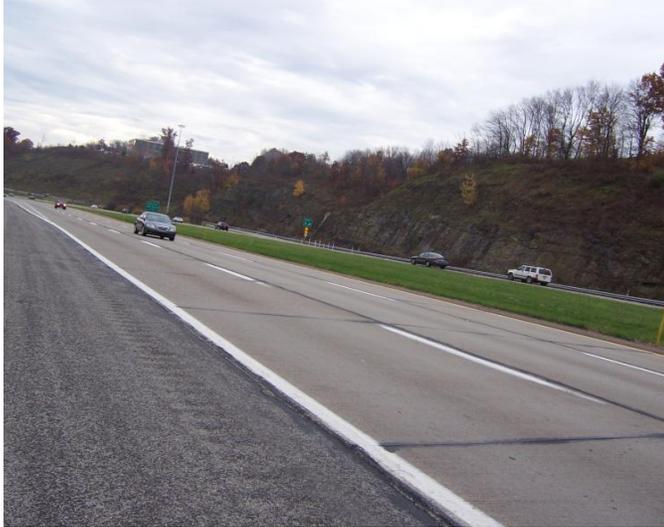
*Figure 5: Overall Condition of SR 60 Segment 303 Southbound (Control Section).*

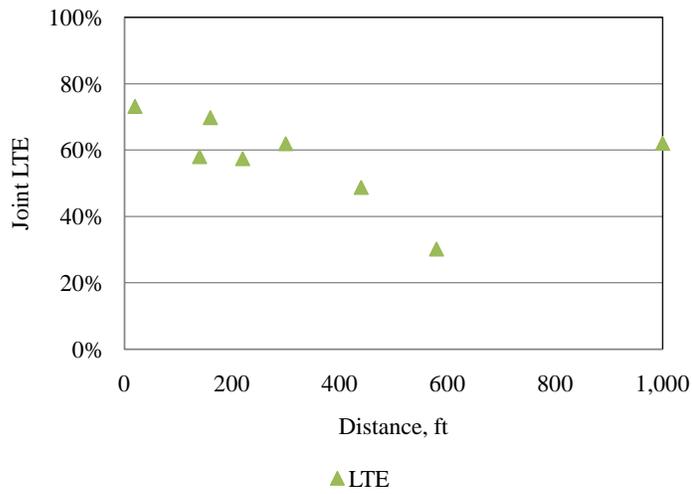
Figure 15: Transverse Joint Load Transfer Efficiencies for SR 60 Segment 303 Southbound (Control Section).

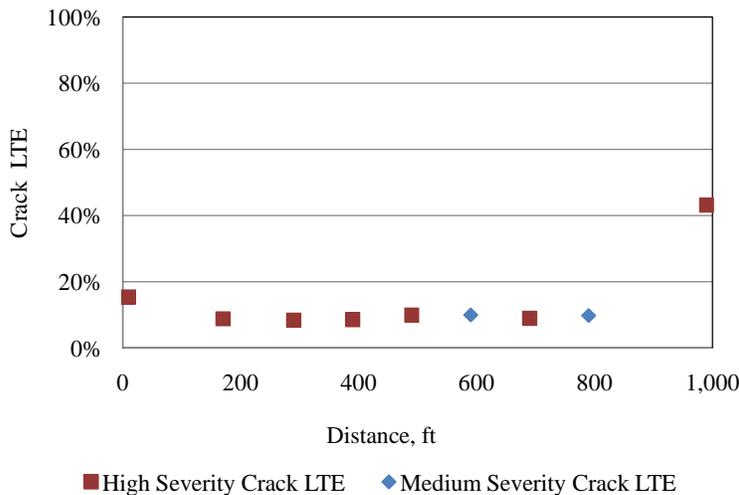
The crack load transfer efficiency for the Distressed and Control sections are presented in Figure 18 and Figure 19, respectively. The difference in the average LTE for the cracks in the Distressed and Control sections is quite significant. Crack LTE for the Distressed section is 14 percent while it is 40 percent for the Control section.

Figure 18: Transverse Crack LTE for SR 60 Segment 323 Southbound (Distressed Section).

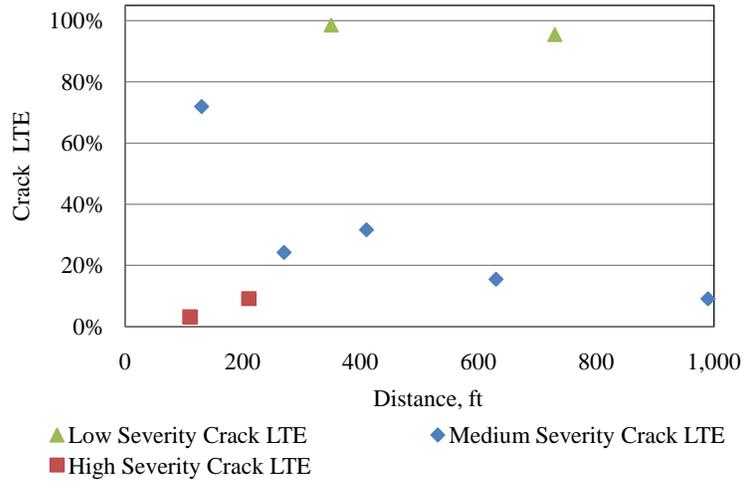
The improved performance of the cracks in the Control section is mainly due to the contribution of the stabilized base. The stabilized base restricts movement to a degree and maintains a smaller crack width. This subsequently enhances the aggregate interlock mechanism

Figure 19: Transverse Crack LTE for SR 60 Segment 303 Southbound (Control Section).

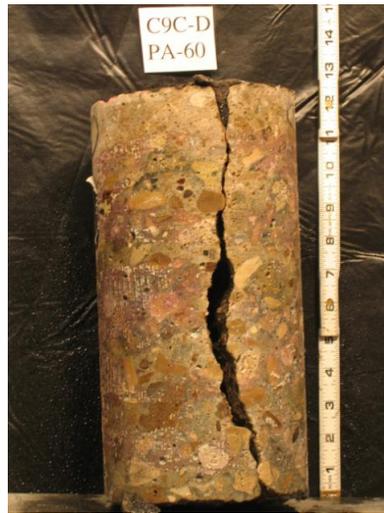
A core retrieved at a high severity crack location in the Distressed section is shown in Figure 20. It is observed in this figure that extensive abrasion has taken place at the lower portion of the core. This condition, which implies large differential movements between the crack faces, combined with a large crack width, is likely responsible for the low LTE observed for the cracks in the Distressed section. Figure 21 presents a core retrieved at a low severity crack located in the Control section. As observed in the figure, the PCC layer is completely bonded with the ATPB layer. This condition restrains the opening of the crack and enhances the effectiveness of the aggregate load transfer across the crack.

Figure 20: High Severity Transverse Crack Core of SR 60 Segment 323 Southbound Slab 9 (Distressed Section)

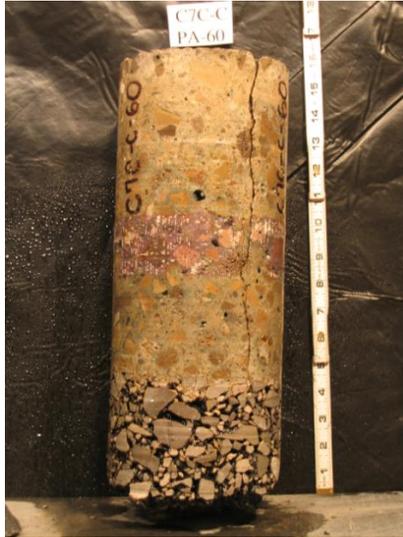
*Figure 21: Low Severity Transverse Crack Core of SR 60 Segment 303 Southbound Slab 7 (Control Section).*

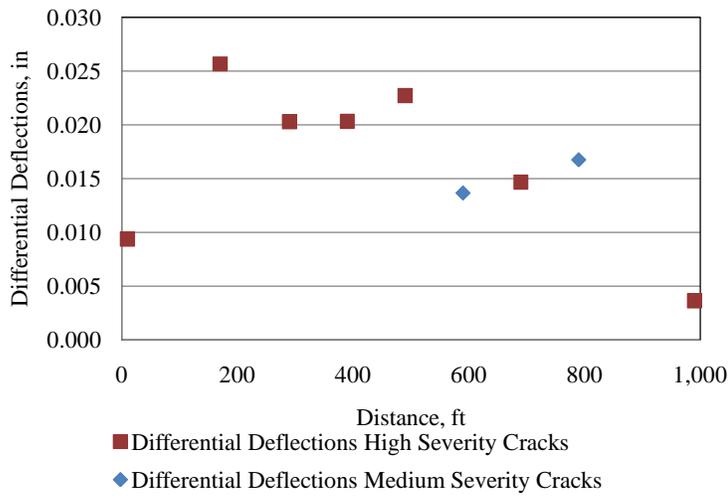
The differential deflections for transverse cracks are presented in Figure 22 and Figure 23 for the Distressed and Control sections, respectively. In the Distressed section, all but two values are above this threshold for differential deflection and only one value is significantly below the threshold. For the Control section, half of the differential deflection values for the Control section are below the threshold value and all of the differential deflections measured for the low severity cracks are well below the threshold values. The overall average differential deflection for the Distressed section is 0.016 in and the average differential deflections for the medium and high severity cracks are 0.015 in and 0.017 in, respectively. For the Control section, the overall average differential deflection is 0.010 in and is 0.001 in and 0.014 in for the low severity and medium severity cracks, respectively. The differential deflections for the Distressed and Control sections agree with the measured crack LTEs.

Figure 22: Differential Deflections at Transverse Cracks for SR 60 Segment 323 Southbound (Distressed Section).

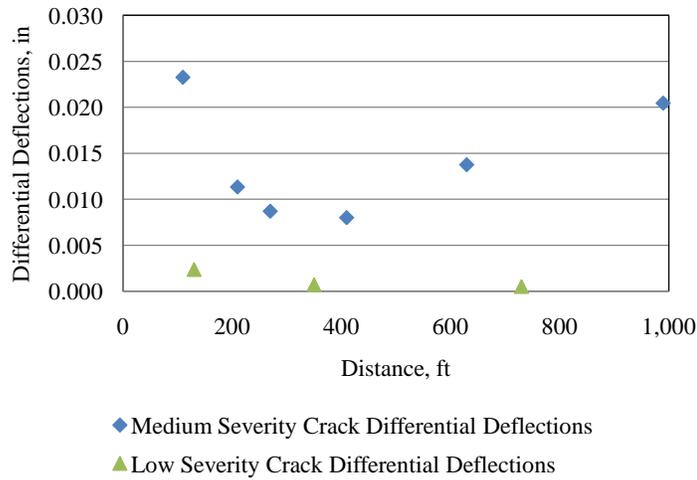
Figure 23: Differential Deflections at Transverse Cracks of SR 60 Segment 303 Southbound (Control Section).

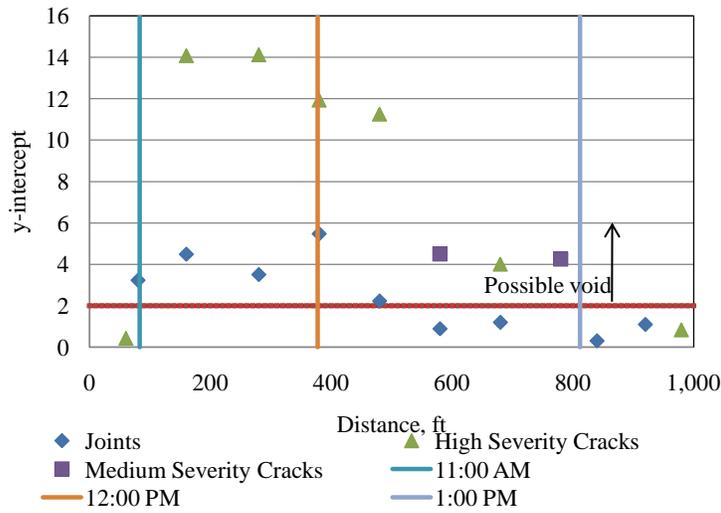
In the Distressed section, 45 percent of the joint tested have possible voids while 78 percent of the cracks potentially have voids. As observed in Figure 24, the transverse joints and cracks with potential voids tend to be located in the first half of the section. While conducting FWD testing in the Distressed section, the slab surface temperature increased 10 °F and the predicted (assumed linear) gradients increased from 0.65 °F/in to 1.25 °F. It is possible that this led to false negatives in the latter portion of the section since the presence of a large positive gradient causes downward curling of the slab, and hence diminishing the ability to detect a void.

Figure 24: Loss of Support of SR 60 Segment 323 Southbound (Distressed Section).

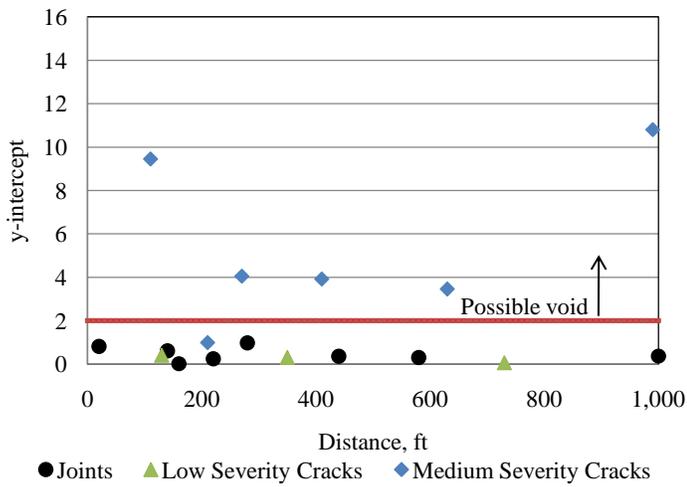
In the Control section, none of the joints or low severity cracks indicates the presence of a void. However, 44 percent of the medium severity cracks show the potential for voids beneath the slab. The identification of voids beneath slab at joints and cracks may be affected by the downward curling of the slab caused by the relatively high positive gradient during the testing (1.26 °F/in). The y-intercept value, which reflects the relative size of the void beneath the slab, could be higher for all of the joints and cracks. This condition suggests the likelihood of the existence of voids at the joints and cracks throughout the whole section.

Figure 25: Loss of Support of SR 60 Segment 303 Southbound (Control Section).

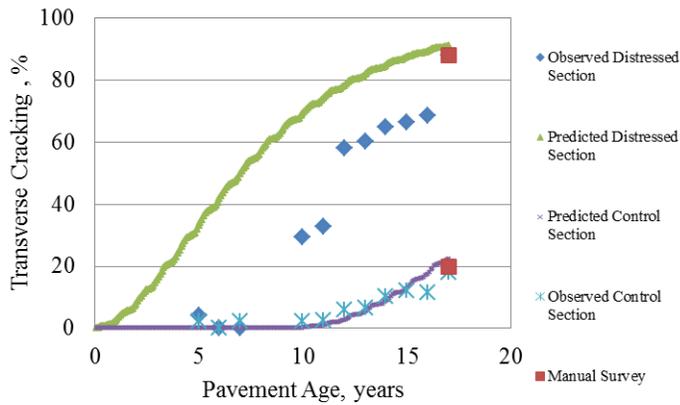
Figure 30 presents the MEPDG-predicted along with the observed transverse cracking for the Distressed section and Control section. The observed transverse cracking over time (from year 5 to year 16) is based on historic distress data provided by PennDOT, which has been collected using automated distress equipment. The data point for year 17 represents the percentage of transverse cracking of the Distressed section that was manually surveyed as part of the field data collection executed in the present study. Although there are some historic data points missing, it can be observed that transverse cracking began to be visible on the surface of the slabs between years 7 and 10. Additionally, it can be noticed in Figure 30 that, for the Distressed section, from year 11 to year 12, the percentage of cracking increases from 33 percent to 58 percent; and from year 16 to year 17 it increases from 69 to 88 percent.

These significant increases can be associated with the sensitivity of the automated equipment. It is possible that under some conditions the automated equipment does not capture all the transverse cracking, thus, it is being underestimated. Based on this belief, and after observing the predicted cracking in Figure 30, it may be possible that the transverse cracking for the Distressed section initiated its development before the 5<sup>th</sup> year. Despite the difference in predicted and observed cracking values, it can be observed that the rate of increase in cracking exhibited for both the predicted and observed transverse cracking of the Distressed section over time is similar. This supports the consideration that the structural capacity of this pavement section is lower than it should be for the pavement to reach its intended design life and locates the pavement in the critical zone in terms of the relationship between fatigue damage and transverse cracking. This critical zone is defined as the zone where cracking increases rapidly with relatively smaller increases in damage as shown in Figure 31.

In the case of the Control section, it can be seen in Figure 30 that the prediction of the MEPDG is also considerably accurate. Unlike the Distressed section, the rate of increase for transverse cracking is considerably low. This implies that this pavement section is not located in the critical zone of fatigue damage shown in Figure 31 and suggests that the structural capacity of this pavement section is sufficient to carry the imposed loads over time.

Figure 30: Predicted and Observed Transverse Cracking for SR 60 Segment 323 and 303 Southbound (Distressed and Control Sections)

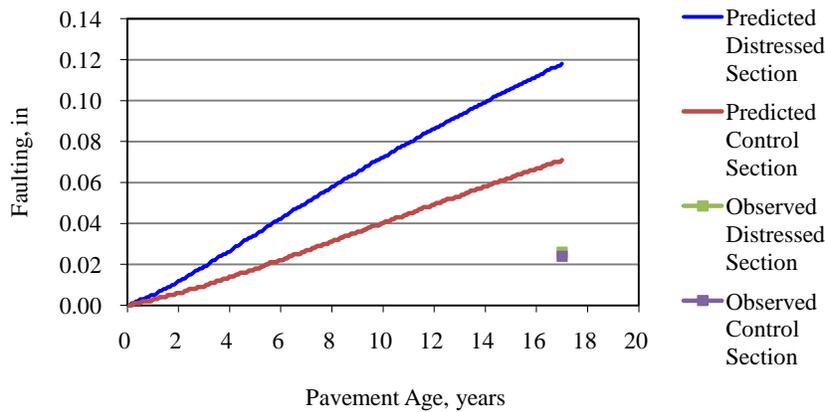
Figure 32 presents the predicted and observed faulting for both the Distressed and Control sections. The observed faulting corresponds to the information obtained as part of the field data collection carried out for the present study. Historic data for faulting was not available. As noticed in the plot, there is a large difference between the predicted and observed faulting. The high predicted faulting is mainly caused by a high upward corner deflection calculated by the MEPDG faulting model, which is function of the CTE of the slab. This upward corner deflection has a considerable effect on the initial maximum mean transverse joint faulting. It is believed that the MEPDG faulting model requires a recalibration considering the required adjustment of the CTE values already discussed.

Figure 32: Predicted vs. Observed Joint Faulting for SR 60 Segments 323 and 303 Southbound (Distressed and Control Sections).

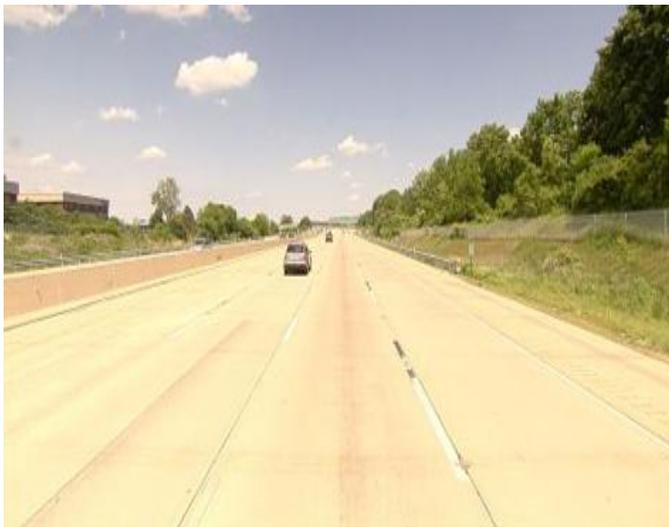
Figure 35: Overall Condition of SR 202 Segment 440 Northbound.

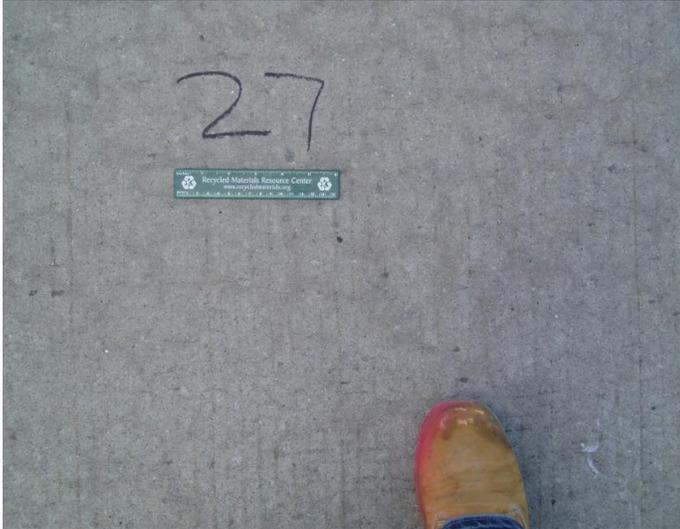
Map cracking was the other major distress observed in Segment 440. Map cracking over the entire surface of the slab was observed in 55 percent of the slabs. The microcracks within the map cracked areas are mainly oriented in the longitudinal direction of the slabs and are interconnected by finer cracks randomly distributed as shown in Figure 38 and Figure 39.

Figure 39: Close-up of Microcracking of SR 202 Segment 440 Northbound, Slab 27.

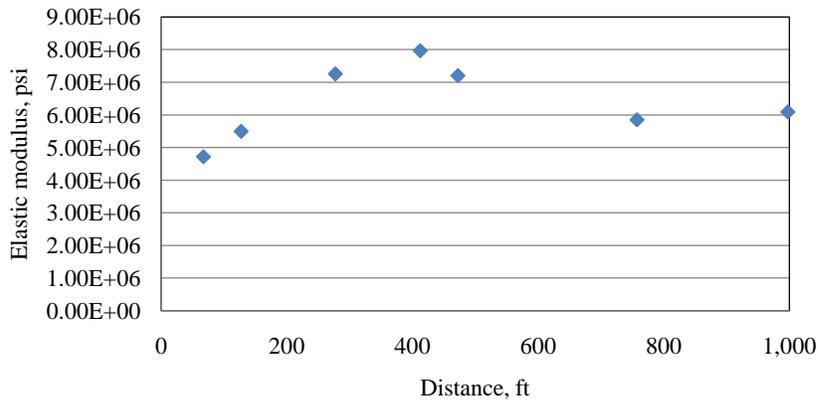
measurements along with the slab and asphalt thickness determined from the cores extracted at the FWD locations. Figure 42 presents the backcalculated static PCC elastic modulus along the segment. As shown in Figure 42, the average backcalculated static elastic modulus for the entire section is 6.35 million psi with a coefficient of variation of 18 percent.

Figure 42: PCC Elastic Modulus for SR 202 Segment 440 Northbound.

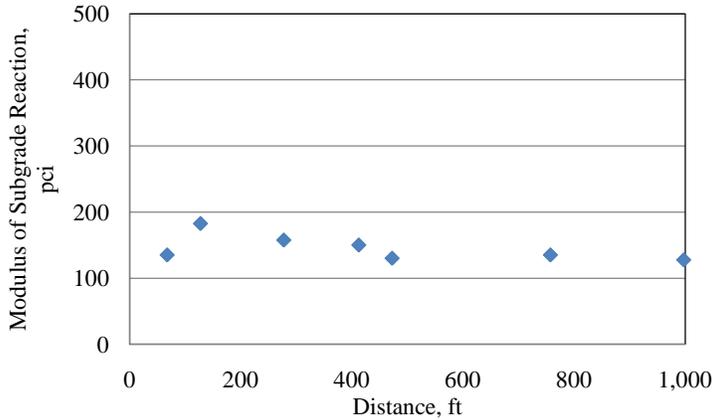
The modulus of subgrade reaction, k-value, was calculated using mid-slab deflections. Figure 43 shows the k-value along the section. The average static k-value for the section is 145 psi/in with a standard deviation of 20 psi/in and a coefficient of variation of 14 percent.

Figure 43: Modulus of Subgrade Reaction for SR 202 Segment 440 Northbound.

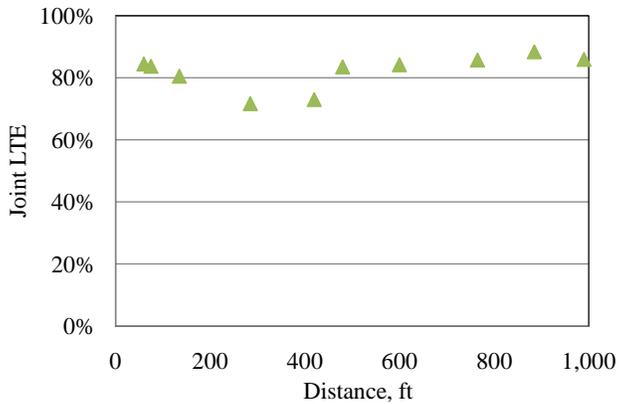
The joint load transfer efficiency values for the entire section are presented in Figure 44. As observed in the figure, the LTE is good (higher than 70 percent) for the majority of the transverse joints. This superior load transfer efficiency was expected considering the 1.5-in dowels used, the 13-in slab thickness, and the pavement is only 8-years old. As mentioned before, the effect of the temperature in the measured LTE values is negligible for this specific section due to the relatively low ambient temperature of 38 °F present when the FWD testing was performed.

Figure 44: Joint Load Transfer Efficiencies for SR 202 Segment 440 Northbound.

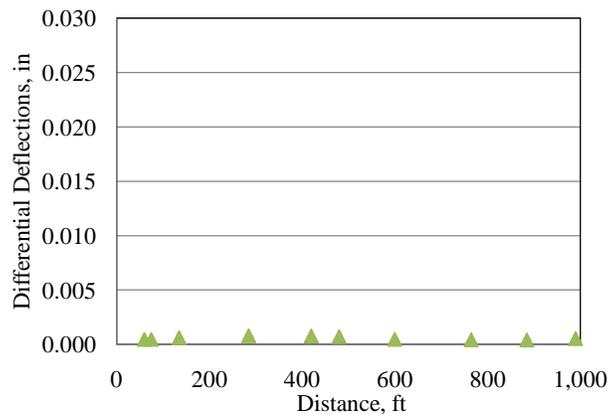
The differential deflections for transverse joints are presented in Figure 45. As seen in Figure 45, the difference between the deflection on the loaded side and the unloaded side of the joints is consistently almost zero along the section. This condition agrees with the good performance of the joints with respect to no faulting and high load transfer efficiencies observed in Segment 440.

Figure 45: Differential Deflections at Transverse Joints for SR 202 Segment 440 Northbound.

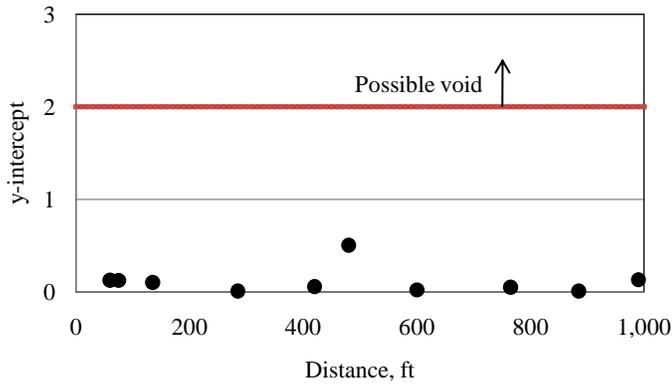
To determine the potential for the presence of voids beneath the slab, the load vs. deflection response for each station was determined. Figure 46 presents the positive y-intercept values, which are relative to the voids size. Values of the y-intercept are higher than 2 mils, indicating a void might be present. The significance of temperature gradients in the slab during the analysis for loss of support is discussed in the Section 2.8.6. However, the temperature gradients predicted at the time of FWD testing for SR 202 likely did not influence the FWD void detection analysis, as is indicated by the consistency between the measurements at different time of the day. Figure 46 presents the void detection analysis results for Segment 440 and shows that the potential of voids being present throughout the entire section is low.

Figure 46: Loss of Support Results for SR 202 Segment 440 Northbound.

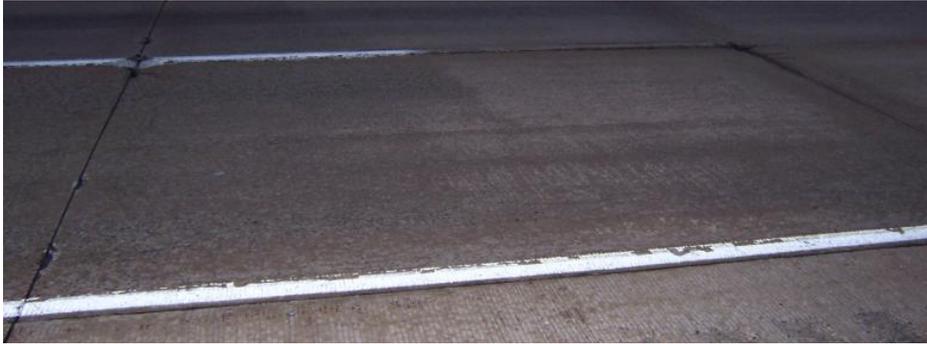
Two cores from SR 202 were examined according to ASTM specification C856 "Petrographic Examination of Hardened Concrete" and ASTM specification C457 "Microscopical Determination of Air Void Content and Parameters of the Air Void System in Hardened Concrete." These cores were from the mid-slab locations of Slab 5 and Slab 9. Slab 5 exhibited significant spalling along the centerline longitudinal joint between the driving lane and the adjacent lane as well as spalling along both transverse joints. The spalling along the transverse joints was closer to the longitudinal joint between the driving lane and the adjacent lane than it was to the lane/shoulder longitudinal joint. Typical locations of the spalled areas are

shown in Figure 47. Slab 9, the other slab from which a core was taken for petrographic analysis, did not exhibit any spalling.

Figure 47: Overall View of Slab 5 SR 202 Segment 440 Northbound

Based on these conclusions, it seems apparent that the joint spalling can indeed be attributed an insufficient air void system. The influence of the traffic loads on spalling can be noticed particularly keenly in the wheelpath shown in Figure 47, as the spalled concrete tends to be dislodged in this area. It was also noted that this distress was observed at the pavement surface but none of the cores pulled exhibited deterioration at the bottom of the core. Generally, D-cracking is more extensive at the bottom since the bottom of the slab is typically saturated. This indicates that the entrained air void system might be better at the bottom of the slab than the top.

Typical repairs made to address spalling are a full-depth repair if the depth of spalling exceeds more than 1/3 the depth of the slab or a partial depth repair if the depth of the spalling is less than 1/3 the depth of the slab. For SR 202, the spalling developed as a result of D-cracking associated with the poor entrained air system. Since the bottom of the slab is always saturated, D-cracking tends to be more prevalent at the bottom of the slab when compared to that observed on the surface. Therefore, full-depth repairs are typically necessary. For SR 202, the distress does not generally develop at depths greater than 1/3 the depth of the slab since the entrained air void system at the bottom of the slab is better than at the top of the slab. It would be beneficial to pull a few more cores to verify this throughout the distress section. With the depth of the spalling being restricted to the upper portion of the slab, partial depth repairs might be effective. If regions are found where the deterioration runs throughout the depth of the slab then full depth repairs would be necessary. These repairs would help to extend the life of the pavement but it can be expected that the deterioration would eventually develop along the newly created joints in the original concrete adjacent to the repair area. It might be possible to further deter the continued deterioration by applying a sealant on the exposed portion of the existing slab prior to placing the repair material. Before this is attempted, one must insure that the sealant does not deter the bond between the existing slab and the repair material.

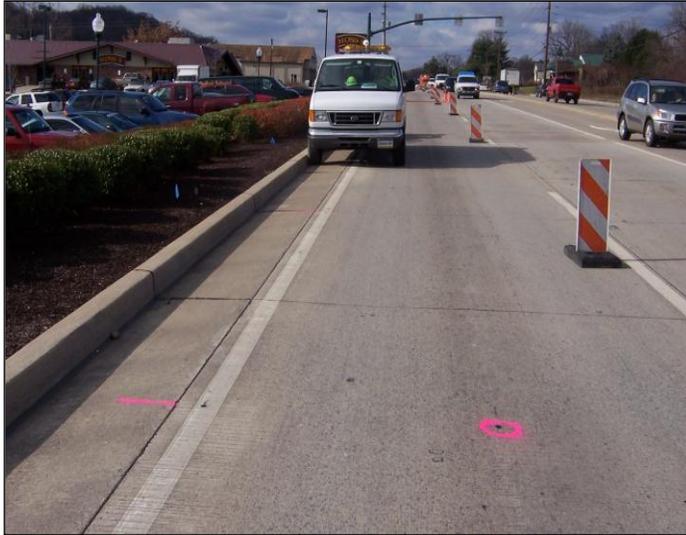
Figure 50: Overall Condition of US-22 Murrysville Segment 50 Eastbound.

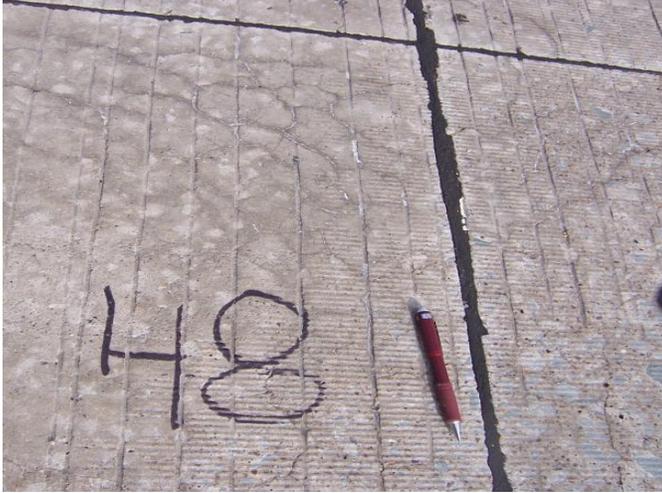
A common distress observed in the section was fine map cracking. At midslab, the cracking is oriented parallel to the longitudinal joints. The fine cracks concentrated near the transverse joints with the concentration of cracking being heavier at the intersection of the transverse and longitudinal joints. Typical examples can be seen in Figure 52 and Figure 53. In addition, white deposits were observed in the vicinity of the fine cracks in the corners. These deposits can be seen in Figure 52. Based on the cracking pattern and the presence of the white precipitate, it appears that alkali-silica reaction (ASR) might be present. A variation in the color of the cement paste between different slabs and in some cases within the same slab was observed during the visual observation of the cores. Some of this variation in the color of the cement paste can be attributed to the use of a ground granulated blast furnace slag while in other cases it is apparent that different concrete mixtures were used in constructing various sections of the roadway.

*Figure 52: Joint Close-up of US-22 Murrysville Segment 50 Eastbound Slabs 48 and 49.*

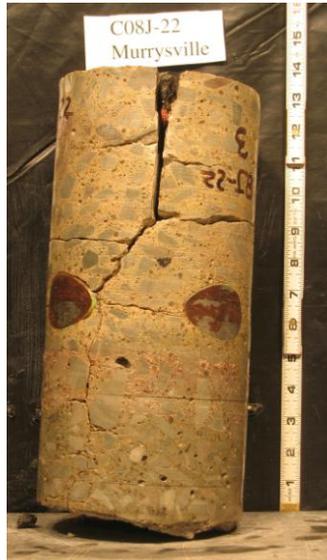
*Figure 55: PCC Core Retrieved at the Transverse Joint of Slab 8 of US-22 Murrysville Segment 50 Eastbound.*

Each core pulled at the transverse joints contained horizontal cracks running parallel to the plane of the slab surface, as shown in Figure 55. These horizontal cracks were observed not only in the four cores pulled from the joints of slabs in the distressed regions, but also the core (core C26J-22 in Table 24) pulled from a joint located approximately 400 feet into the section, a substantial distance away from the distressed areas. These horizontal cracks typically develop from internal stresses created when the joints lock-up. The expansion created as a result of ASR could be the cause of some of this cracking. The fact that the horizontal cracking is also present

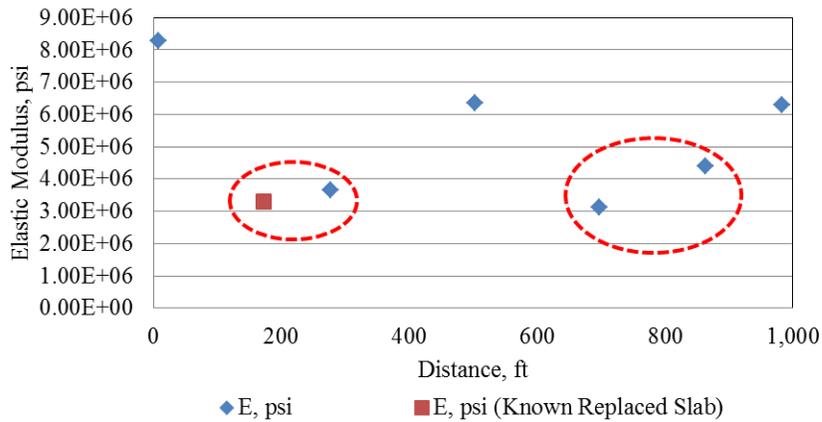
backcalculated static PCC elastic modulus along the section. As observed in the figure, there is a significant variation in the stiffness of the PCC layer along the section with a coefficient of variation of 38 percent. As mentioned previously, it appears that at least two separate concrete mixture designs were used in the construction of this section of roadway. This might be the result of paving the blockouts in front of the business access driveways with a separate mixture than the other throughway sections. One indicator of this is that the color of the paste in some of the cores was greyish, as is commonly found with concrete containing ground granulated blast furnace slag (GGBFS). The paste of the other cores was dark beige in color. The FWD locations in regions where the cores were beige are circled in red in Figure 57. Of the slabs for which coring was performed, the only slabs replaced, as evidenced by the granular base found to be present, were Slabs 8 through 12, beginning at a distance along the project of 178-ft. The average static elastic modulus for the cores taken in the sections without distress was 7.00 million psi with a COV of 16 percent. The average elastic modulus for the distressed slabs was 3.65 million psi with a COV of 16 percent.

Figure 57: PCC Elastic Modulus for US-22 Murrysville Segment 50 Eastbound.

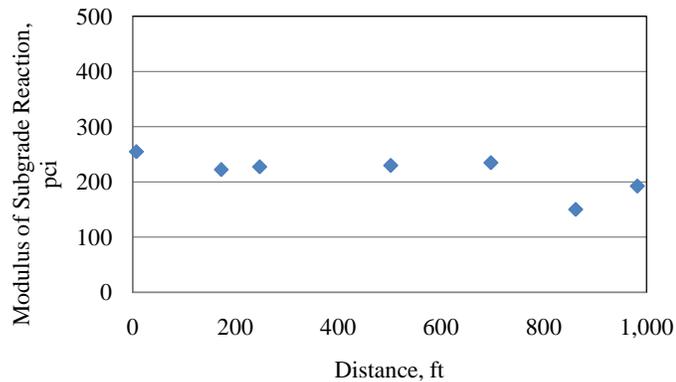
The static modulus of subgrade reaction, k-value, was calculated using mid-slab deflections. Figure 58 shows the k-value along the section. The static k-value for the area of the replaced slab is 215 psi/in with a standard deviation of 38 psi/in. As observed in Figure 58, the k-value is relatively constant indicating uniform support conditions throughout this project.

Figure 58: Modulus of Subgrade Reaction for US-22 Murrysville Segment 50 Eastbound.

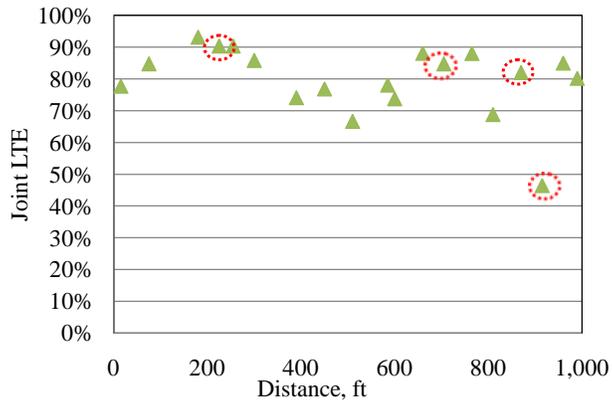
The joint load transfer efficiency along this section of roadway is shown in Figure 59. The average value is 81 percent and as observed in Figure 59, the LTE is good (higher than 70%) for the majority of the joints. Although, several of the joints have a LTE below 70%, considering the relatively young age of the pavement combined with the fact that 1.5-in dowels were used in constructing this section of roadway, it would be anticipated that the LTEs should not be below 80 percent.

The dashed circles in Figure 59 indicate joints in regions where the slabs are exhibiting the pattern of fine interconnected cracking. It should be noted that the joints in the distressed regions, as well as the joints directly adjacent to the distressed regions, tend to have higher levels of load transfer. The expansion resulting from ASR could result in narrower cracks widths and higher load transfer efficiencies.

Figure 59: Joint Load Transfer Efficiencies for US 22 Murrysville Segment 50 Eastbound.

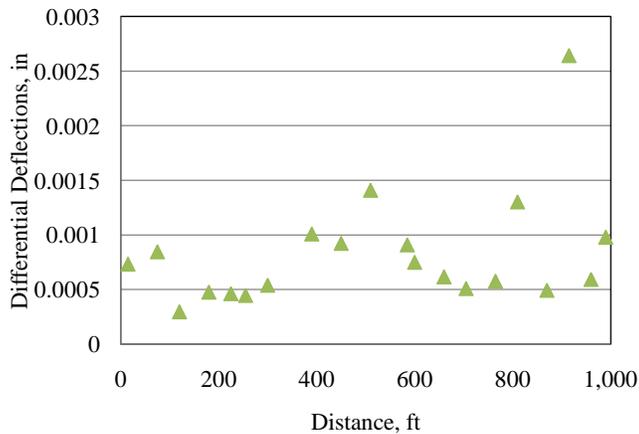
The differential deflections for the representative section are presented in Figure 60. As observed in Figure 60, the values are significantly below the threshold for poor joint performance, which is 0.01 in.

Figure 60: Differential Deflections at Transverse Joints for US-22 Murrysville Segment 50 Eastbound.

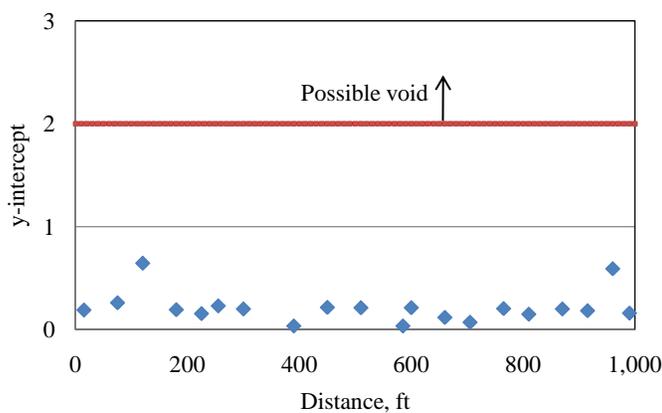
Figure 61 presents the y-intercept values of the load vs. deflection relationship for the FWD

data collected at the corner of the slab. As observed in Figure 61, there appears to be no voids present throughout the entire section. The consistency of the y-intercept values along the section help to emphasize the minimal influence of the measured temperature gradients on the FWD testing since these values were obtained when both small positive and small negative temperature gradients were present.

Figure 61: Loss of support for US-22 Murrysville Segment 50 Eastbound.

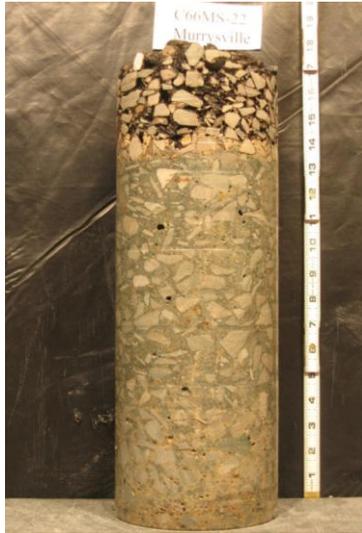
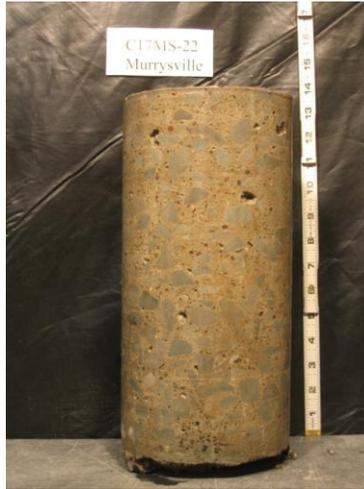
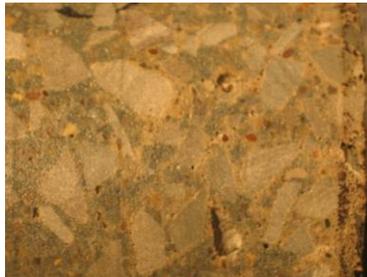
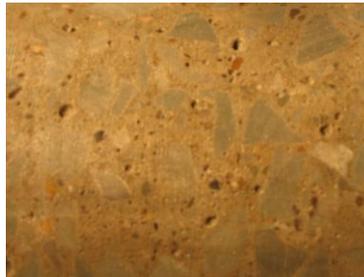
As mentioned previously, the color of the paste in the cores taken throughout the section also varied. The color of the paste for the cores pulled from areas not exhibiting distress was grey, especially in the lower portion of the core. This indicates that GGBFS was used. The color of the cores in the distressed sections were predominately dark beige, indicating that the proportion of GGBFS in this concrete might be lower than in the areas not exhibiting distress. This can be seen in Figure 62. Based on the cores pulled, the type of coarse aggregate used appears to be consistent throughout the section surveyed.

a.) Core from Slab without Distress

b.) Core from Distressed Slab

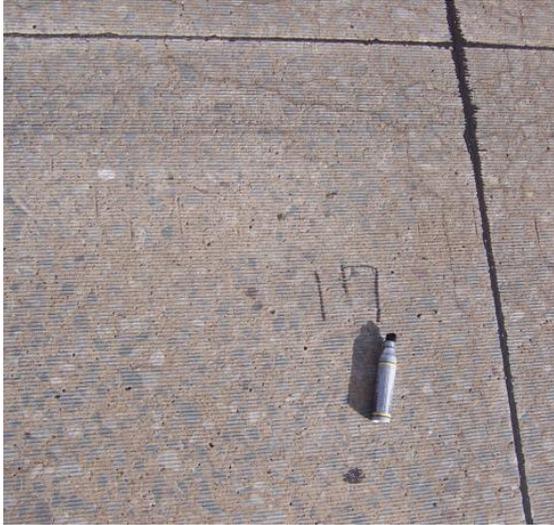
Two cores from SR 202 were examined according to ASTM specification C856 “Petrographic Examination of Hardened Concrete” and ASTM specification C457 “Microscopical Determination of Air Void Content and Parameters of the Air Void System in Hardened Concrete”. These cores were from the mid-slab of Slab 17 and Slab 34. Slab 17 exhibited significant cracking. Slab 34, exhibited no distress. Figure 63 shows visible ASR cracking where the joints intersect at Slab 17. Figure 64 depicts the condition of the slab surface for Slab 34.

*Figure 63: Map Cracking Observed on Slab 17 US 22, Westmoreland County Segment 50 Eastbound*

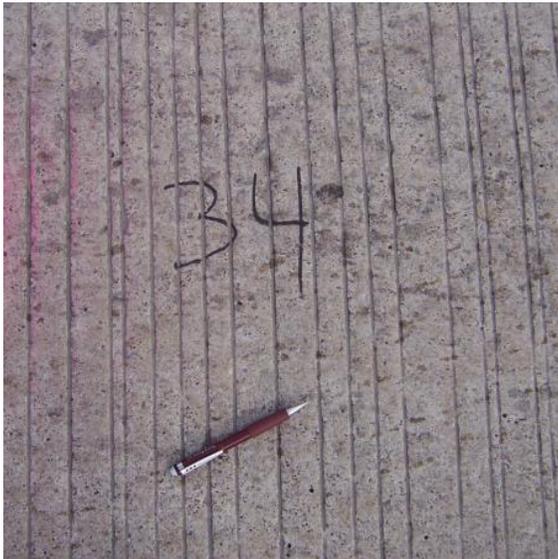
*Figure 64: Overall View of Slab 34 US-22, Westmoreland County Segment 50 Eastbound*

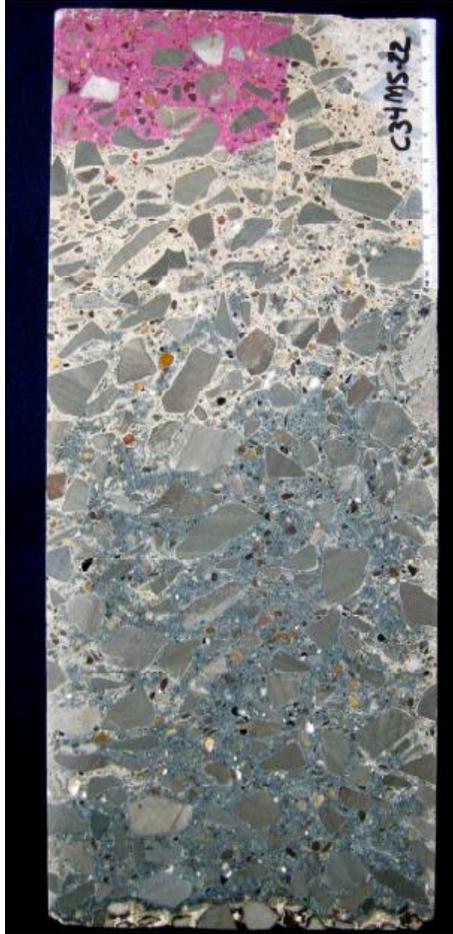
*Figure 67: Overall Condition of Core C34-MS22 of US-22 Murrysville Westmoreland County Segment 50 Eastbound*

As was commented on in Section 4.7.4, and can be observed in Figure 66 and Figure 67, there is a significant difference in the coloration of the cement paste between the two cores examined by petrographic analysis. The blue coloration of the cement paste in the bottom portion of Figure 67 is the result of hydrated ground granulated blast furnace slag incorporated in the mix design as a supplementary cementitious material. The residual Portland cement in C17-MS22 is between 9 to 10 percent, while the residual slag is estimated to be between less than 1 percent. This level of GGBFS incorporated in the mix is representative of a level typical of a processing addition in the manufacturing of Portland cement. The residual Portland cement in C34-MS22 is between 5 to 7 percent while the residual slag is estimated to be between with 4 and 6 percent. This would represent a purposeful addition, represented by the mix design information summarized in Section 4.3. The incorporation of GGBFS mitigated the development of ASR Core C34-MS22 by reducing the effective alkali content of the cementitious material.

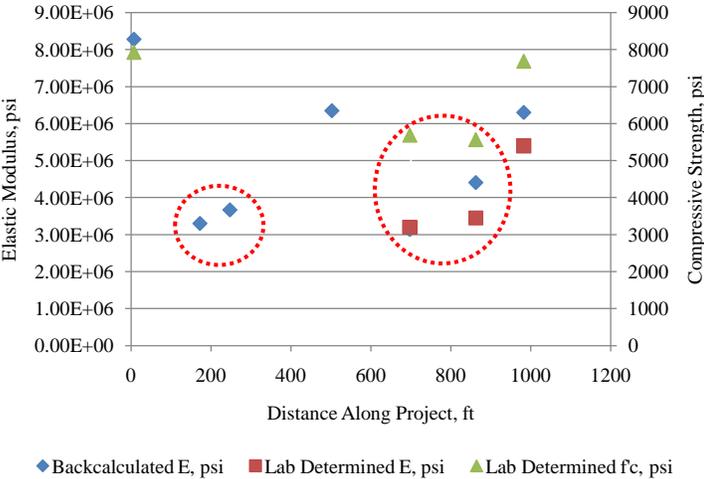
As mentioned in Section 4.11, the microcracking that developed in some of the slabs can result in a significant reduction in the strength and stiffness of the concrete. Like the backcalculated values, the laboratory measured stiffness and strength showed significant variation along the section. Although there is a difference between the backcalculated and laboratory values, the variation along the section follows a similar trend. This is illustrated in Figure 69 where the dashed red circles highlight the distressed areas.

Figure 69: Backcalculated Elastic Modulus, Laboratory-Determined Elastic Modulus, and Compressive Strength along US-22 Murrysville Segment 50 Eastbound.

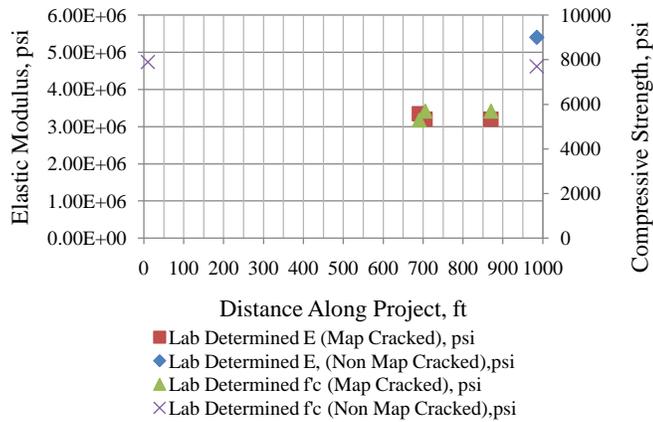
By incorporating the results of the petrographic analysis into the interpretation of the laboratory determined data it is clear that as stated in Section 4.11 the ASR is negatively influencing the structural properties of the concrete. Figure 70 shows the lab determined compressive strength and elastic modulus along the section with different series differentiating between data from map cracked and non-map cracked areas. Table 27 summarizes the statistics assuming that map cracked and non-map cracked areas are inherently different. From the results presented in Table 27 it can be seen that considering the map cracked and non-map cracked areas separately results in a decrease in the variation within each area. When comparing the differences in the statistics between the two areas it can be seen that there is a 29 percent

reduction in the compressive strength and a 40 percent reduction in the elastic modulus of the concrete due to the effects of ASR.

Figure 70: Influence of ASR on Concrete Structural Properties for US-22 Murrysville Segment 50 Eastbound

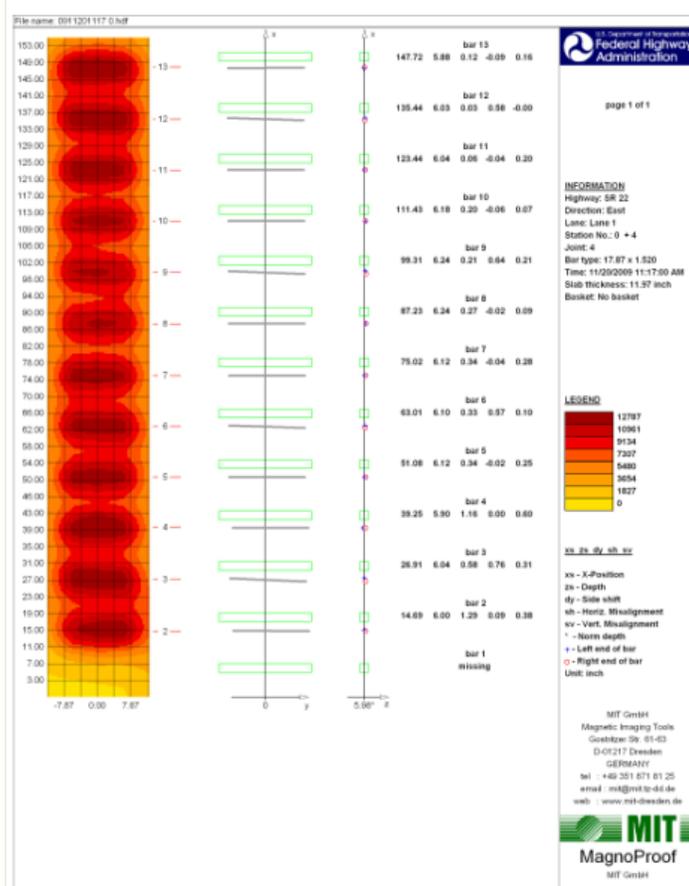
Figure 72: Visual Representation of the Dowel Locations at Joint 4 for US-22 Murrysville Segment 50 Eastbound.

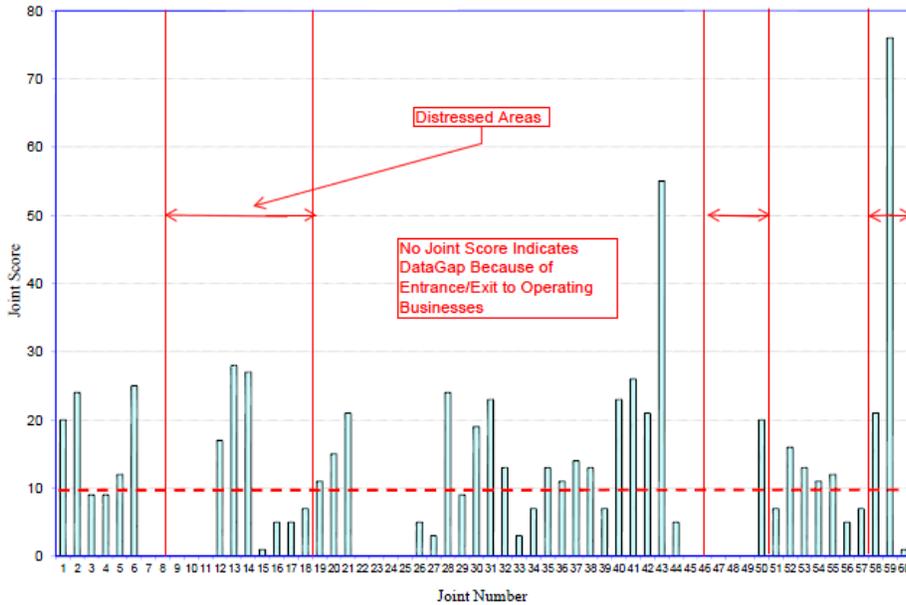
The joint score concept was developed by Yu and Khazanovich [12] and is a weighting system used to rate the potential of a given joint to lockup. According to Yu and Khazanovich, a joint score greater than ten indicates at least a moderate risk for joint lockup. Figure 73 shows the joint scores for the joints of this project. As can be seen in Figure 73, there is no clear relationship between the areas exhibiting the clearly defined crack parallel to the transverse joint and the joint score. In addition, some of the joints are missing scores. During the execution of the scans, these joints were skipped because they were located at entrances to businesses along Segment 50 and were not accessible for testing. It should also be noted that the last six joints in the section were also not evaluated.

Figure 73: Joint Scores along US-22 Murrysville for Segment 50 Eastbound.

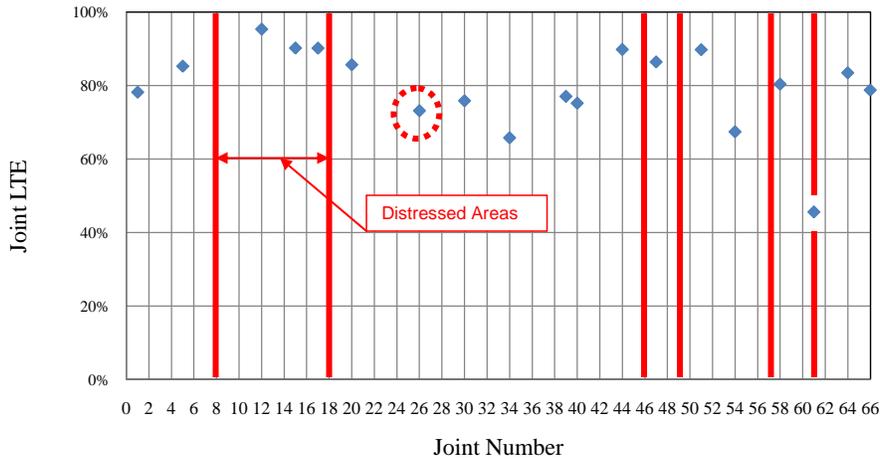
Load transfer efficiency data obtained from FWD testing was compared to the areas of the segment where ASR cracking was observed in attempt to correlate the LTE with this distress. The expansive nature of ASR should result in locked joints. Any high LTE outside of these areas could be the result of locked joints from dowel bar misalignment or inadequate lubrication of the dowel bars at the time of construction. Figure 74 shows that the LTE increases as joints become closer to the distressed areas with the LTE being quite high within the distressed areas. It should be pointed out that a core was pulled in a non-distressed area from joint 26 and the LTE at this joint is only 73%, indicating that the joint is not locked. The core did reveal a horizontal crack running parallel to the surface of the slab along mid-depth of the dowel. This joint is circled in Figure 74. This type of cracking could help explain the relatively low LTEs exhibited in the non-distressed sections. The cracking might be attributed to stress generated by the ASR in the distressed regions, insufficient lubrication of the dowel and/or dowel misalignment.

Figure 74: Comparison of Joint LTE with Known Distressed Areas of US-22 Murrysville for Segment 50 Eastbound

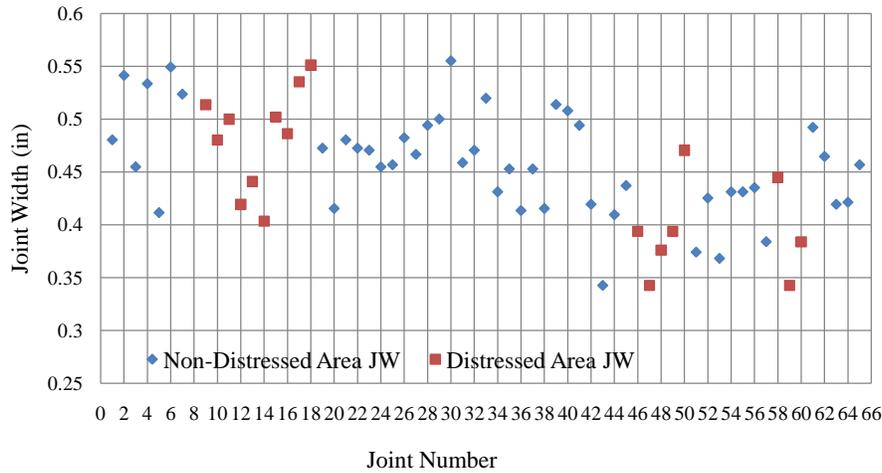
The measured joint widths at each joint, as well as the locations of the distressed areas, are shown in Figure 75. The purpose of this comparison was to determine if the distressed areas had smaller joint widths relative to the rest of the segment. If so, this could also indicate potential joint lockup. In order to draw some conclusions from this data, the magnitude of the joint width at known locations with locked joints was compared to other locations. Both Joints 12 and 58 were known to be locked since they contained embedded dowels that were immobile. The joint widths at Joints 12 and 58 are 0.42 and 0.48 in respectively. The average joint width for all the joints measured is 0.45 in and the standard deviation is 0.05 in. Therefore, it is concluded that the joint widths at Joints 12 and 58 are not significantly different from the other joints. As observed in Figure 75 the joint width exhibits a downward trend along the section, however, the cause for this is unknown.

Figure 75: Transverse Joint Width along US-22 Murrysville Segment 50 Eastbound.

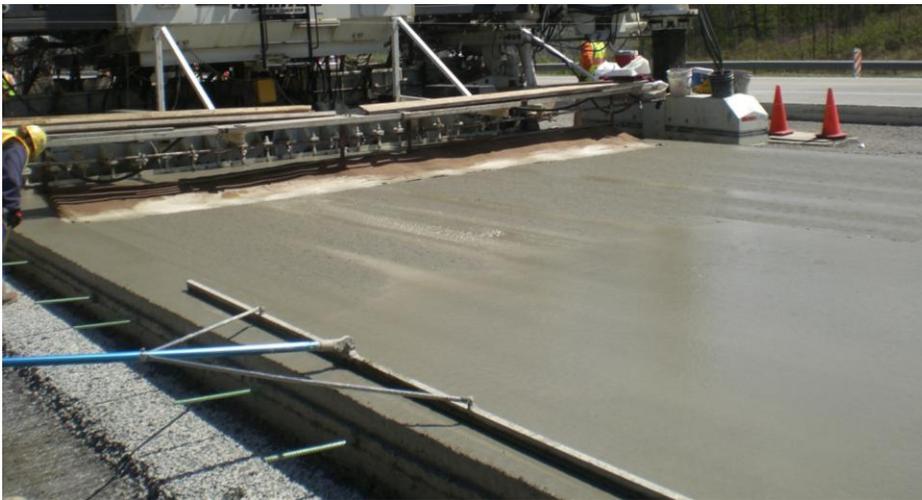
It is suggested that the curing specifications be changed, as previously described, to help address the drying shrinkage that was observed. It has been noticed that many of the pavers in the state drag wet burlap hung behind the paver along the surface of the pavement. This burlap is continually soaked, which results in an increase in the water to cement ratio on the pavement surface. This is then worked into the surface by about six to eight finishers following behind the paver. Figure 77 and Figure 78 below show the wet burlap drag and the resulting slurry

*Figure 77: Wet Burlap Drag and Finishing Behind the Paver*

These cracks can be prevented through the adoption of proper curing and finishing practices. The soaked burlap drag commonly drug behind the paver as shown in Figure 77 should be eliminated. This practice creates a high water to cement ratio at the surface and thereby increases the potential for drying shrinkage cracking and reducing the overall durability of the surface by increasing the porosity. Several of the projects also exhibited paste worn away at the surface, as seen in Figure 65. Eliminating this activity would help reduce the surface wear observed as well.

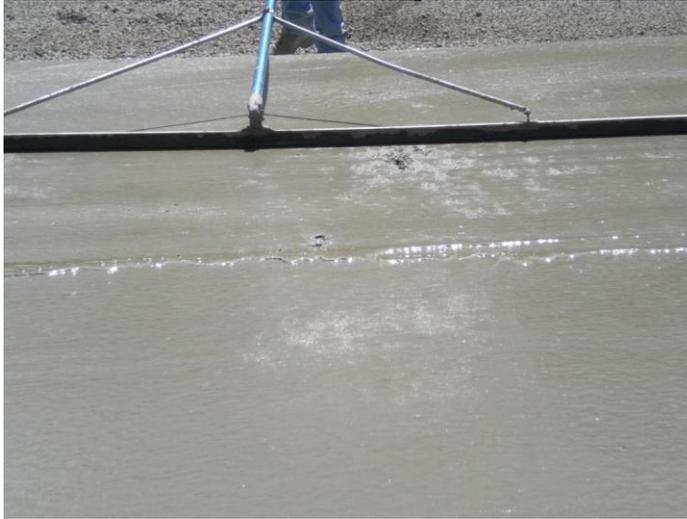
*Figure 78: Slurry Produced by the Wet Burlap Drag behind the Paver*

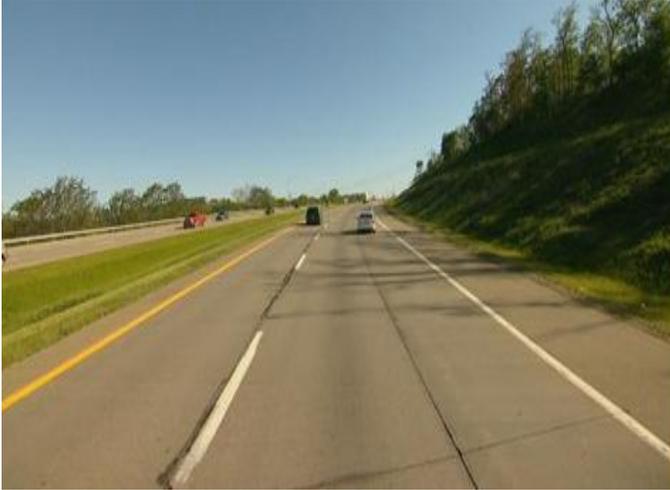
*Figure 83: Overall Condition of I 79 Segment 470 Northbound (Distressed Section)*
