## Premature Deterioration of Jointed Plain Concrete Pavements

FINAL REPORT

Date April 2011

By (PI) Dr. J. M. Vandenbossche, P.E.  
University of Pittsburgh

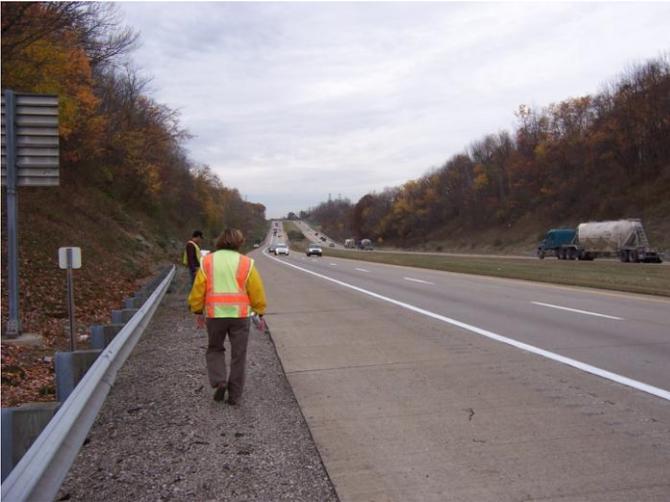
*Figure 84: Overall Condition of I 79 Segment 480 Northbound (Control Section)*

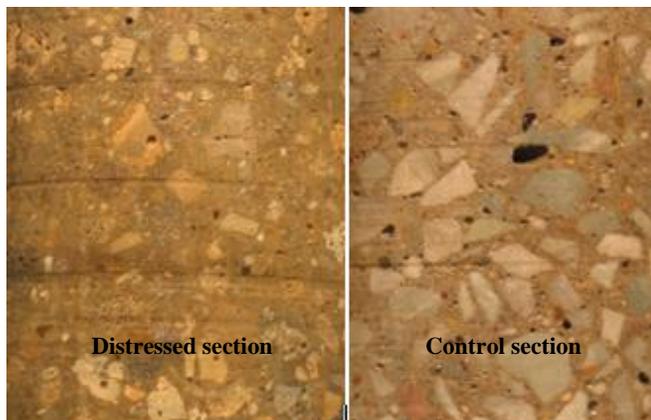
For I79 there is no available information regarding the concrete mixture design. Despite this missing information, based on the visual examination of the retrieved cores, it can be concluded that the concrete mixture designs used for the Distressed and Control sections are different. As observed in Figure 85, the coarse aggregate for the Distressed section is blast furnace slag whereas it is limestone for the Control section. The coarse aggregate gradation for the Control section also appears to be more uniform than that for the Distressed section. Additionally, the paste color for the specimens in the Control section was constant from top to bottom (brown). In the case of the Distressed section, a color variation from brown to grey was observed in the paste. The grey color was present around some coarse aggregate particles. This discoloration is a normal process in concrete containing blast furnace slag and it is not a detrimental characteristic.

*Figure 85: Concrete Core Surface Detail of I 79 Segments 470 and 480 Northbound (Distressed and Control Sections).*

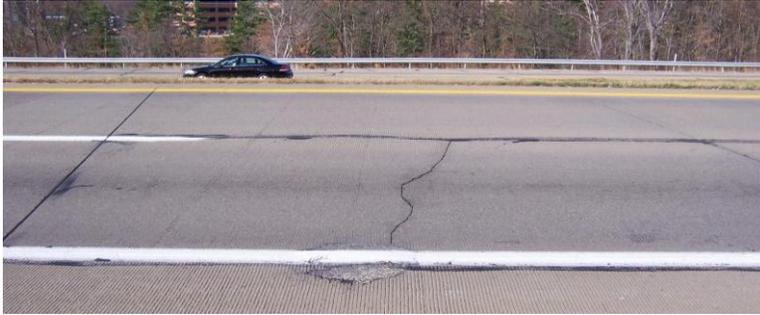
Figure 88 shows a low severity crack with an asphalt patch. Fourteen percent of the slabs in the Distressed section have an asphalt patch. The patches can be found at cracks, transverse joints, and longitudinal joints. The crack in this picture has been traced over with a marker to enhance its visibility.

*Figure 88: Digitally Enhanced Low Severity Transverse Crack and an Asphalt Patch of I 79 Segment 470 Northbound (Distressed Section)*

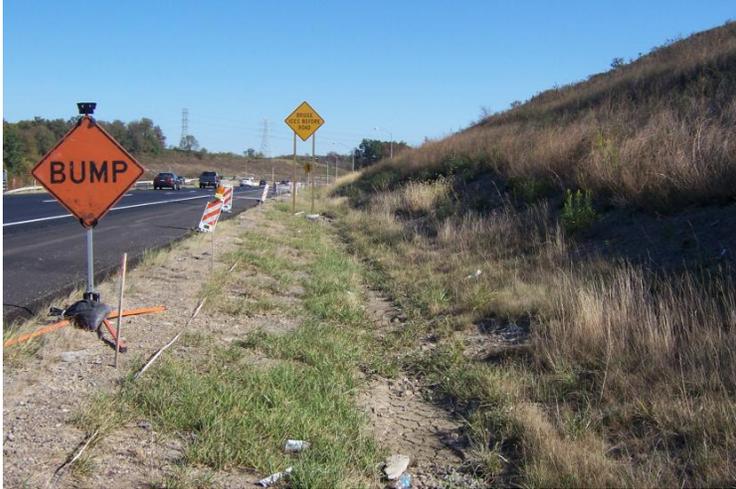
The Distressed and Control sections are located in cut areas as seen in Figure 89 and Figure 90 respectively. As observed in the figures, both sections are situated next to steep side slopes for which runoff water drains towards the pavement structure and is collected by a grass lined channel. The direction of the transverse slope of the pavement is different between the sections. The transverse slope in the Distressed section is directed such that all the water on the pavement surface drains towards the outside shoulder, while the transverse slope in the Control section is such that half the water drains towards the inner shoulder and half drains towards the outside shoulder. As a result, the ditch at the outside shoulder of the Distressed section collects more runoff water from the pavement than the ditch at the outside shoulder of the Control section. The side slope next to the Distressed section is also much larger and contributes a larger volume of water draining to the ditch than the corresponding side slope in the Control section. Another important difference in the overall drainage condition between the sections is that the longitudinal slope of the pavement for the Control section is considerably larger than that for the Distressed section.

*Figure 89: Side Slope of I 79 Segment 470 Northbound (Distressed Section) (photo taken after overlay placement)*

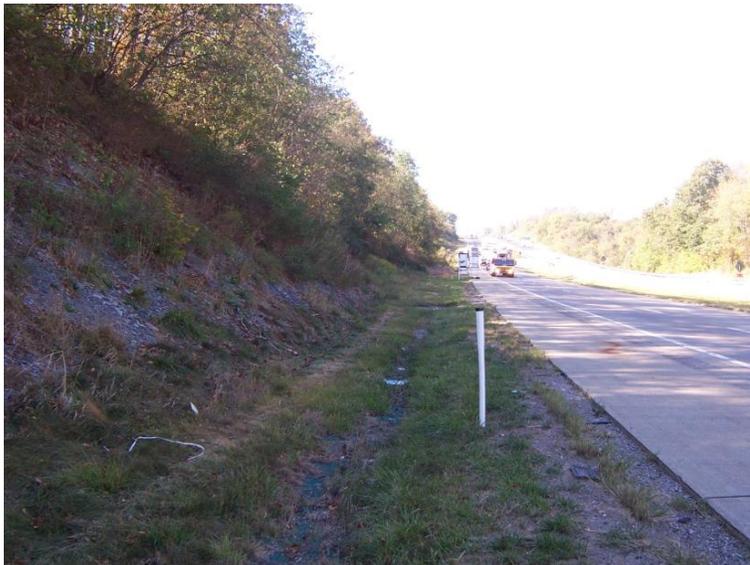
*Figure 90: Side Slope of I 79 Segment 480 Northbound (Control Section)*

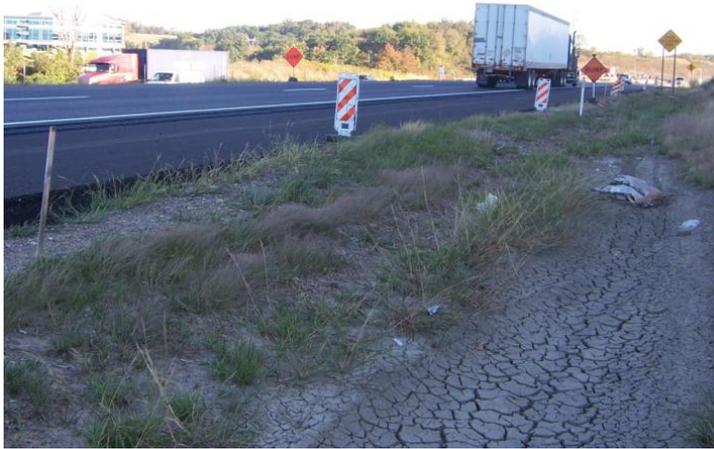
It was also noticed that several areas in the Distressed section exhibited drainage deficiencies. These areas were characterized by the absence of grass and dry natural soil with desiccation cracks on the surface as observed in Figure 91. The dimensions and severity of these areas varied along the section but were most pronounced in the areas adjacent to Panels 20 through 30. It is believed that the drainage deficiency is created by a combination of both poor grading of the ditch and lack of proper maintenance to guarantee positive flow towards a

drainage collector. Because of these deficiencies, ponding of water seems to have occurred resulting in a weakened structural capacity of the pavement. In the case of the Control section, no potential areas were ponded water gathered were observed.

*Figure 91: Typical Ponding Area of I 79 Segment 470 Northbound (Distressed Section) (photo taken after overlay placement)*

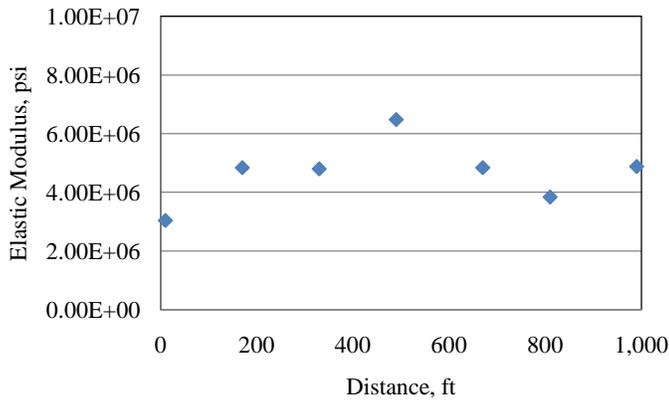
The average backcalculated static elastic modulus for the Distressed section is 4.70 million psi with a coefficient of variation of 23 percent. The average backcalculated static elastic modulus for the Control section is 5.35 million psi with a standard deviation of 1.98 million psi and a coefficient of variation of 37 percent. These average values are between typical ranges for mature concrete in highways. In both the Control and Distressed sections there is high variability with the variability being even more pronounced in the Control section. Taking this variability into account, the difference between the average values for both sections is not considered significant. Although the results of the laboratory testing for I 79 will be presented later, the relatively higher static elastic modulus for the Control section shown here agrees with the laboratory-determined values.

Figure 94: PCC Elastic Modulus for I 79 Segment 470 Northbound (Distressed Section)

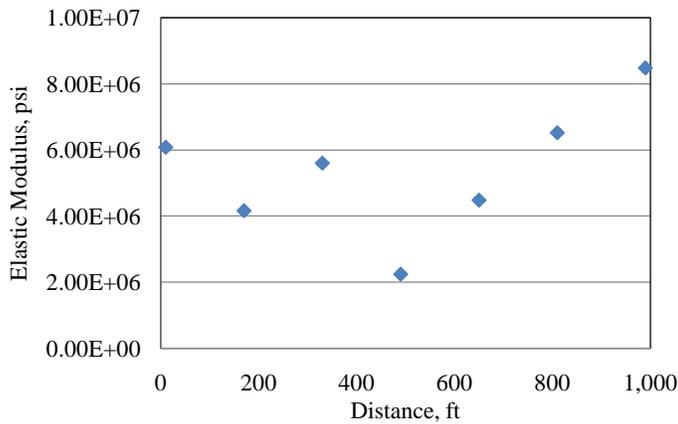
Figure 95: PCC Elastic Modulus for I 79 Segment 480 Northbound (Control Section)

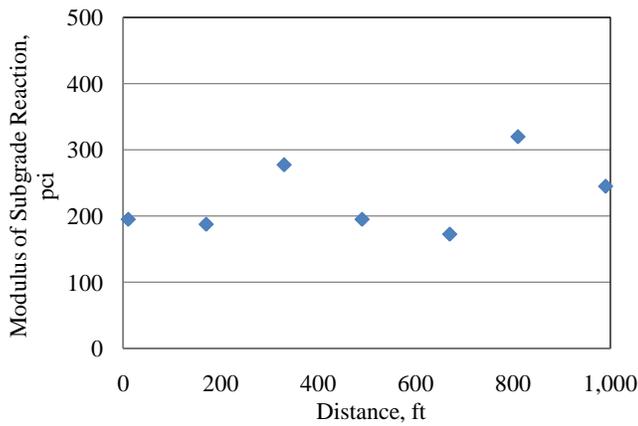
The modulus of subgrade reaction, k-value, was calculated using mid-slab deflections. Figure 96 and Figure 97 show the k-value along the Distressed and Control sections, respectively. The average static k-value for the Distressed section is 230 psi/in with a standard deviation of 55 psi/in and coefficient of variation of 24 percent. The average static k-value for the Control section is 280 psi/in with a standard deviation of 95 psi/in. The coefficient of variation is 34 percent. While the variability is considerably high for both sections, the average

k-values obtained are still typical for an unstabilized base. A higher average k-value was expected for the Distressed section considering that, as mentioned before, the subgrade in the Distressed section is mainly A-4 soil, whereas it is mainly A-6 soil in the Control section. During the field data collection, three panels (Slabs 27 to 29) were visually observed to be moving whenever traffic passed by suggesting significant support problems.

Figure 96: Modulus of Subgrade Reaction for I 79 Segment 470 Northbound (Distressed Section)

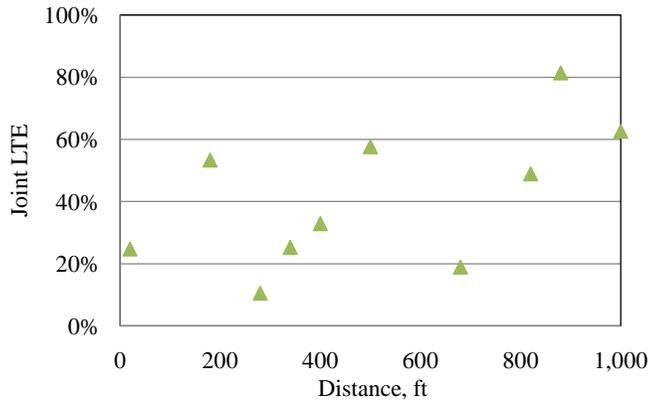
The joint load transfer for the Distressed and Control sections of I 79 are presented in Figure 98 and Figure 99. The relative performance between the Distressed and Control sections with respect to transverse joint load transfer was quite varied. The average LTE for the Distressed section was 42 percent and there was only one location for which the load transfer was above the recommended acceptable value of 70 percent. As one can surmise from the average value of 42 percent, many values were significantly lower than 70 percent indicating poor load transfer. The transverse joints in the Control section on the other hand had an average LTE of 93 percent. These high LTEs are indicative of consistently good load transfer performance in this segment. In the Distressed section, approximately half of the joints with poor load transfer have spalling.

Figure 98: Transverse Joint Load Transfer Efficiencies of I 79 Segment 470 Northbound (Distressed Section)

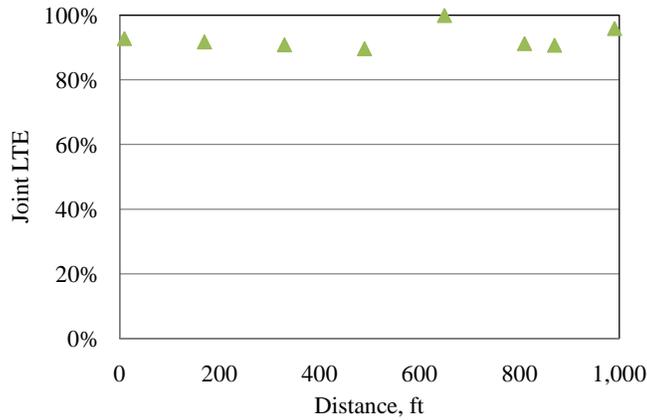
*Figure 99: Transverse Joint Load Transfer Efficiencies of I 79 Segment 480 Northbound (Control Section)*

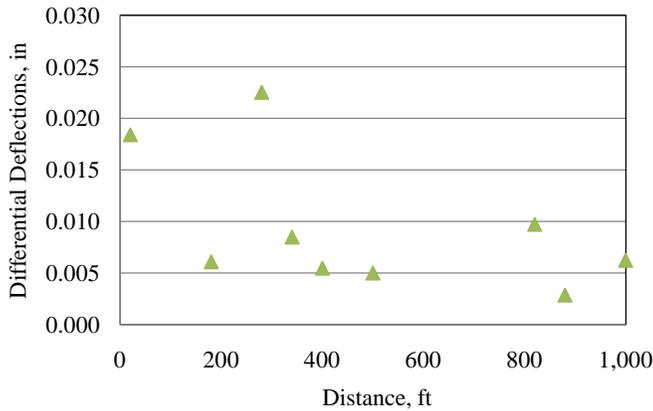
The differential deflections at joints for the Distressed and Control sections can be seen in Figure 100 and Figure 101, respectively. In the Distressed section, the differential deflections range from 2 to 23 mils. Low differential deflections correspond to high LTE and vice versa. A possible explanation for this is that there could be variability in the OGS base. While there are voids underneath all of the joints, some are larger than others. In general, the largest voids correspond to the locations where the LTE is the lowest.

Figure 100: Differential Deflections at Transverse Joints for I 79 Segment 470 northbound (Distressed section)

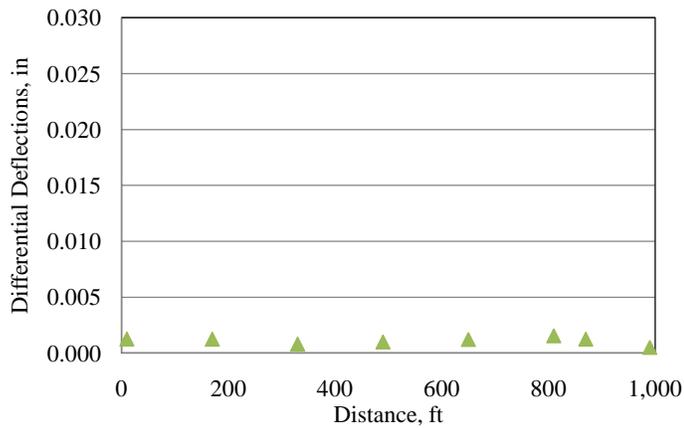
In the Control section, the LTE along the section is excellent and all of the differential deflections are less than 2 mils. However, analyzing the measured peak deflections revealed that these values are considerably high with an average value of 15 mils. This condition suggests a potential loss of support beneath the slabs.

Figure 101: Differential Deflections at Transverse Joints for I 79 Segment 480 northbound (Control section)

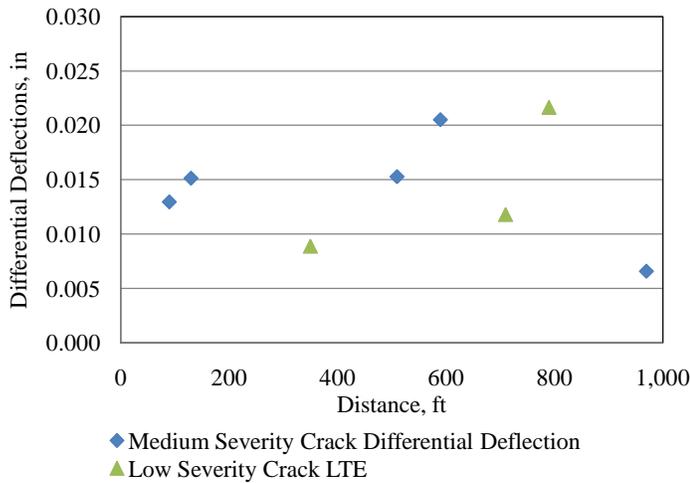
The differential deflections measured for the cracks in the Distressed section are presented in Figure 103. As stated previously, if differential deflections are greater than 10 mils, then there is a problem with load transfer. Almost all of the locations tested had differential deflections greater than 10 mils and the locations that did not exceed this threshold were close to 10 mils differential deflection. The values with larger differential deflections all have poorer load transfer efficiencies.

Figure 103: Differential Deflections at Transverse Cracks for I 79 Segment 470 Northbound (Distressed Section)

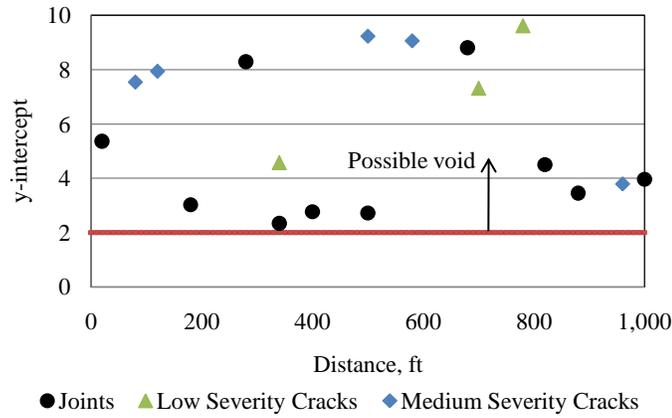
The Distressed section shows the potential for voids at every joint and crack. This agrees with the load transfer efficiencies and differential deflections calculated at these locations. It is suspected that the base beneath the slab has been eroded or experienced significant settlement.

Figure 104: Loss of Support for I 79 Segment 470 Northbound (Distressed Section)

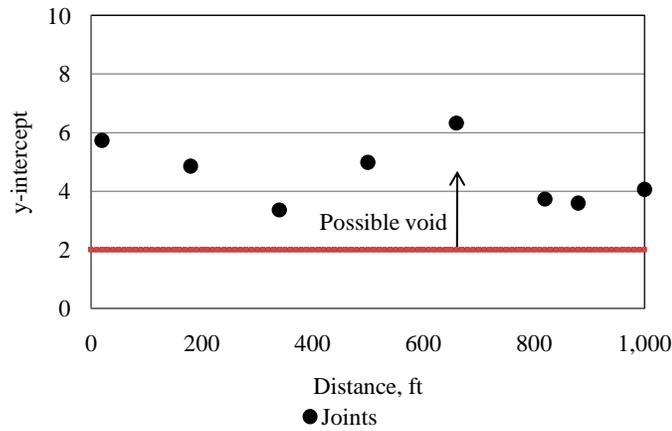
As mentioned previously, the load transfer efficiencies in the Control section are extraordinarily good with virtually no faulting, however, the section shows the potential for voids at every joint. This implies that even with a limited contribution of the base layer in load transfer, the dowels and aggregate interlock are working efficiently and are able to maintain a high level of load transfer. While no pumping or staining of fines near the longitudinal or

transverse joints was observed out in the field; there is a potential for a reduction in support through consolidation or aggregate degradation since an OGS was used.

Figure 105: Loss of Support for I 79 Segment 480 Northbound (Control Section)

As mentioned in the FWD analysis section, the only deficiency noticed in the Control section was the presence of voids beneath the slabs. As discussed previously, these voids could be the result of settlement or migration of the subbase or subgrade into the OGS layer. The LTE at the joints is still quite high so pumping is not providing a substantial contribution to the loss of support. Although the voids have not yet resulted in increased fatigue damage to the point where mid-slab cracking has developed, there exists the potential for these issues to arise. Slab

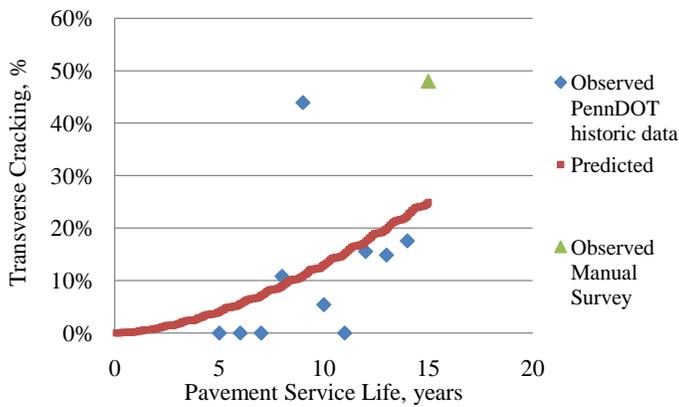
Figure 113 presents the MEPDG predicted against the observed transverse cracking. The observed transverse cracking over time (from year 5 to year 14) is based on historic distress data provided by PennDOT, which was collected using automated distress detection equipment. The data point from the pavement management system for year 15 represents the percentage of transverse cracking in the Distressed section that was manually surveyed as part of the field data collection effort for this study. As observed in Figure 113, the historic distress data exhibits some anomalies. Despite the anomalies, it can be concluded that in the Distressed section, transverse cracking began to become visible on the surface of the slabs between years 7 and 10. Additionally, it can be noticed in Figure 113 that from year 14 to year 15, the percentage of cracking varies from 18 to 48 percent. As mentioned previously, this variation can likely be attributed to the inability of the automated equipment to identify cracks. Consequently, and as mentioned in Section 2.14.5, it is possible that the transverse cracking quantified using the automated equipment is being underestimated.

The slope of the predicted transverse cracking trend presented in Figure 113 implies that the fatigue damage the Distressed section is significant. For the Control section, the predicted and observed transverse cracking shown in Table 40 suggest that the Control section has not yet reached the critical zone of fatigue damage. The increase in slab thickness for the Control section was effective in decreasing the fatigue cracking, as predicted using the MEPDG.

periods of time. Exposure to moisture can also degrade the quality of the material. As mentioned in Section 5.7.5, several areas exhibiting drainage deficiencies were observed in the Distressed section. This condition explains the difference between the predicted and observed transverse cracking for year 15. Additionally, it is noteworthy that the MEPDG software does not consider such drainage deficiencies in its analysis and this consideration can also explain the difference between predicted and observed performance.

Figure 113: Predicted and Observed Transverse Cracking for I 79 Segment 470 (Distressed section)

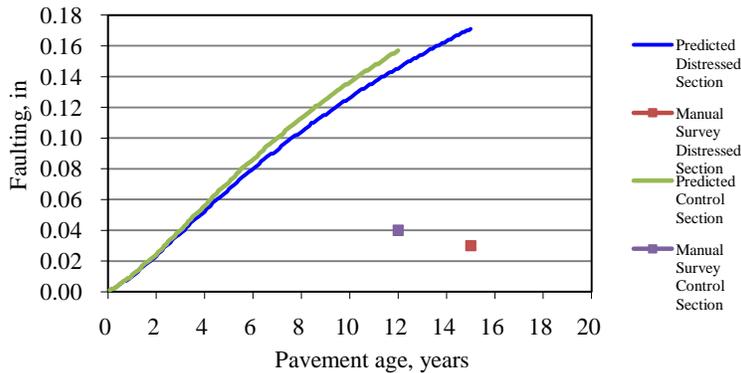
Figure 114 presents the predicted and observed faulting for both the Distressed and Control sections of I 79. The observed faulting corresponds to the data measured as part of the field data collection for the present study. Historic data for faulting was not available from PennDOT. As is evident in Figure 114, there is a large difference between the predicted and observed faulting in both the Distressed and Control sections. As discussed in Section 2.14.5, the high predicted faulting is principally caused by a high upward corner deflection calculated by the MEPDG.

Figure 114: Predicted vs. Observed Joint Faulting for I 79 Segments 470 and 480  
(Distressed and Control Sections)

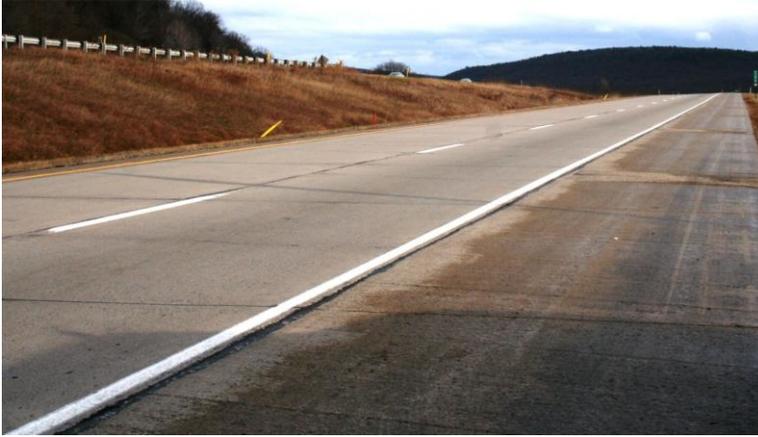
*Figure 119: Overall Condition of I 80 Segment 1914 (Portion of Distressed Section)*

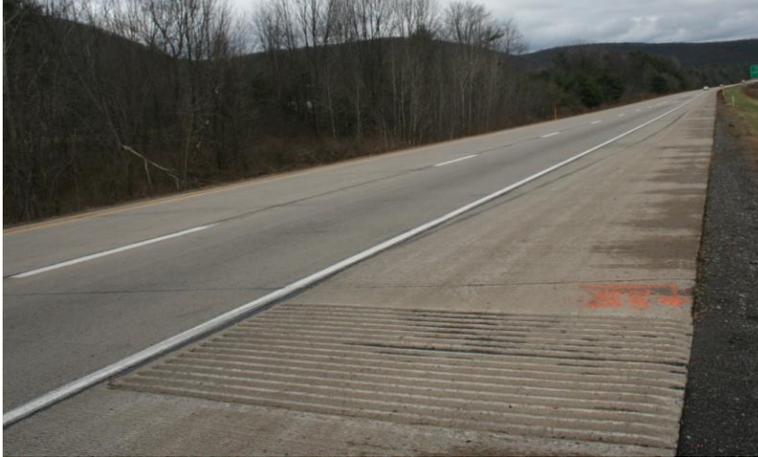
*Figure 120: Overall Condition of I 80 Segment 1930 (Control Section)*

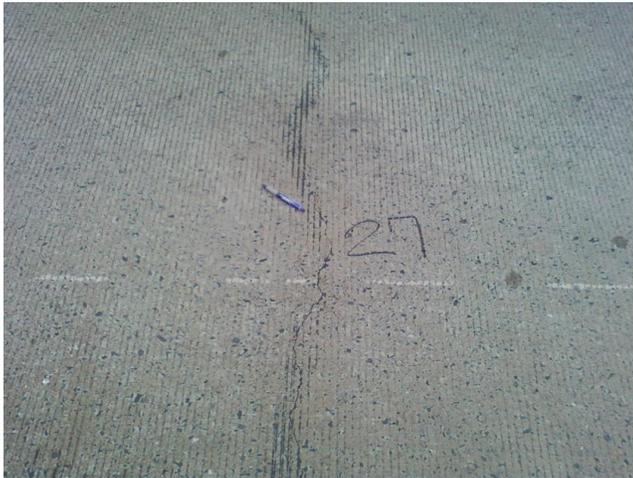
*Figure 122: Low Severity Transverse Crack of I 80 Segment 1914 Eastbound (Distressed Section)*

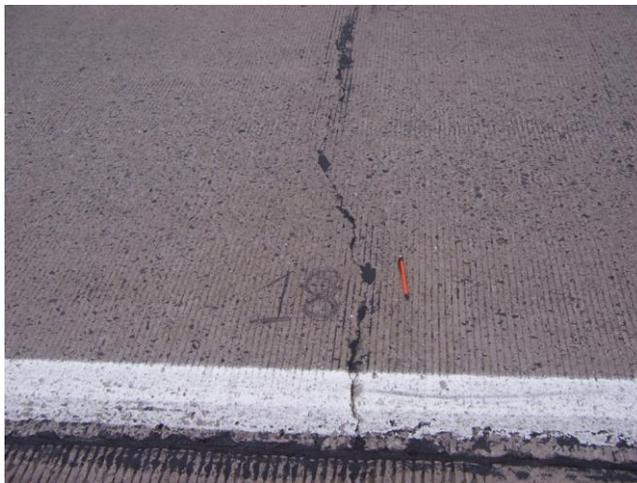
*Figure 123: Medium Severity Transverse Crack of I 80 Segment 1914 Eastbound (Distressed Section)*

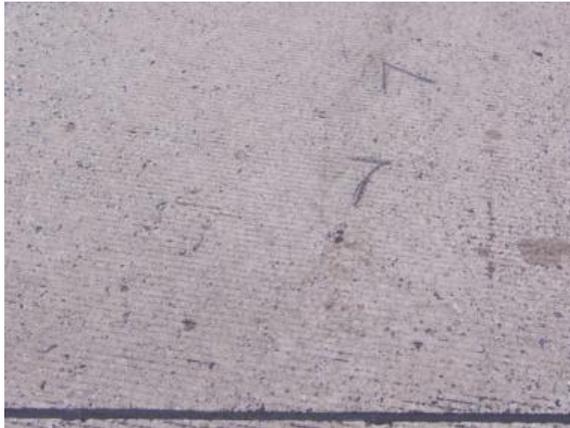
Low severity longitudinal cracking is present in 42 percent of the slabs in the Distressed section. There is no longitudinal cracking in the Control section Figure 124 shows a longitudinal crack in the Distressed section.

*Figure 124: Longitudinal Crack of I 80 Segment 1914 Eastbound (Distressed Section)*

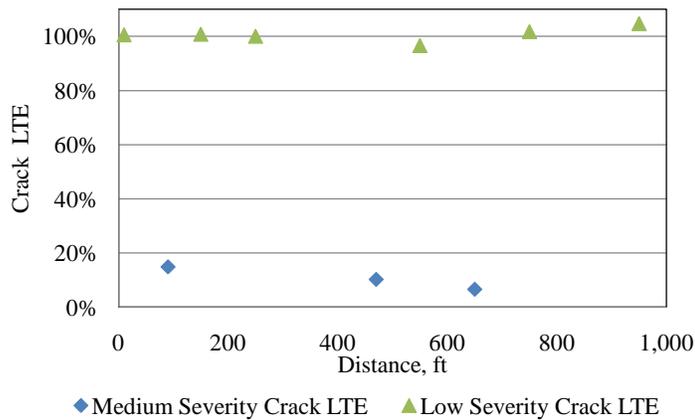
The crack load transfer efficiencies for the Distressed and Control sections of I 80 are shown in Figure 135 and Figure 136, respectively. The average crack load transfer efficiencies at the approach and leave sides of the cracks for the Distressed and section are 75 and 74 percent, respectively. As can be observed in Figure 135, there are three locations along the Distressed section for which the load transfer efficiency is significantly lower than the rest of the section.

The average LTE for only these three locations is only 11 percent while the average crack LTE for the other cracks is 100 percent. All three of the underperforming test locations are at cracks of medium-severity. Additionally, all three of those panels have longitudinal cracks. The rest of the locations have very high load transfer efficiencies with cracks that are of low-severity and crack widths that are too small to be measured.

Figure 135: Transverse Crack Load Transfer Efficiencies of 180 Segments 1914 and 1920 Eastbound (Distressed Section)

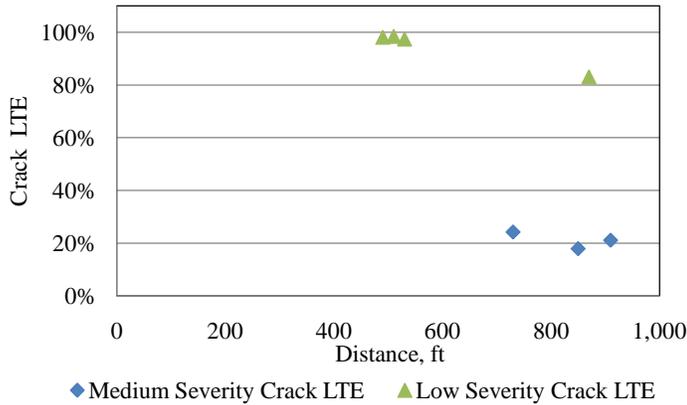
In the Control section, the same trend can be observed considering the performance of low and medium severity cracks. Much like the Distressed section, the average LTE of the medium severity cracks in the Control section, 21 percent, is much lower than the average LTE for the low severity cracks, 94 percent.

Figure 136: Transverse Crack Load Transfer Efficiencies of I 80 Segment 1930 eastbound (Control Section)

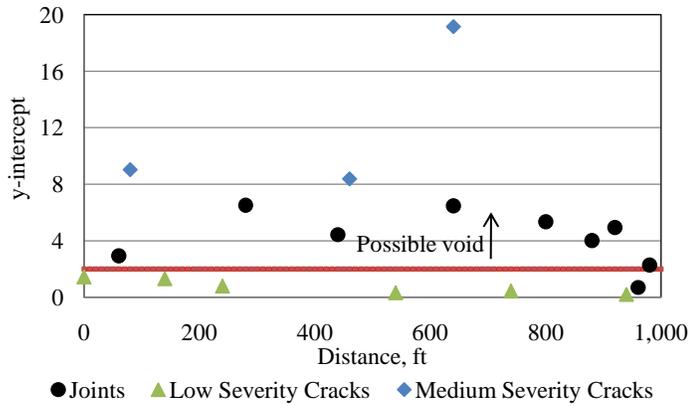
To determine the presence of voids, the load vs. deflection response for each station was determined. As mentioned previously and explained in detail in Section 2.8.6, when the load vs. deflection relationship is plotted for the standard load levels and the deflection intercept value is greater than two mils, then the potential exists for the presence of voids beneath the slab. The load vs. deflection graphs for I 80 is presented in Figure 139 and Figure 140. These figures are for the Distressed and Control sections respectively. The Distressed section, shown in Figure 139, shows the potential for voids at eight joints and three medium severity cracks. The Control section, shown in Figure 140, shows the potential for voids at eight joints and two medium severity cracks. One contradiction to the generally observed trend for the Control section is that there is one crack of medium severity that does not show the potential for voids. Concerning this particular crack, the potential for voids, although not above the threshold value, is still higher than all of the low severity cracks. The loss of support for the cracks in both sections agrees with the load transfer efficiencies calculated above. Considering that the base is unstabilized, there is a potential for pumping. Despite the unstabilized base and the measured voids underneath the slab determined through FWD testing, no evidence of pumping was observed in the field. The

presence of voids at joints and crack locations is believed to be caused by consolidation of the OGS over time.

Figure 139: Loss of Support Results for I 80 Segments 1914 and 1920 Eastbound (Distressed Section)

voids are due to settlement of the OGS layer from the many load applications over the years. However, because of the pavement age, it is doubtful that the voids will increase in size as most of the possible settlement has been realized already. In addition, there appears to have been no adverse effects to the pavement structure from the voids as load transfer efficiency is good at most of the joints in both the Distressed and Control section. A further breakdown of the LTEs at the transverse joints revealed that while some joints had LTEs less than the recommended value of 70 percent, these joints did not exhibit exceedingly poor load transfer. The lowest load transfer efficiency at the joints of I 80 was 54 percent at one of the joints in the Control section. This value, while not great, does not suggest complete failure of the dowels either. Therefore, performing slab stabilization as a means of addressing the voids underneath the slab might not be a rehabilitation procedure that provides good economic value for this section of I 80.

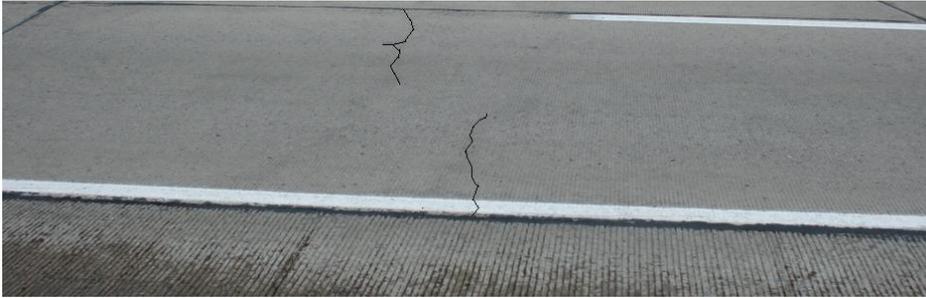
Determination of Air Void Content and Parameters of the Air Void System in Hardened Concrete”. The core was from a microcracked region of Slab 25 as shown in Figure 125. Slab 25, other than the microcracked region, exhibited cracks in the transverse direction as shown in Figure 143. These cracks, as highlighted in Figure 143, did not extend across the entire slab, but did happen to occur roughly at mid-slab.

*Figure 143: Digitally Enhanced View of Slab 25 I 80 Segment 1914 Eastbound (Distressed Section)*

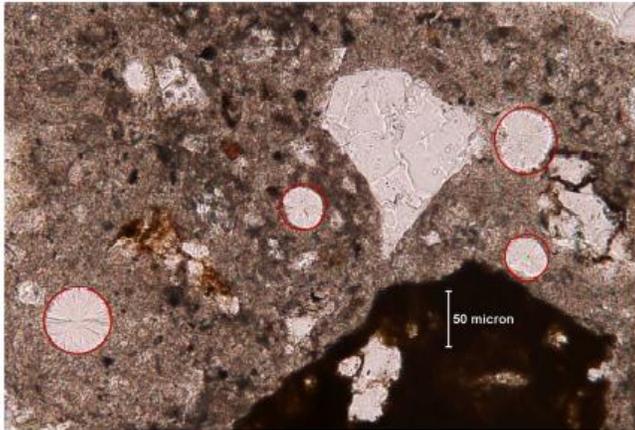
Table 46 presents the results from the petrographic and hardened air void analysis relevant to the determination of the cause of the distresses for I 80. the air void system in its present state is substandard for this pavement’s freeze thaw exposure conditions because it does not meet the requirements for spacing factor or specific surface area recommended by ACI to achieve good freeze thaw resistance. The recommended requirements set forth by ACI are a spacing factor  $<.008$ -in and a specific surface area  $>600\text{in}^2/\text{in}^3$ . Despite the current state of the air void system, it was also noted that secondary ettringite has partly or completely filled much of the finer air voids throughout the upper half of the core reducing the air void system in that region. This is illustrated in Figure 144. Despite these observations, the pavement has still functioned fairly well for almost 20 years without significant amounts of spalling or d-cracking near the joints.

Figure 144: Illustration of Ettringite Filled Air Voids (Circled in Red) in I 80 Core MC25-D. Magnification 200x

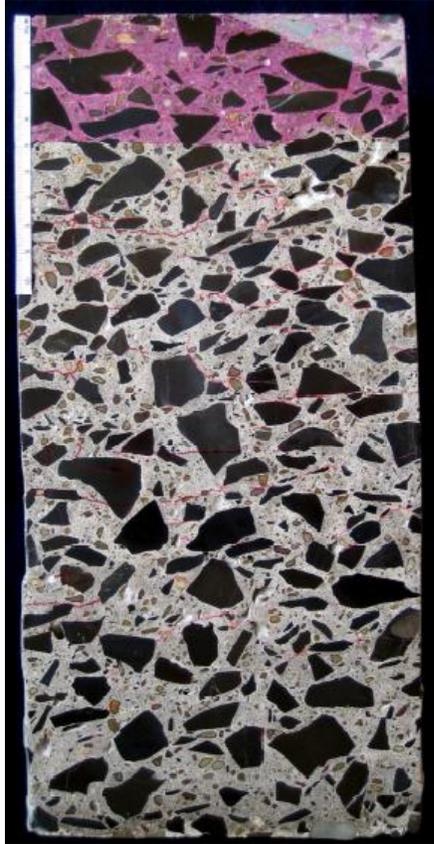
On a larger scale, the developing ASR is contributing to expansion throughout the depth of the core and causing internal cracking, it is noteworthy however that the microcracking caused by the ASR is only visible with magnification or the aid of a dye. This cracking takes the form of sub-horizontal microcracks at depth within the core as illustrated in Figure 146 by the red lines throughout the depth of the core and manifests itself as sub-vertical microcracks within the top 13-mm (.5-in) of the pavement, as shown in Figure 147. The large colored rectangular area in Figure 146 and Figure 147 represents the area tested for carbonation, while the slightly darker red lines represent ASR. Figure 147 was included to illustrate the sub-vertical microcracks in the region that were also tested for carbonation. Although it appears that minor amounts of ASR has developed, it does not appear that it has significantly affected the performance of the pavement to date.

*Figure 146: Illustration of the Extent of Microcracking Due to ASR within Core C25MC-D of 180.(ASR Illustrated by Red Lines)*

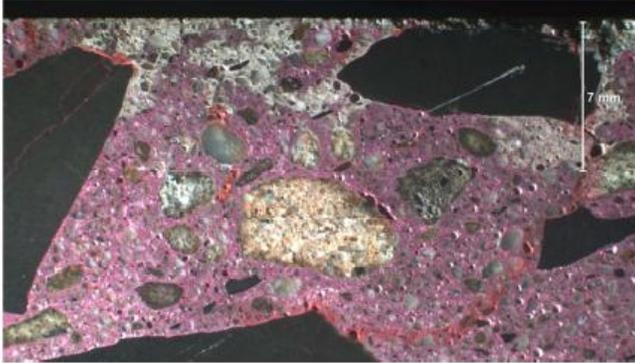
*Figure 147: Illustration of Sub-Vertical Microcracking due to ASR near C25MC-D Core Surface. Magnification 5x*

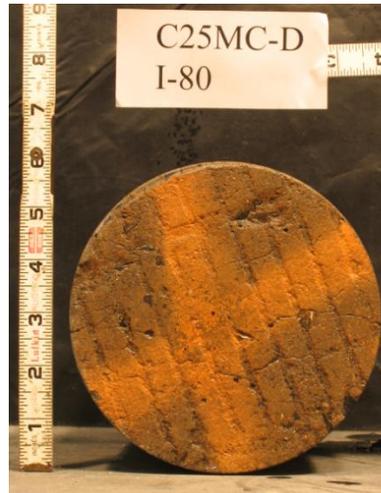
The map-cracking was found in a common and localized area adjacent to the outer lane-shoulder joint. Available moisture is required for ASR to occur. This can explain why the map cracking is primarily prevalent around the joints since these locations are a source of moisture infiltration into the pavement structure and are also prone to retaining moisture. The orientation and spacing of the cracks do not follow a noticeable trend; they are randomly oriented and distributed as seen in Figure 148. The depth of the microcracks shown in Figure 148 is approximately 0.7-in and the visual observation of the core revealed that at some points the crack goes through the coarse aggregate.

*Figure 148: Top View of PCC Core Retrieved at a Microcracked Location of I 80 Segment 1914 Eastbound, Slab 25,(Distressed Section)*

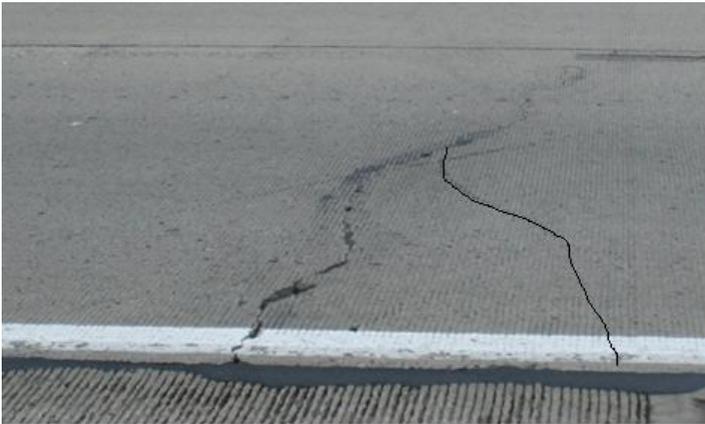
To address medium severity transverse cracking full-depth repairs are suggested. For I 80, there are many low severity cracks that do not extend through the entire depth of the pavement. These types of cracks, shown in Figure 151, can result in secondary cracks that deviate from what can be considered a primary crack extending across the slab. As mentioned in the previous section, these cracks are believed to be the result of drying shrinkage of the concrete. While they do not extend through the depth of the pavement, in many cases they do create a location with a reduced effective thickness and increased likelihood of being the location of the initiation of a fatigue crack. It appears that the initiation of a fatigue crack from a drying shrinkage crack is indeed happening in this section as evidenced by Figure 151. This figure shows a working crack with drying shrinkage crack branching off of it. The boundary area for the full depth repairs

*Figure 151: Medium Severity Transverse Crack with Digitally Enhanced Branching Drying Shrinkage Crack on I 80 Segment 1914 (Distressed Section)*

Because of the tightness of the drying shrinkage cracks and the uncertainty surrounding their future development into full depth transverse cracks, it is recommended to do nothing to address these cracks at this point in time. This recommendation is also valid for the longitudinal cracks as they also appear to be due to drying shrinkage. The extent of the medium severity transverse cracks within the section, 20 percent in the Distressed section and 6 percent in the Control section, suggests that this is an economically viable option for this pavement as the extent is not such that reconstruction or an unbonded overlay is yet needed. This concrete pavement restoration technique will only serve to enhance the existing remaining life of the current pavement.

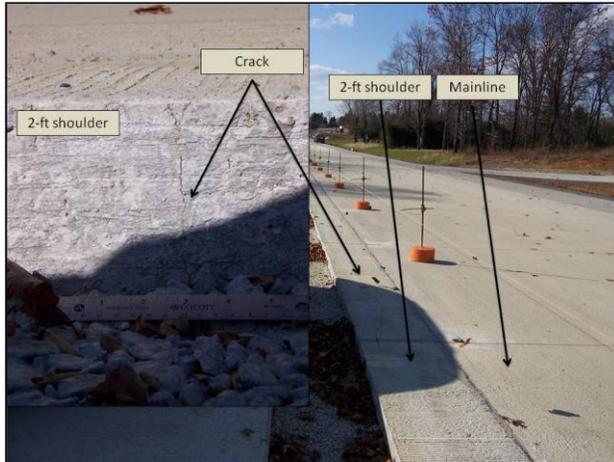
The mid-panel cracking in the shoulders was the only distress that the pavement exhibited. A typical crack can be seen in Figure 156 while a breakdown of the number of shoulder slabs cracked per section can be found in Table 61. The majority of the cracks propagated across the full width of the shoulder (full-length cracks); however, there were a few cracks that only partially traversed the width of the slab (partial-length cracks). The cracks were more open along the free edge and tight at the edge adjacent to the mainline. All of the cracks were wider at the top than at the bottom. This could be an indication of top-down cracking or just the result of the restraint provide by the base restricting further crack opening near the bottom of the slab. Based on these two observations, it seems possible that the cracks initiated at the upper outside edge away from the junction of the shoulder and the mainline.

Figure 156: Typical Crack Found in the 2-ft Shoulder of US 22, Indiana County

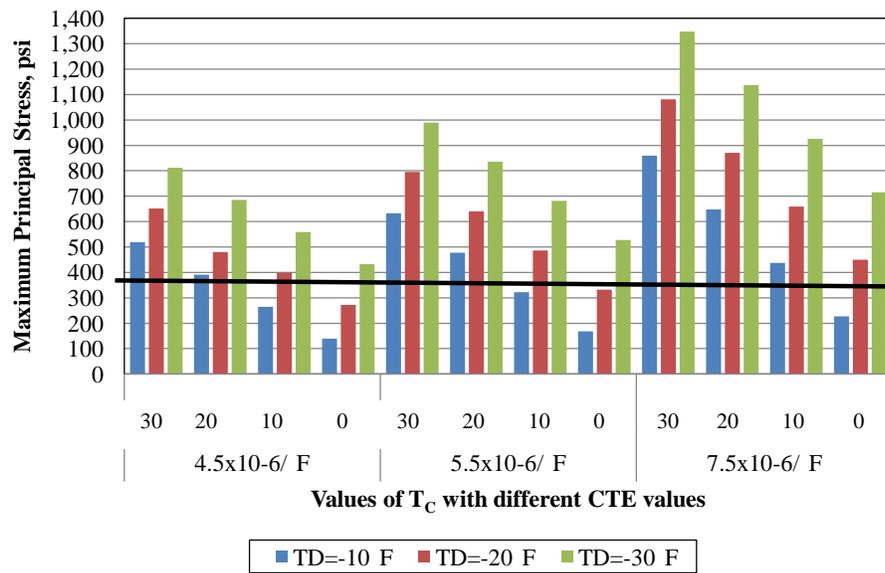
The following sections will discuss each parameter and the influence it has on the development of transverse cracking in the shoulder. Figure 166 shows a summary of the results for the stiffness of 3.3 million psi (corresponding to the seventh day). As shown in Figure 166, a crack is likely to occur for any stress larger than 405 psi.

From Figure 166 it seems that whether or not a crack will occur depends on the values of  $T_D$  and  $T_C$ . Assuming a CTE of  $5.5 \times 10^{-6}/^\circ\text{F}$  and 7-day strength/stiffness, a  $T_D$  of  $-10^\circ\text{F}$  will not result in cracking unless the value of  $T_C$  is  $20^\circ\text{F}$  or higher. A  $T_D$  of  $-20^\circ\text{F}$  will not produce cracking if  $T_C$  is lower than  $10^\circ\text{F}$ . A  $T_D$  of  $-30^\circ\text{F}$  will result in cracking even if  $T_C$  is  $0^\circ\text{F}$ . The potential for a shoulder to develop transverse cracking based on the construction sequence and CTE can also be expressed as shown in Table 66.

Figure 166: Critical Value of  $T_c$  for Different CTE Values with a Tensile Strength of 405 psi.

Figure 166 shows the effect that CTE has on transverse cracking in the shoulder. As expected, a larger CTE results in a higher chance for crack to develop. A lower CTE reduces the chance for cracking. According to the LTPP database, the national average for CTE is approximately  $5$  to  $5.5 \times 10^{-6} / ^\circ\text{F}$ .

Based on this result, the best way to avoid the shoulder transverse cracking seems to be constructing the shoulder and the mainline at similar temperatures. If it is unavoidable to construct the mainline and shoulder during the same season, Equation 5 can be used to determine the difference in zero-stress temperatures for the mainline and shoulder. The best months to construct pavements are the months when the pavement temperatures night are not too low. In Pennsylvania, these months seem to be from May to September. It is also possible to pave in April and October as long as the ambient temperature is relatively high.

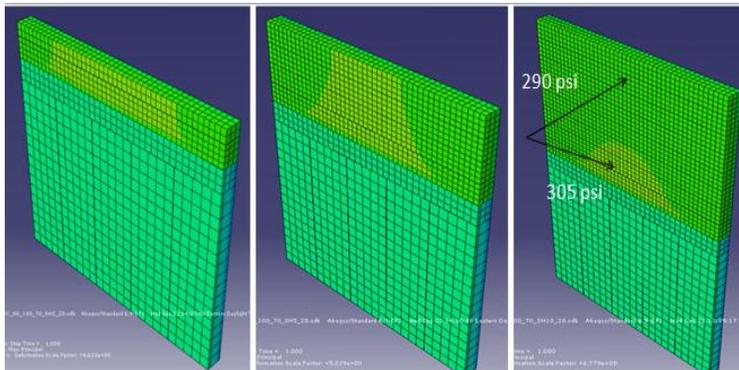
Figure 167, Figure 168 and Figure 169 show screen shots from three models that are identical except for the shoulder width. In Figure 167, the three models have a CTE of  $4.5 \times 10^{-6} / ^\circ\text{F}$  and

stiffness of 2.8 million psi. There is no crack present and at first glance, it would appear as if there is no difference between the three different shoulder widths with respect to the maximum stress magnitude. Despite seeing a lack of variation in the magnitude of the stress, the distribution of stress in the shoulder is different among the three models in Figure 167. In the 2-ft shoulder, there is an area of higher stress that is located in the center of the shoulder and extends across almost the entire width. In the 5-ft shoulder, that same area of higher stress still extends across almost the entire width of the shoulder but the area of higher stress begins to taper as it reaches the outside edge of the shoulder. In the 10-ft shoulder, the area of higher stress extends across a noticeably smaller width of the shoulder. It can be noticed from Figure 167 that the tie bars have a major influence on the area of higher stress. Although not completely apparent, the area of higher stress begins where the first tie bar is located and ends where the last tie bar is located. Figure 170 is more effective in illustrating this point.

*Figure 167: Influence of Shoulder Width When  $T_D = -20^\circ F$  and  $T_C = 70^\circ F$  for the Shoulder Transverse Cracking Model.*

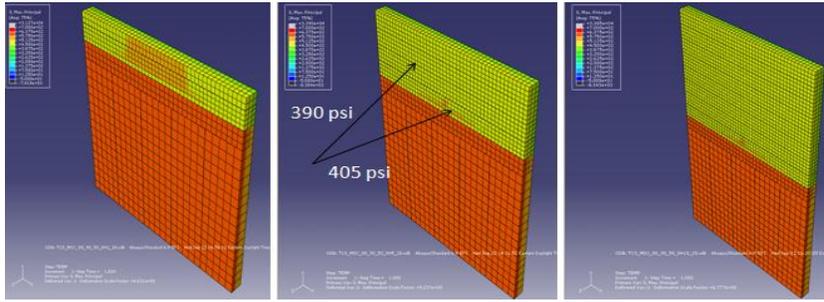
In Figure 168, the three models have a CTE of  $5.5 \times 10^{-6}/^\circ F$  and a stiffness of 2.8 million psi. The calculated stress in this figure is less than the strength of the concrete. It should be noted that for the color schemes within the same figure, areas represented by the same color share the same magnitude of stress. These same comparisons cannot be made between different figures because colors represent different magnitudes of stress for different figures. Similar to Figure 167, there is an area of higher stress in the 2-ft shoulder that is located in the center of the shoulder and extends across the entire width. However, compared to Figure 167, the area of higher stresses in Figure 168 diminished significantly quicker and extends only a 1-ft across the

shoulder. This might be due to the fact that the thermal incompatibility ( $T_D=-10^\circ\text{F}$ ) for models in Figure 168 is smaller than that for models in Figure 167 ( $T_D=-20^\circ\text{F}$ ).

Figure 168: Influence of Shoulder Width When  $T_D=-10^\circ\text{F}$  and  $T_C=50^\circ\text{F}$  for the Shoulder Transverse Cracking Model.

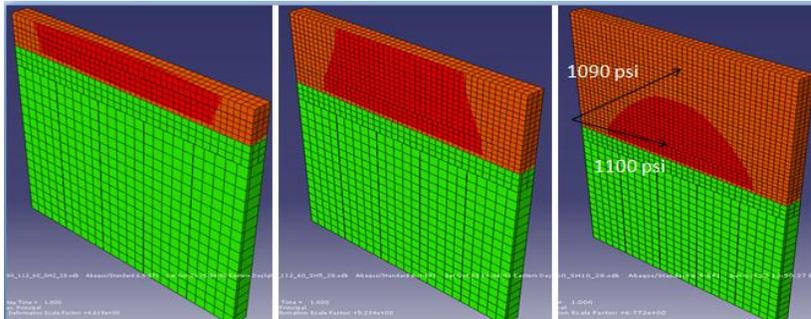
In Figure 169, the three models have a CTE of  $7.5 \times 10^{-6}/^\circ\text{F}$  and stiffness of 2.8 million psi. In all three of the models, the predicted stresses exceed the defined strength of the concrete indicating a crack occurring for all three models. In the 2-ft shoulder, there is an area of higher stress that is located in the center of the shoulder and extends across the entire shoulder width. In the 5-ft shoulder, the same area of higher stress still extends across the entire width of the shoulder; however, it begins to thin out as it reaches the outside edge. In the model with the 10-ft shoulder, the area of higher stress extends only a few feet across the shoulder. In all three of the models, the area of the shoulder that has a high stress concentration is the area around the tie bars.

Figure 169: Influence of Shoulder Width When  $T_D=-30^\circ\text{F}$  and  $T_C=70^\circ\text{F}$  for the Shoulder Transverse Cracking Model.

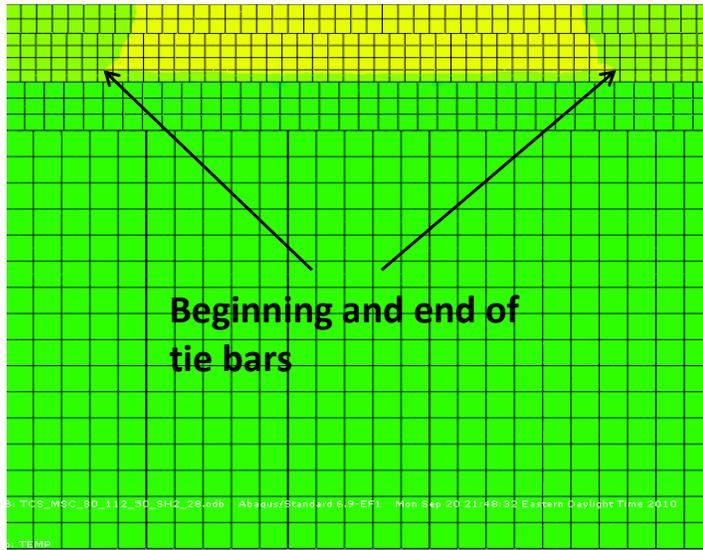
Figure 170 illustrates the concentration of stress surrounding the tie bars. This is a model

that is sliced in the z-direction so that the tie bars are visible. The larger stresses clearly begin to form around the tie bars. This holds true for all of the cases in the parametric study.

Figure 170: Illustration of the Stress Concentration Surrounding the Tie Bars in the Shoulder Transverse Cracking Model.

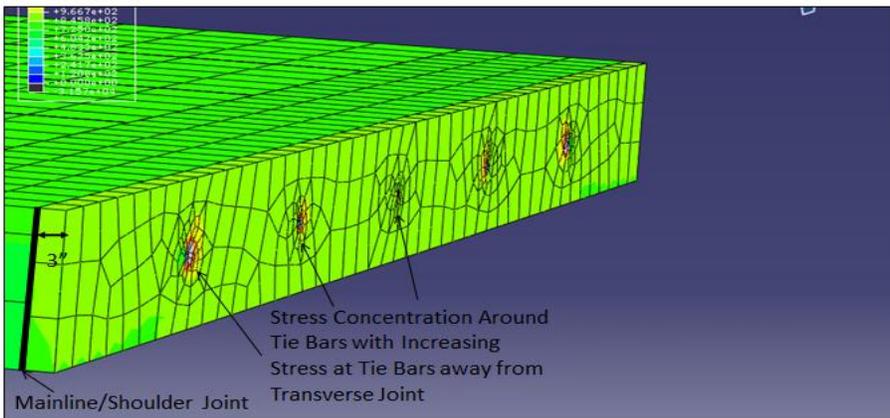
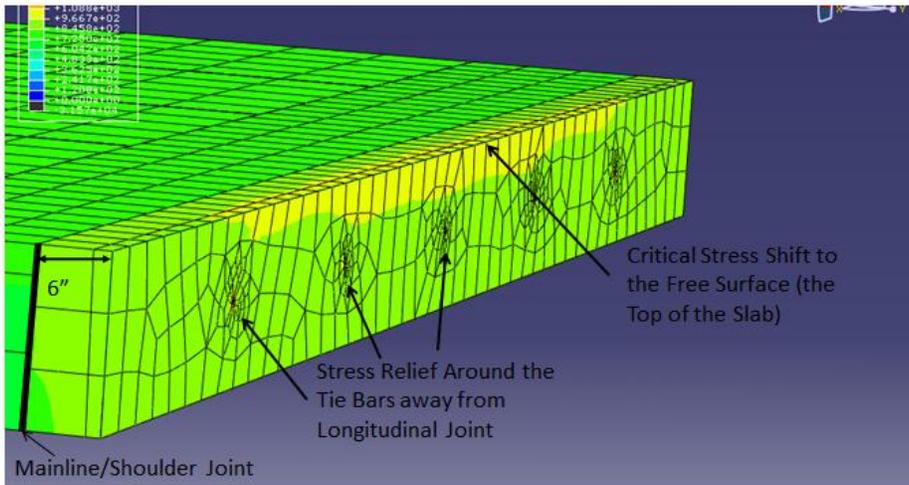
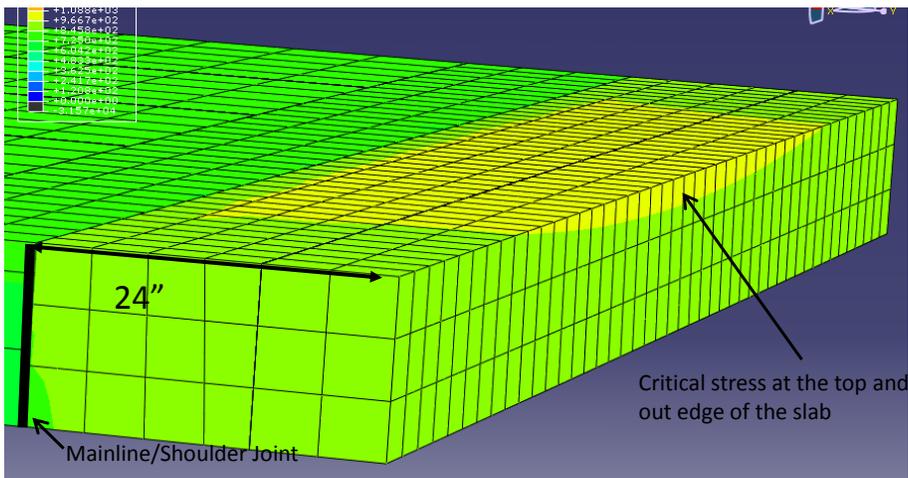
Figure 171: Illustration of the Shift of Stress Concentration from the Tie Bars to the Free Surfaces in the Shoulder Transverse Cracking Model.

Cross sections were cut as shown in Figure 146 to examine the details in the stress concentration around the tie bars. In Figure 171, three such cross sections that are 3 in, 6 in and

24 in away from the mainline/shoulder joint are shown. From Figure 171 (a), it is easy to observe that the stress concentration is more severe at the tie bars that are closer to the transverse joints. This observation results from the symmetry of the problem resulting in less constraint to relative displacement between the mainline and the shoulder at the transverse joint than at the mid-slab. More importantly, it is found through examination of Figure 171 (a, b, and c) that the stress concentration shifts away from the tie bars towards the free surfaces. Comparing Figure 171 (a, b, and c) it can be seen that trend becomes more pronounced as the cross section moves further away from the mainline/shoulder joint and starting with the cross section that is at 2 to 3-in from the mainline/shoulder joint.

This shift of stress concentration is highly oriented, as shown in Figure 171 (b) towards the free surfaces where the least constraint for displacements exists. Furthermore, in Figure 171 (b), it can be seen that the stress concentration zone reaches the top of the slab after 6-in from the mainline/shoulder joint. After a distance of 6 in from the mainline/shoulder joint, this zone remains constant and within the top 2 to 3 in of the shoulder as indicated by Figure 171 (c) that shows a cross section 24 in away from the lane-shoulder joint.

An additional conclusion based on Figure 171 (a) through (c) seems to be that the stress concentration occurs in the concrete surrounding the tie bars caused by the load transfer through the tie bars and the critical stress most likely lies at a zone that is around the top and outer edge of the shoulder. Although in Figure 171 (c), it appears that such a zone might cross the majority of the width of the shoulder, in actuality the zone will get narrower when the microcracks start to occur in the concrete around the tie bars due to the dramatic stress generated at these locations. Microcracking around the tie bars, starting with the tie bars towards the transverse joints will release some of stresses there and the stresses will be redistributed resulting in more stress at the middle of the shoulder. A cascading effect would likely result in this instance with each occurrence of microcracking at a tie bar resulting in the stress zone moving closer to the top and outer edge of the shoulder.

Based on the numerical modeling, the cracks might have initiated at the top and outer edge of the shoulder. This agrees with the field observation as mentioned in Section 7.7. It is unknown if there are any cases where this distress occurs in a shoulder that has a width greater than 2 ft. It is believed that if this distress commonly occurred in larger shoulders, it would have already been studied and documented since 5 and 10-ft shoulders are much more common than 2-ft shoulders.
