## Premature Deterioration of Jointed Plain Concrete Pavements

FINAL REPORT

Date April 2011

By (PI) Dr. J. M. Vandenbossche, P.E.  
University of Pittsburgh

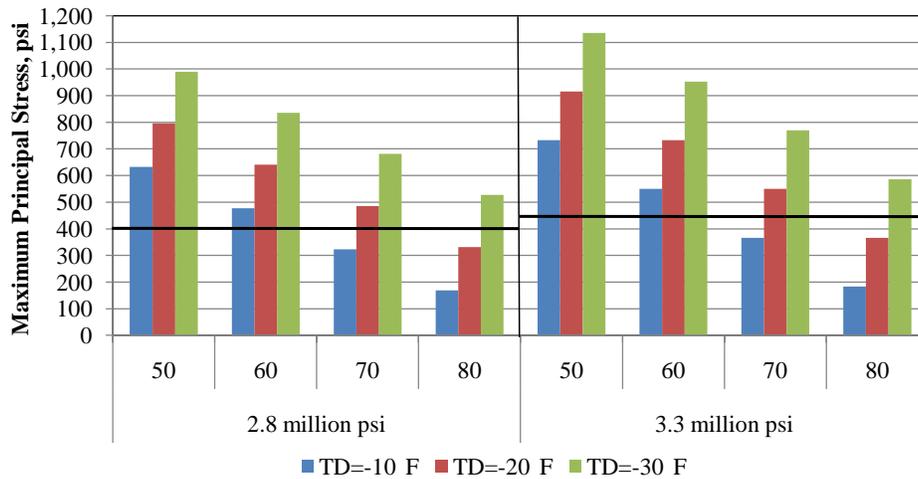
The stiffness of the concrete was only defined using the elastic modulus and Poisson’s ratio. However, by increasing the stiffness, the trigger value for flexural strength also increases. Figure 172 shows 12 different scenarios with two different stiffnesses. The stiffness of 2.8 million psi corresponds to the 1-day strength and 3.3 million psi corresponds to the 7-day strength. The stresses seen with 3.3 million psi stiffness are larger than the stresses seen with 2.8 million psi stiffness; however, the strength for the stiffer concrete is also greater. Based on the results from Figure 172, it can be concluded that the transverse cracks in the shoulder could occur at any of the first few days.

Figure 172: Influence of Concrete Stiffness and Strength on the Shoulder Transverse Cracking.

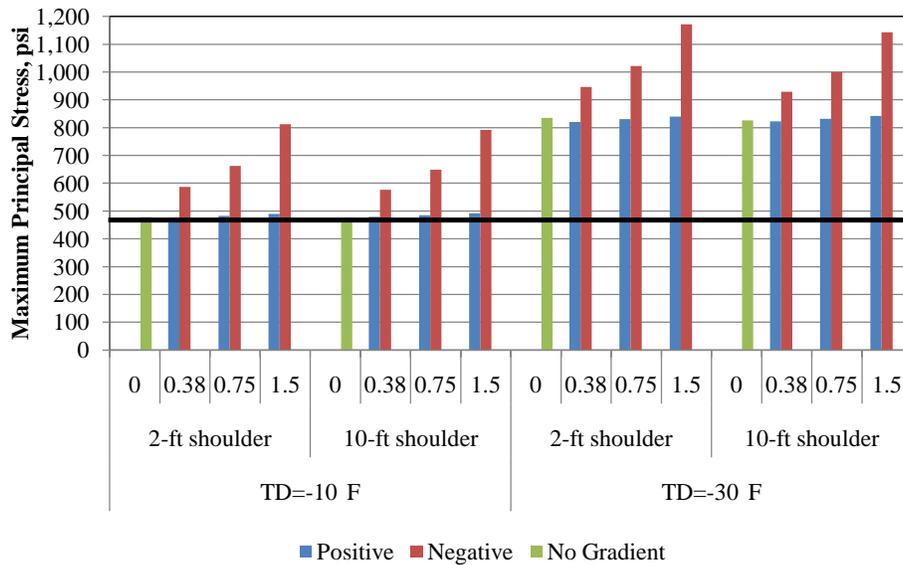
Figure 173 shows the effect of positive and negative gradients in comparison to a uniform temperature for a TD of -10°F and -30°F. In general, the critical tensile stress occurs at the bottom of the slab when a positive gradient is present and it occurs at the top of the slab when a negative gradient is present. Therefore, in Figure 173, the stresses with the negative gradients were recorded at the bottom of the slab and the stresses with the positive gradients were recorded at the top of the slab. When there is no gradient present, the critical stress location is at the top of the slab.

As shown in Figure 173, a positive gradient does not have an effect on the magnitude of stress when compared to a situation with no gradient. If there is a negative gradient present in the slab, the stresses at the top of the slab are magnified, even for the smallest gradient of -0.38 °F/in.

Figure 173: Effect of Gradients When  $T_S = 110$  °F in the Shoulder Transverse Cracking Model
