# STRUCTURAL EVALUATION OF SLAB REHABILITATION BY THE METHOD OF HYDRODEMOLITION AND LATEX MODIFIED OVERLAY

FINAL REPORT

December 2013

Kent A Harries, PhD, FACI, PEng  
Matthew McCabe, BSCE  
Michael Sweriduk, BSCE  
University of Pittsburgh

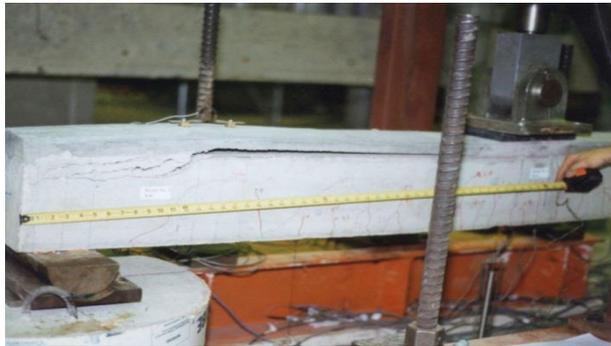
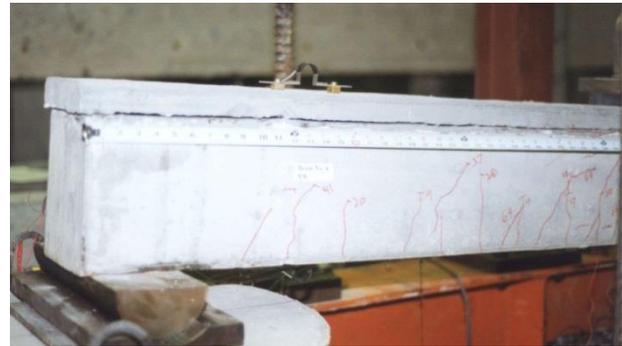
Figure 3: Examples of bond failure of overlays subject to positive bending (Cole et al. 2002).

a) 'buckling' failure of overlay in compression

b) 'slip' failure of overlay characterized by relative movement at the ends of the test slab

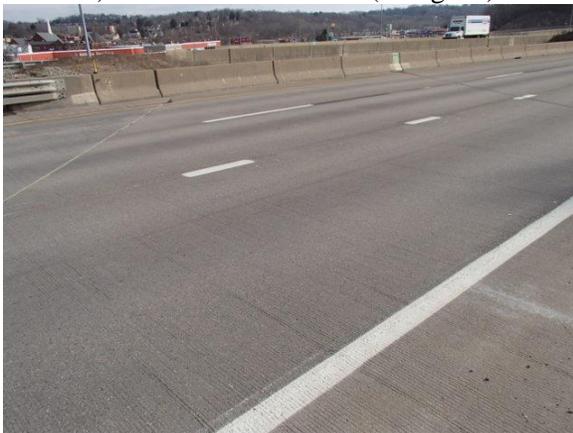
c) LMC overlaid deck of Bridge C  
(photo taken 1.14.13)

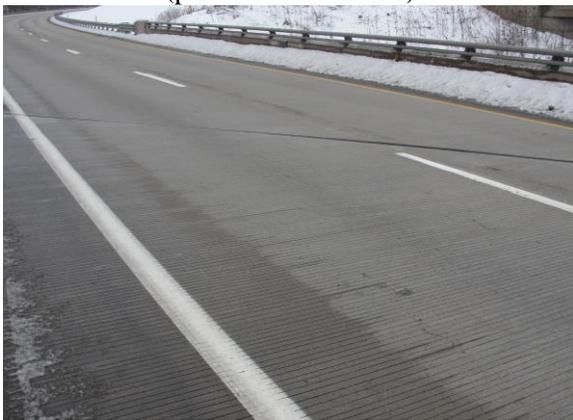
e) LMC overlaid deck of Bridge E

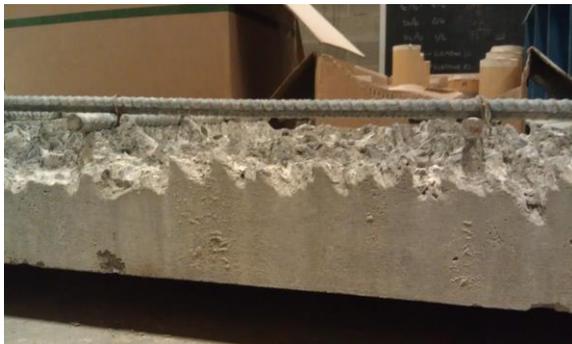
c) "shadows" removed

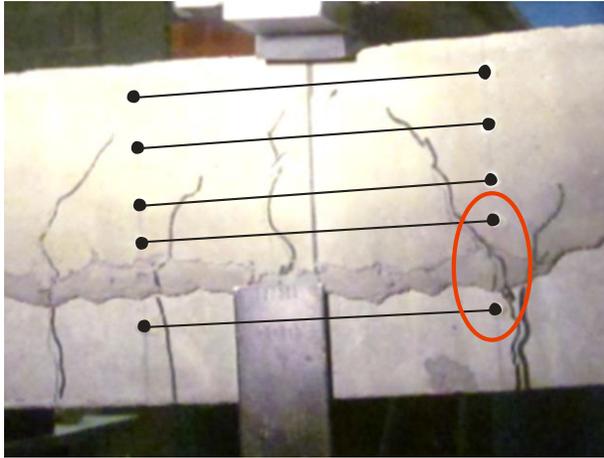
Figure 18: Example of the effect of crack location on strain profiles (Slab AAA shown).

DEMEC gages report the *average strain* over their 8 in. (203 mm) gage length. It is expected that multiple cracks will intersect the gage length and the strain reading is therefore essentially the sum of the crack widths since concrete strain between cracks is negligible. In cases were a crack passes from outside the gage length to inside the gage length between gages – as shown in the circled region of Figure 18a – the DEMEC reading between adjacent gages is affected as shown in Figure 18b. In the case shown in Figure 18, three cracks are included in the top four gages. The right-most crack passes outside the gage at

the bottom DEMEC gage; the associated crack width (strain) is therefore not captured in the reading and the apparent bottom strain falls. In this case, the curvature is calculated over the linear section from the top gage to the fourth gage.

a) crack pattern on Slab AAA (gages enhanced)

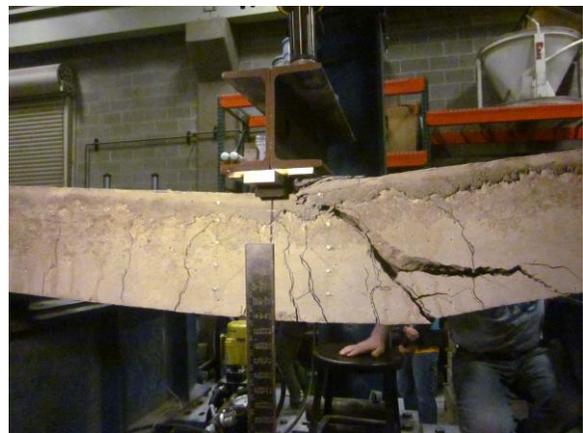
Figure 20: Slab B results.

f) ultimate load (68.9 kipft)

Slab B, having the thinnest overlay and some evidence of overlay separation in the final failure (see Figure 20f), was selected for further investigation. Additional pull-off tests were conducted to determine pull-off strength along the span of the slab: from the undamaged support region to the heavily damaged midspan. Figure 36a shows the location of each test on the slab. In the figure, the first number listed is the test number, and the number in parentheses is the pull-off strength in psi (average values are reported for the 7-day tests and tests 10-12; see Appendix B for complete test data). Figure 36b plots the pull-off strengths for tests 10-20 versus their location along the span. Clearly, the pull-off strength decreases as the test locations approach the heavily damaged midspan region. Nonetheless, the poor pull-off results near midspan tend to be Mode S failures (Figure 36b), indicating that the damage is concentrating below the interface in the substrate corresponding with the location of the neutral axis (see Figure 20c). While these results indicate that the interface region has been damaged as a result of the compression failure of the slab, the damage is not preferentially located along the interface. This behavior is in contrast to that has been observed by Cole et al. (2002), shown in Figure 3. Finally, it is noted, that the applied load to cause failure of Slab B was approximately 2.6 times that of the STRENGTH I design requirement.

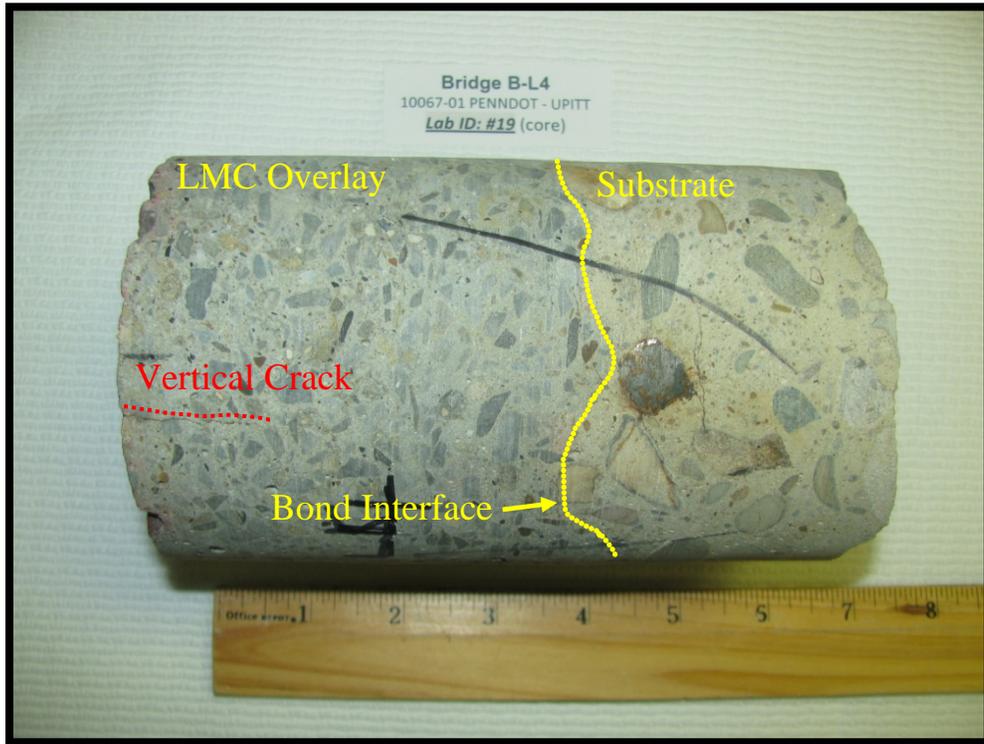
Photograph 1: SR28 (Bridge B) – L4 - Core

The cores that did not break during extraction (cores B-L4 and F-L4) also exhibited substantial rebar diameter losses. The core (B-L4) shown in Figure 3 exhibited horizontal cracking at the rebar level due to corrosion. Since the rebar in core B-L4 was located in the original chloride contaminated concrete (as opposed to overlay concrete with possibly less chloride contamination), continued corrosion of the rebar will occur and lead to delamination and spalling.

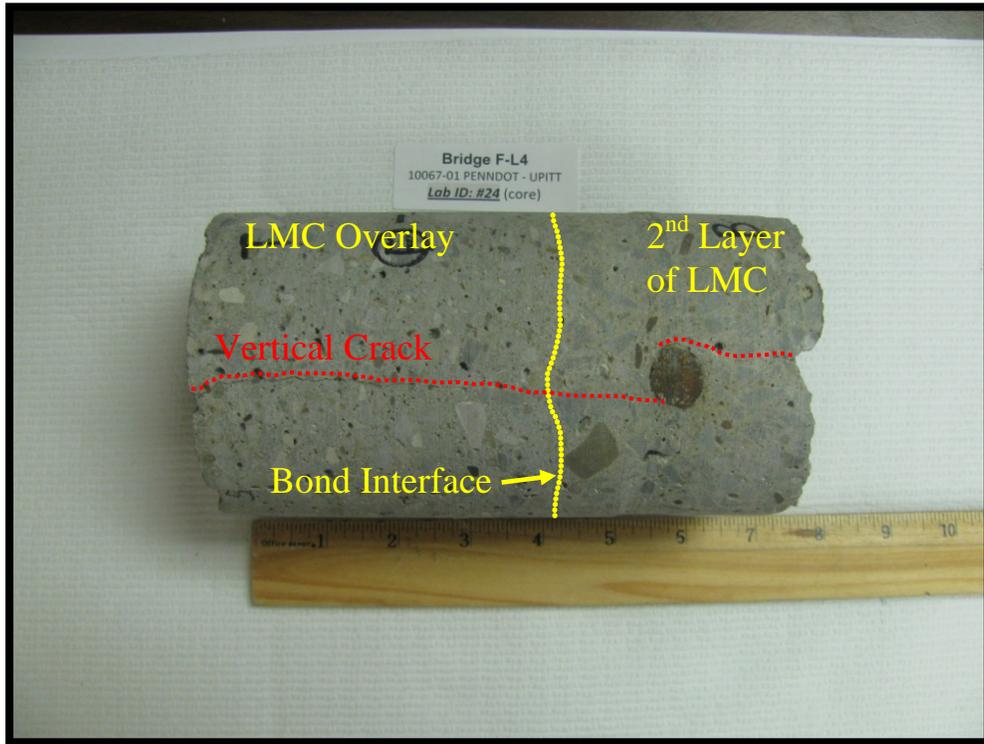
Photograph 1: SR837 (Bridge F) – L4 - Core

The entire core F-L4 (6.8" long) had only overlay material. No original concrete was a part of this core. The rebar from core F-L4 was centered along a vertical crack. Though the vertical crack extended past the rebar, the core was extracted without any horizontal cracking at the rebar level. This indicates that the crack may be structural in nature and that it allowed for corrosion product expansion without delamination. Even though the rebar had a significant section loss (25%), the core was extracted intact. This is due to the fact that corrosion product present on the rebar prior to overlay placement was removed during repairs/overlay placement.
