### Longitudinal Joint Repair – Mill & Fill vs. Microsurfacing PennDOT District 11 – Lawrence County

# MICROSURFACING VS. MILL & RESURFACE JOINT REPAIRS

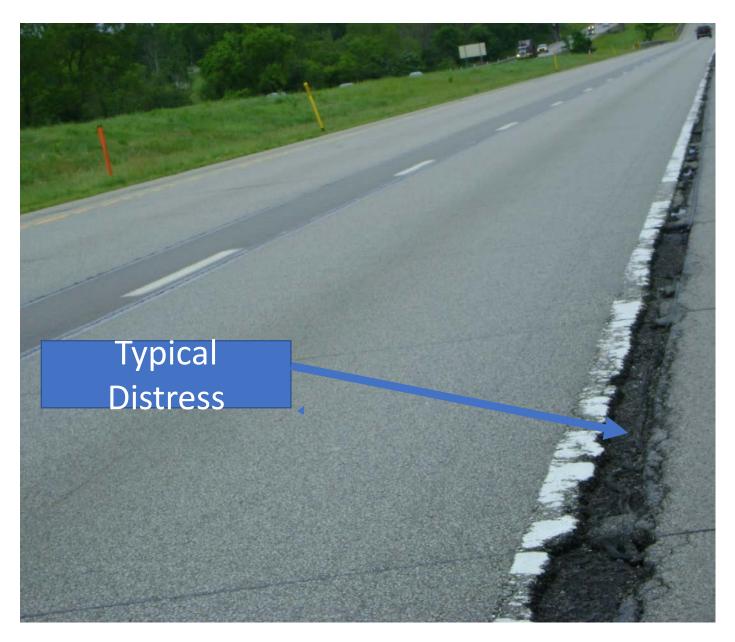
At \$2.39/LF, the Microsurfacing only cost about 25 percent of the traditional Mill & Fill method and only took 60 percent of the number of working days. Another advantage to Microsurfacing is that there are no joints to seal and maintain while the M&F results in two joints and both are close to the wheel path. Since both treatments are relatively new, their durability will need to be compared as time goes on.
