Pine Creek Lenticular Truss Bridge

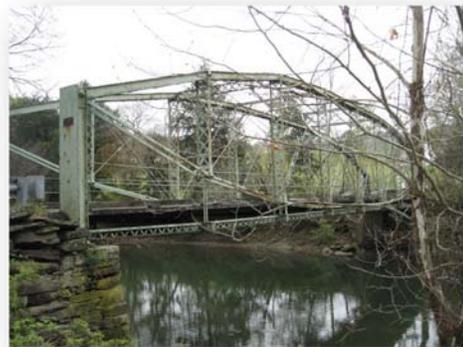
Lenticular Truss Before Rehabilitation

As with many other metal trusses, however, deterioration over time, inadvertent damage caused by poor structural repairs, and inadequate historical engineering all eventually required PennDOT to take action on the Pine Creek Lenticular Bridge. In the face of all of these issues, it would be reasonable to ask why PennDOT elected to repair the bridge at all. The answer is two-fold. On one hand, it is a truly significant and extremely rare historic resource that PennDOT understood should be retained in service if possible. In addition, the immediate area around the bridge was archaeologically sensitive. Archaeological investigations are often labor-intensive and costly.

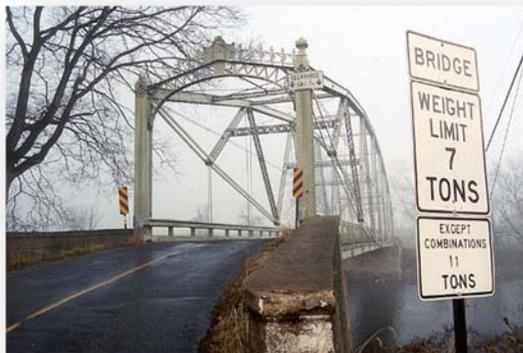
After the rehab!

PennDOT made many repairs and improvements to the structure. As part of the project the bridge was improved to meet legal loads and the approaches were modified to improve safety. However, some of the most severe damage to the structure was caused by inappropriate repairs during the 1960s, when the bearings were encased in concrete. Since bearings allow the structure to expand and contract, encasing them in concrete prevented that movement and ultimately caused the bottom chord to buckle. Theoretically, to fix the problem it could have been possible to heat straighten the chord, and thereby retain the original material. Iron from the 1800s, however, is often of uncertain quality—no regulations existed, and strength, quality, and even chemical composition can vary widely—and heat straightening in that situation can have a detrimental effect. As a result, the Department elected to augment or replace damaged members with high-strength steel and the Pine Creek Lenticular Truss stands at its original location today, still serving Lycoming County as it has for 125 years.
