## The GUIDE-ing LITE Fox Township, Elk County

### Problem/Challenge Addressed

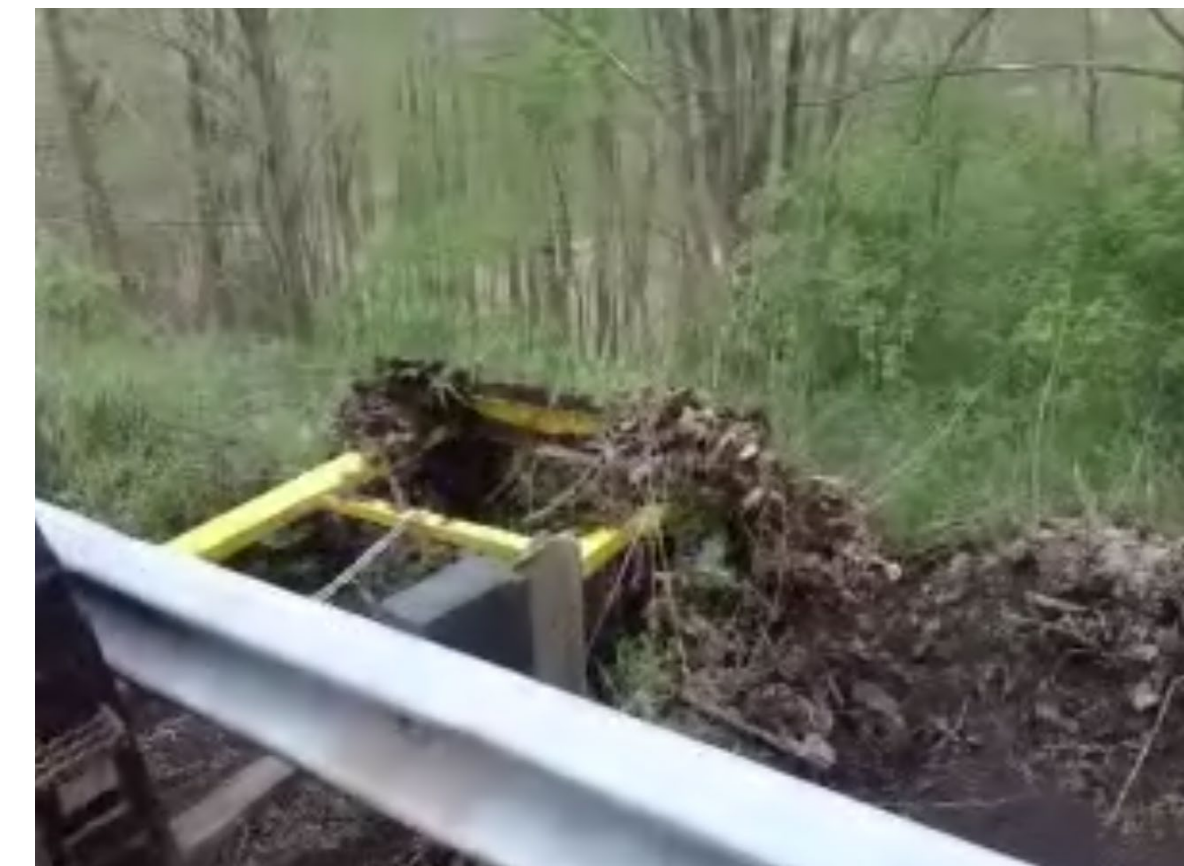
A task that used to take five people and a backhoe all day can now be done with the same five people but in only two hours. Plus, this reduces chances of injury.
