# POR-15 Rust Preventative Applied to Truck Frame Rails

PennDOT District 5 – Lehigh County

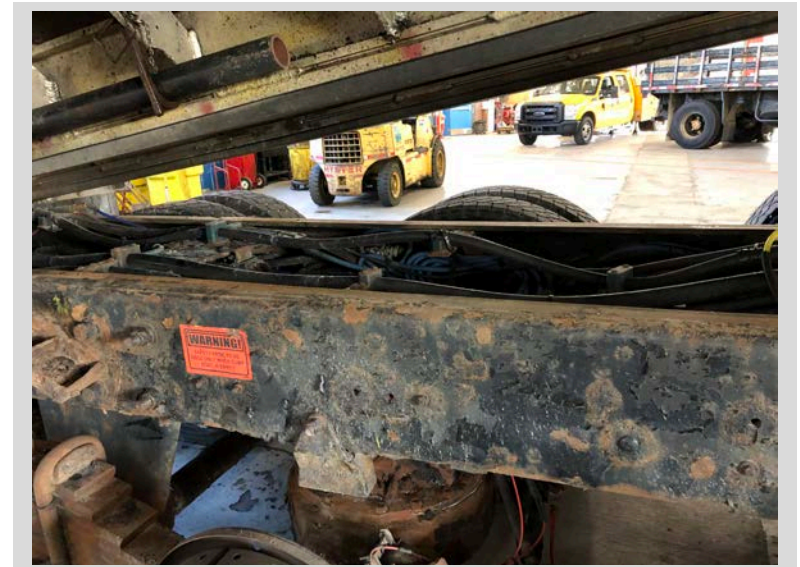
Due to not having a wash facility in our county, trucks were washed on a limited schedule causing frame rails to rust. Trucks had to be taken to another county (closest is approximately 25 miles away) to wash or spend approximately \$135 per truck at a local commercial truck wash facility.
