# STRATEGIC RECYCLING PROGRAM FACT SHEET

Original Date: FY 2005  
Updated: FY 2020

*Project:*  
**Plasphalt™**

*Site Locations:*  
**PennDOT District 5-0  
Wilson Borough**

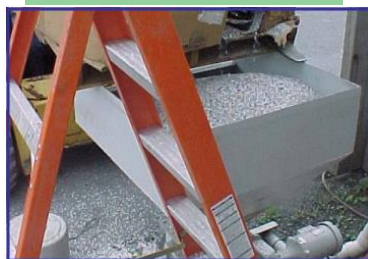
TRPA Material being  
added to the Hot Mix  
Asphalt

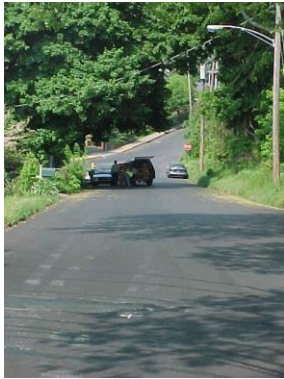
Post-construction view of the Jefferson Street Project, from the eastern boundary facing west

During the first-year evaluation, six random core samples were taken along Jefferson Street. Three samples were collected in the Superpave Plasphalt™ wearing section and three in the control paving section. Of the six samples only one sample from the control section passed the minimum 92% theoretical density requirement.

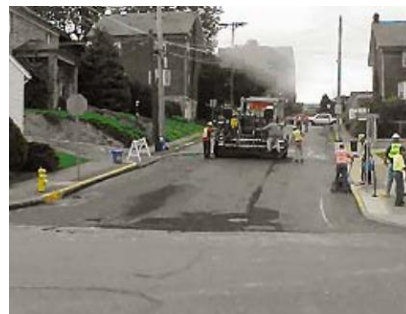
View of the 21<sup>st</sup> Street Project during construction

This Project location is characterized with a very steep grade and significant non-standard rutting. Due to limited length, control sections were not installed for this Project.

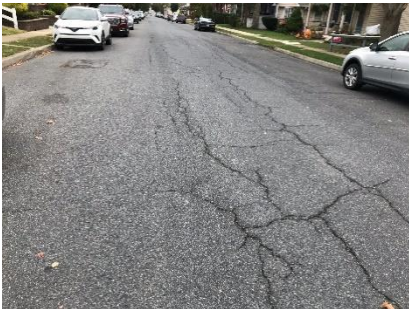
In 2019, the SRP performed a follow-up on the performance of these Projects. Upon inspection of the roadways, the material appeared to be performing fair with evidence of longitudinal cracking.

View of longitudinal cracking observed at the Hay Terrace Project

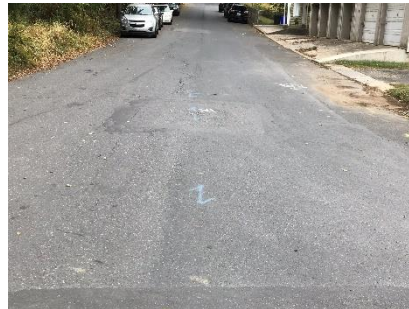
View of both the control and experimental sections of the western boundary of the Jefferson Street Project

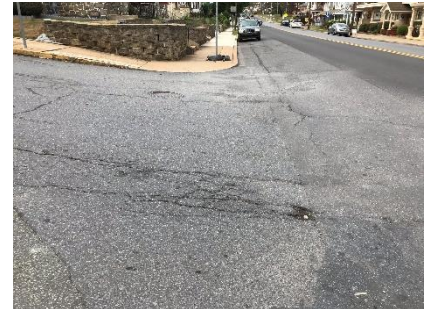
In 2008, the final performance evaluation was completed for this Project, the results yielded minimal rutting and a circular rut formation in the southbound traffic. The five-year evaluation at this location of steep grade and higher observed truck traffic was considered encouraging in terms of potential rut-resistance performance.

View of cracking and potholes observed along the northern boundary of the 21<sup>st</sup> Street Project
