Liberty Bridge Incident

QAW February 2018
Tom Macioce, P.E.
Chief Bridge Engineer
PennDOT

Liberty Bridge Fire – 9-2-2016

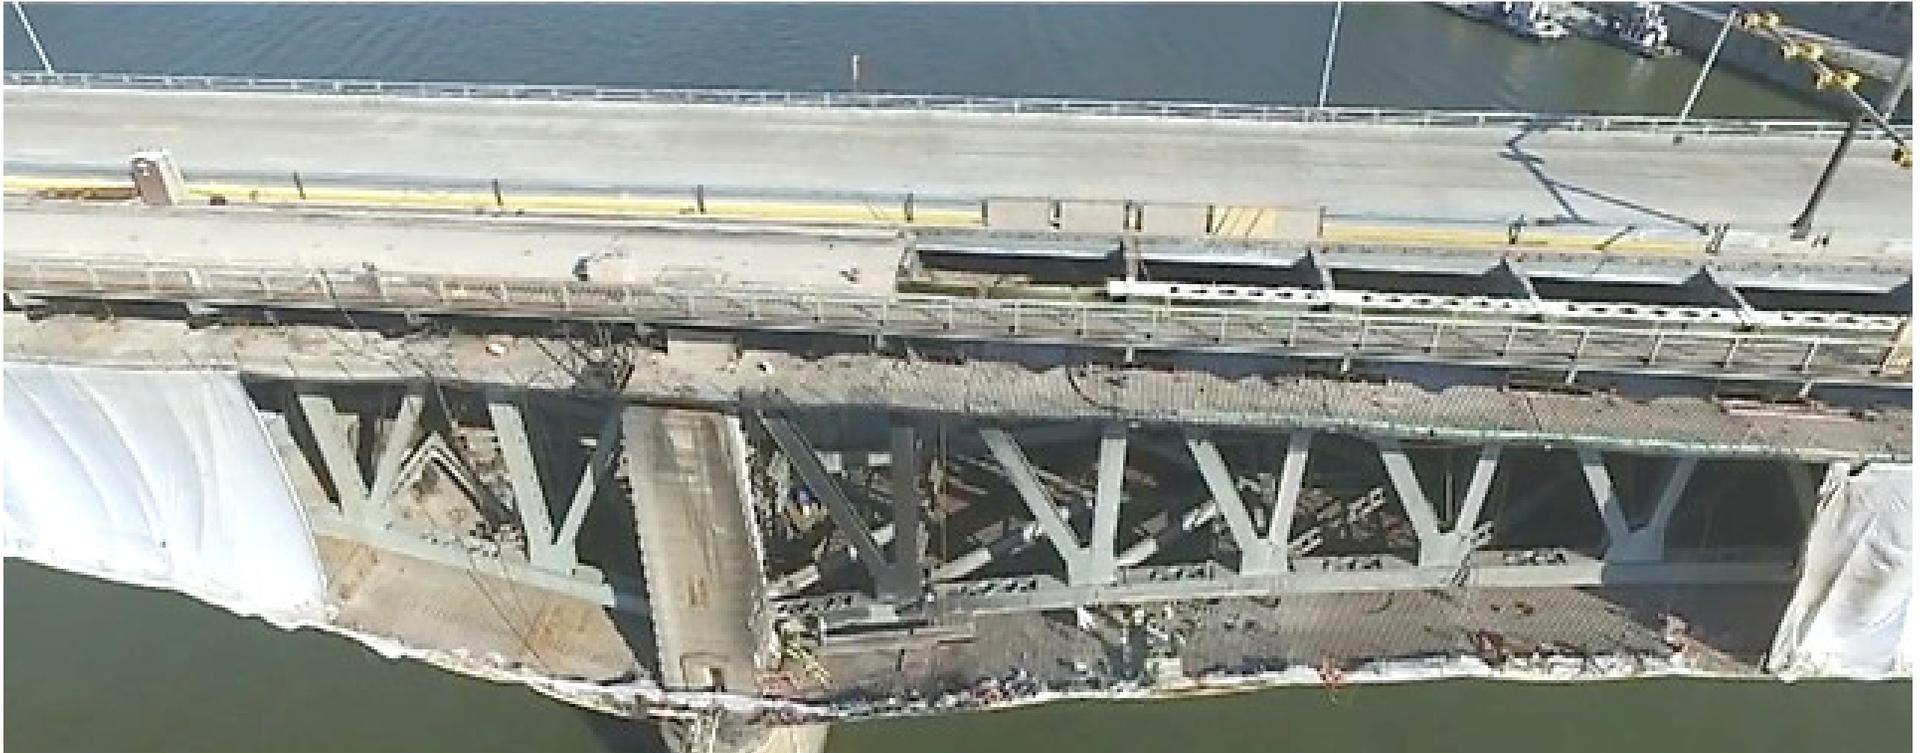
The fire was extinguished by the City of Pittsburgh Fire Department within a half hour of their arrival. There were no injuries reported.

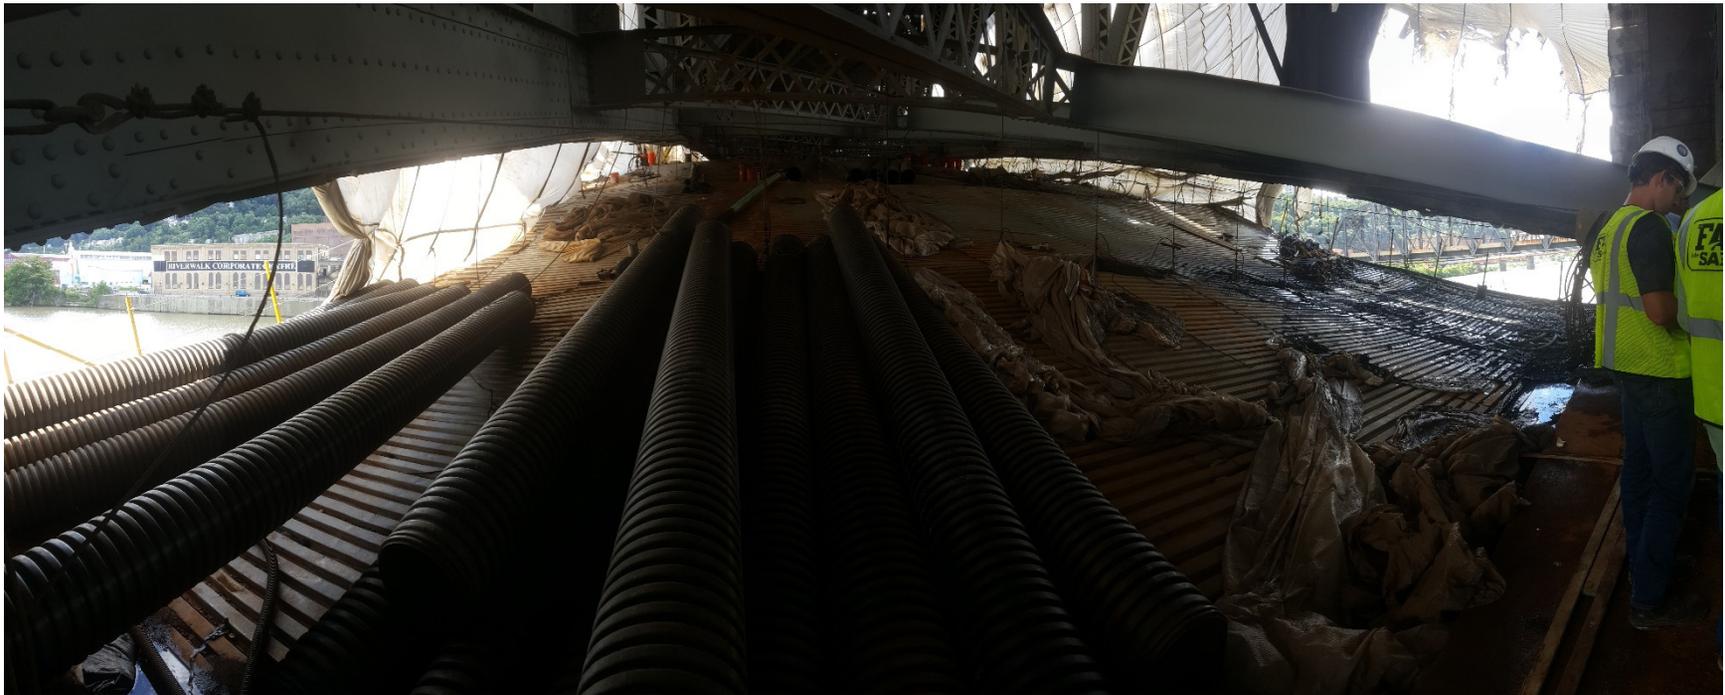
▶ Fire Damage to L31L32 West Truss

- 30' primary member compression chord L31L32 severally damaged.
- Local lateral buckling shortened the beam (by ~2" and bent in the lateral direction by 6 ¾"), load shedding to other members of the bridge.

- Note:
 - Sagging of lacing channels
 - Crippled flanges

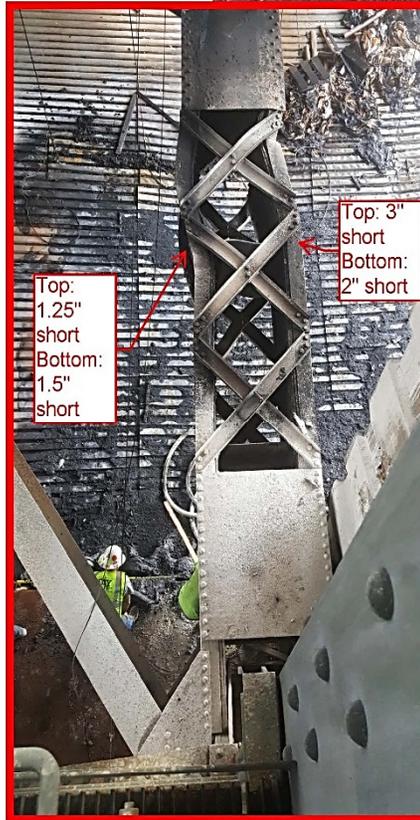
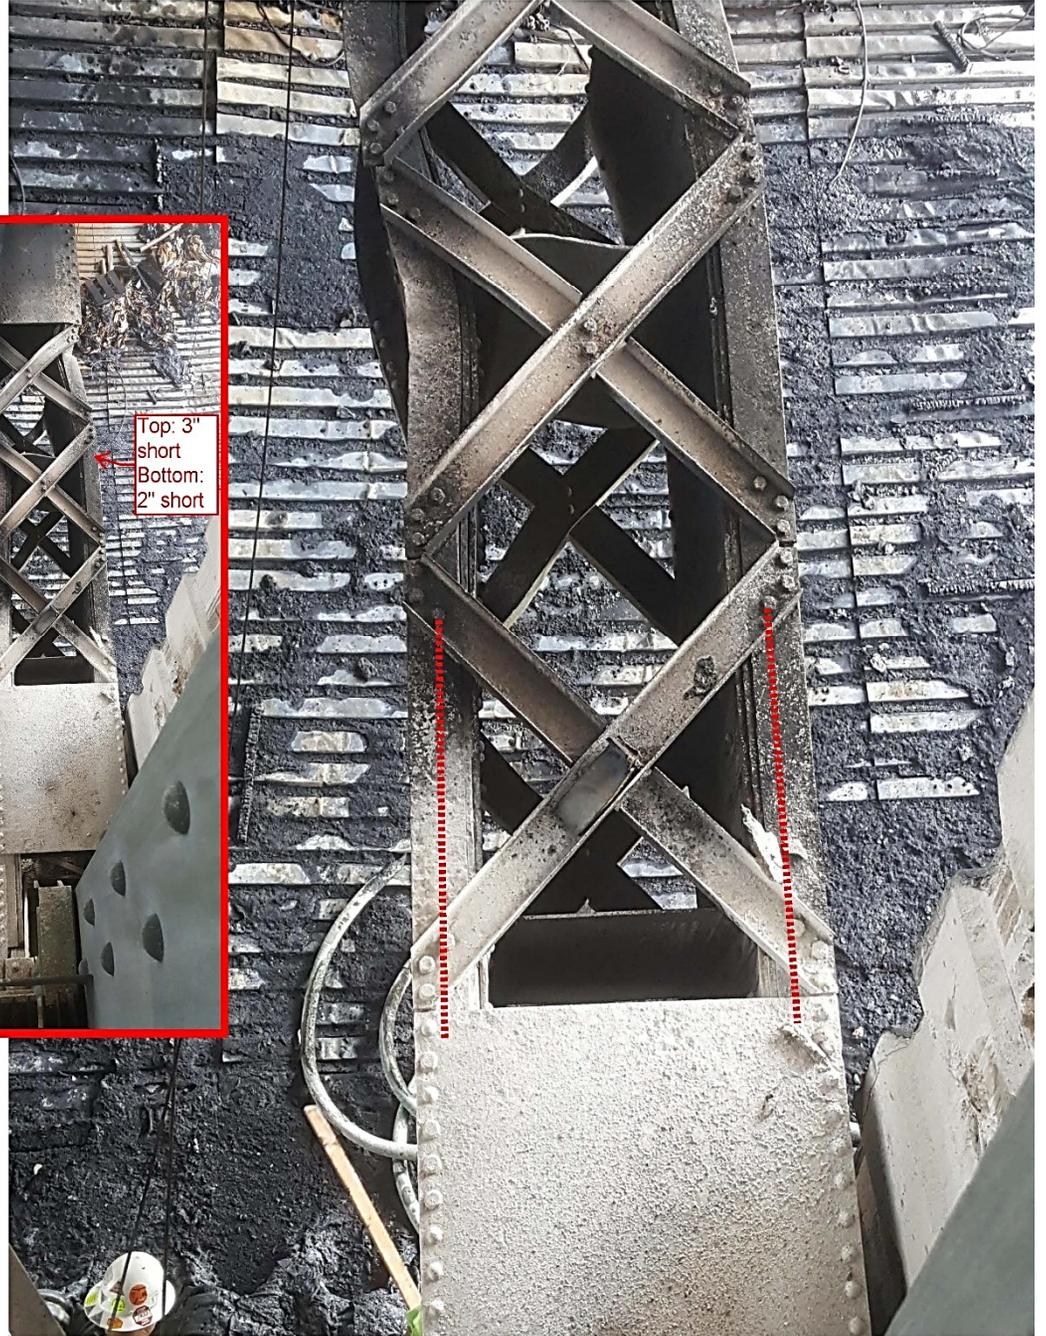
Top: 1.25" short
Bottom: 1.5" short

Top: 3" short
Bottom: 2" short

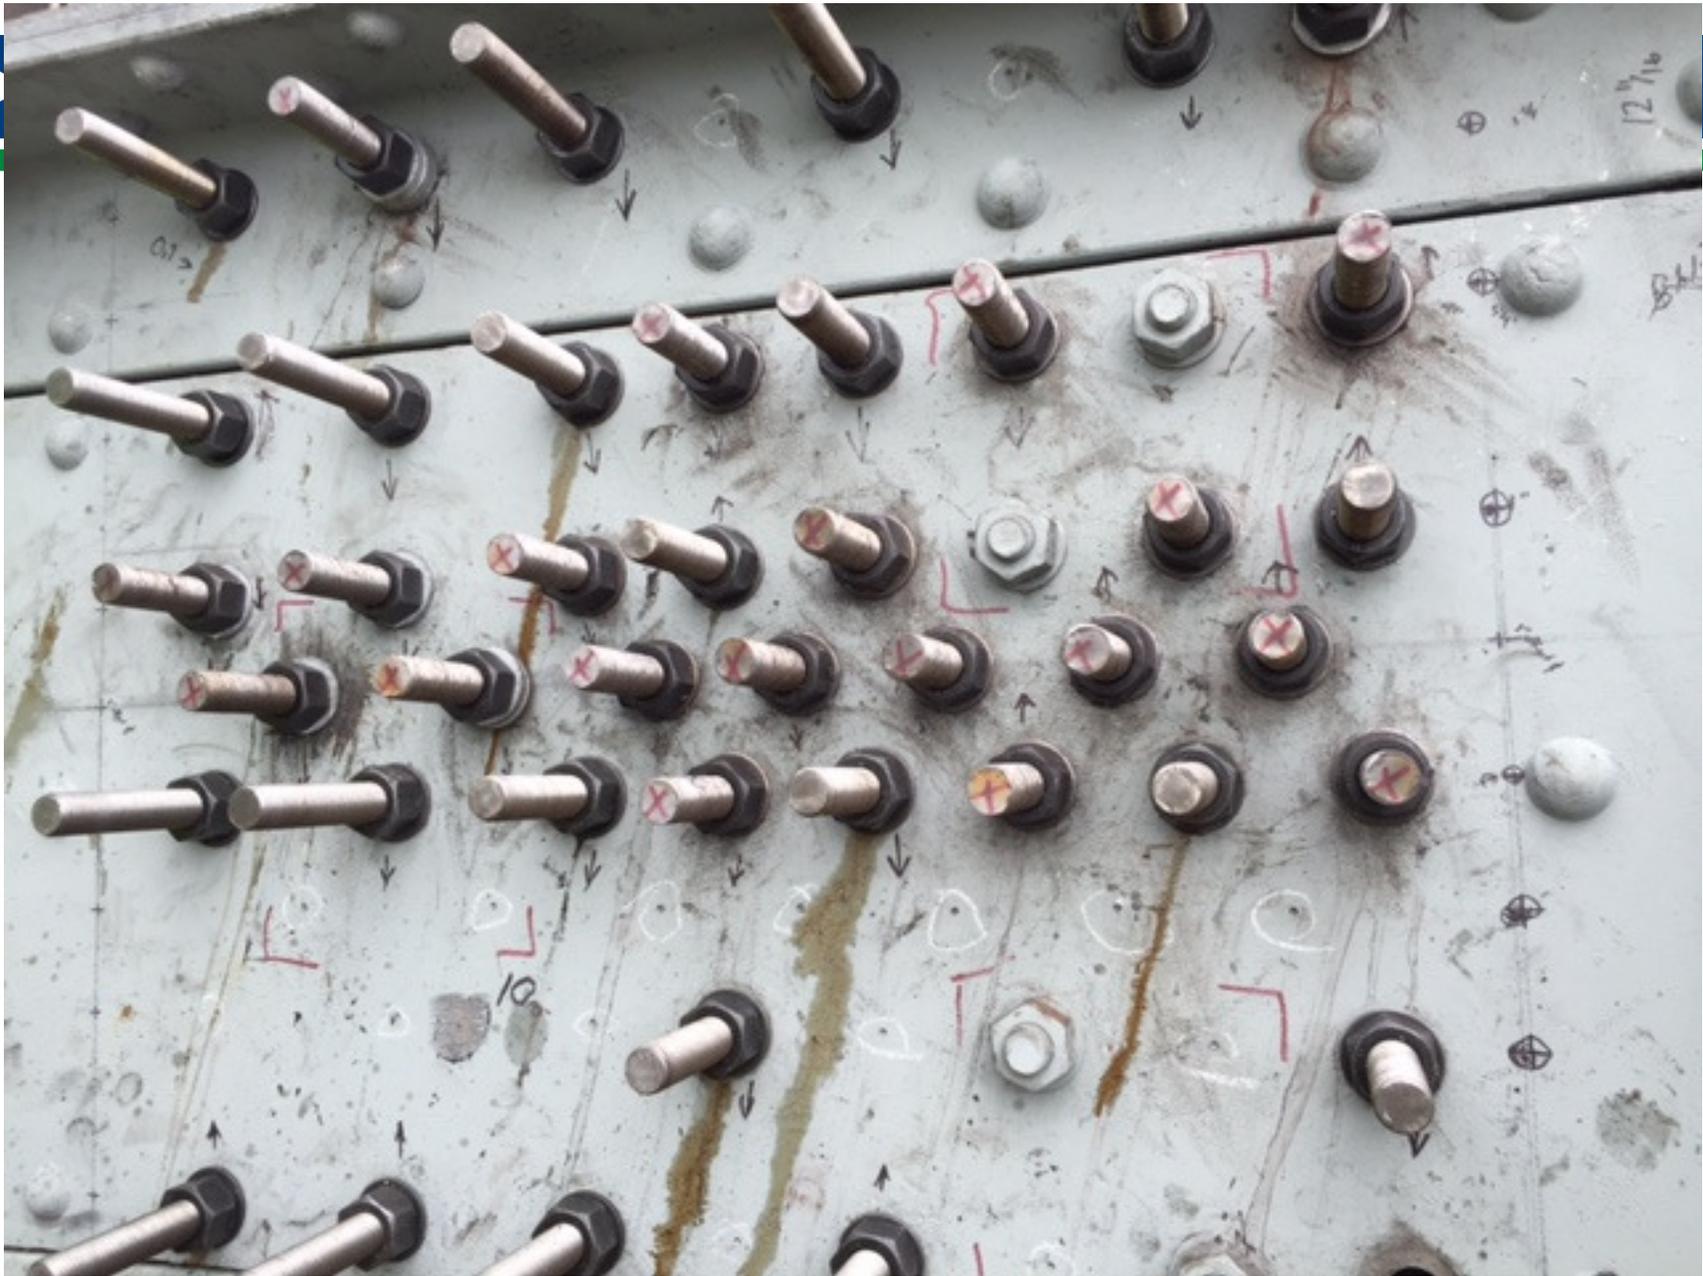
Rivet removal

- Repairs began on Sunday night, September 4th by removing rivets and replacing them with temporary A325 bolts.
- 200 Bolts were replaced, 4 at a time, 1 in each corner of the damaged lower chord.

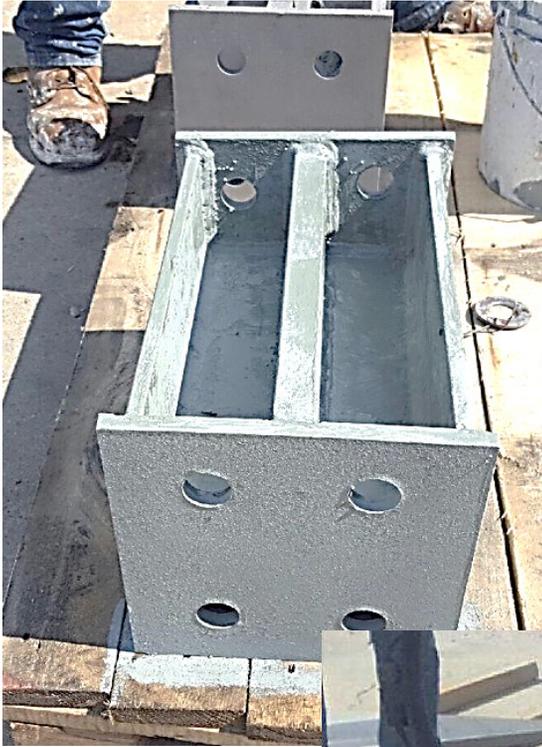
A490s Bolt ROCAP Testing
Bolt issues – procurement,
cracks, testing

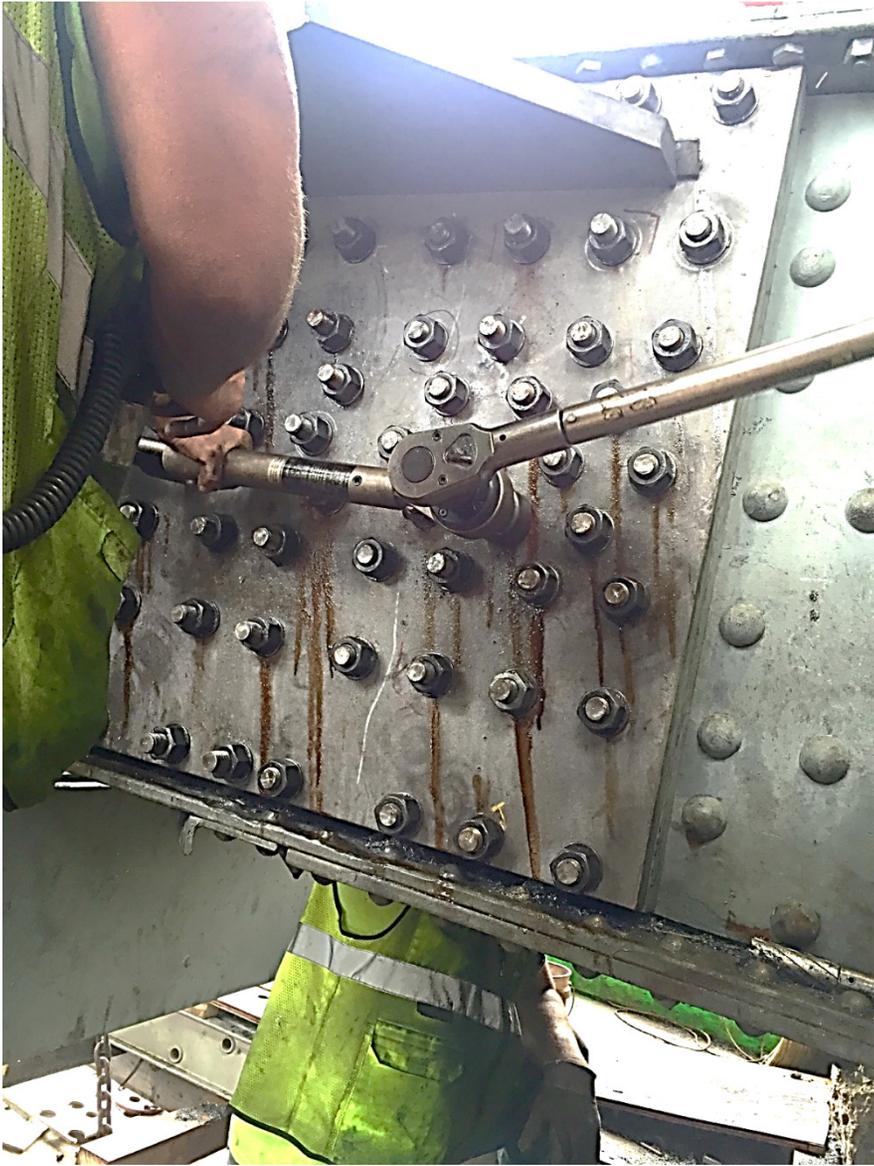
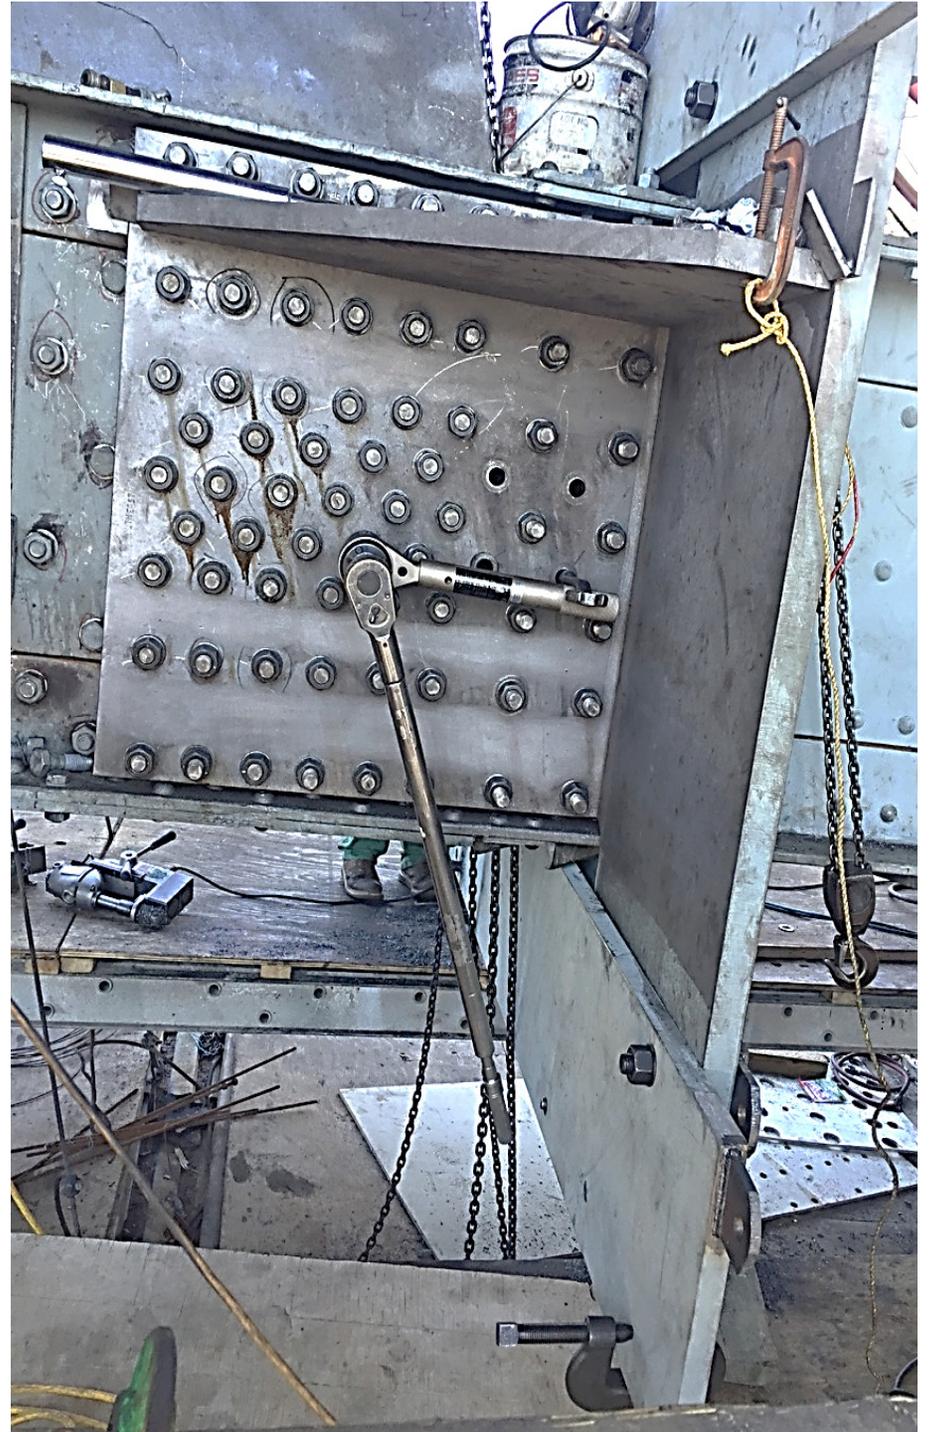
Jacking assembly continue – torque verification of bolts at bottom plate, L31 and L32

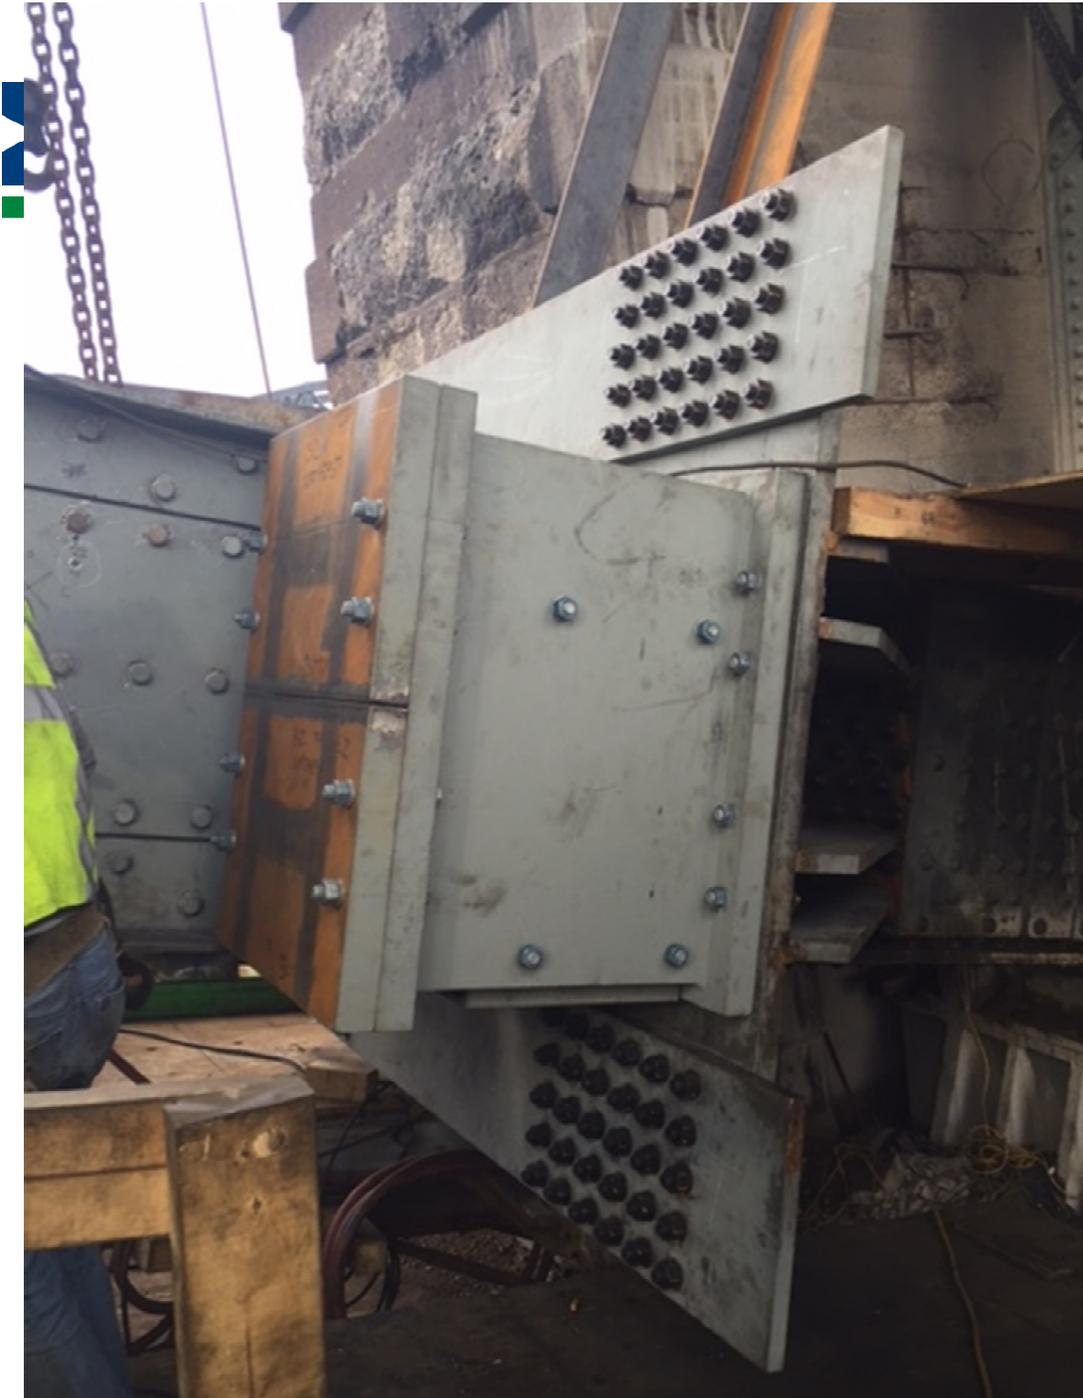
- Jacking box
- 4 – 565 T Jacks

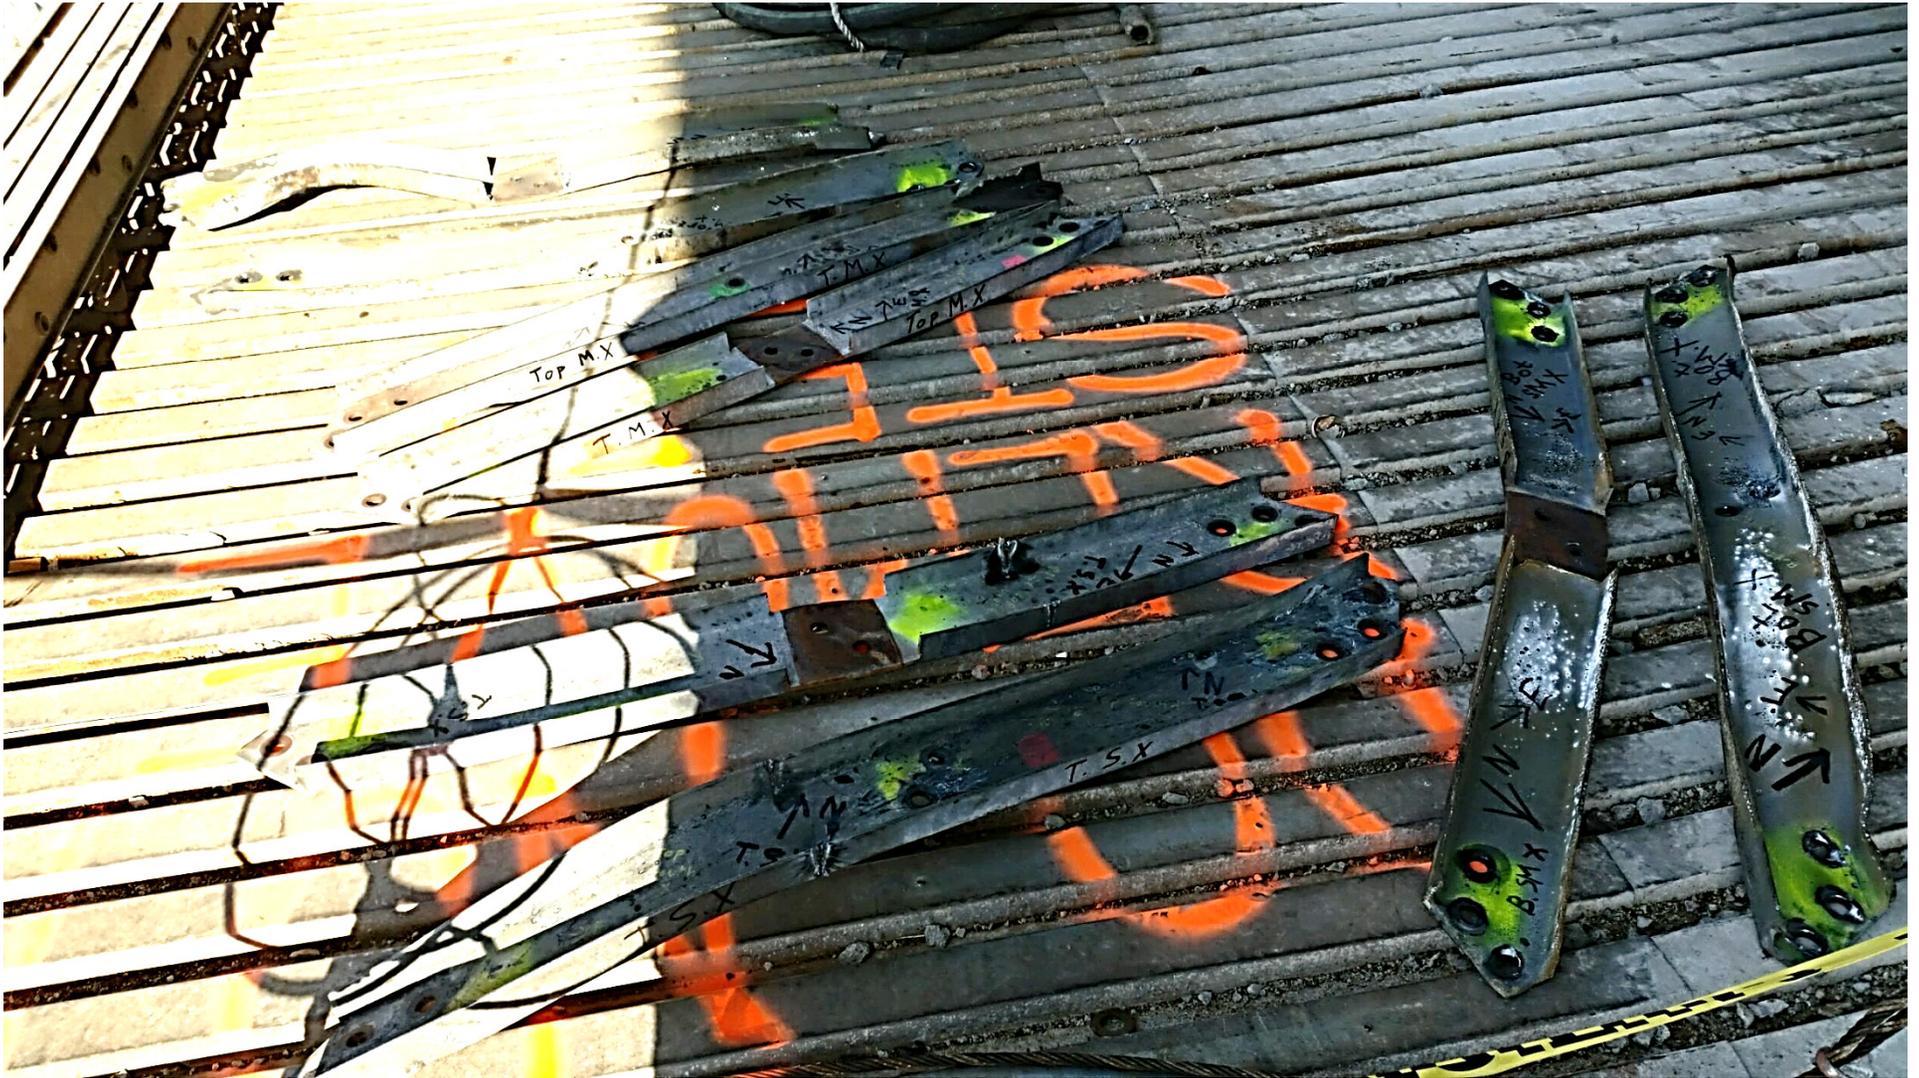
Damaged Diaphragms

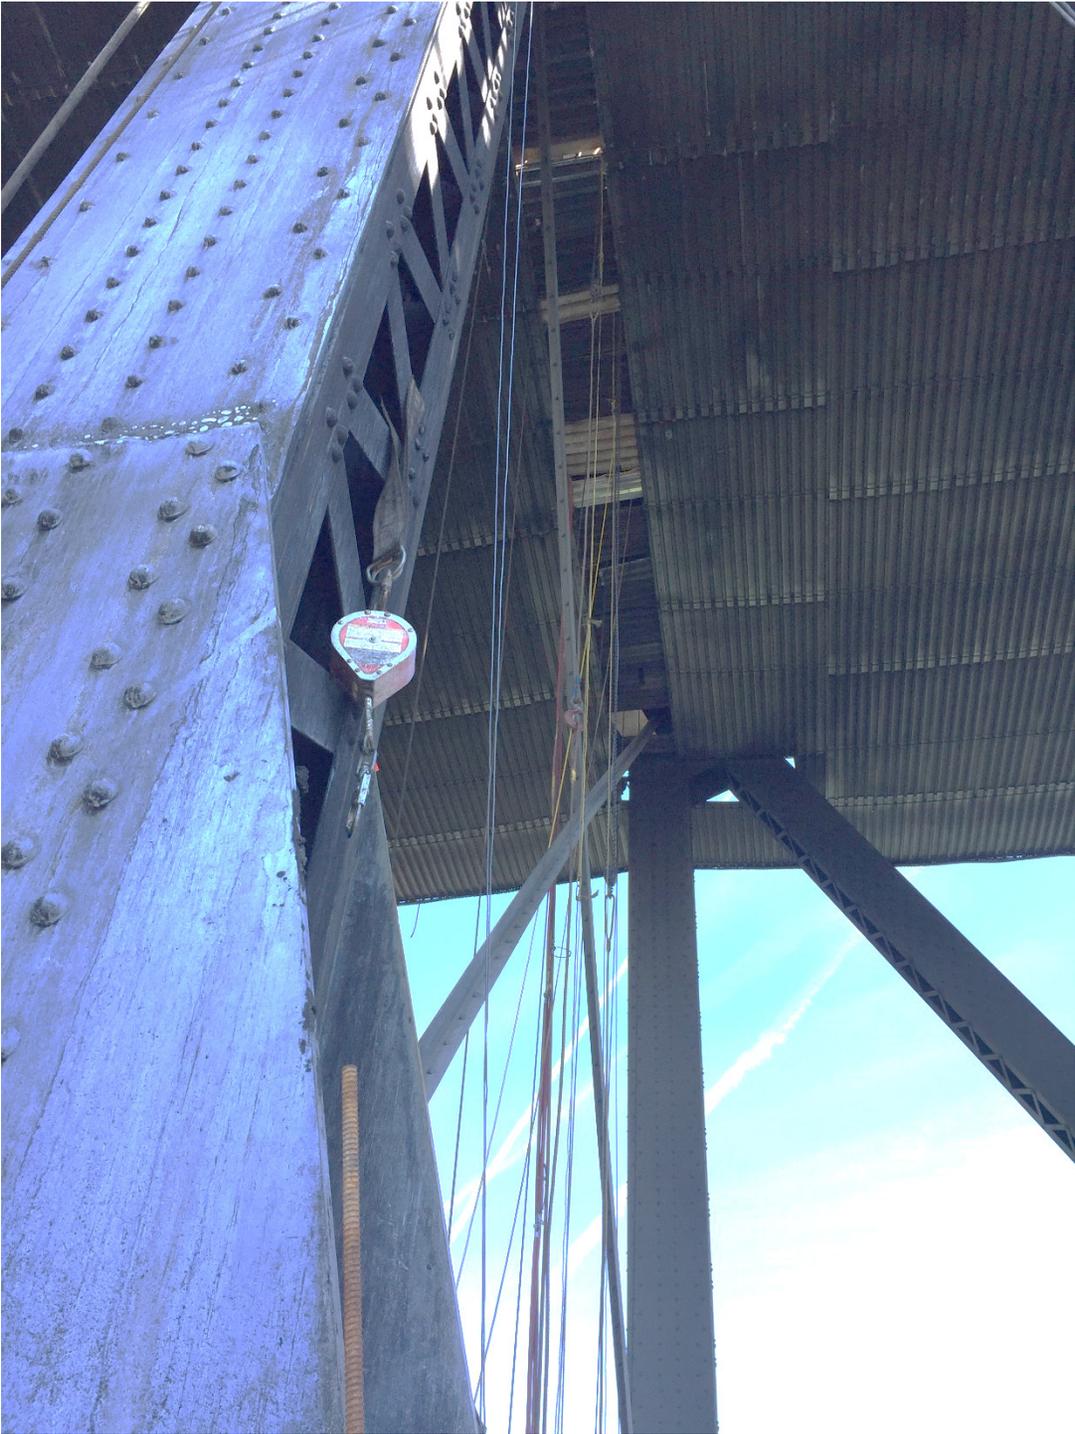
Cross bracing
starting to
straighten

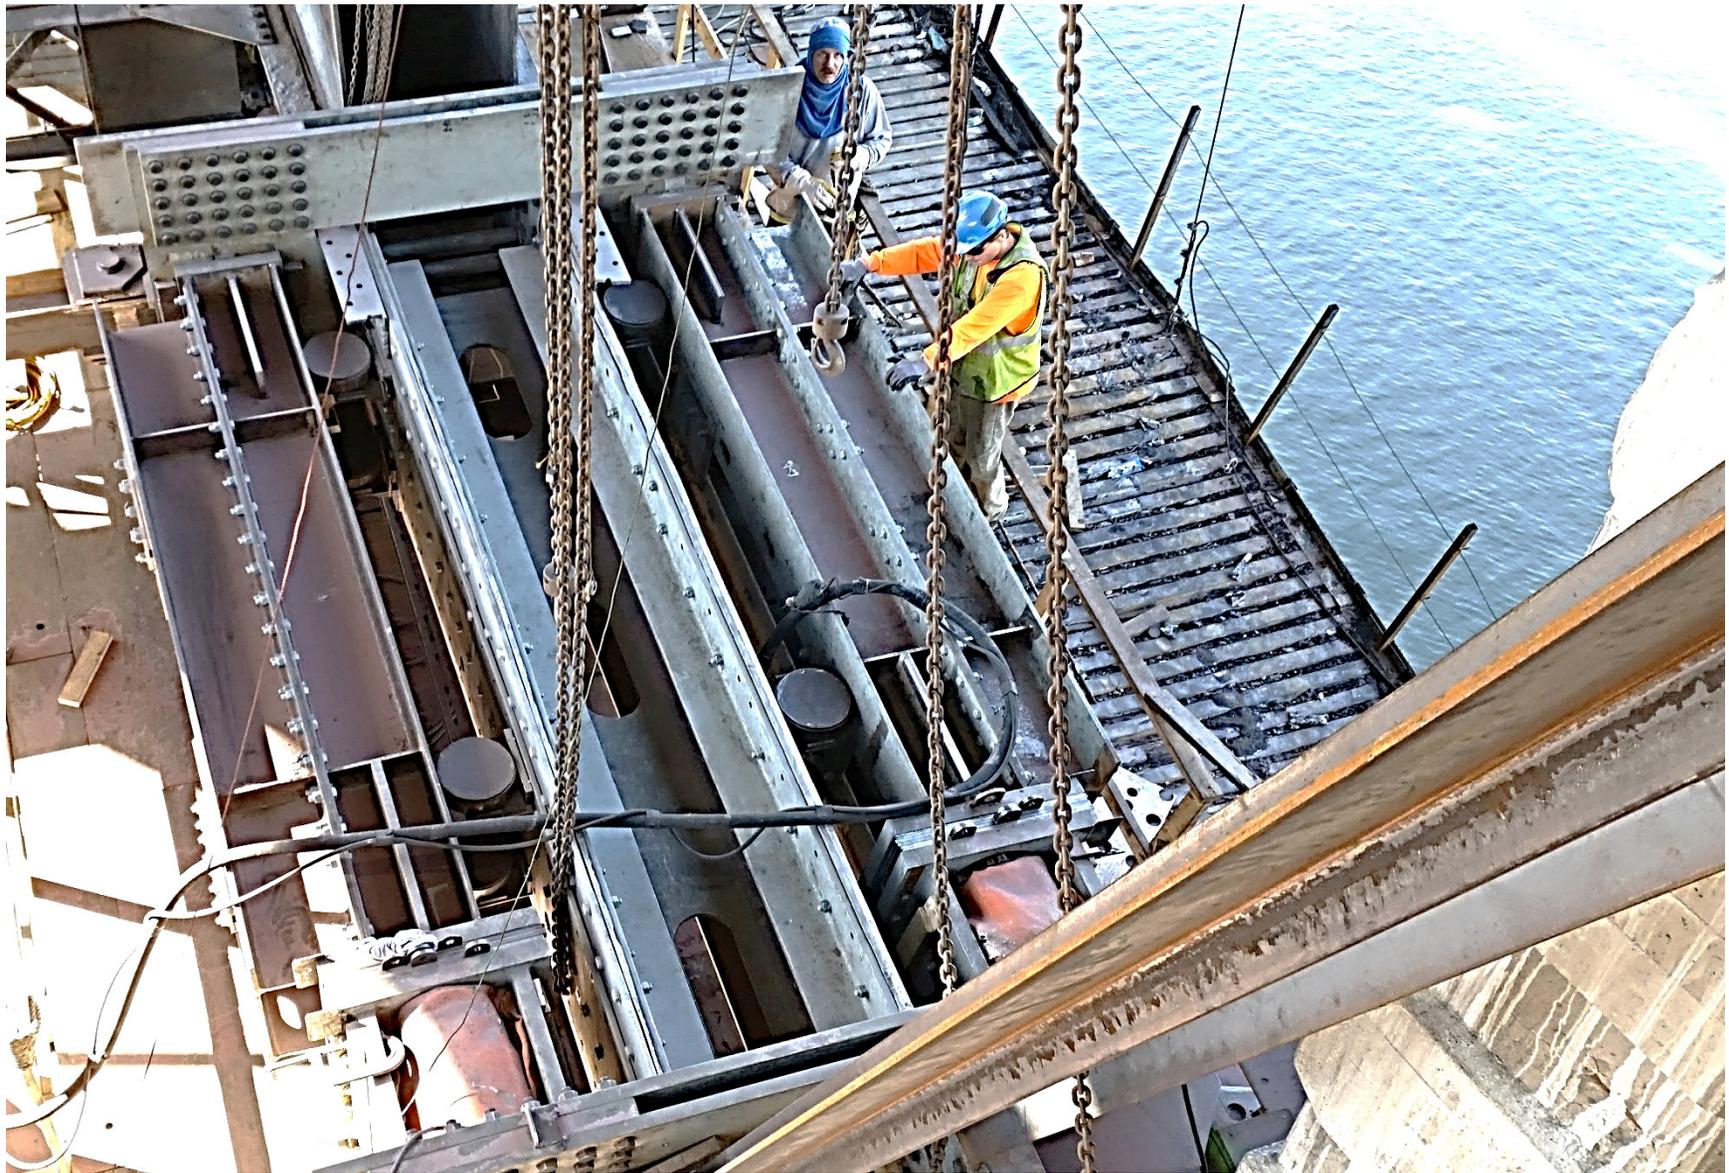
Post Jacking – Restored Displacement of 1.63"

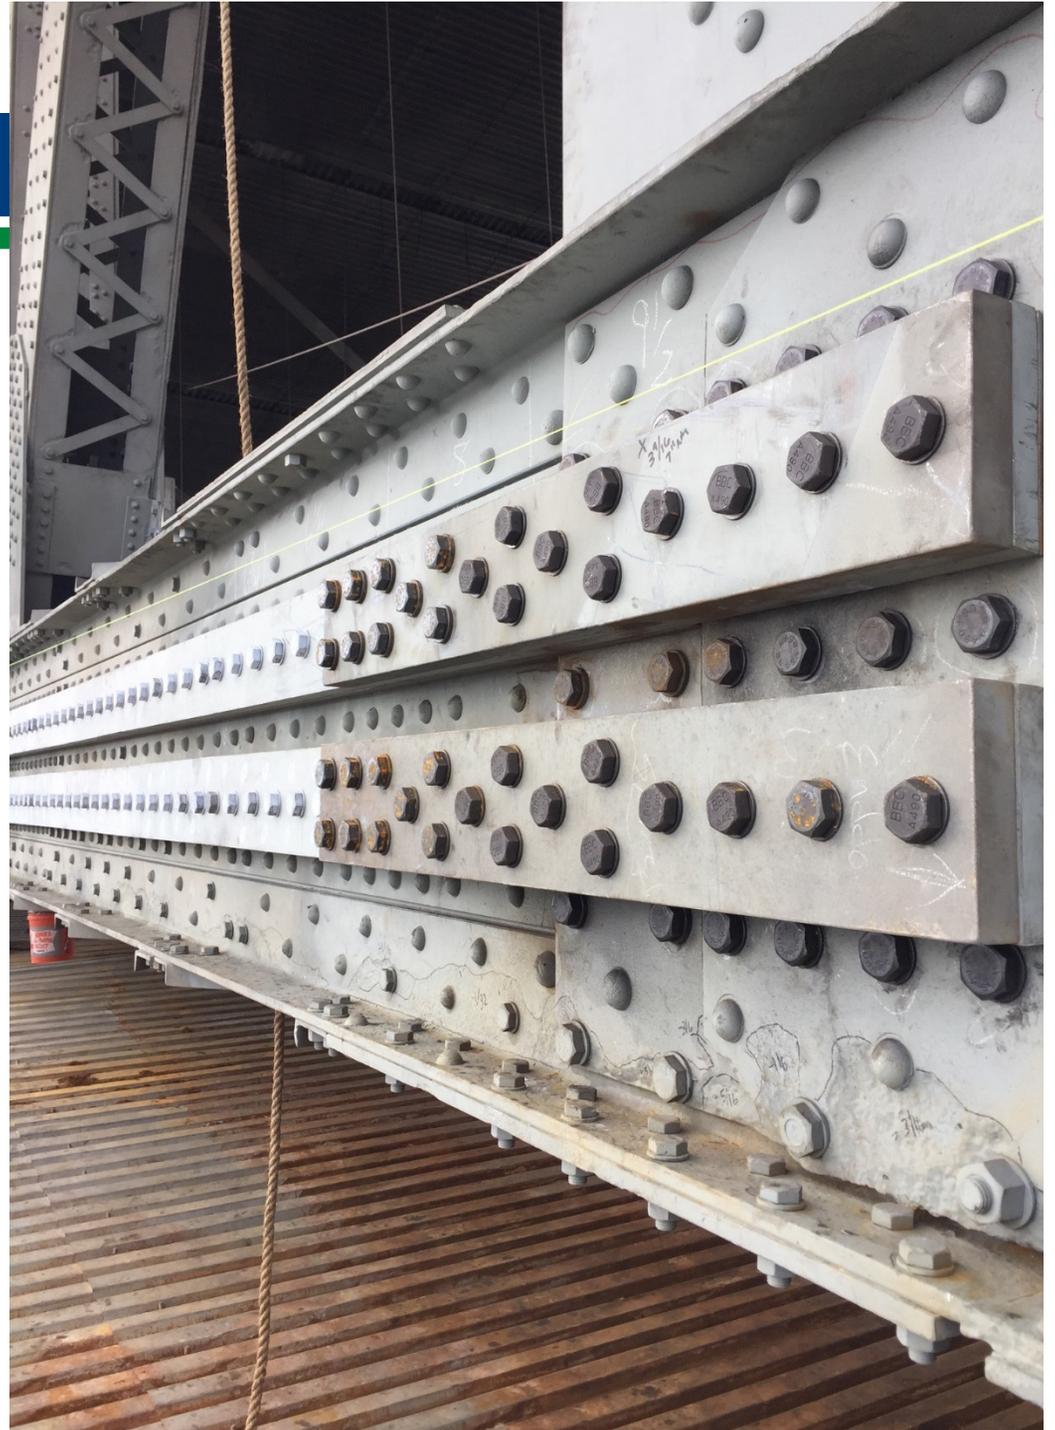
- L29L30 strengthening from 9 ton to 30 ton
- 98 square inches of steel added to East Truss member L29L30
- 30 Ton Weight Limit Restored on 9/29/16

Post Jacking Work
