Deterioration of J-Bar Reinforcement in Abutments and Piers

FINAL REPORT

Kent A Harries, PhD, FACI, PEng
University of Pittsburgh

COMMONWEALTH OF PENNSYLVANIA
DEPARTMENT OF TRANSPORTATION

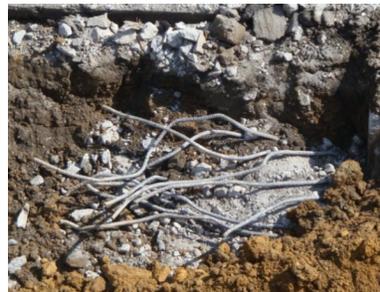
b) exposed #8 J-bars of demolished pier.
(Bridge C, Pier 2)

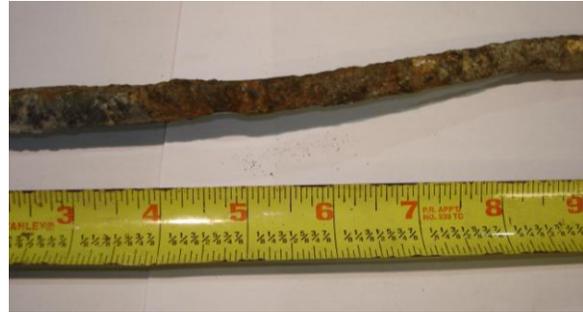
b) detail of #4 front bar 6 in. above footing.

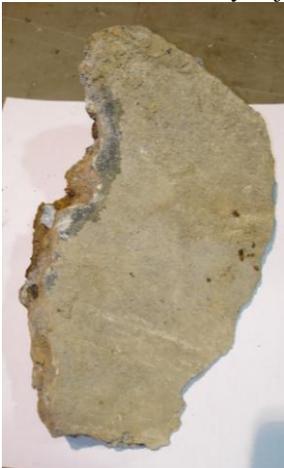
e) face of stem wall.

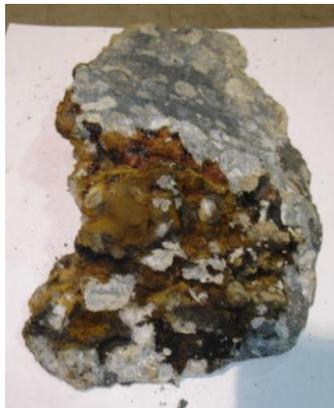
f) reverse view of (e)

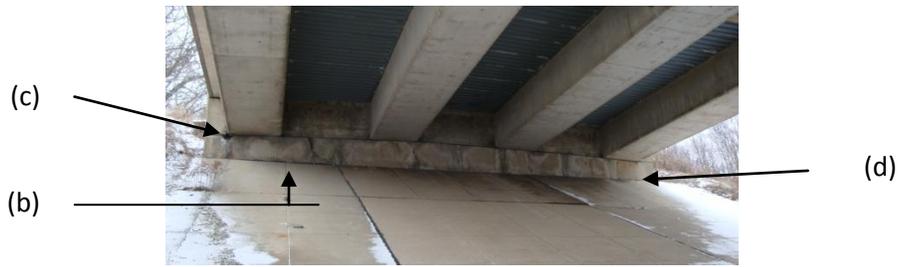
(a) Stem wall and embankment.

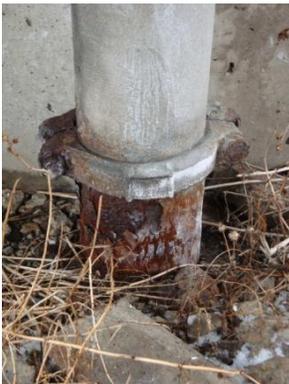
(a) Pier 7; drainage tied into roadway drainage.

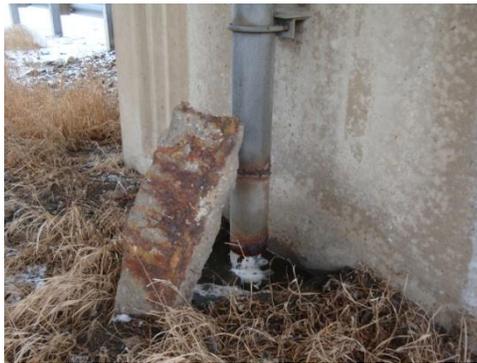
(b) Pier 6; 'free drainage'; fallen piece of pier (at girder bearing) shown.

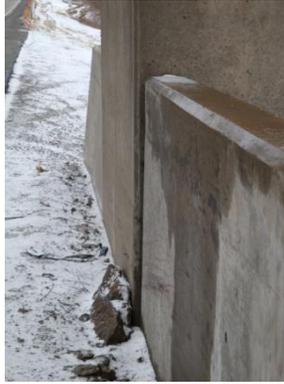
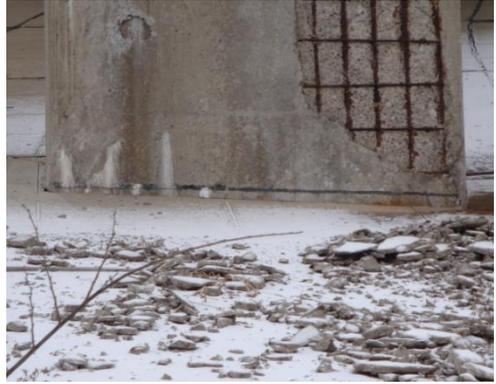
(b) Pier 1; approximately 6 inch settlement of embankment slab evident at base of pier.

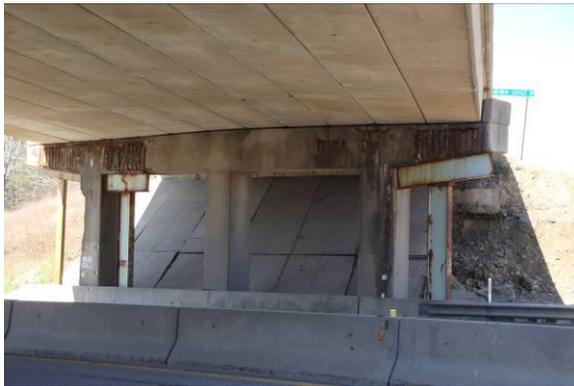
(a) Pier 1 (South face)

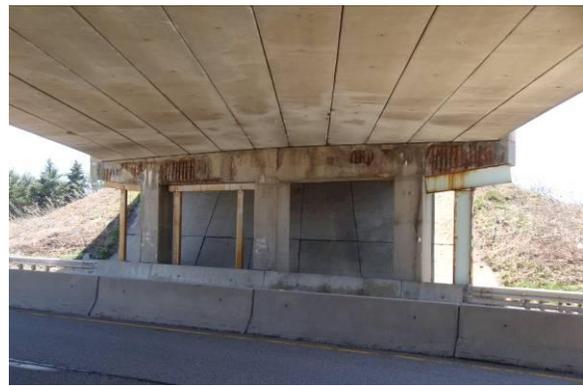
(b) Pier 2 (North face)

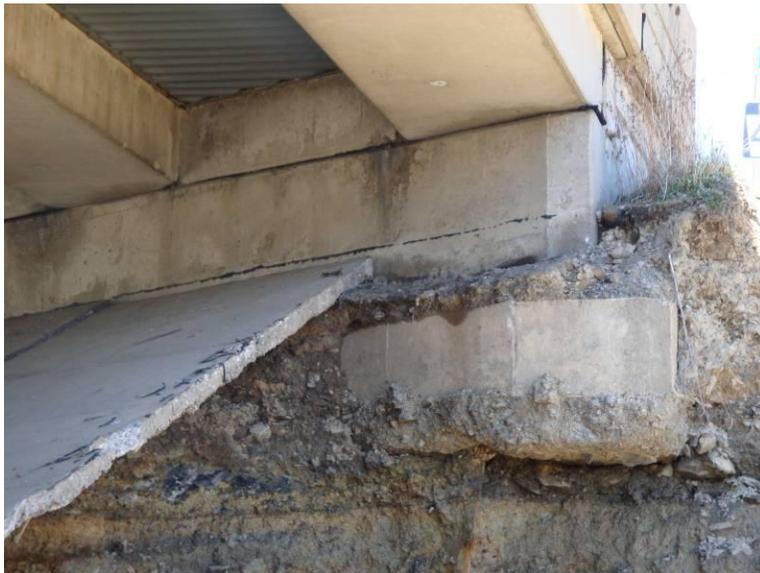
(a) North stem wall and embankment showing excavated footing.

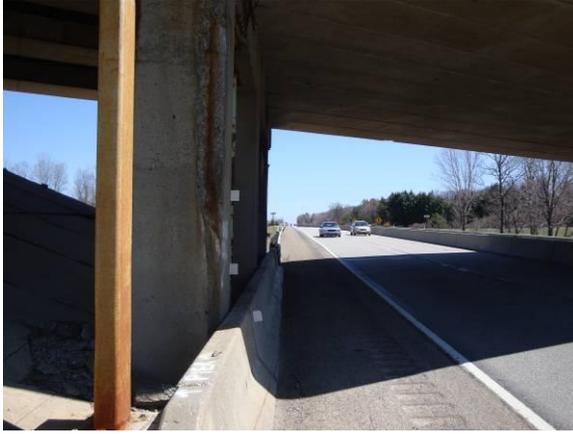
(a) Pier 1 proximity to SR 422 WB.

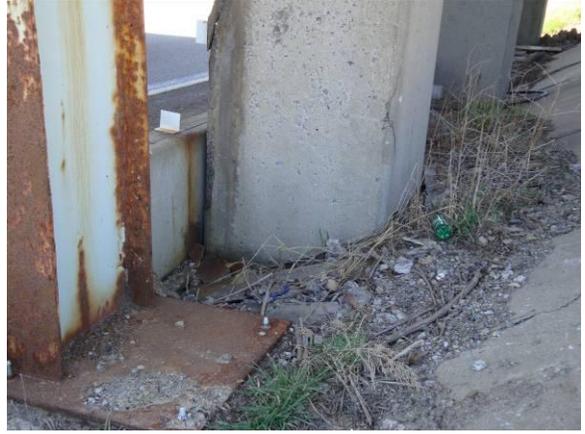
(b) Base of East-most column of Pier 1 and steel support column.

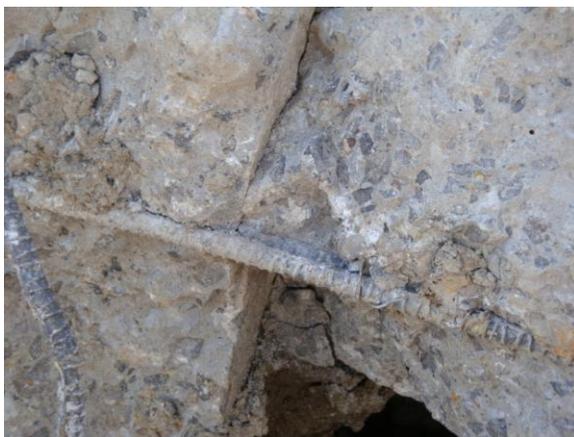
(b) lap splice of J-bar and stem wall bar *in situ*

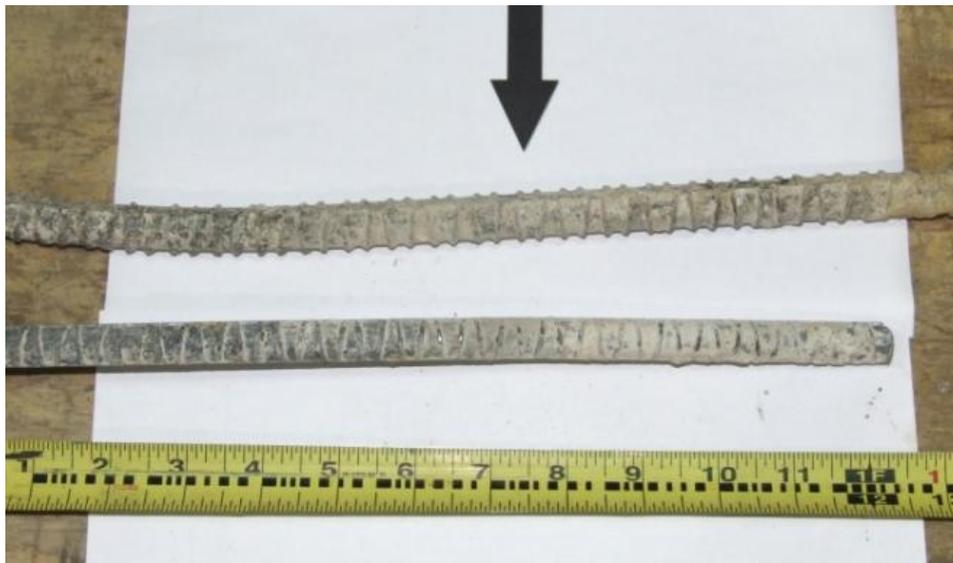
Based on the inspection, review and site availability, J-bar sampling was carried out on Abutment 2 as indicated in Figure 5. In the end, abutments and footings of the original bridge were not demolished; D10-0 arranged for the corners of Abutment 2 to be made available for this study. Specimens were removed from the East end of Abutment 2 as shown in Figure 5 (also shown in Figure 3b). Visual inspection of all recovered J-bars indicates no deterioration as shown in Figure 7.

Figure C7 #5 J-bar (top) #4 dowel bar (bottom).
(extension into footing to right of arrow; extension into stem wall to left)

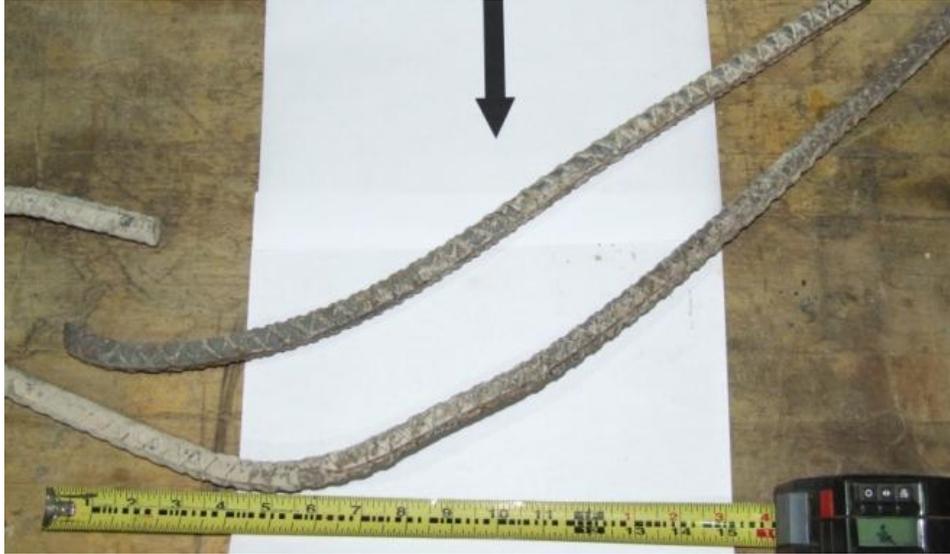
Figure D5 #5 J-bars
(interface location is approximate embedment into footing is at left)

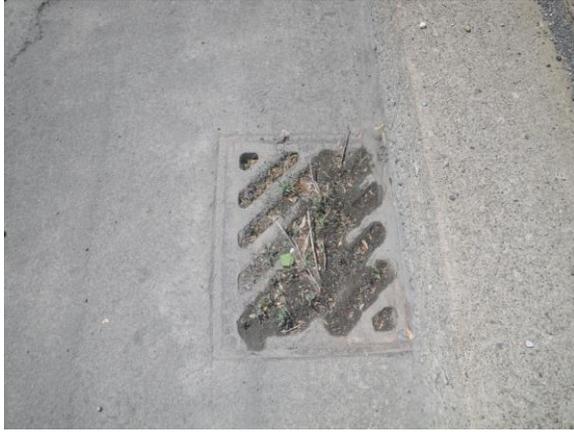
The PITT team visited the bridge on May 6, 2010 (see Figures 1 through 5). The bridge was open to traffic. The weather was clear and thus no assessment of active drainage could be made. Nonetheless, evidence of blocked drains and broken downpipes was noted (Figure 2).

(a) Deck drain

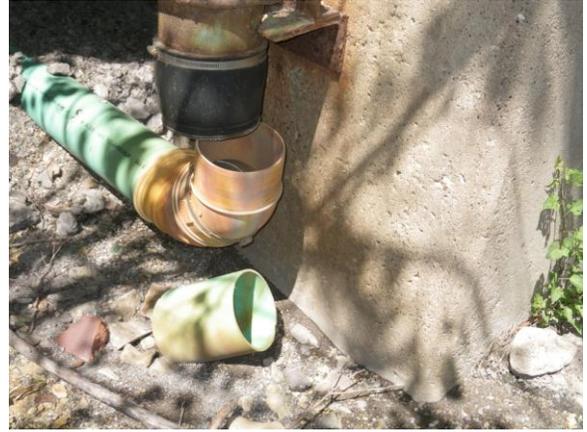
(b) Downpipe at North Pier (Pier 2)

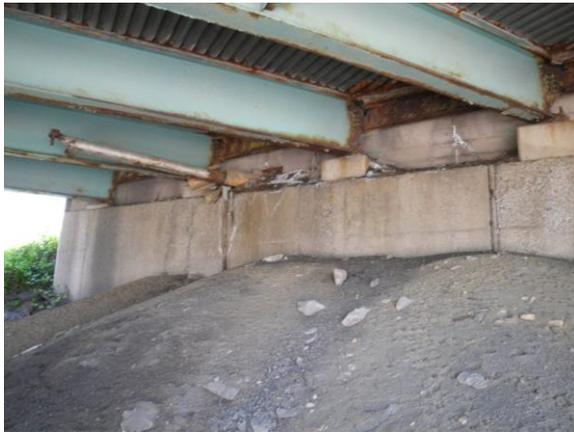
(a) North abutment.

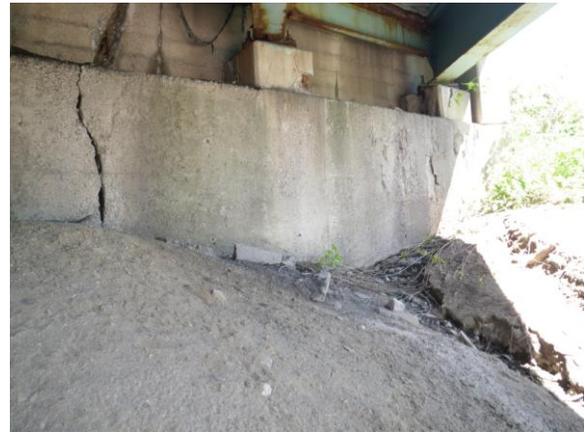
(b) Detail of North abutment.

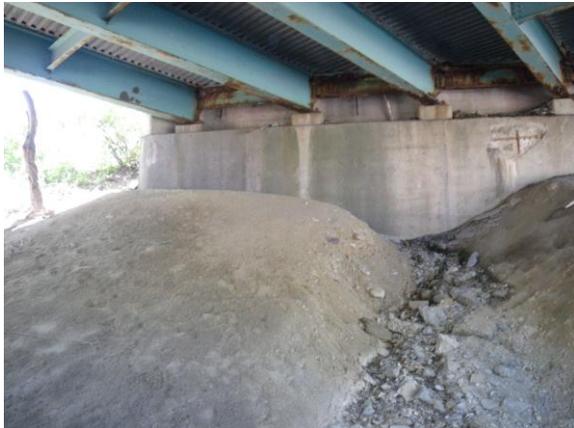
Figure E3 Condition of abutments.

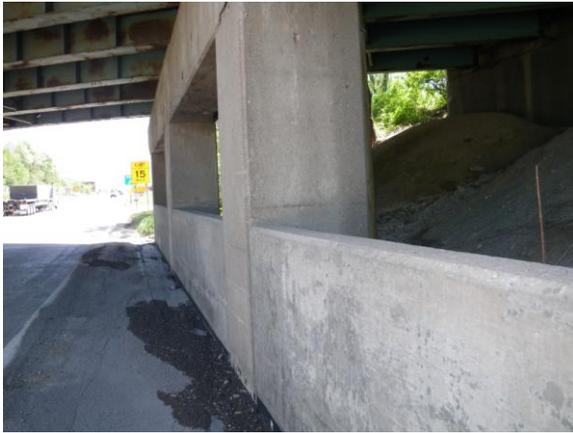
(a) Pier 2 proximity to SR 22.

Figure E4 Other issues that may affect J-bar performance.

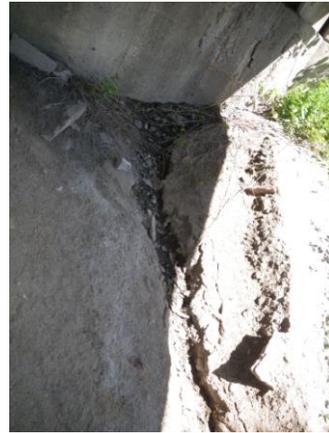
(b) drainage along slope at stem wall.

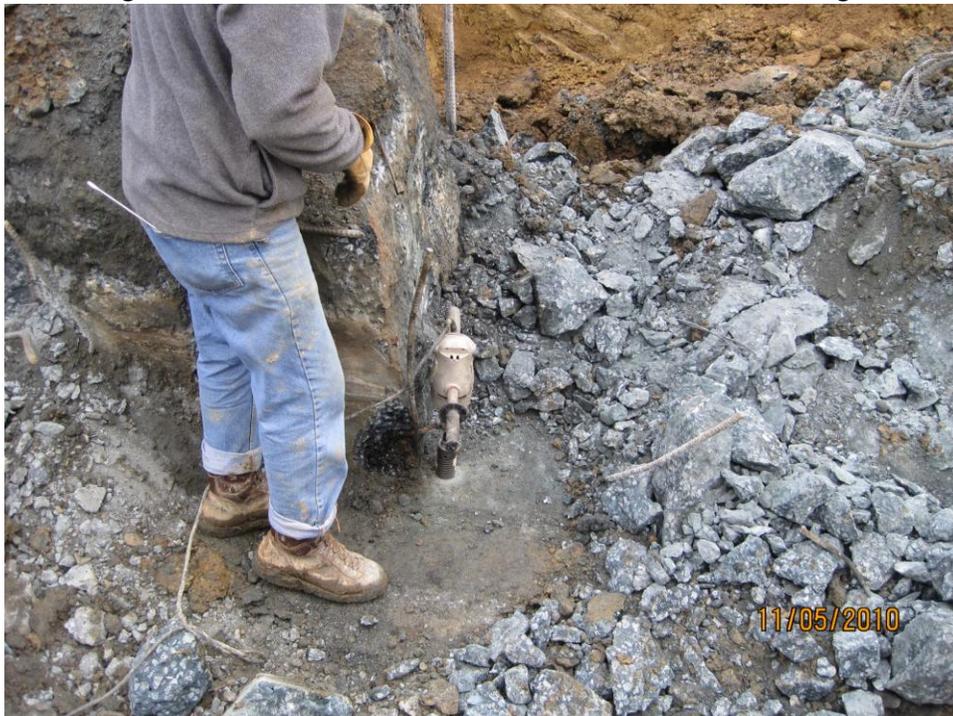
(c) Coring near front face bars

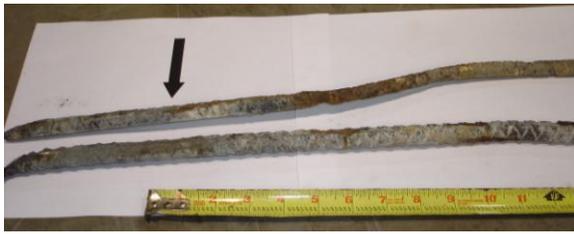
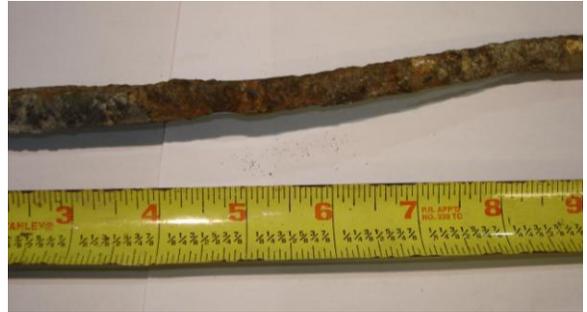
detail of #4 front bar 6 in. above footing.
Figure E6 #4 front J-bar (top) and #5 back J-bar (bottom).
 (extension into footing to left of arrow; extension into stem wall to right)

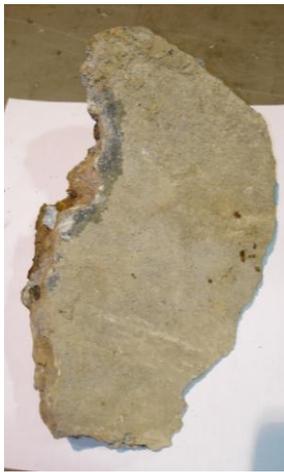
(a) face of stem wall.

Figure E7 Spalled stem wall concrete recovered from vicinity of crack showing significant evidence of corrosion product and concrete voids.

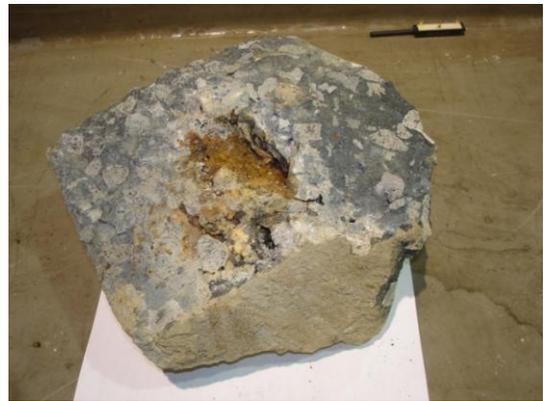
(c) void in concrete (front face of stem wall shown, interface to left)

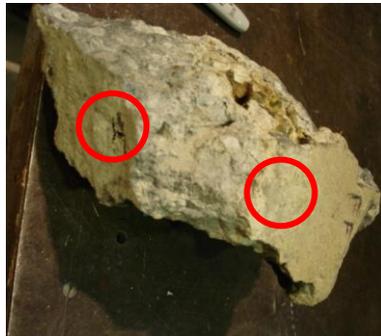
d) locations of chloride sampling

Chloride content was obtained from samples taken from the front face of the North Abutment (Figure 7). At a location 0.5 in. above the wall-footing interface, the chloride content was found to be 0.23%. At a location 1.5 in. behind the stem wall face, the chloride content was found to be 0.18%. The core recovered from the footing block (Figure 5a) was not available for testing.

interface: sample taken 1.5 in.
 behind face of stem wall

front face of stem wall: sample taken 0.5 in. above interface

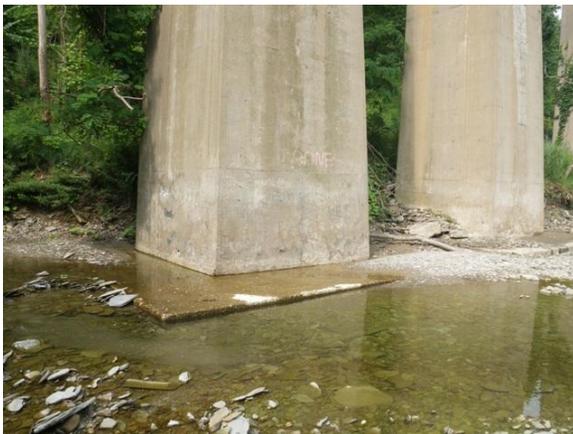
(a) Pier EB2

The bridge spans the six mile creek ravine. Piers EB2 and WB2 are located in/at the edge of Six Mile Creek as shown in Figure 2. Piers EB3 and WB3 are founded on the ravine floor in the flood plain as shown in Figure 3. Piers EB1/WB1, EB4/WB4 and WB5 are shorter and are located up the side of the ravine as shown in Figure 4. Table 2 summarizes the pier stem-footing interface details. The quality of available drawings is poor. Details given in Table 2 are therefore limited; missing data is denoted ^m.

Figure F2 Piers in Six Mile Creek.

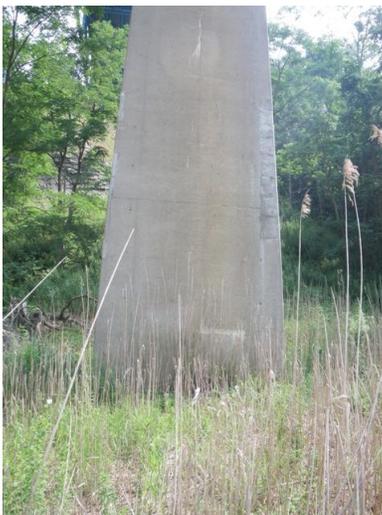
(a) Pier EB3

Due to their depth, the footings of Westbound piers 1,3,4 and 5 and Eastbound pier 3 could not be inspected. Although dry summer conditions were present during the site visit, it was observed that Eastbound pier 3 was located in an area which is similar to a wetland. Grass, sediment and driftwood were all present near and around Eastbound pier 3 and Westbound pier 3 (Figure 3).

Figure F3 Piers on ravine floor.

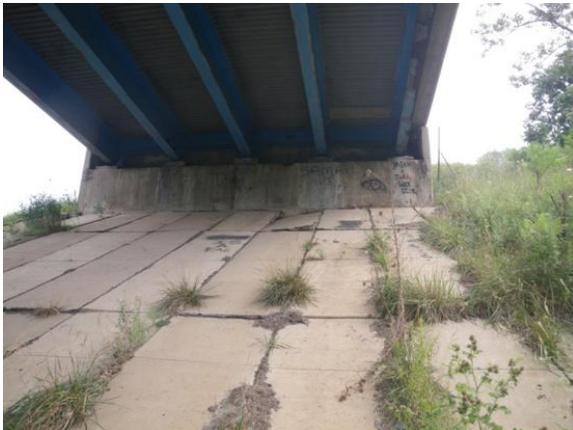
(a) EB abutment 1.

A significant amount of sediment was observed to be present on the Westbound abutment 1 (Figure 5b) Eastbound abutment 1 had some sediment on it and displayed a moderate degree of settlement and erosion issues (Figure 5a). Damage due to erosion and settlement was noticed on Westbound abutment (Figure 6b).

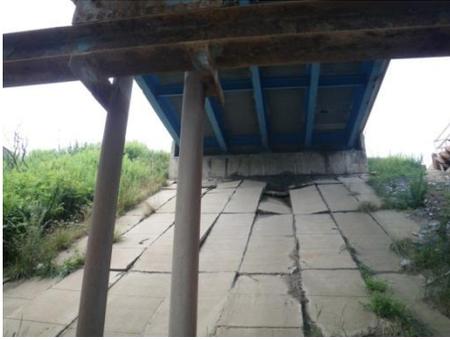
(a) WB abutment 2

showing temporary shoring of approach span..

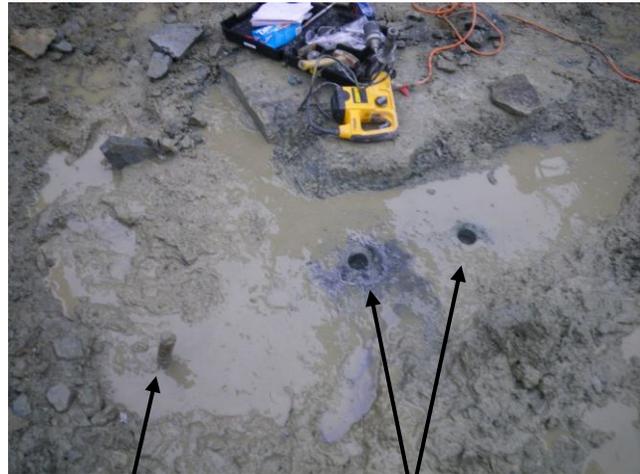
Chloride content obtained from two samples in the footing at the pier interface (Figure 8a) indicated an essentially uniform chloride content of 0.36% at depths to 1.75 in. In this case, both samples were taken from the face of the pier nearest the creek.

top: #11 dowel bars; no corrosion evident

Figure F8 Location of specimens and condition of reinforcement in Pier EB3.
