Repair Method for Prestressed Girder Bridges

FINAL REPORT

June 2009

Kent A. Harries, Ph.D., F.A.C.I., P.Eng.
Jarret Kasan
Can "John" Aktas
University of Pittsburgh

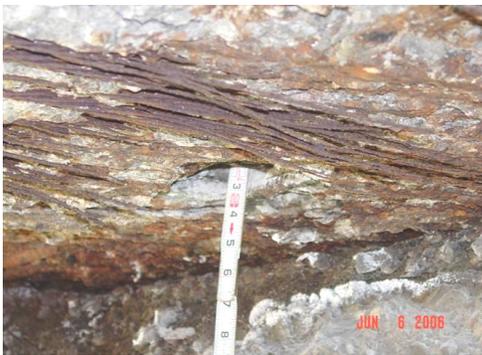
- Built in 1962
- In 2004:
 - Heavy erosion at piers near creek
 - Deck Drains clogged with soil
- From Inspection Photos:
 - Span 2, Pier 1 – extensive spalling at mid section
 - Span 2, Pier 1 – visible concrete spalling at pier connection together with strand exposure and heavy corrosion
 - First layer of strands exposed and broken, second layer is exposed and corroding
 - Span 2, Pier 2 – extensive corrosion and spalling at support
 - Many beams have end spalling, exposed strands and stirrups and visible corrosion
 - Beam 12 has apparent impact damage – exposed and broken strands with spalling
 - Beam 12 has significant underside strand exposure (spalling) believed to be from corrosion

Beam 12 – Strand unraveled and 4" hole

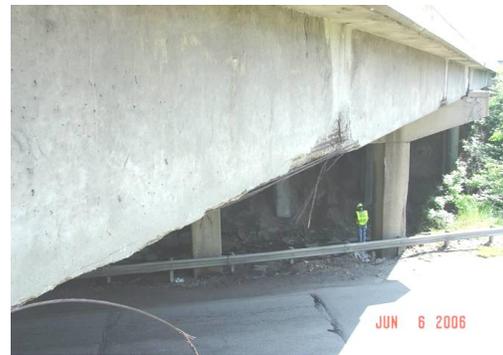
Beam 12 – Exposed strands near midspan, apparent impact damage

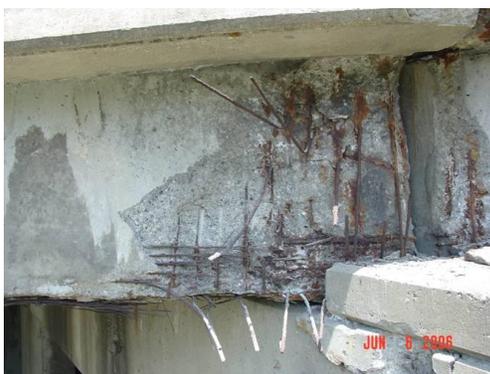
Beam 11 – exposed strands and reinforcing with heavy corrosion

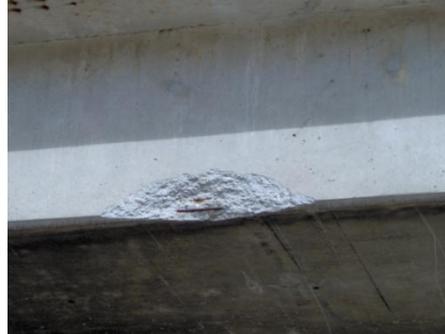
- Built in 1963
- From photos, it can be seen that drains have been clogged
- Crushing and/or shear related cracks at beam ends in a few places
- Seems to be impact damage*
- This damage is on the far side of the bridge considering the direction of traffic
- Slight spalling and one (possibly more) strand exposed

Close up of impact damage

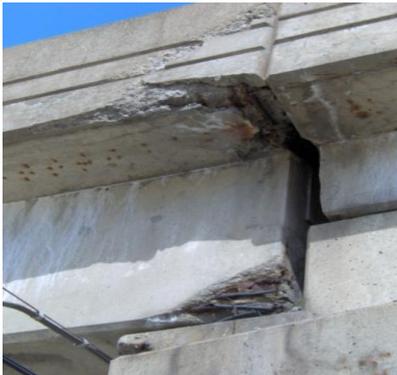
Beam end spall and parapet spalling

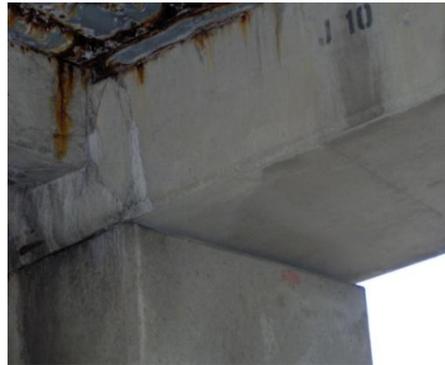
Efflorescence and cracking at beam end

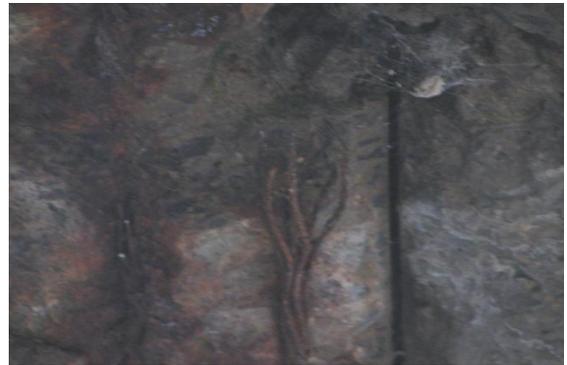
Beam 8 - Close up of broken strands

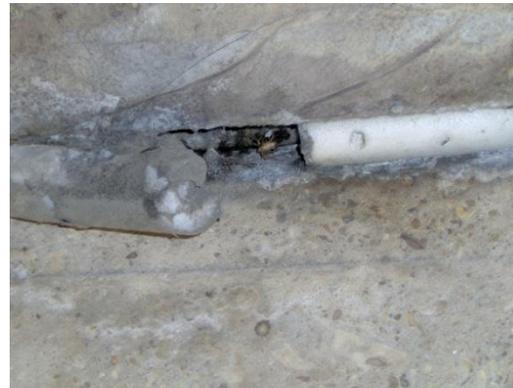
Filler material between Beams 6 & 7

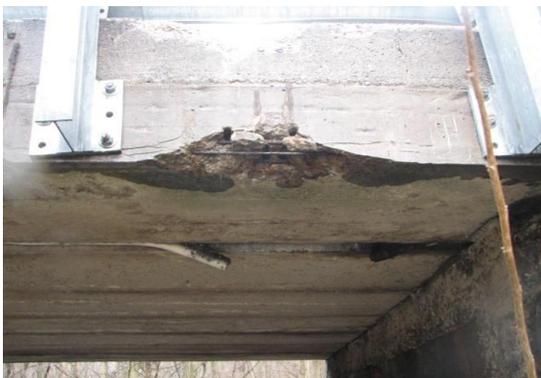
Spalling and exposed strands on exterior beam

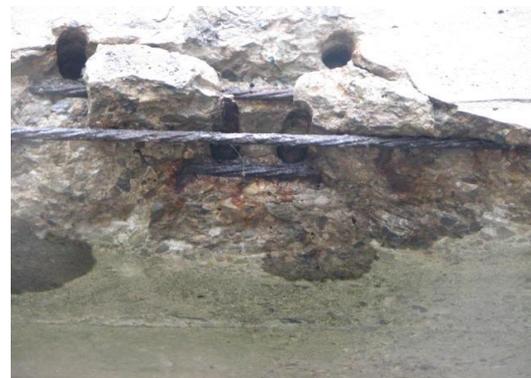
Close up of location of former guard rail location

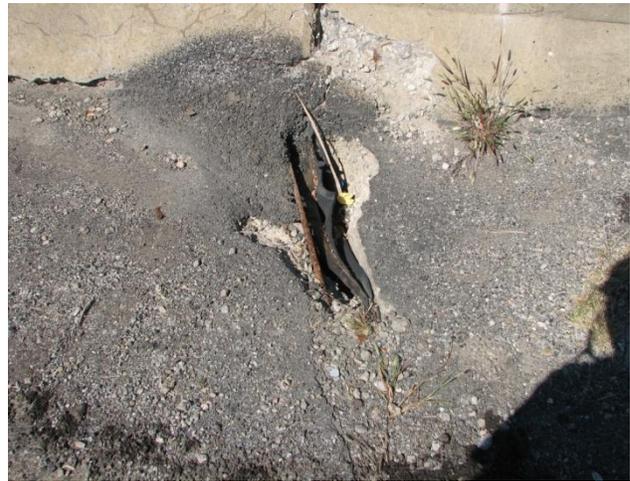
Hole in FLT paved joint

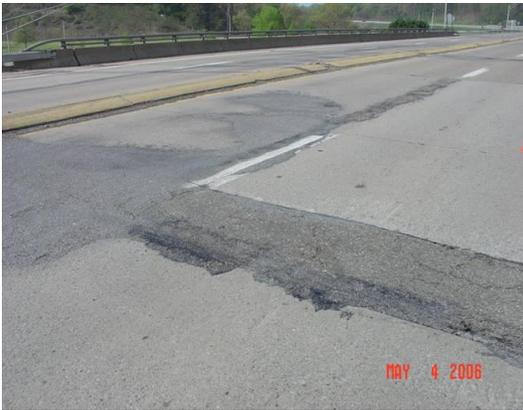
Far approach relief joint and approach slab

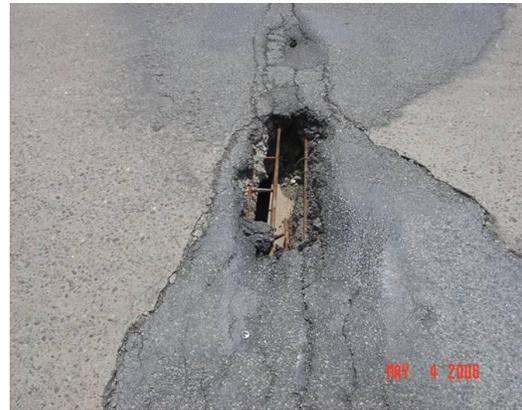
Hole through joint at Pier 3

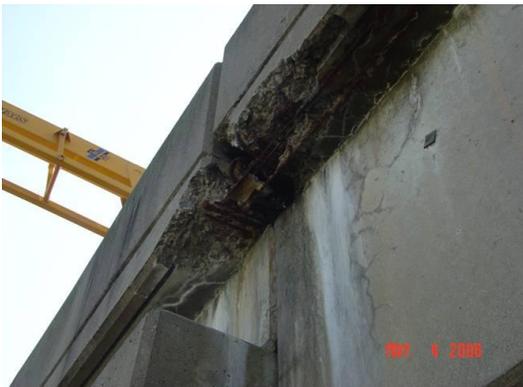
Sever spalling and reinforcement exposure on underside of parapet wall at Pier 3

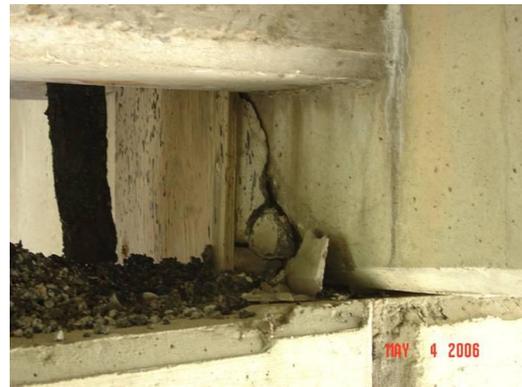
Cracking at the end of Beam 9, Span 1

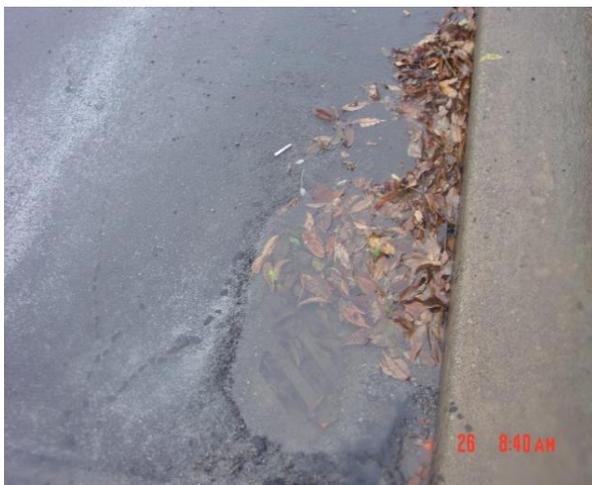
Clogged inlet of Span 1

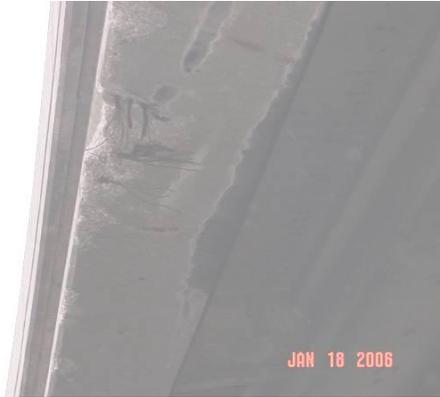
Span 3, Beam 8 – collision damage with exposed and severed strands

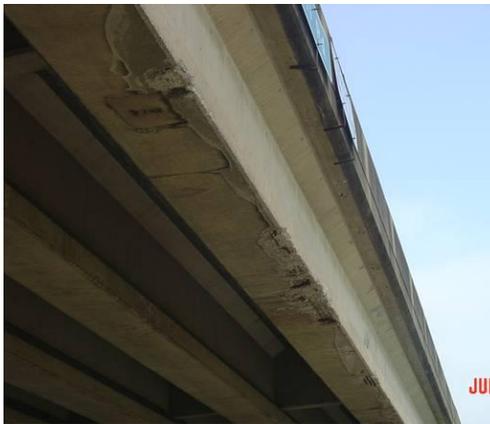
Collision damage on Beam 1, Span 2
